**Investigation of Fatal Accident
South Pelto Block 15, Well No. 4
OCS-G 09652
26 January 2005**

Gulf of Mexico
Off the Louisiana Coast

U.S. Department of the Interior
Minerals Management Service
Gulf of Mexico OCS Regional Office

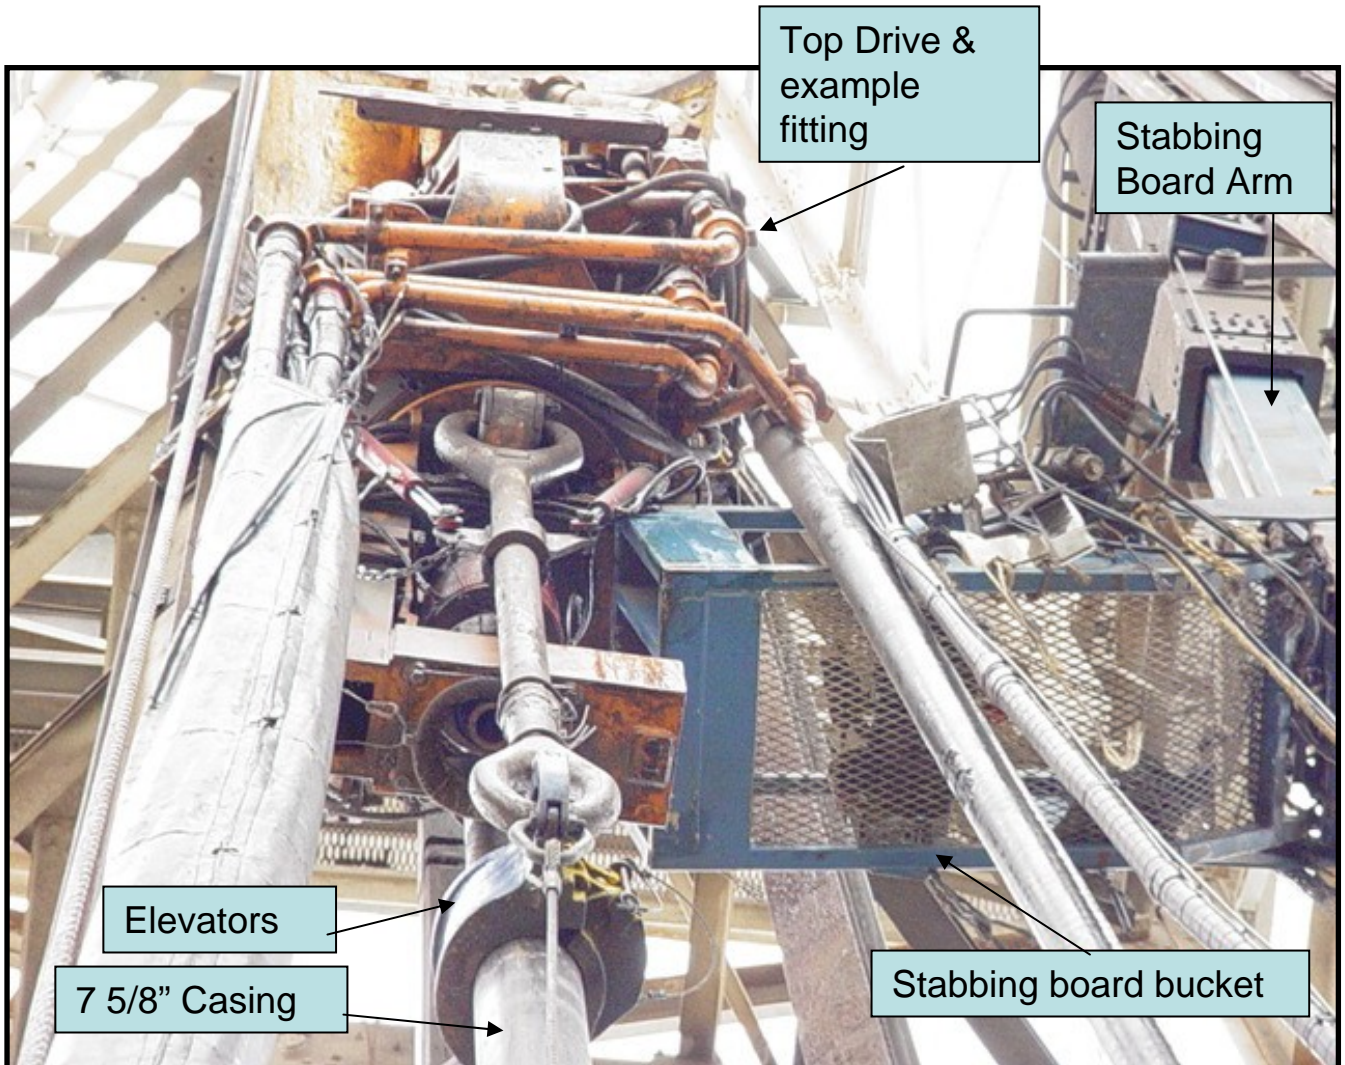
It was then discovered that the personnel bucket of the HSB was caught on the top drive unit and was suspended horizontally (*see Attachment 2*). The Stabber, who had been in the bucket, was observed to be partially suspended from his safety harness, not responding to communication from the drill floor.

Hydraulic Stabbing Board Bucket Hung on Top Drive

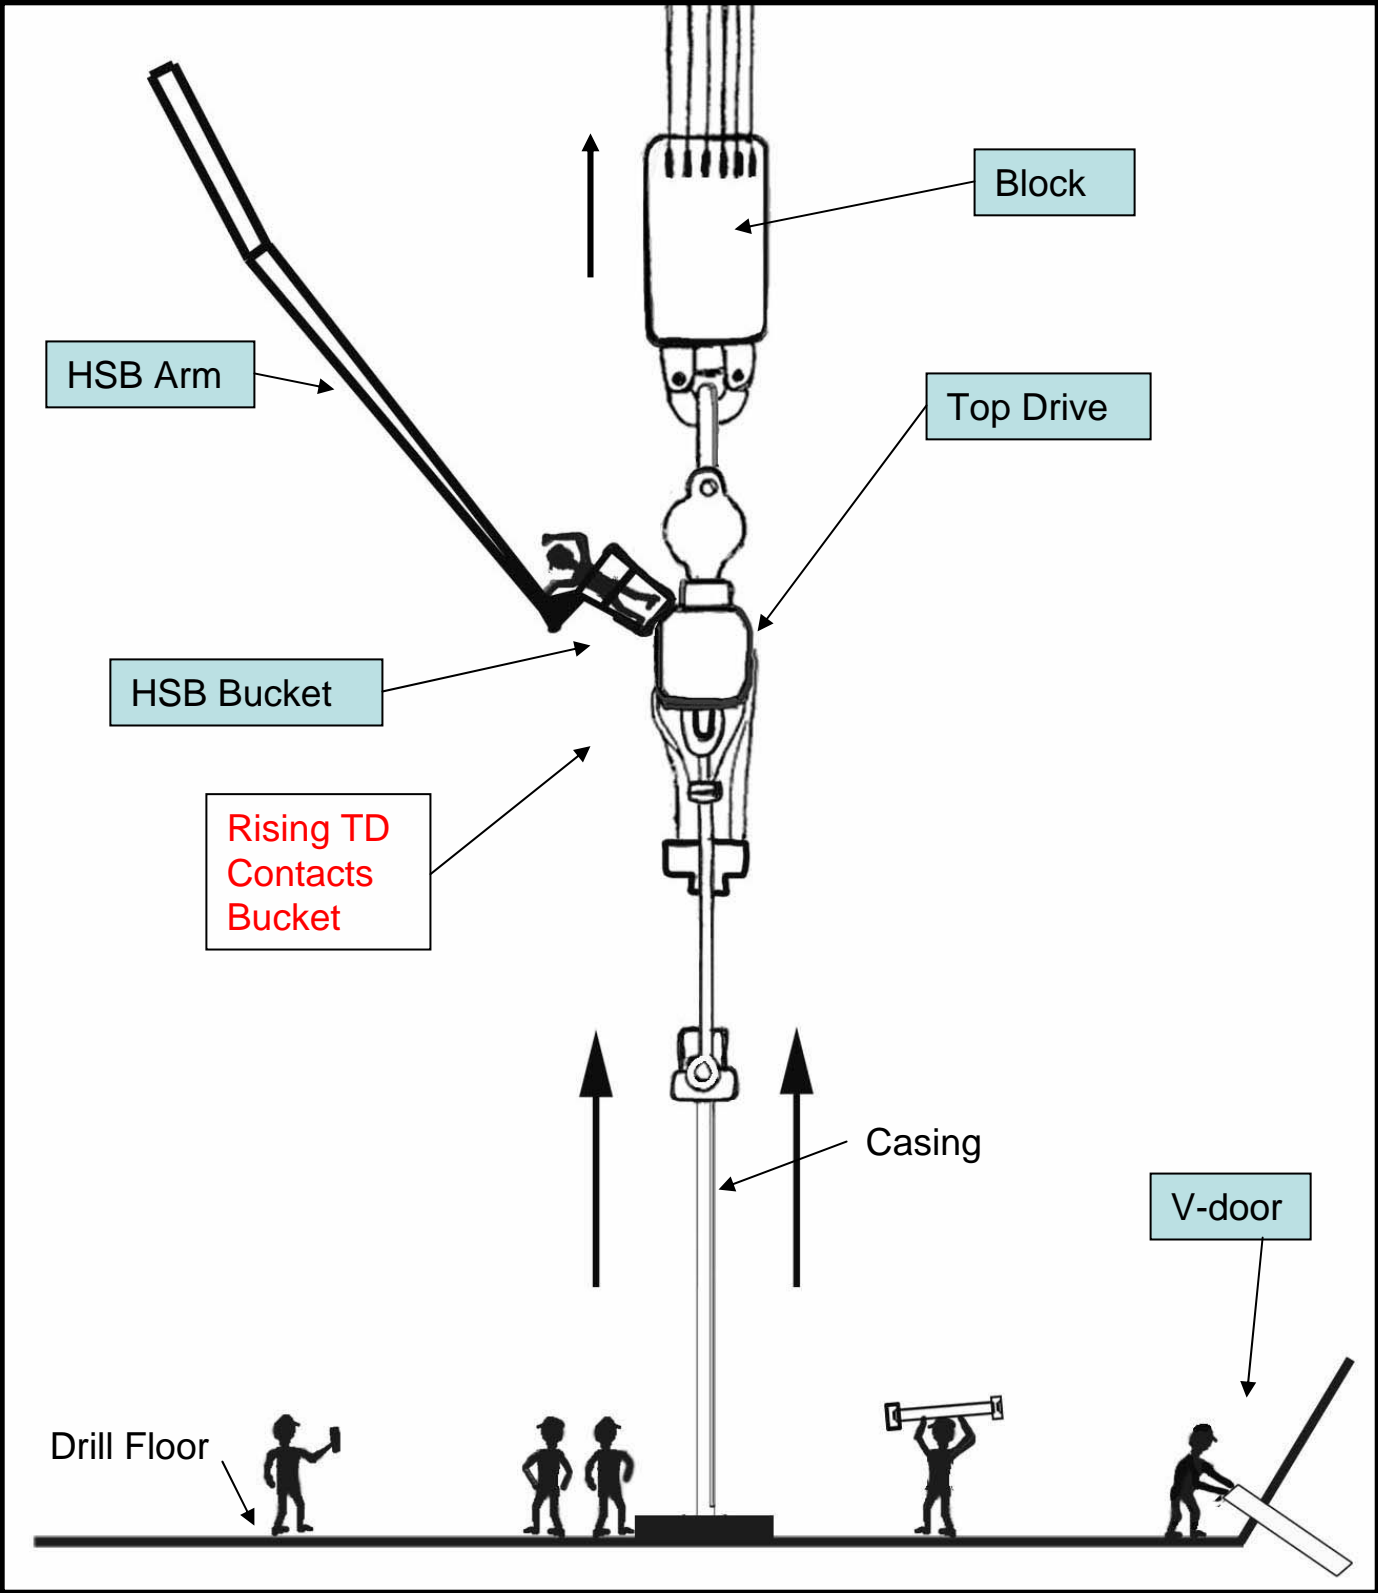
Pictorial Representation of Casing Operation Accident

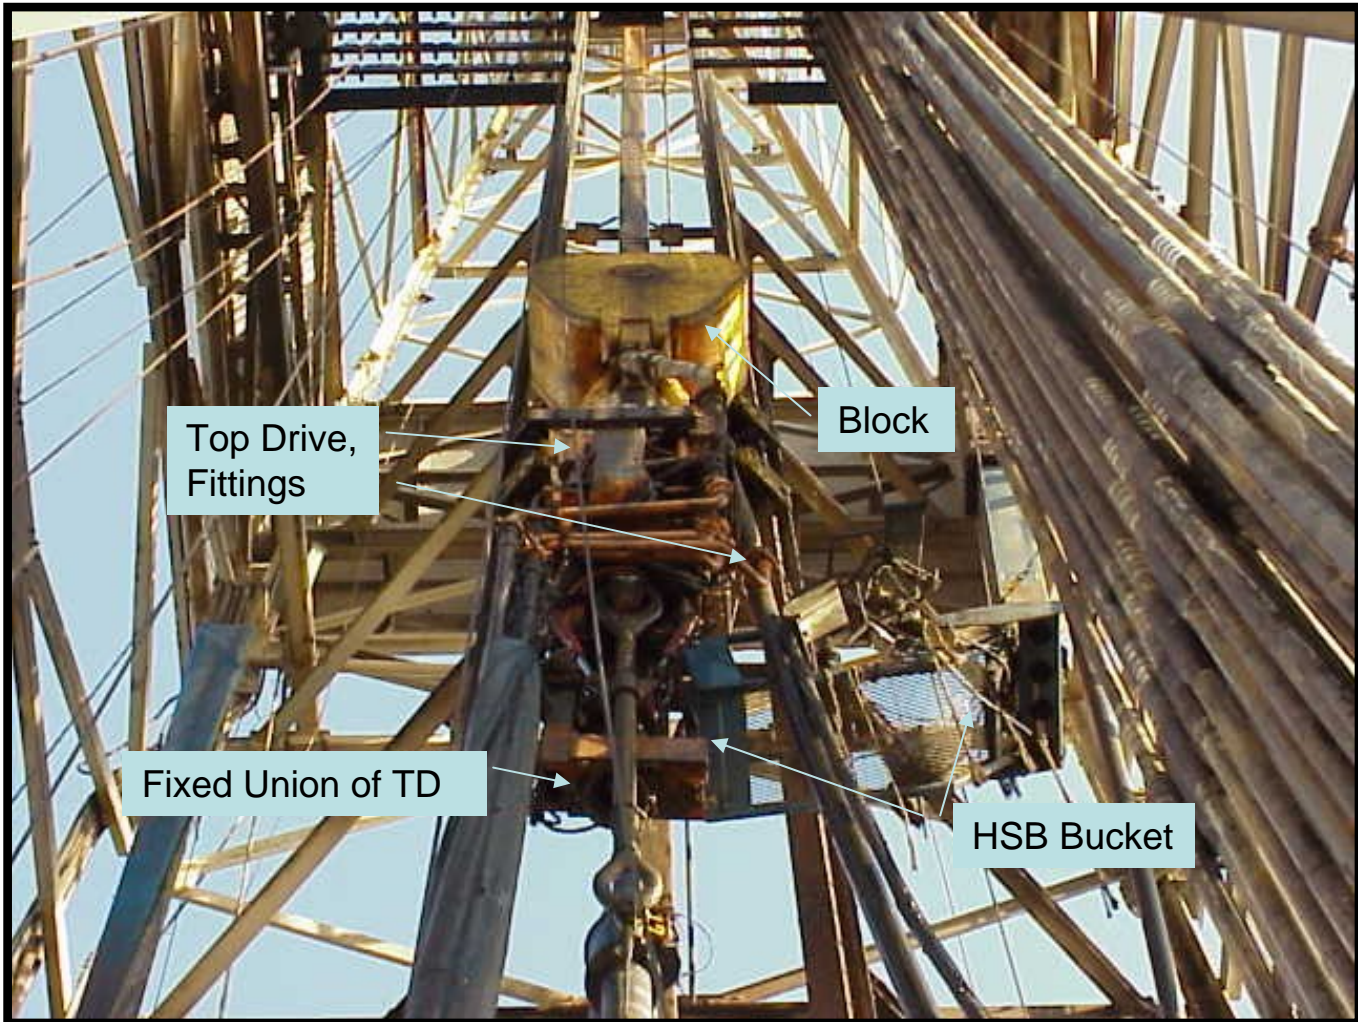
At 0800 hrs, the HSB personnel bucket was struck and hung up on the top drive unit as the block was ascending. The driller immediately halted the ascension of the block after hearing verbal warnings from the Casing Crew floor men, who had been preparing to set the slips. The ascent of the block, estimated at about 4 ft per second (from testimony), was completely halted within approximately 2-3 seconds (calculated) of the impact of bucket and top drive. Afterwards, the personnel bucket was found hung at 90 degrees from vertical on the top drive fixed union, some 10 ft below the top of the top drive unit (*see Attachments 10 & 11*).

Block, Top Drive, Hung Stabbing Board

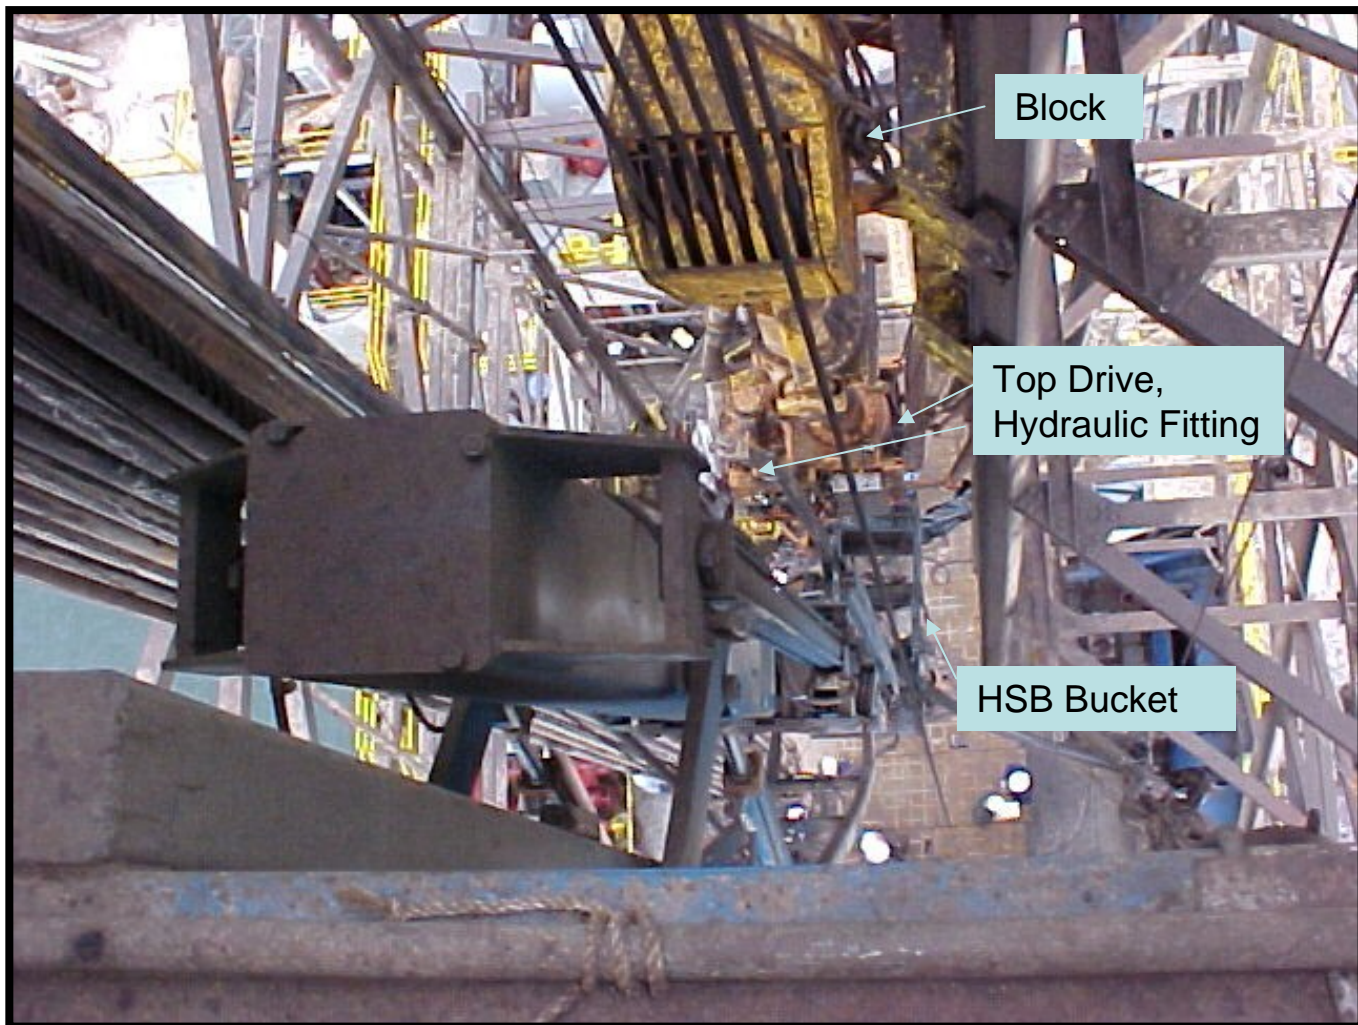
View From Above:

Block, TD, Hydraulic Fitting, Hung HSB Bucket

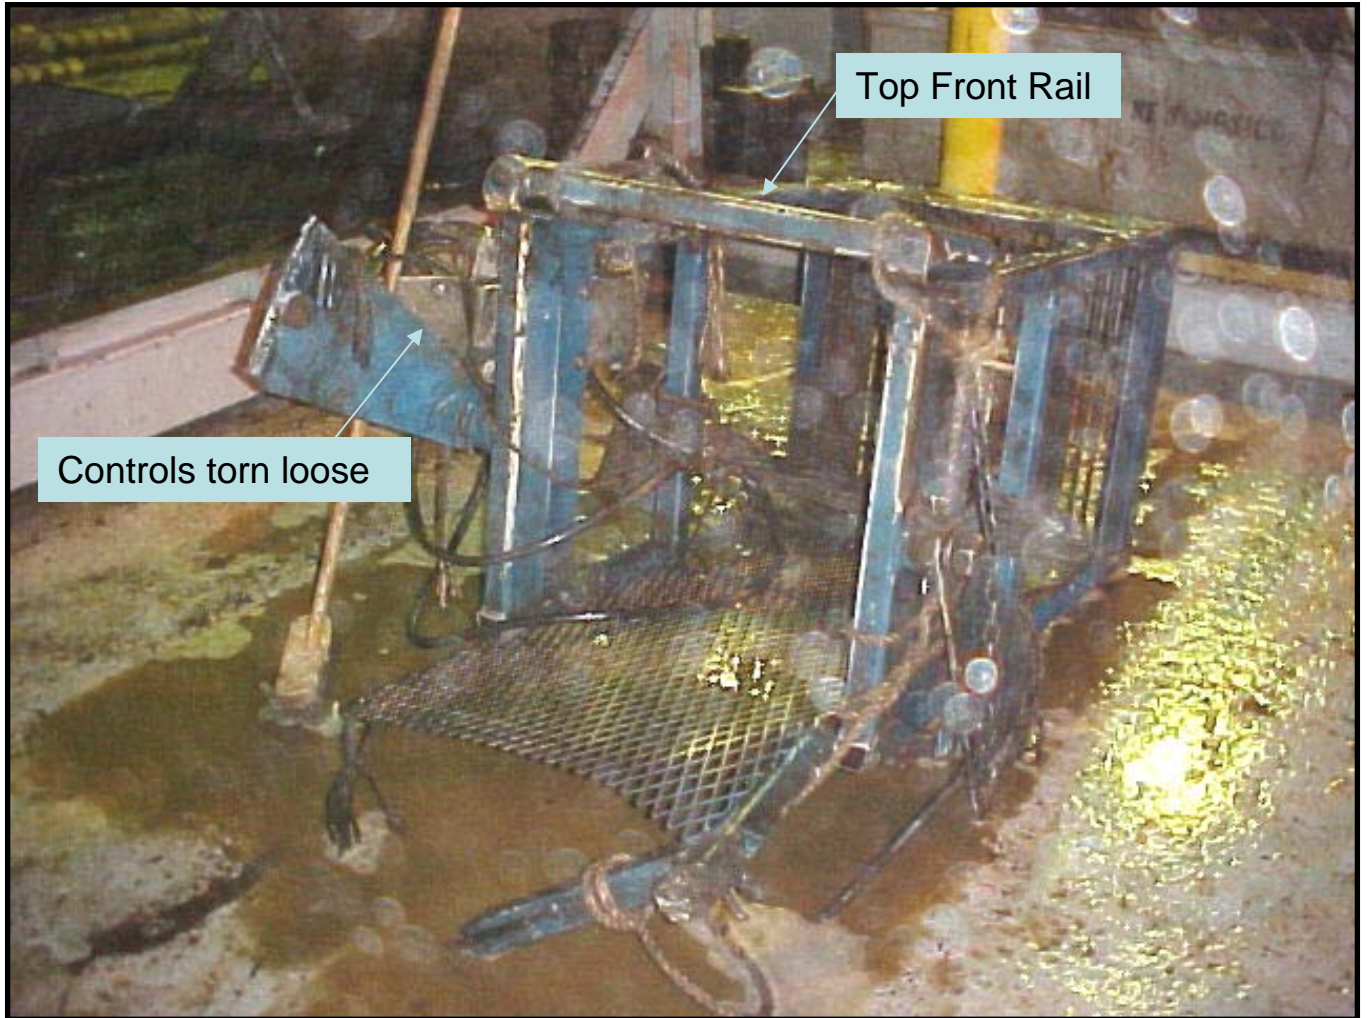
Marks on the bottom of the HSB personnel bucket matched the profile of a hydraulic fitting on the top of the top drive (*see Attachments 12 & 13*) and some residual scratch marks and personnel basket paint was on the top drive. A drawing was constructed approximating the path that the personnel basket would follow if it were initially lifted by the hydraulic fitting and then broke loose, ending in the observed position (*see Attachment 14*). The drawing shows that the personnel bucket could have been lifted to an angle of approximately 135 degrees before breaking loose from the hydraulic fitting, sliding along the top drive, falling, and lodging on the fixed union.

HSB Personnel Bucket, After Accident

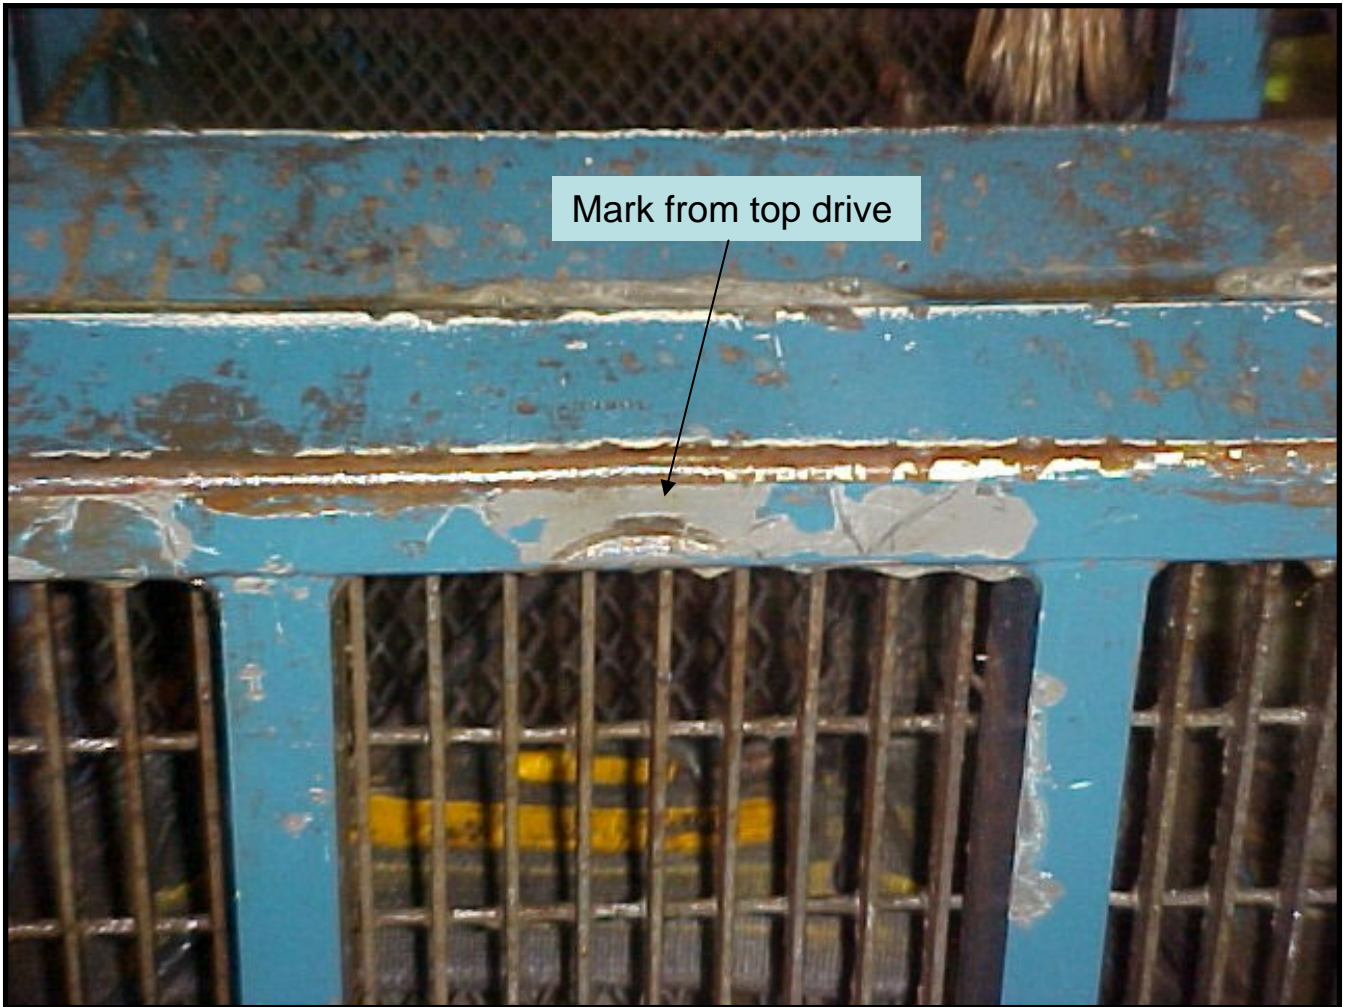
Fitting Union Mark on Bottom of Personnel Bucket

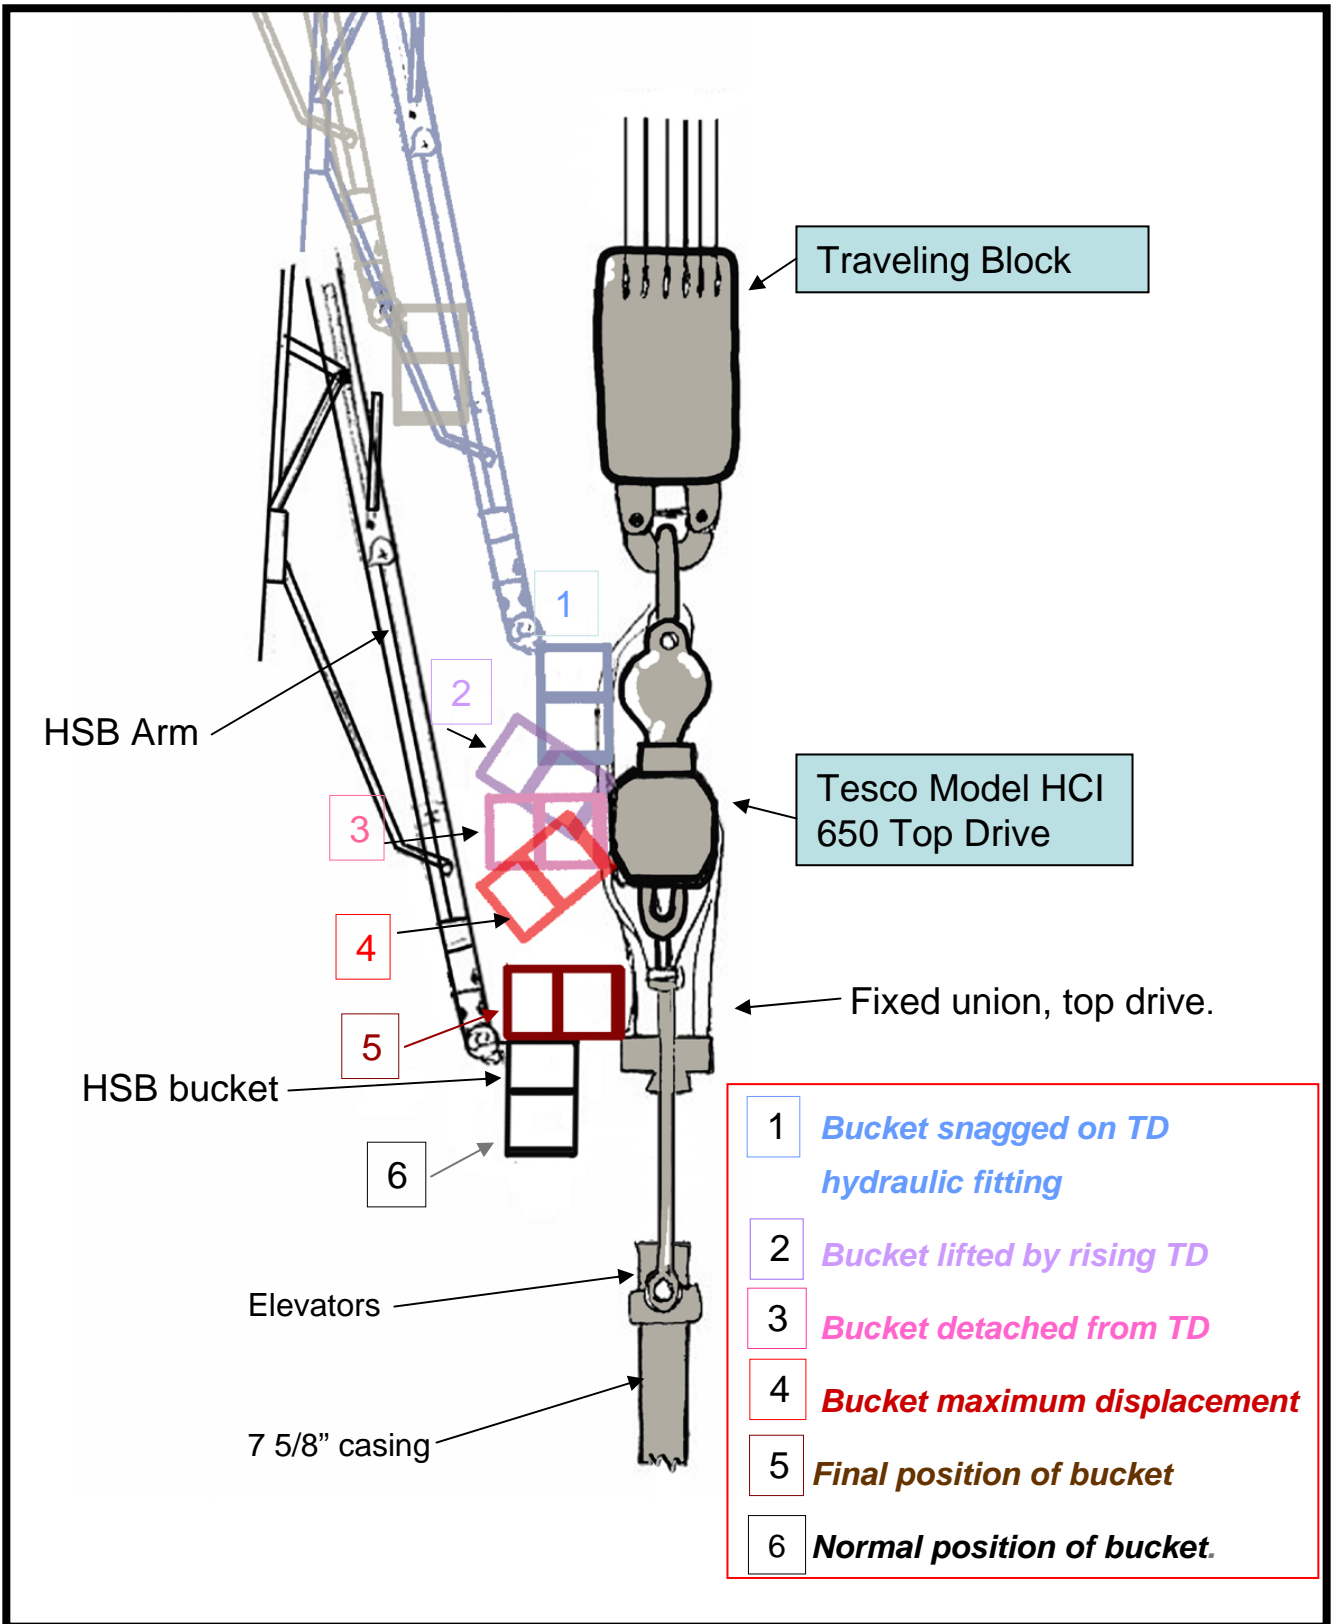
- 1. The HSB personnel bucket was caught on the top drive unit as it was ascending, and upended. This upending caused the front top rail of the HSB personnel bucket to crush the stabber against the boom arm of the HSB. The injuries from this contact caused the death of the stabber.*
- 2. It is concluded that the stabber activated the controls for the HSB before the passage of the top drive unit and that, as a result, the HSB bucket was accidentally maneuvered by the Stabber into the path of the rising top drive unit.*
- 3. It is concluded that the HSB controls had a prolonged response hesitation or Delay. The Delay of the response to the controls played a contributory role in the fatality.*

Drawing of Movement of HSB Bucket When Hit by Top Drive
