REPORT OF INVESTIGATION

Underground Metal Mine
(Zinc)

Fatal Fall of Back Accident

Balmat Mine No. 4 & Mill
St. Lawrence Zinc Company, LLC
Gouverneur, St. Lawrence County, New York
Mine I.D. No. 30-01185

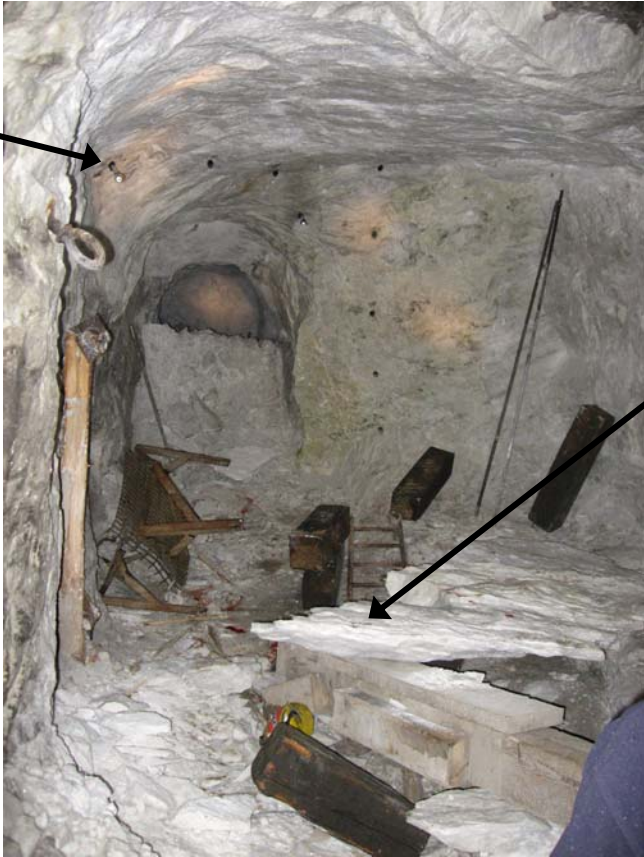
Drill steel

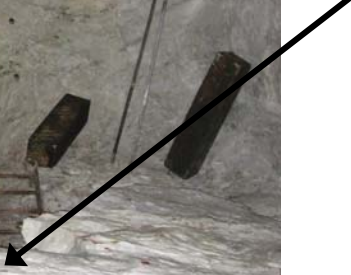
Rock that fell from back and struck the victim pinning him.

The ground fell in a single slab that broke into three large pieces and several smaller pieces upon impact. The individual slabs measured 8.5 feet by 4.0 feet by 14 inches thick; 7.0 feet by 1.6 feet by 9 inches thick; and 9.0 feet by 4.0 feet by 10 inches thick. The combined weight of the material was estimated to be roughly 3.3 tons.

The ground, ribs, and floor at this drift were composed of bright white, coarsely crystalline dolomitic marble referred to as “Bed 12.” According to mine geologists, this rock unit was highly susceptible to spalling.

The evaluation of the 2100 level vent drift revealed that no action had been taken to support the loose, drummy sounding, material in the back of the drift. There were separations or cracks present over the entrance into the drift but no support was installed.

Corrective Action: Ground support should be used where conditions or mining experience in similar ground conditions in the mine indicate that it is necessary.

Corrective Action: Management should ensure that established policies, procedures, and controls are followed. Miners should be trained to install ground support in adverse conditions as required.

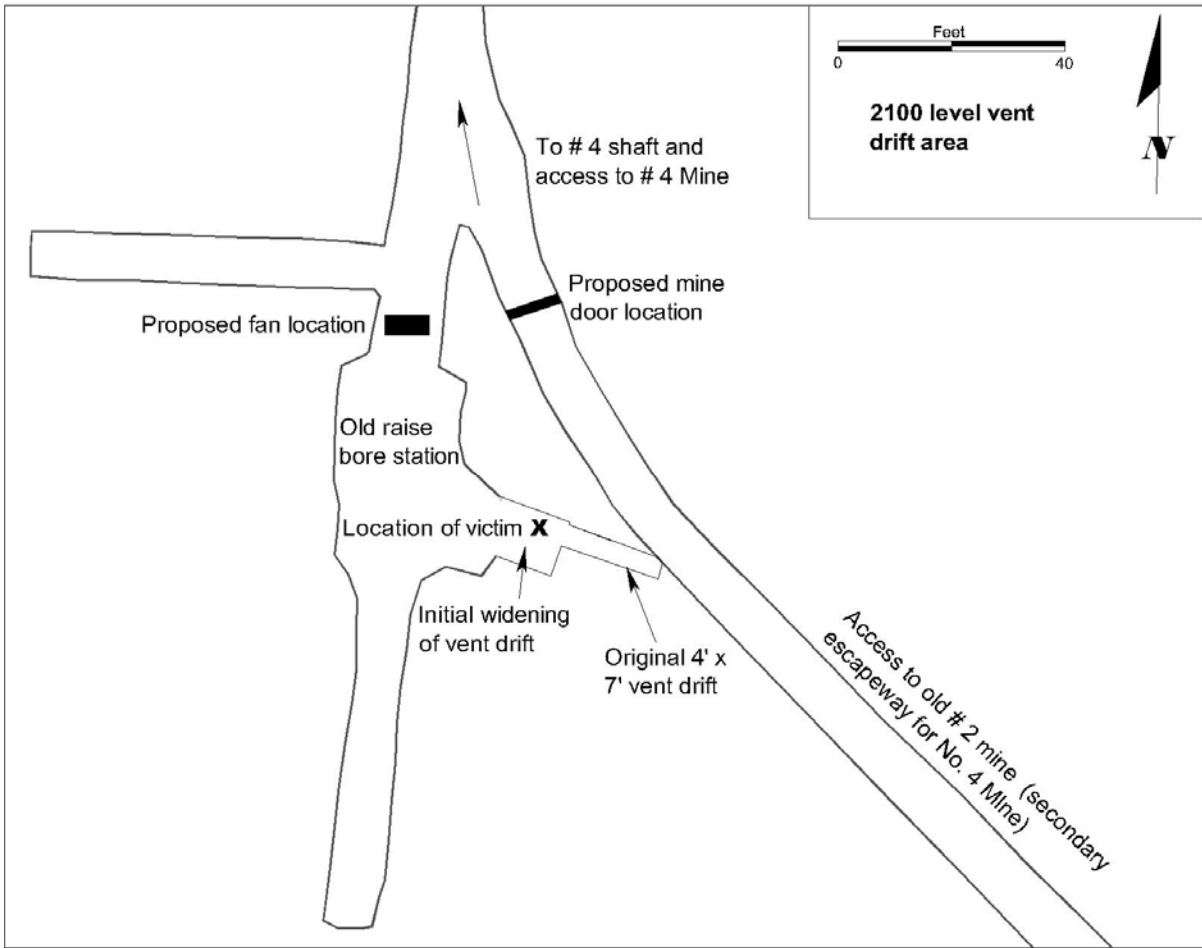
Figure 1 – Schematic of the Accident Scene (2100 Level Vent Drift)

The accident occurred in a vent drift on the 2100 level approximately 614 feet from the No. 4 Shaft and approximately 1,380 feet below the surface (Figure 1). The vent drift comprised one leg of a triangular development configuration and connected an old raised bore station and the access drift to the old No. 2 Mine. The access drift served as the secondary escapeway for the No. 4 Mine.
