**JOHN F. KENNEDY  
SPACE CENTER**

MAB 3221-69

**(Status Report)**

**Study of Corrosion Protection  
Methods for GSE Applications at  
Kennedy Space Center**

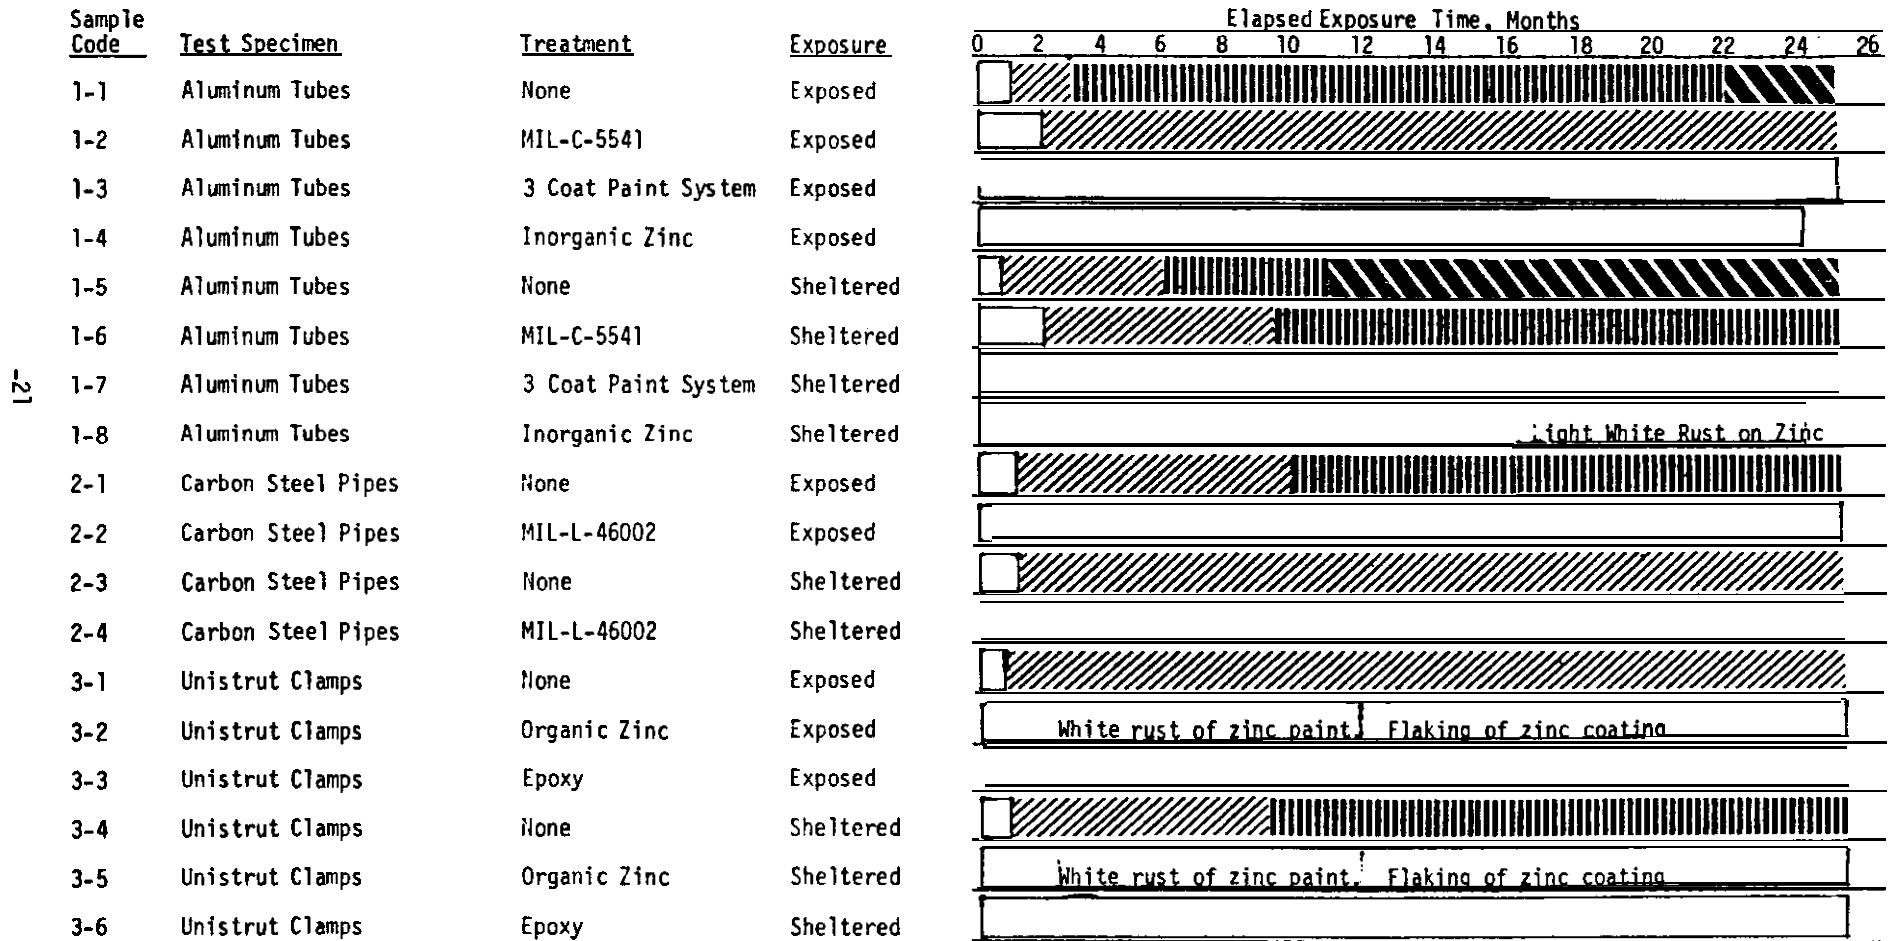
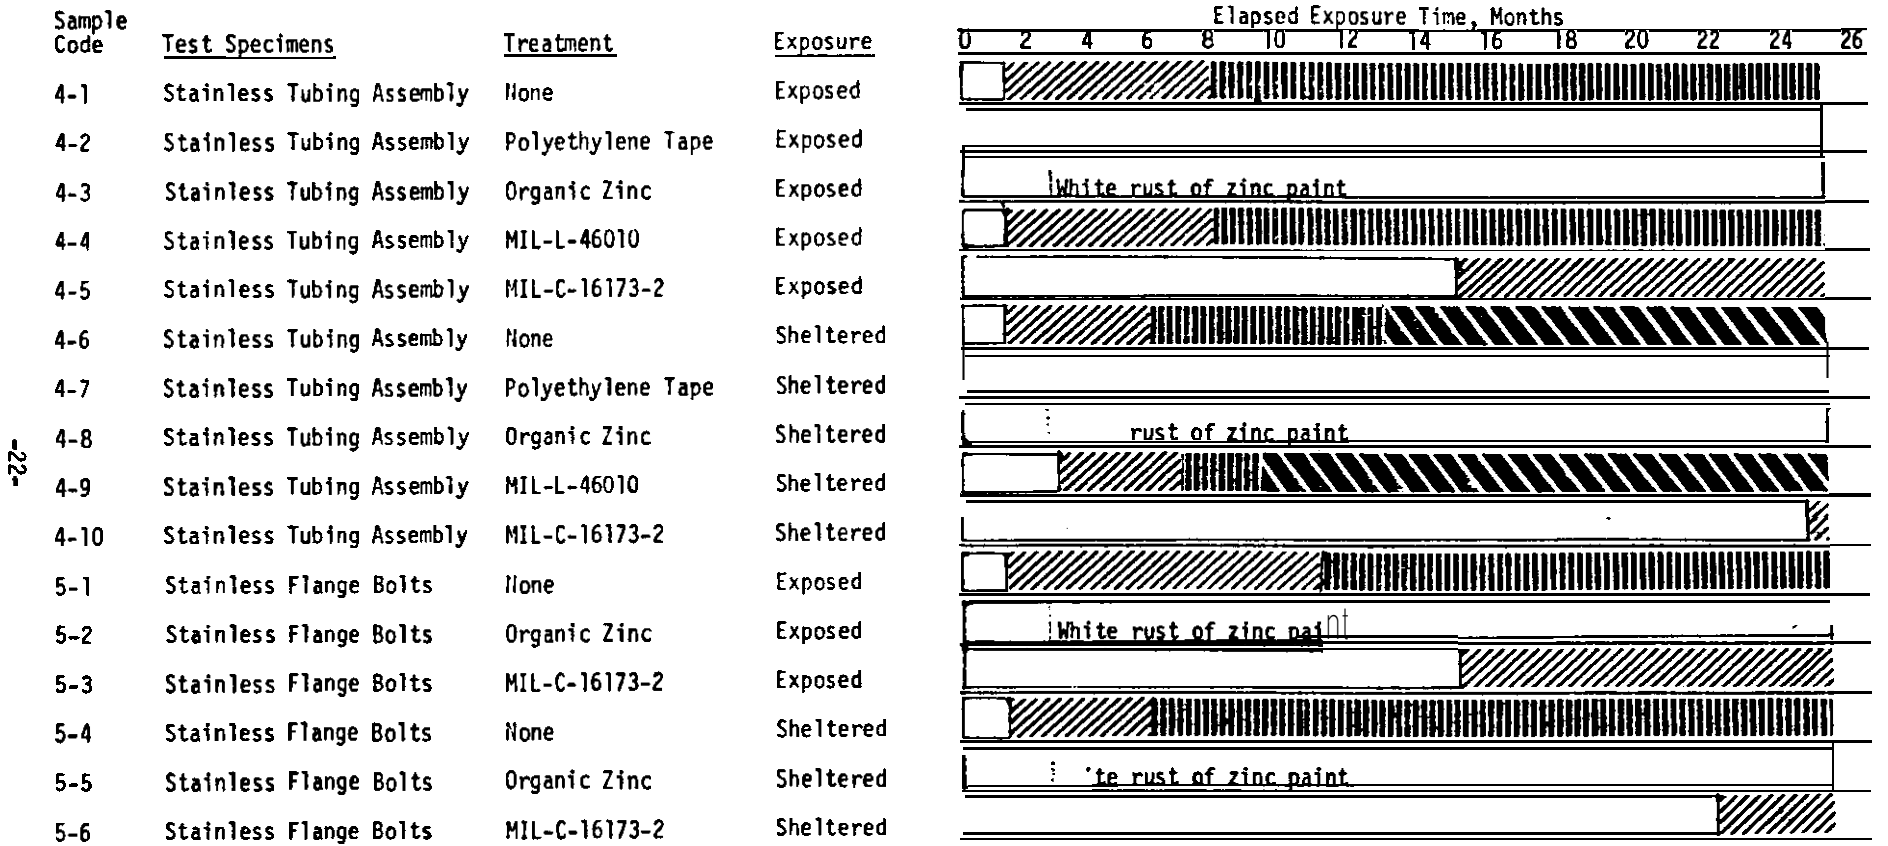
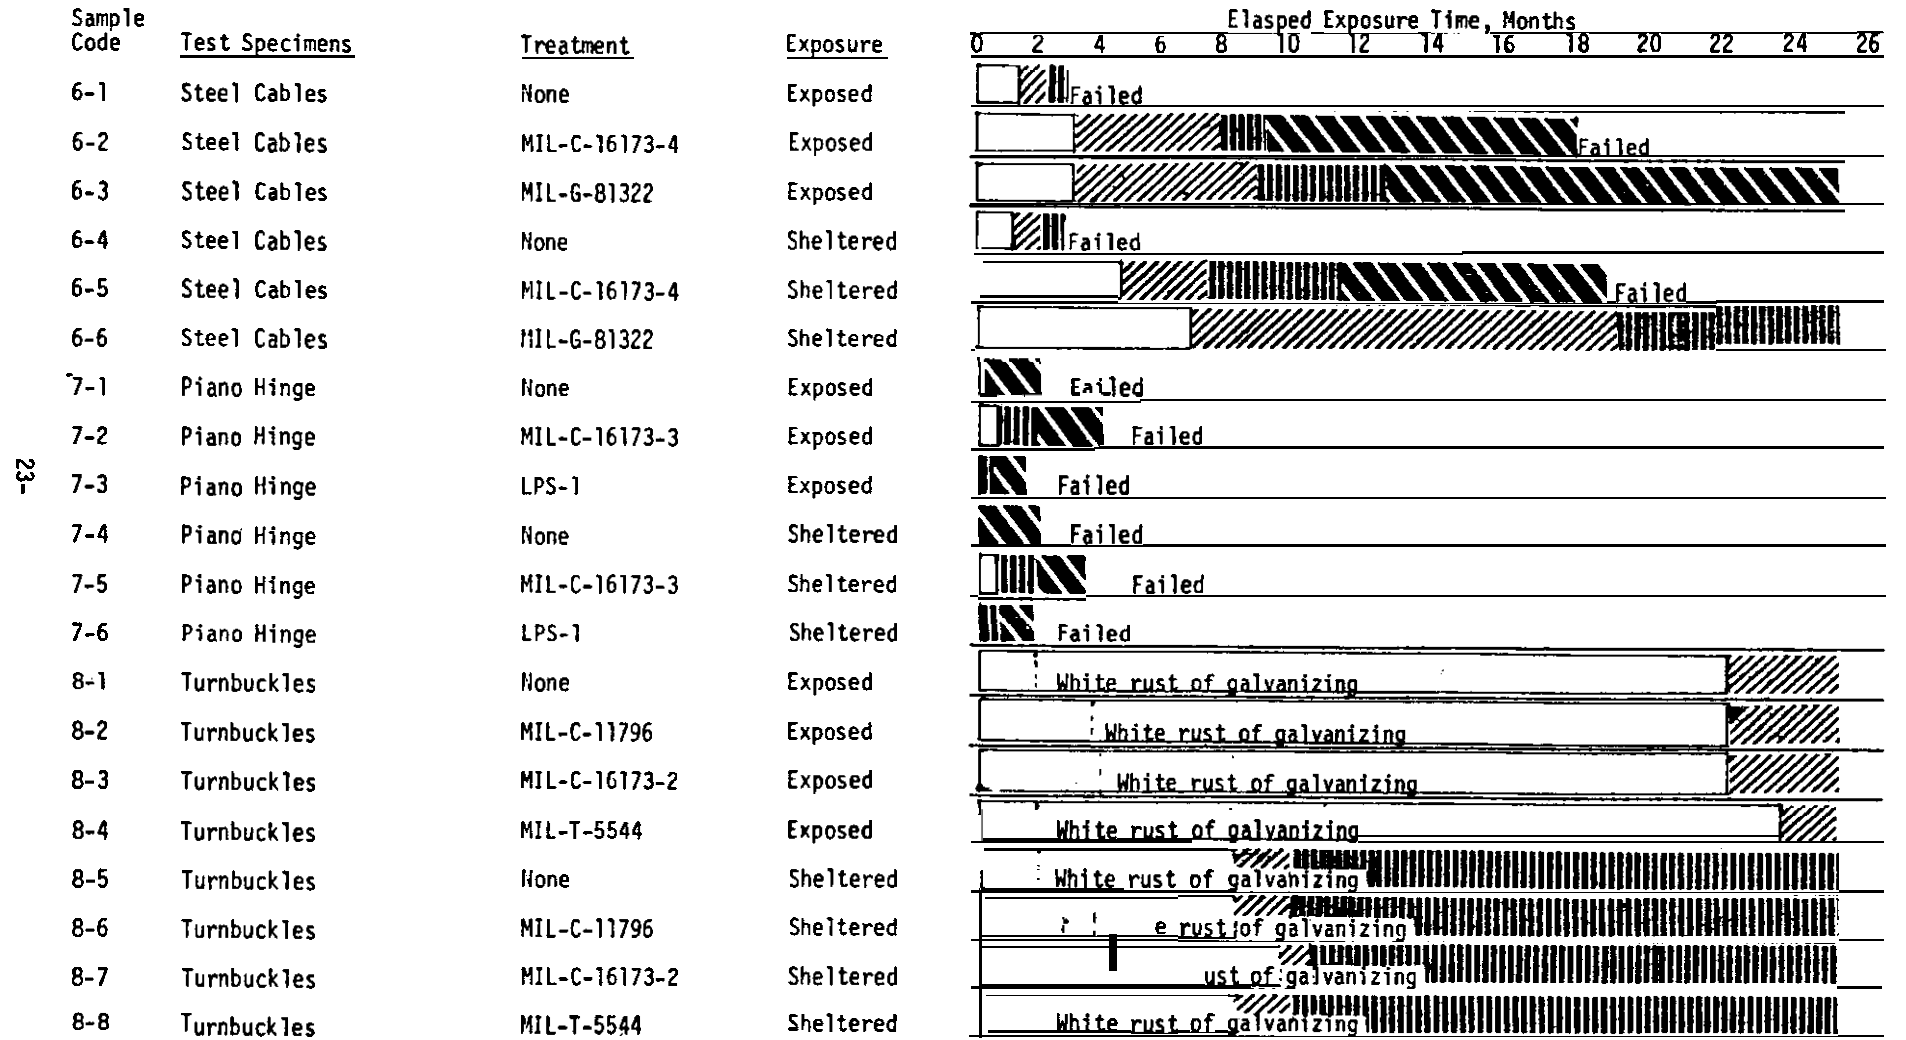
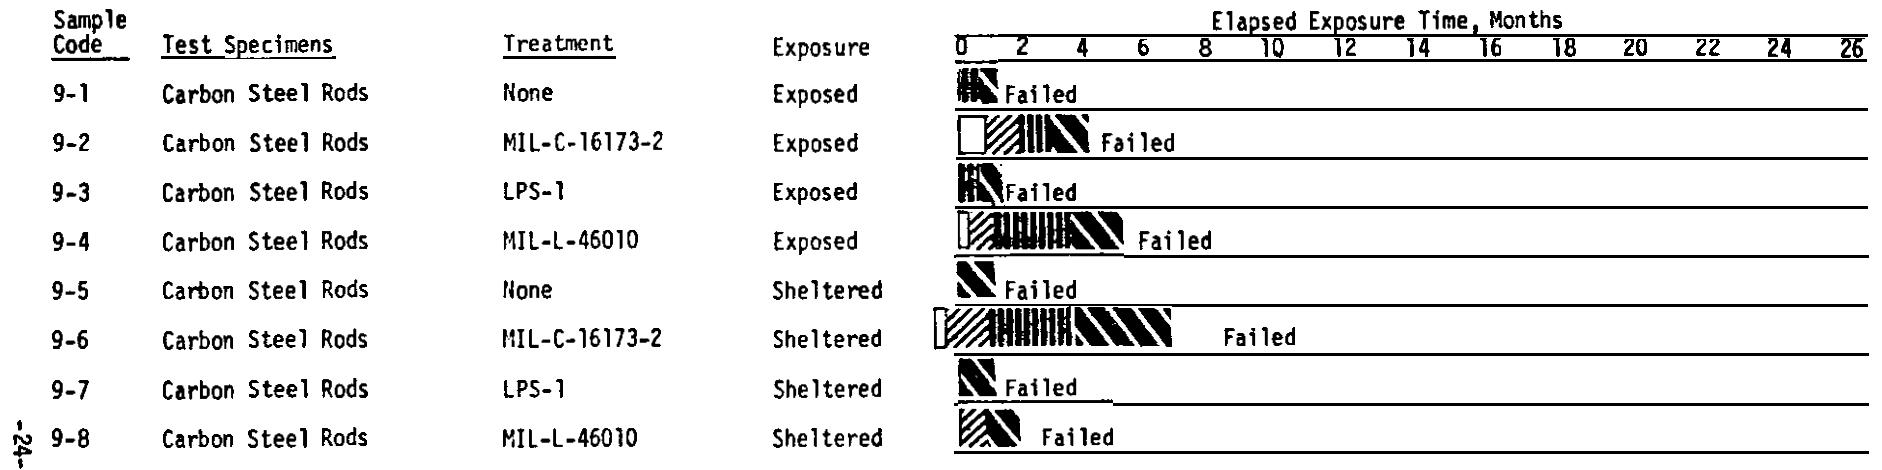
Figure 2

- 3.3 The test results are summarized in Figure 2, which is a bar graph defining the progression of corrosion in terms of the scale described, for each group of test specimens. The results for both the exposed and the sheltered specimens of each group are presented together, so that the effects of these two different types of exposure on corrosion rate can be evaluated. The photographic documentation of specimen condition after six months of exposure is presented in Figures 3 through 10. These photographs, and those taken after two years of exposure, were made in color. Unfortunately, it is not economically feasible to present a complete set of these photographs with each copy of the report. The half-tones shown here give some indication of specimen condition and also depict the arrangement and attachment of the specimens in the support rack. A complete set of all of the color photographs taken for the program is maintained by the Materials Testing Branch, and this is available for inspection by interested individuals.

- 3.5 From the data presented in Figure 2, the following observations are made with regard to the various sample groups and the corrosion control treatments applied.

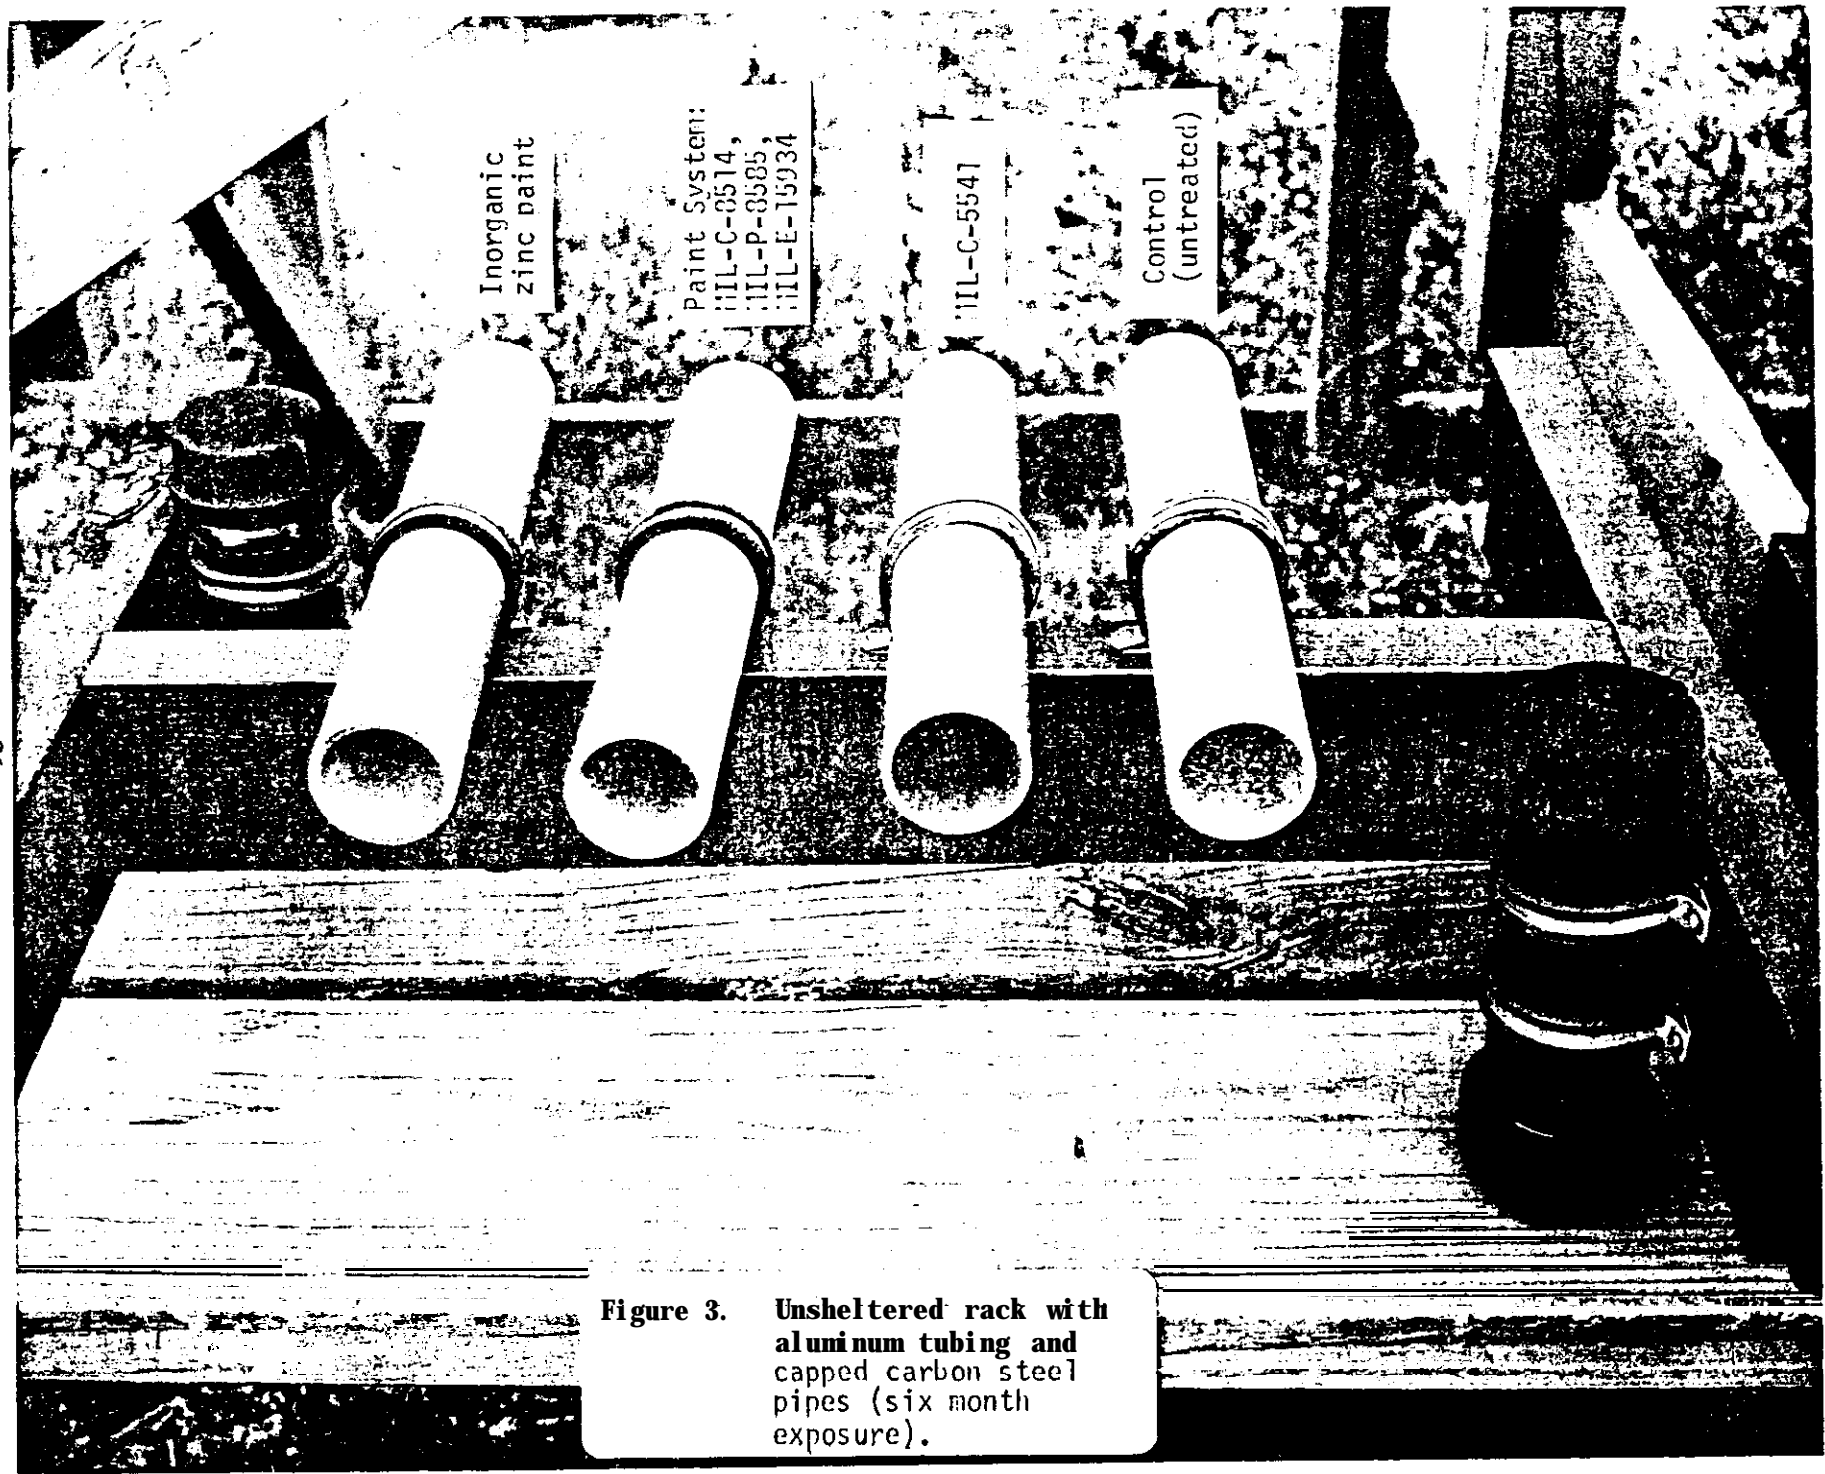
Pitting corrosion initiated quickly on both control (untreated) specimens, but its development was more rapid on the sheltered specimen. The conversion coating treatment (NIL-C-5541) delayed the initiation of corrosion and reduced

its severity in both exposures. Both of the other treatments---the three-coat paint system and the inorganic zinc---have afforded excellent protection. There is no evidence of corrosion initiation on any of the specimens, other than a very light white rust on the zinc-coated sheltered specimen.

Figure 3. Unsheltered rack with aluminum tubing and capped carbon steel pipes (six month exposure).

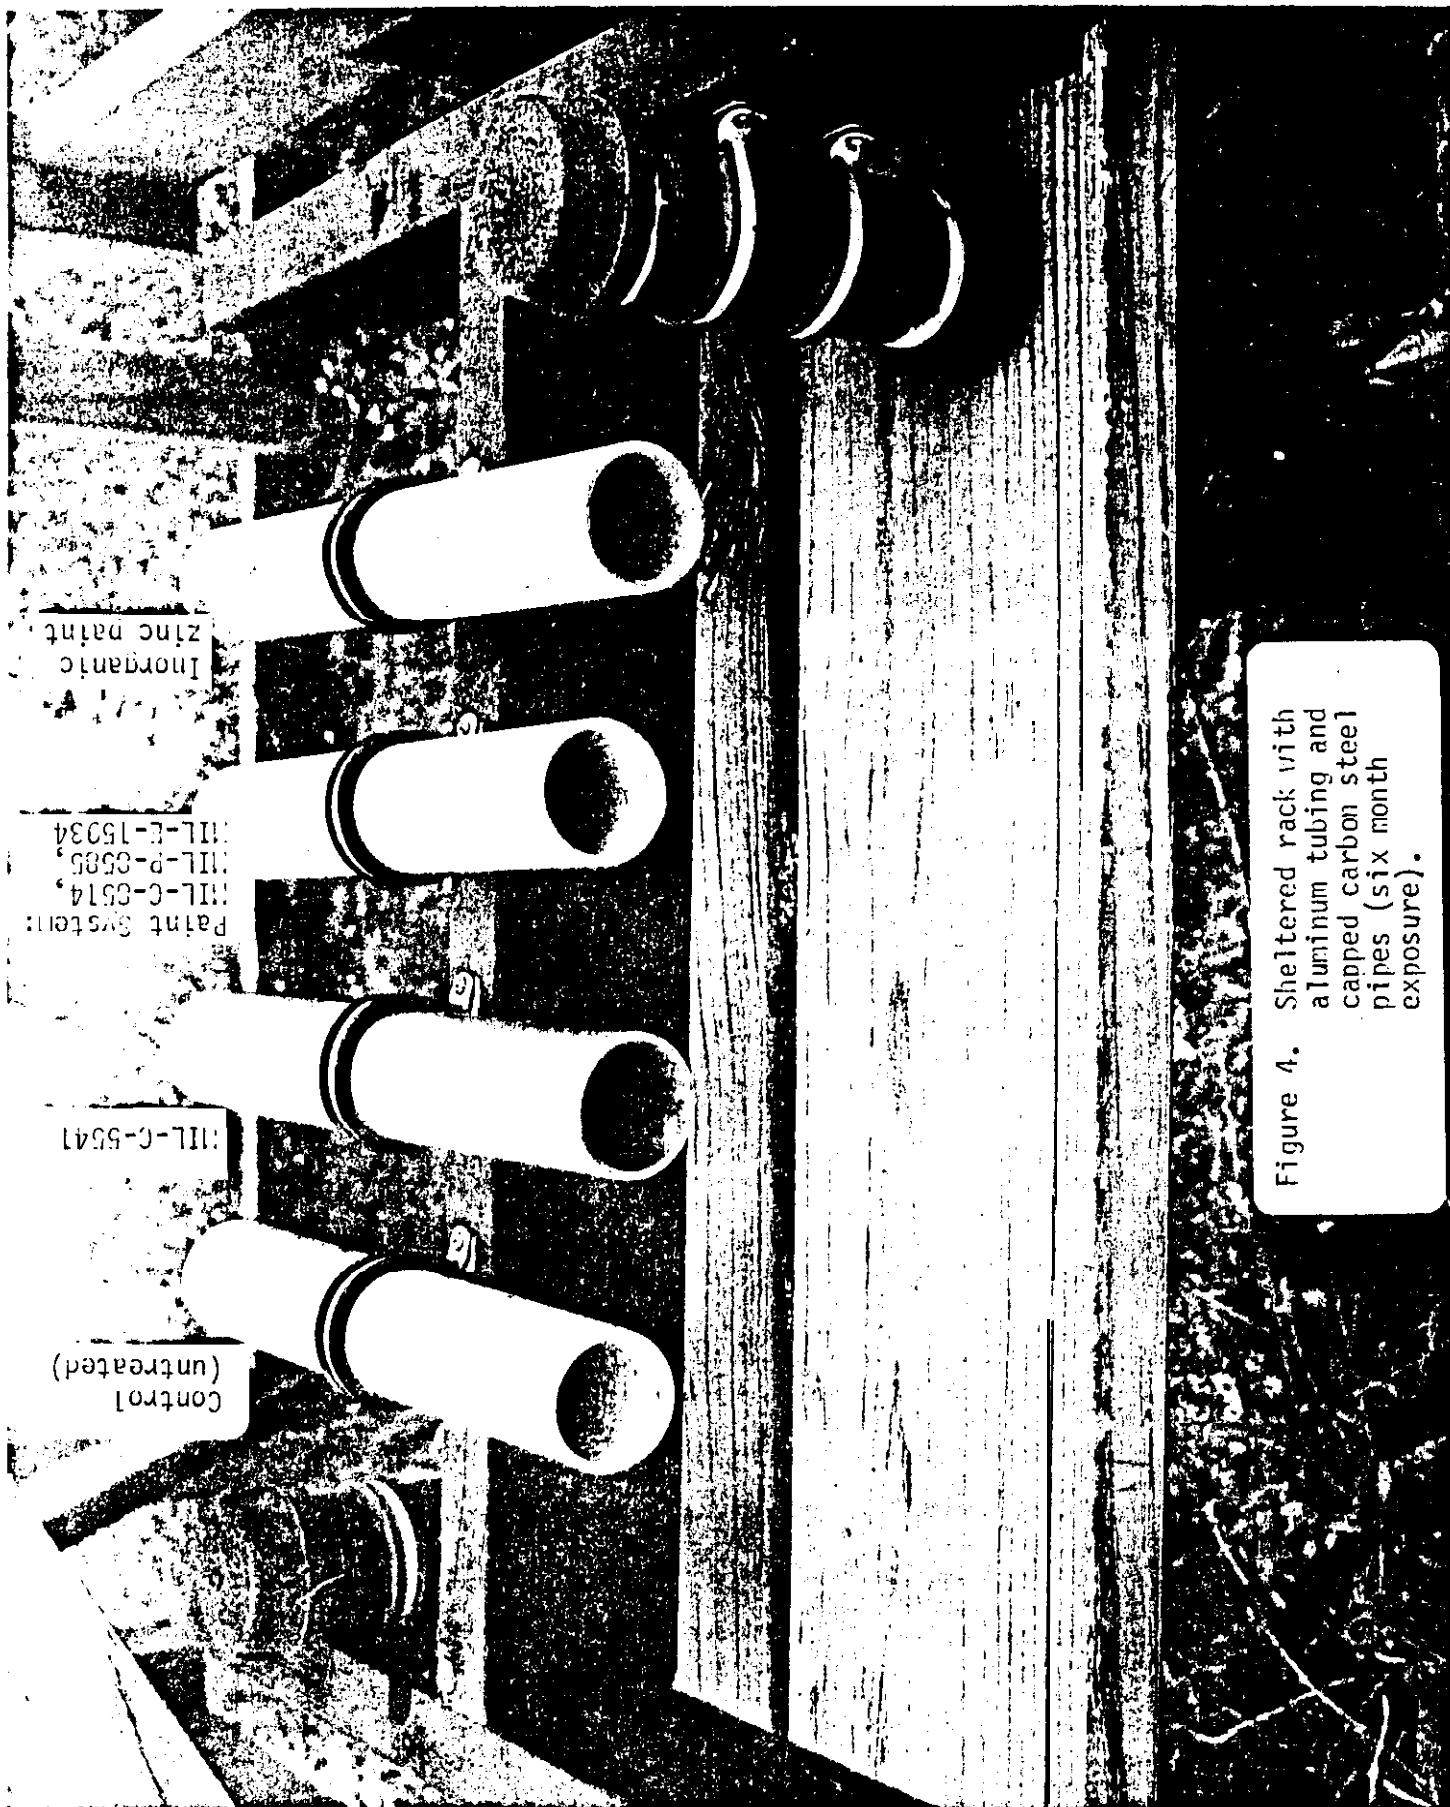
Inorganic  
zinc paint

Paint System:  
MIL-C-5514,  
MIL-P-5585,  
MIL-E-15034

MIL-C-5541

Control  
(untreated)

Figure 4. Sheltered rack with aluminum tubing and capped carbon steel pipes (six month exposure).

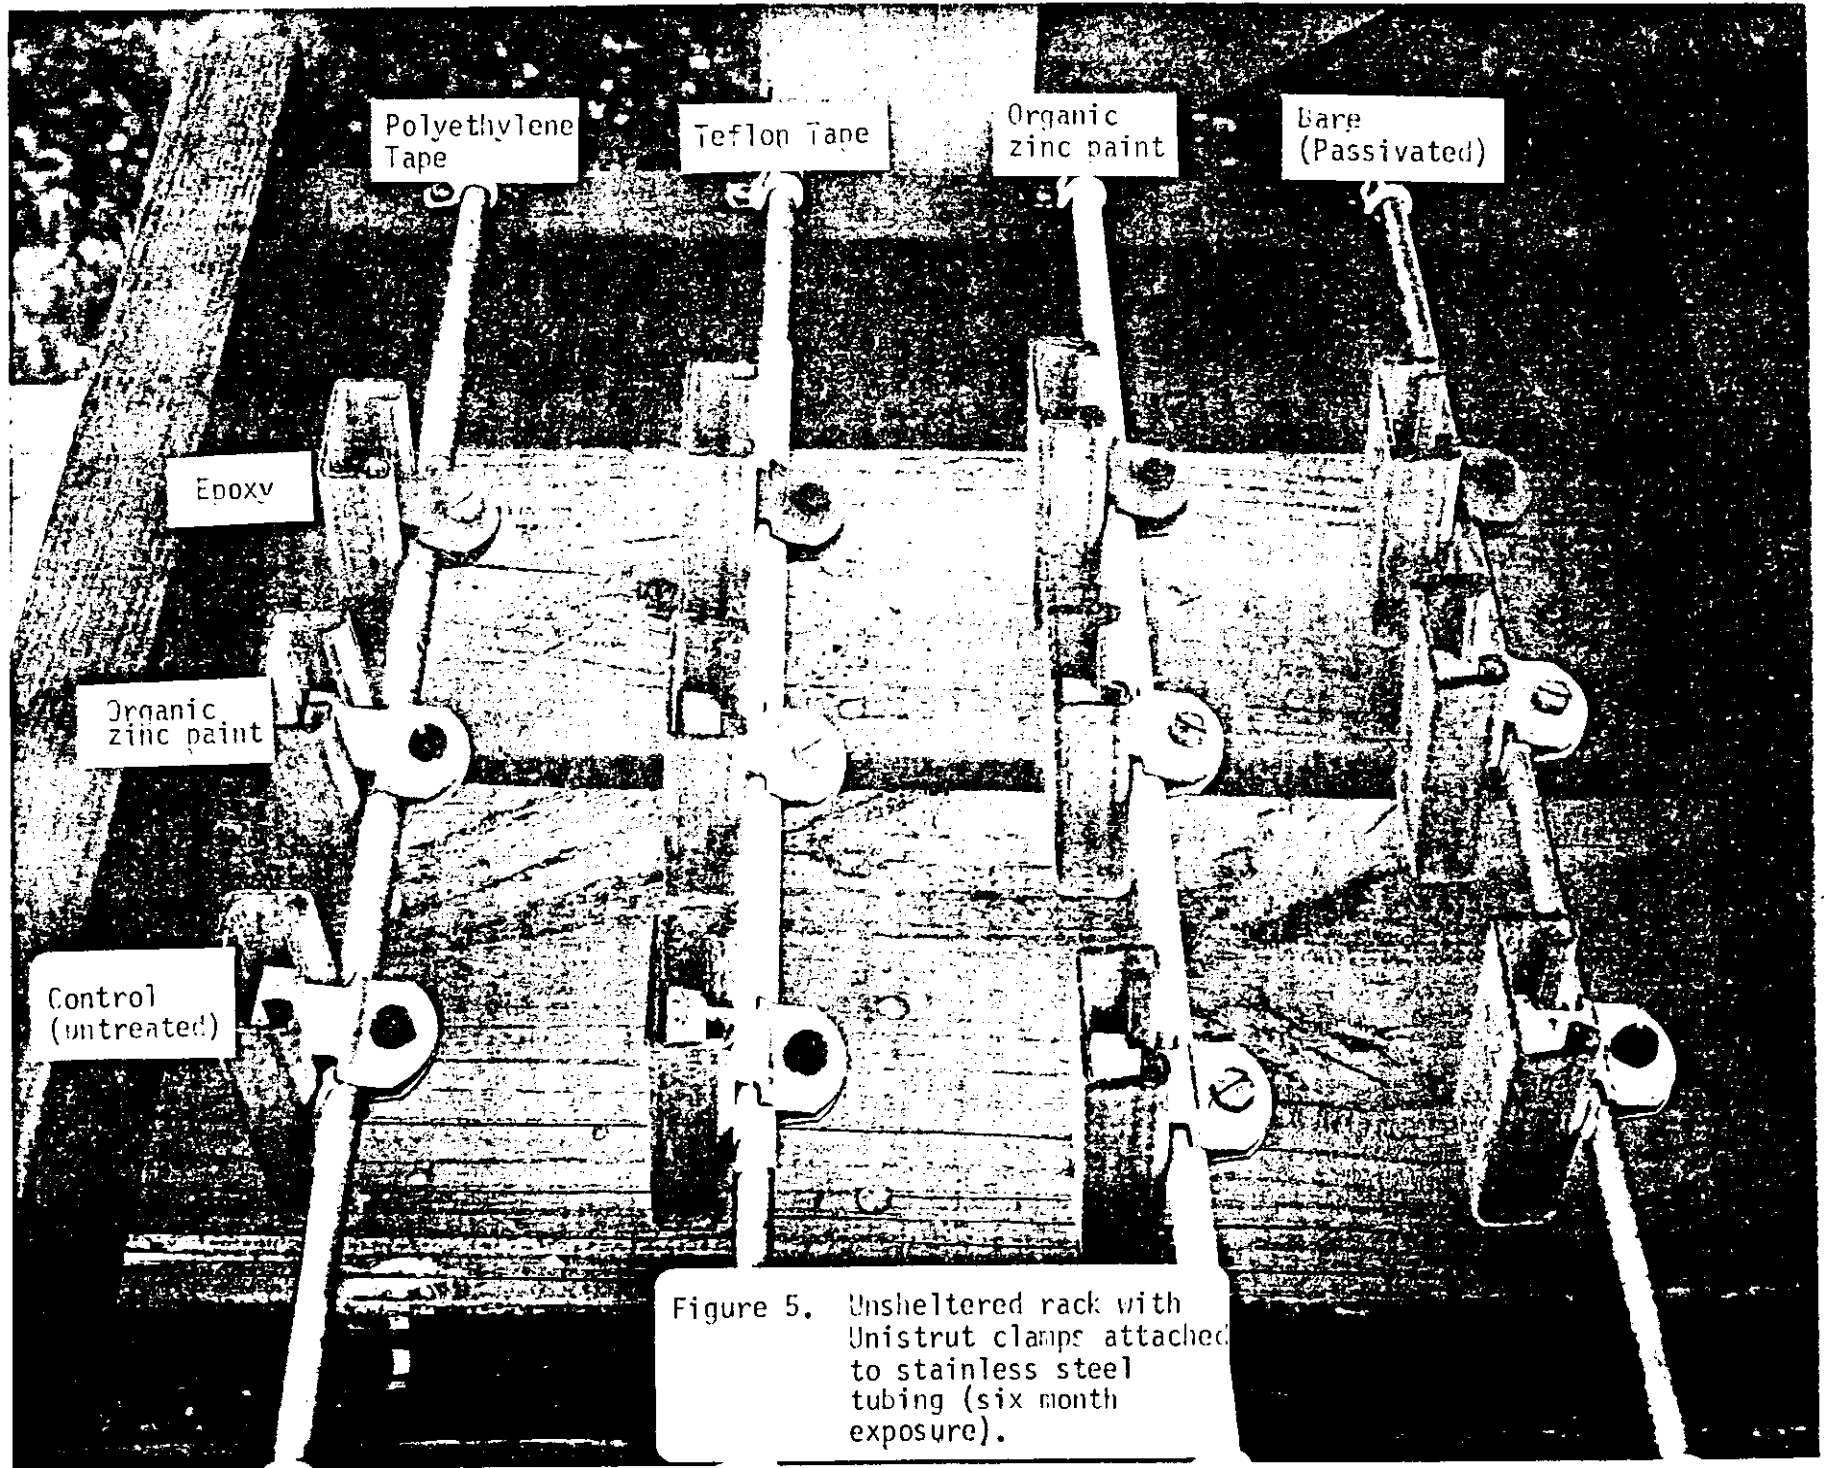
Corrosion of the control specimens involves both pitting over the clamp surface and crevice corrosion near the bolt head used to assemble the clamps. This corrosion developed more rapidly on the sheltered specimens than on the exposed specimens. The organic zinc paint began to flake extensively on specimens, in both exposures after about 9 months. In spite of this flaking, however, there was no significant evidence of pitting or crevice corrosion of the stainless steel in two years of exposure. Apparently, enough of the zinc coating has remained on the clamps to afford sacrificial protection. The epoxy coating has remained completely effective for the entire exposure period. As is seen in the photographs (Figures 5 and 6), the Unistrut clamps were attached to sections of stainless steel tubing in four different "conditions" in the area of clamp attachment: bare (passivated only), wrapped with self-sealing polyethylene tape, wrapped with Teflon tape, and coated with organic zinc paint. With regard to the tape wrapping, it was observed that the polyethylene tape tended to retain moisture, contributing to pitting of the stainless steel tubing in the clamp area. Complete sealing could not be maintained because of damage to the tape by the clamp. The thinner, more loosely wrapped Teflon tape did not tend to retain moisture, and its use appears preferable. The organic zinc paint was a satisfactory treatment for the tubing in

the clamp attachment area. However, some blistering of the zinc coating, particularly on the sheltered specimens, was noted.

Figure 5. Unsheltered rack with Unistrut clamps attached to stainless steel tubing (six month exposure).

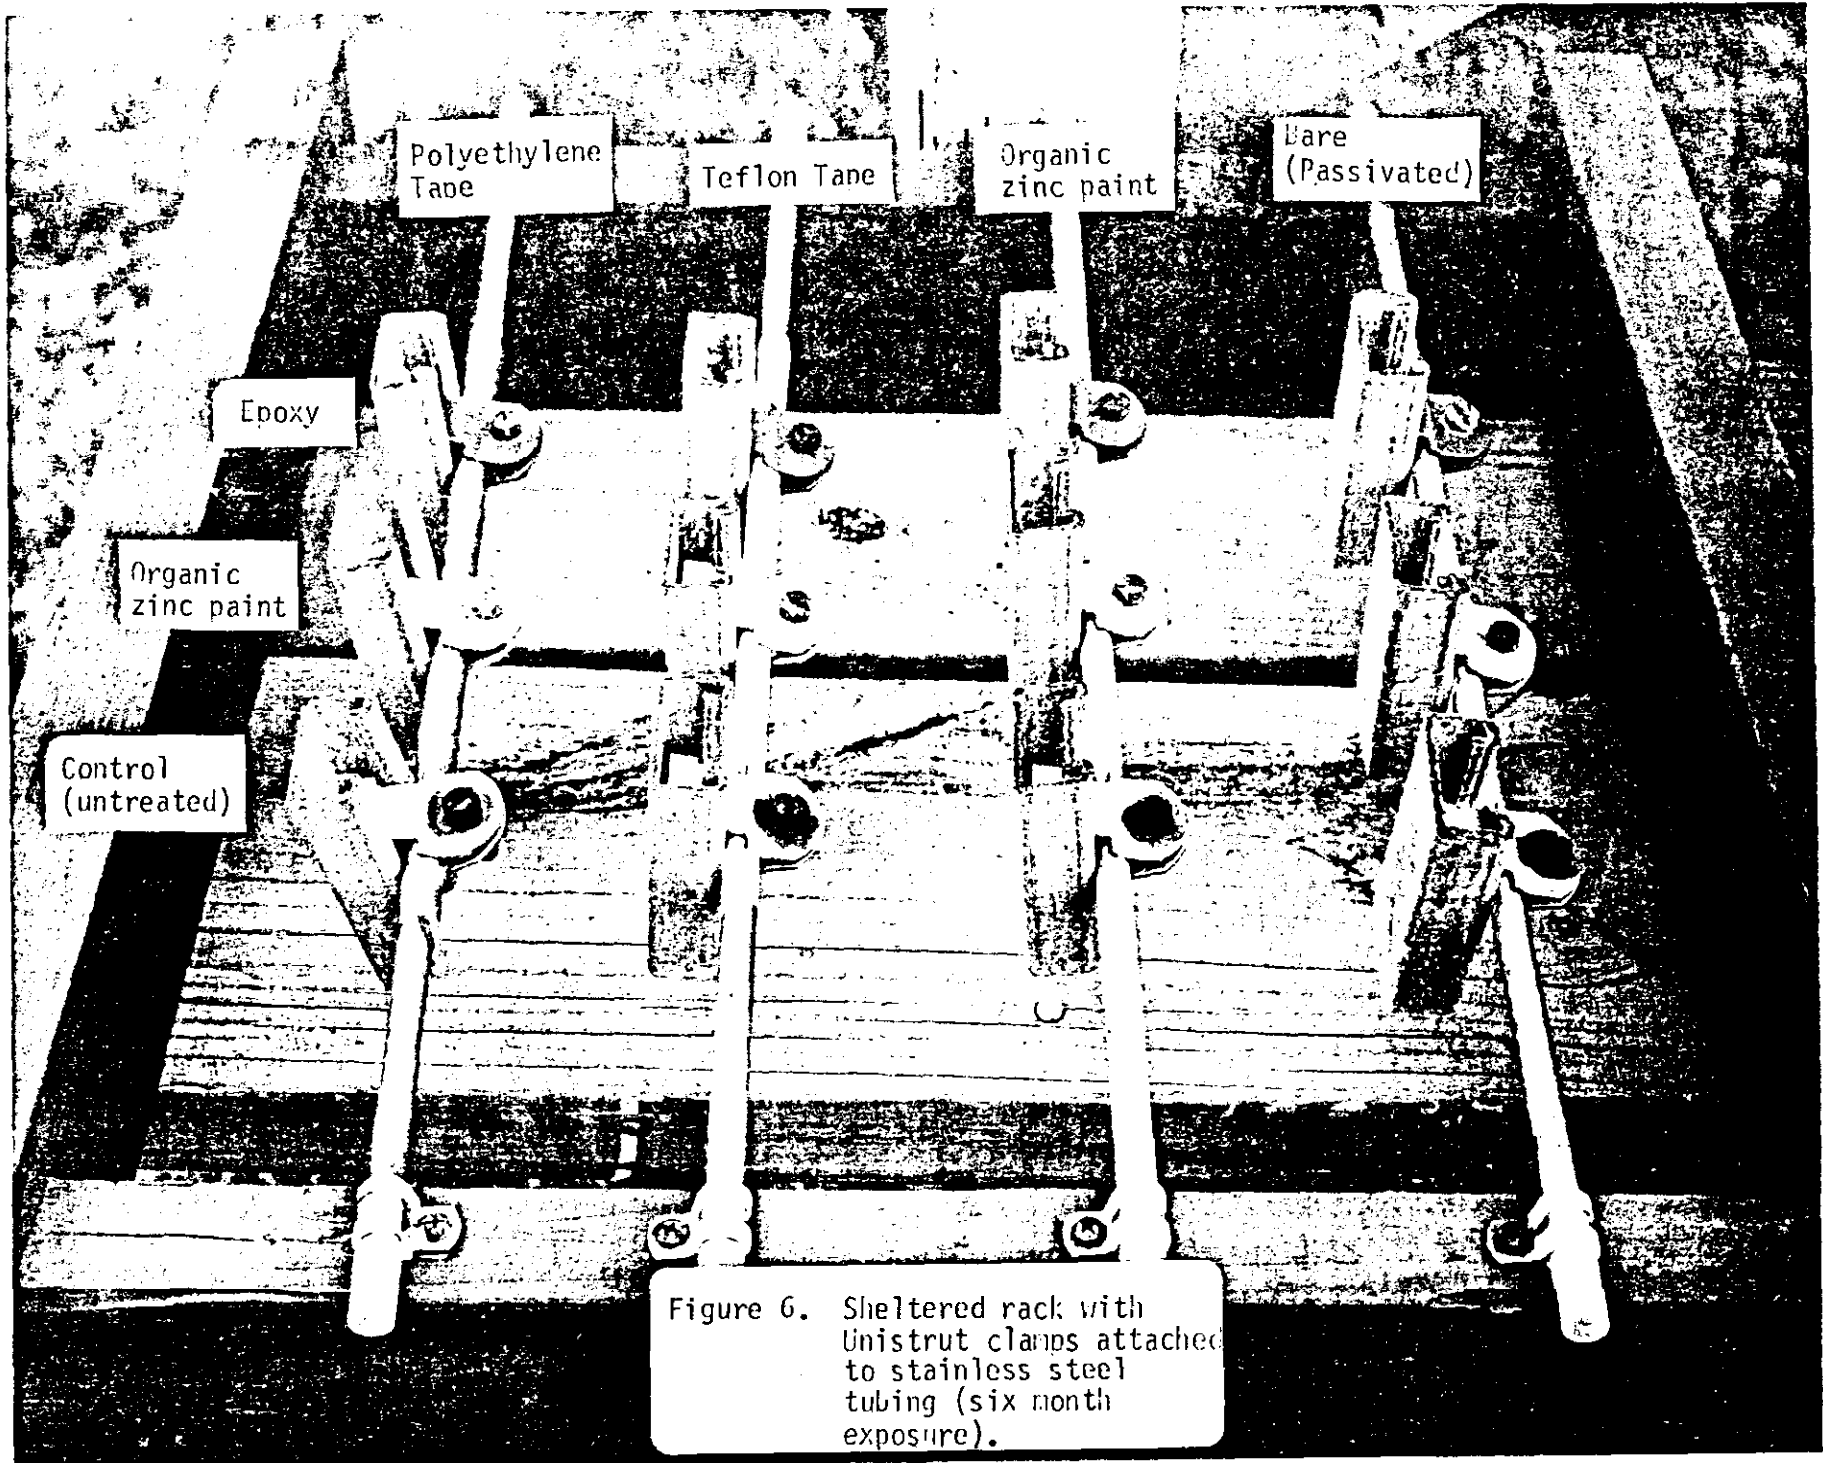
Figure 6. Sheltered rack with Unistrut clamps attached to stainless steel tubing (six month exposure).

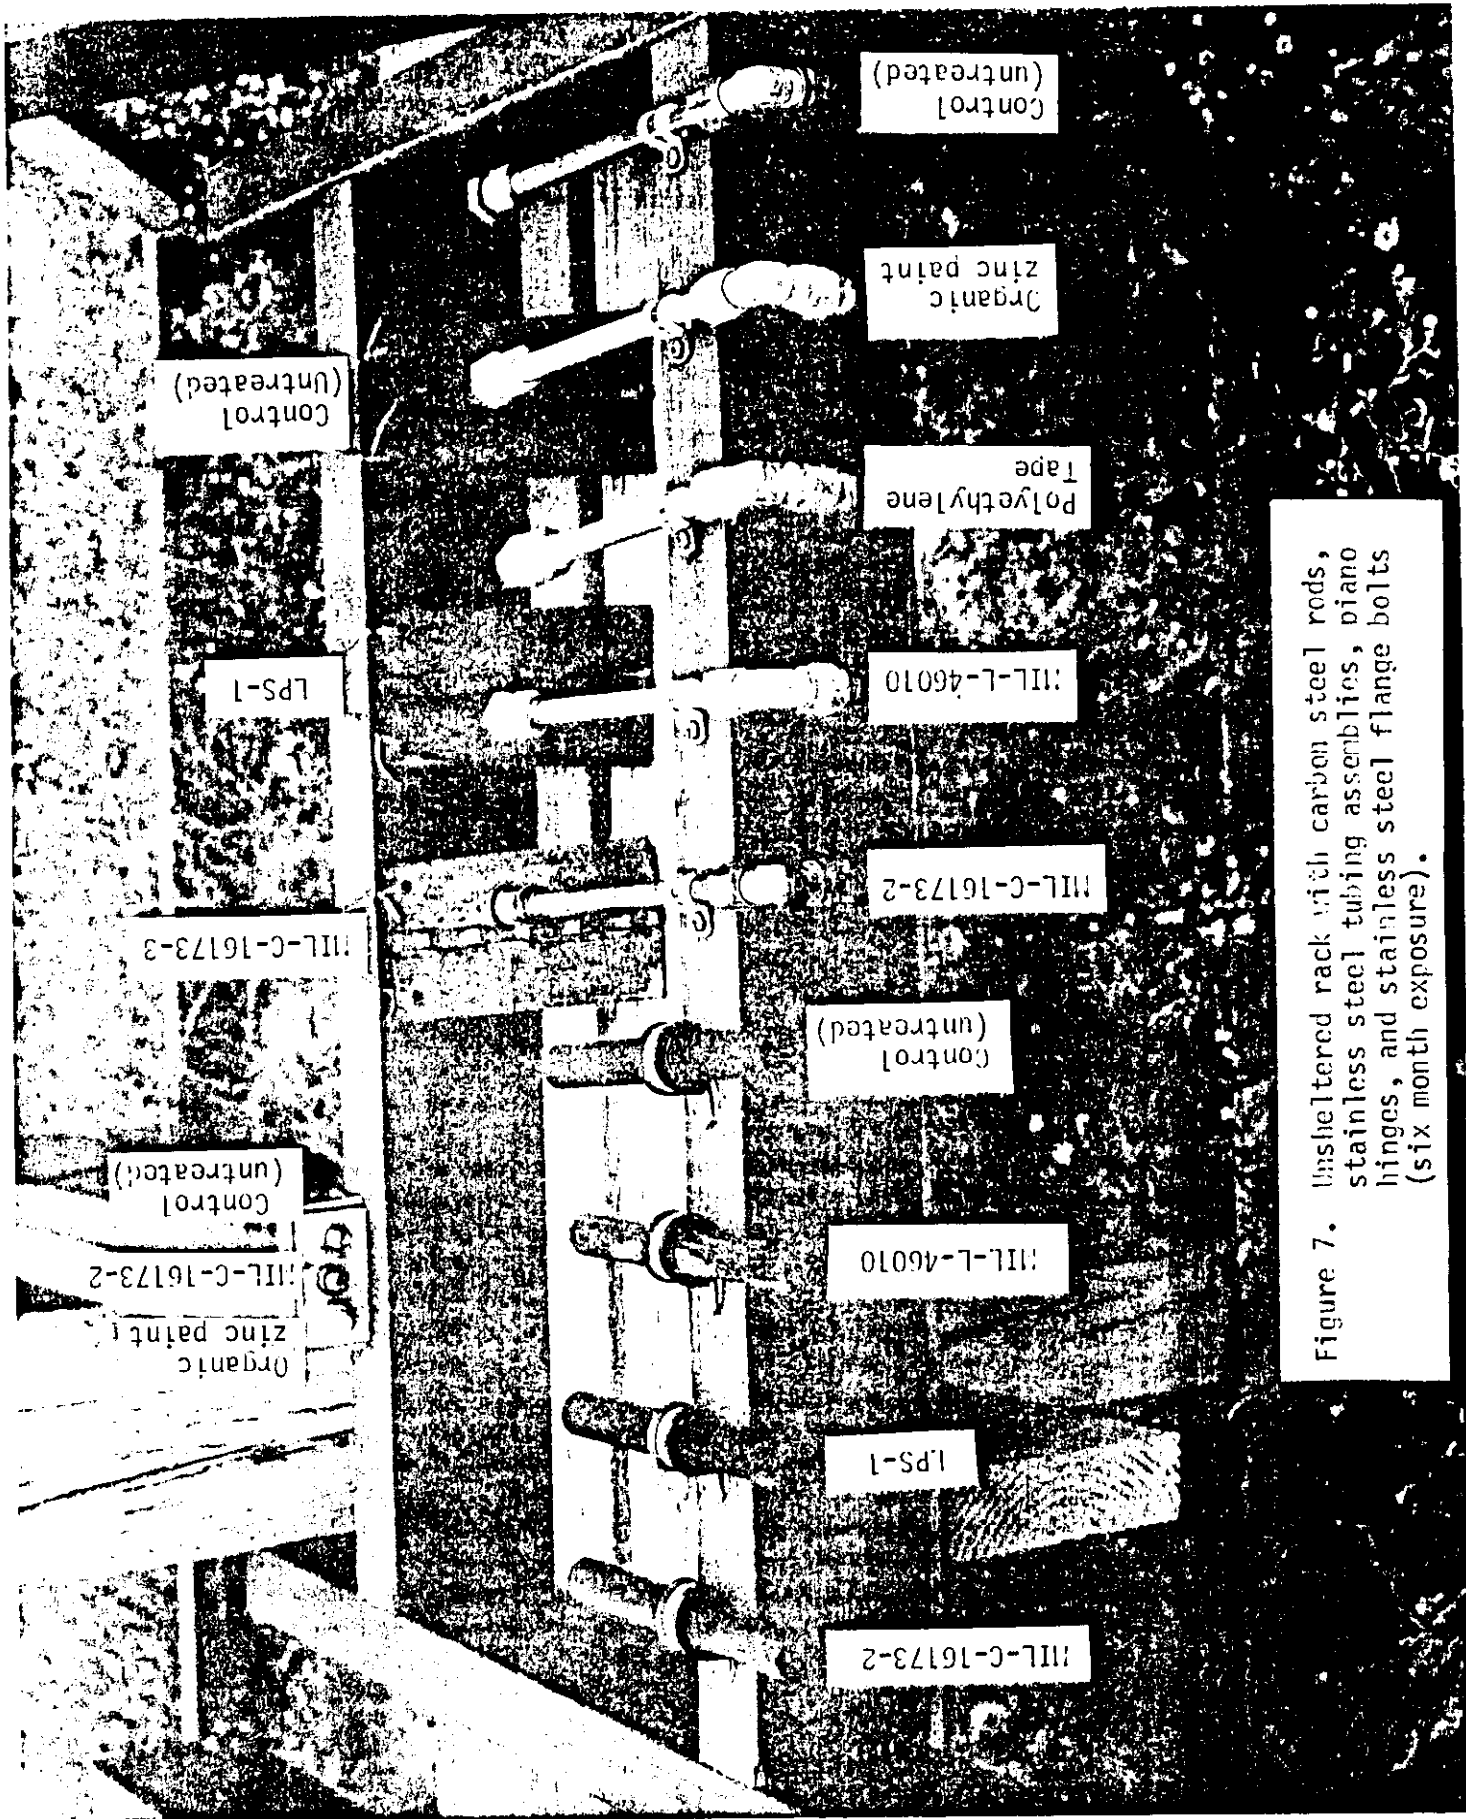
Figure 7. Unsheltered rack with carbon steel rods, stainless steel tubing assemblies, piano hinges, and stainless steel flange bolts (six month exposure).
