**JOHN F. KENNEDY  
SPACE CENTER**

MAB 3221-69

**(Status Report)**

**Study of Corrosion Protection  
Methods for GSE Applications at  
Kennedy Space Center**

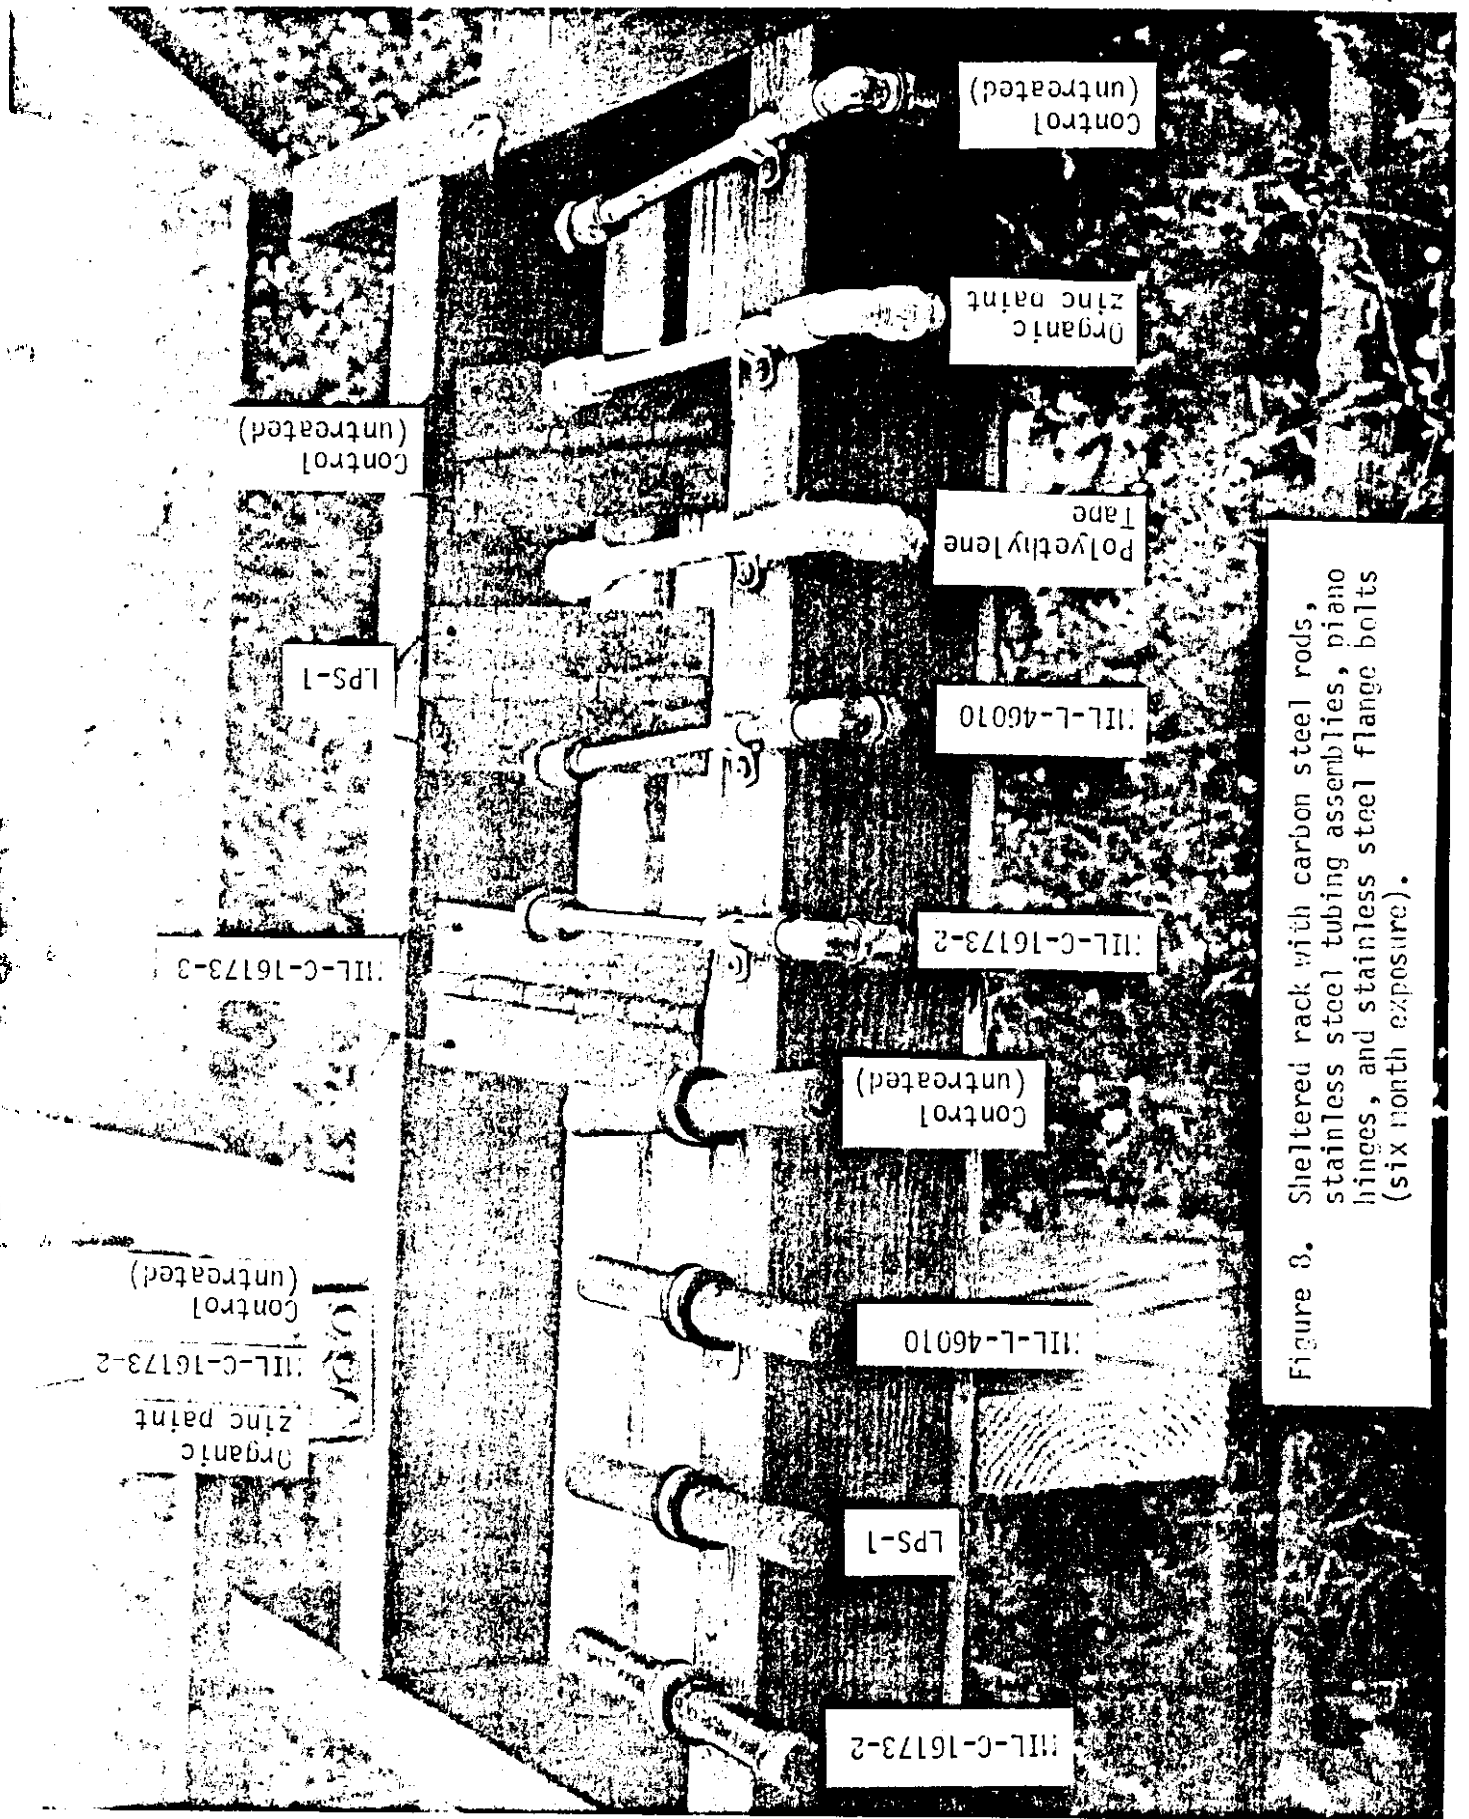
Figure 8. Sheltered rack with carbon steel rods, stainless steel tubing assemblies, piano hinges, and stainless steel flange bolts (six month exposure).

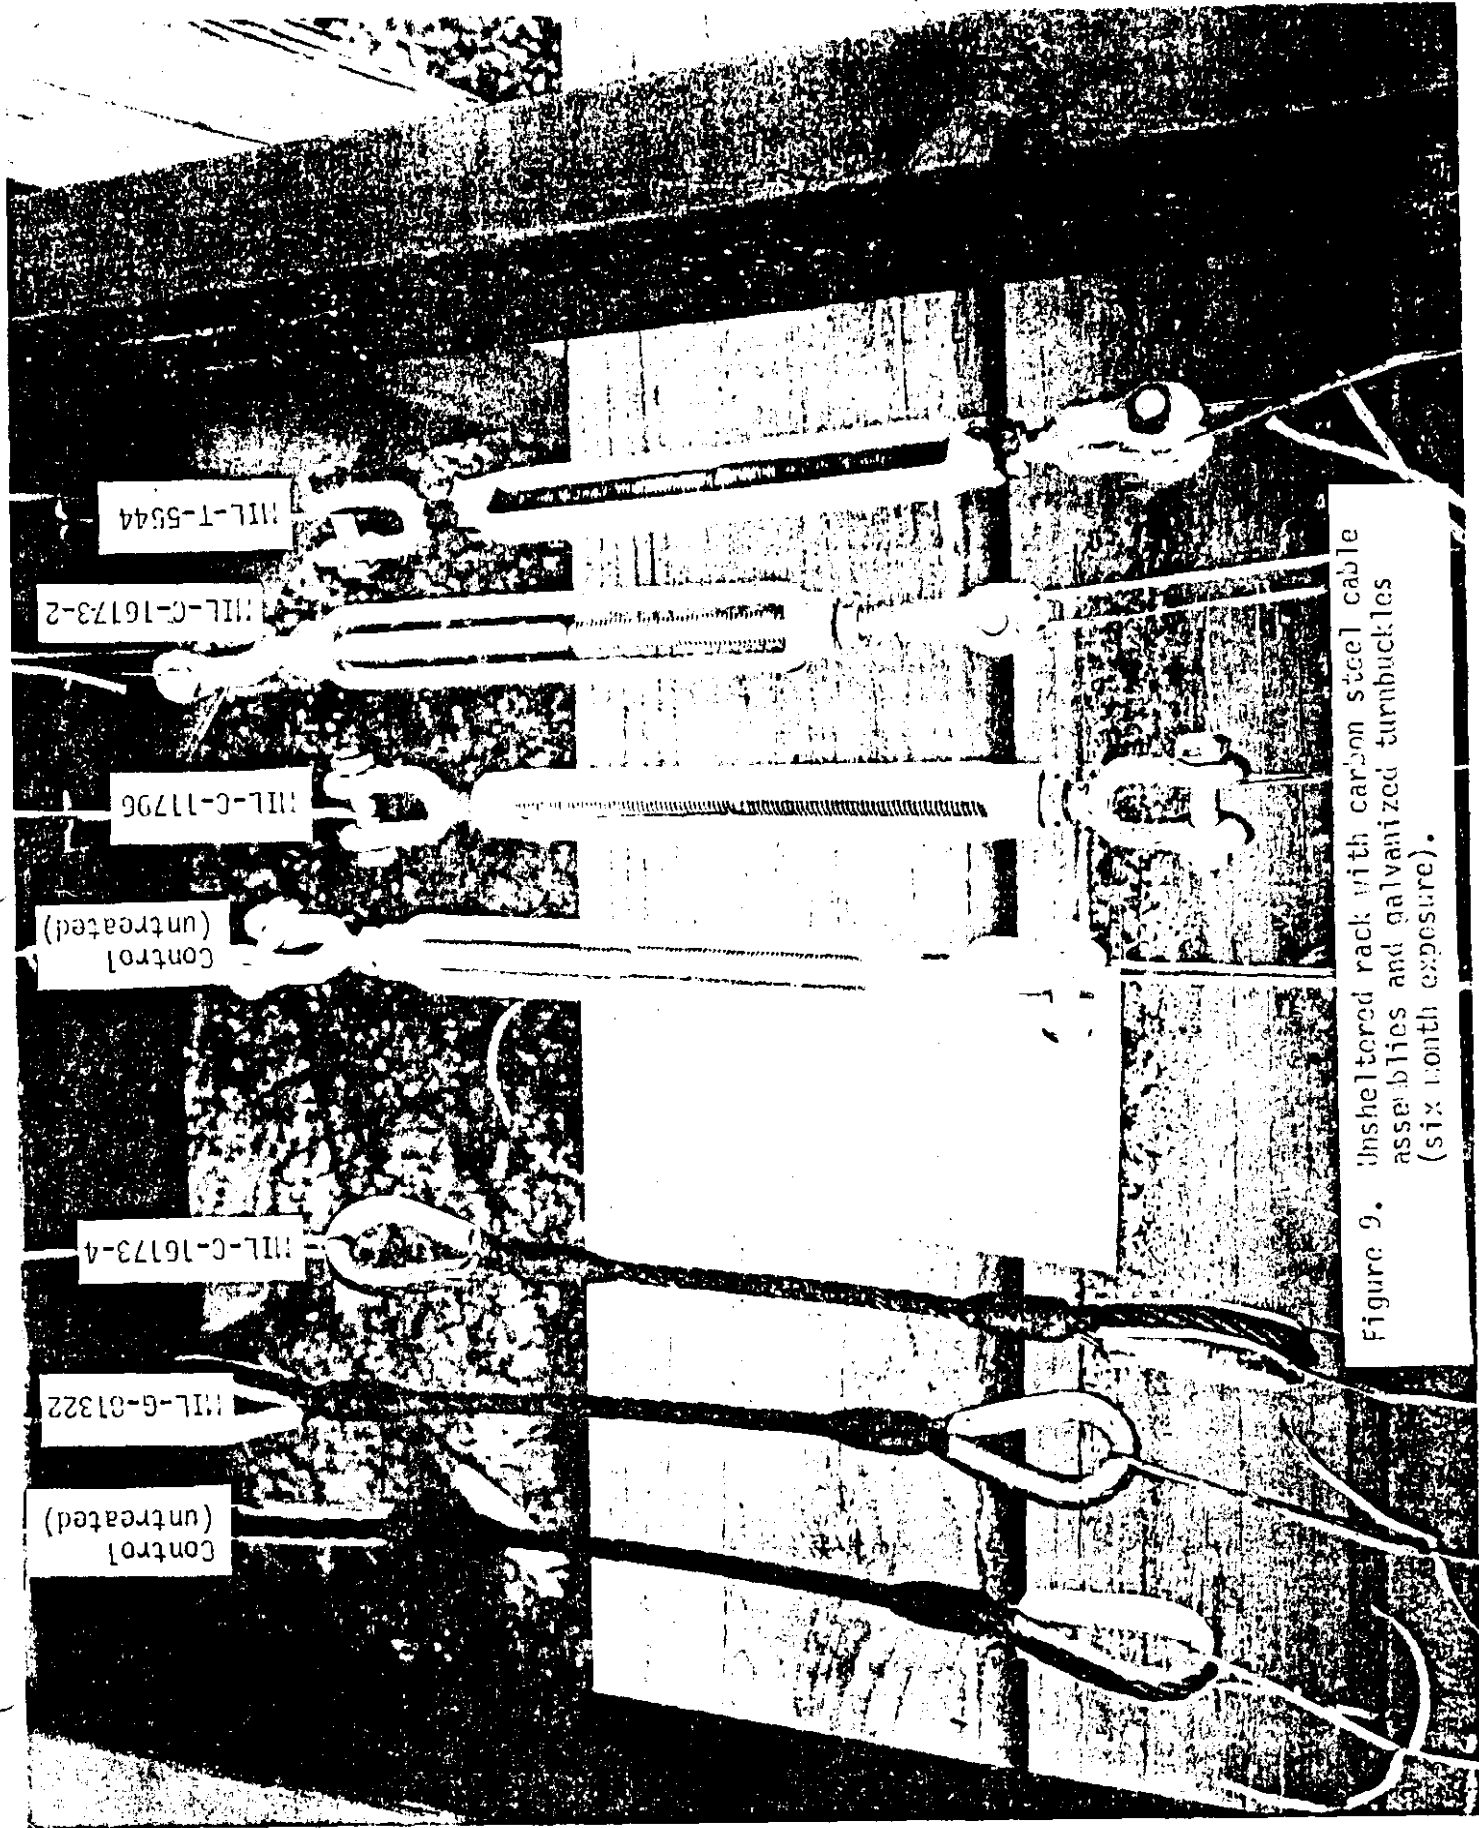
Figure 9. Unsheltered rack with carbon steel cable assemblies and galvanized turnbuckles (six month exposure).

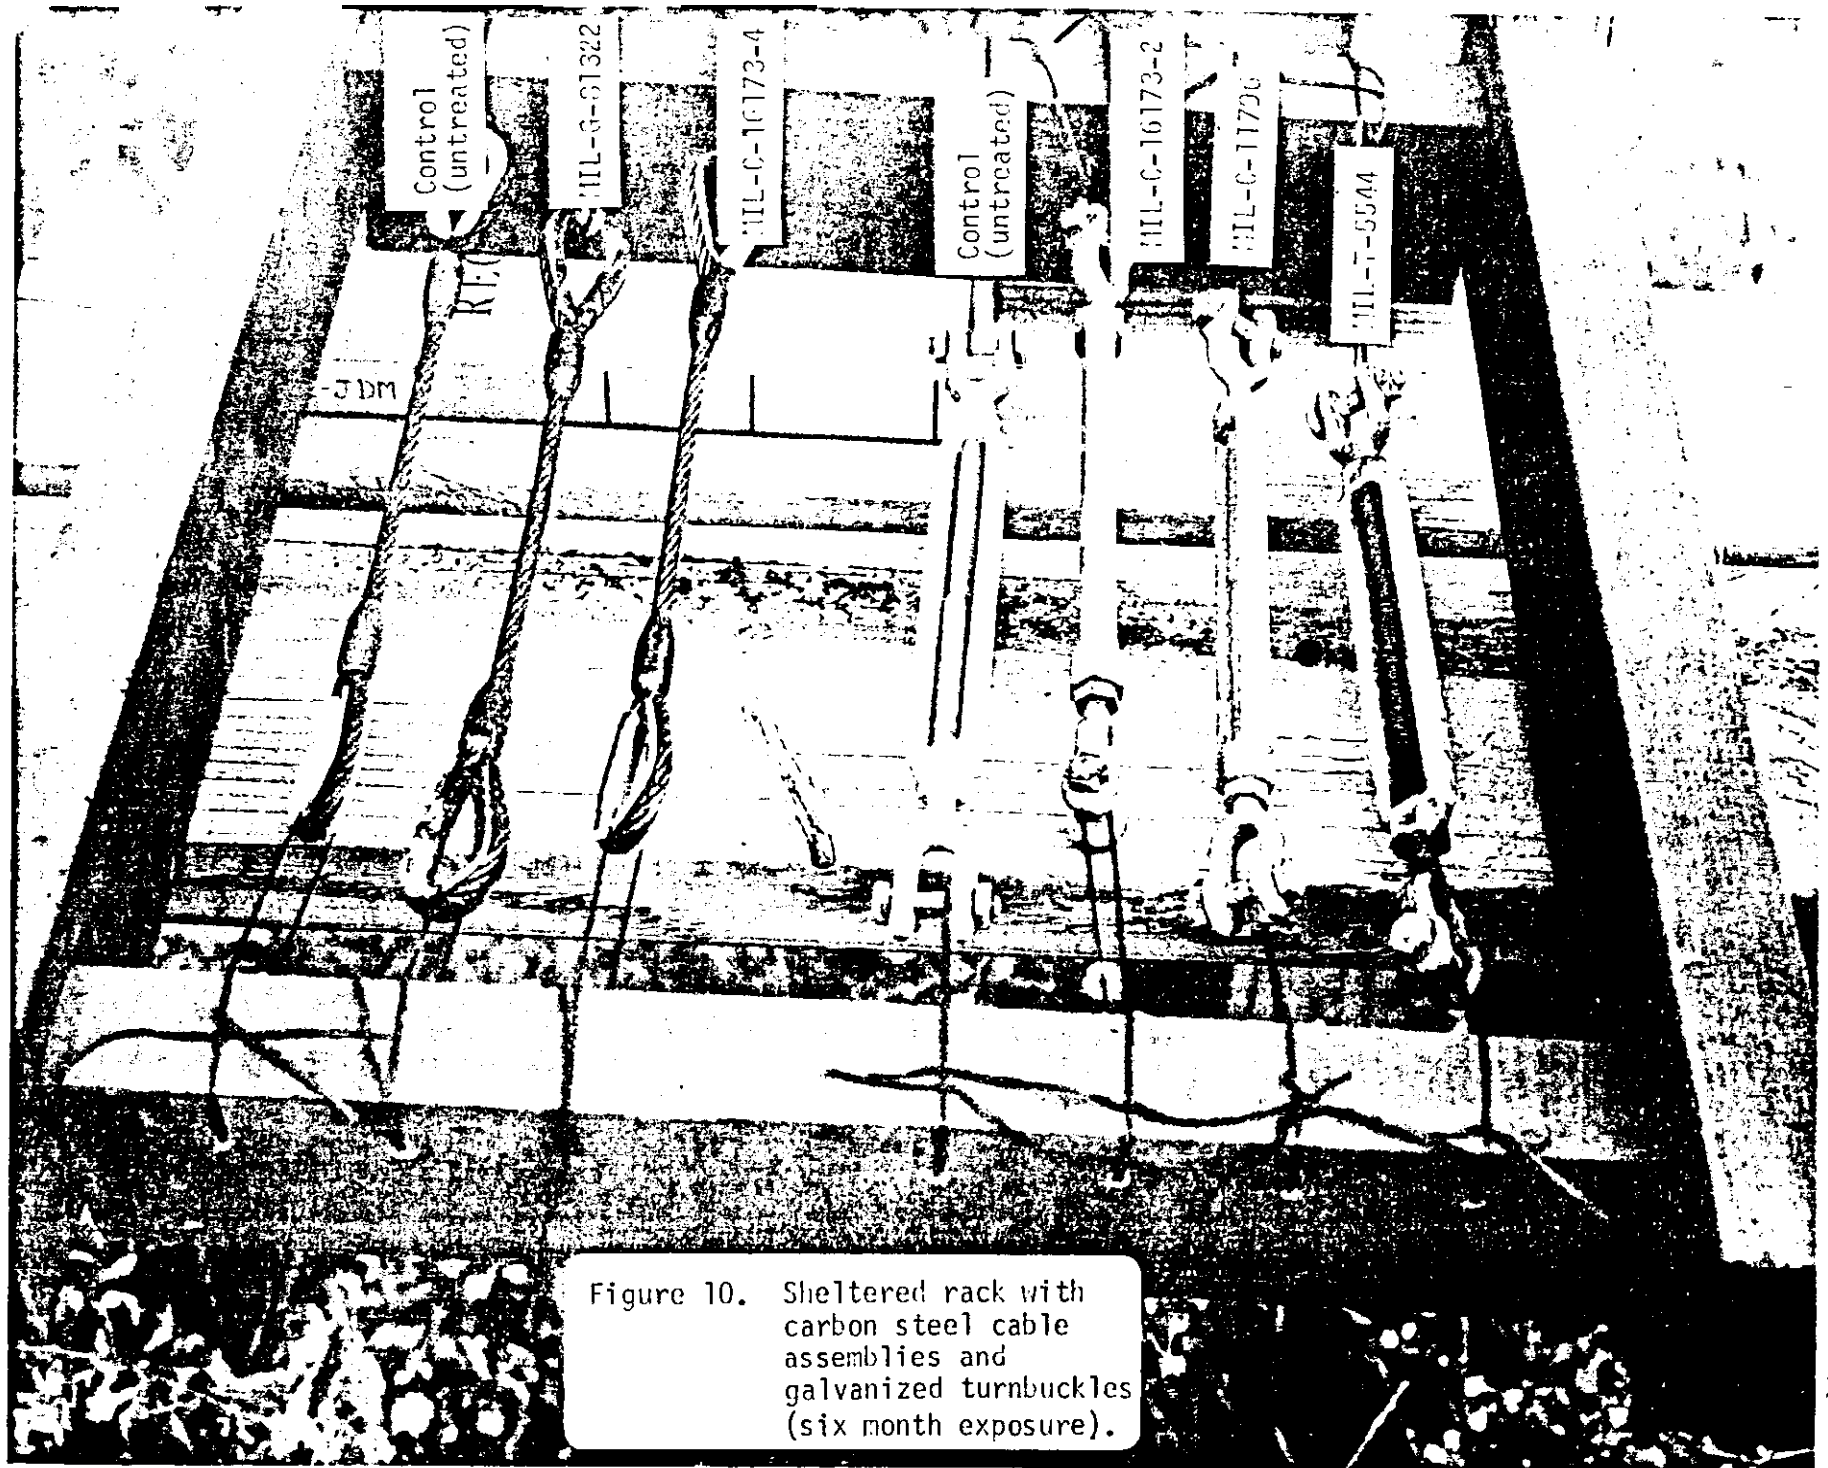
Figure 10. Sheltered rack with carbon steel cable assemblies and galvanized turnbuckles (six month exposure).

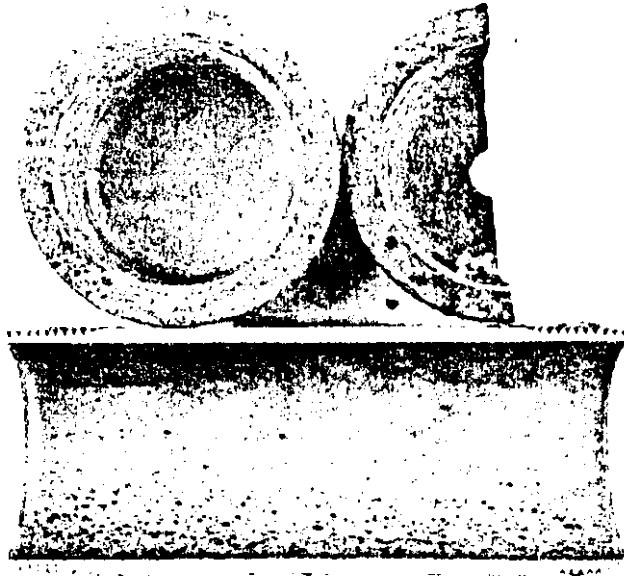
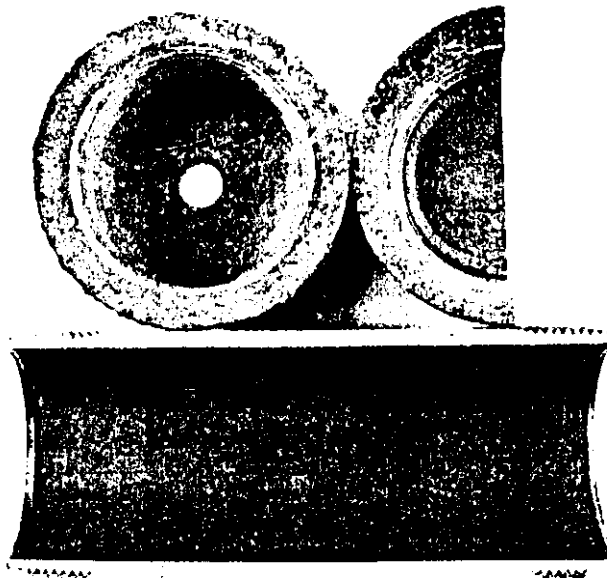
- 3.4 The condition of the carbon steel tubes treated with MIL-L-46002 cannot be evaluated from these photographs, since the application of the corrosion preventive compound was made to the internal surfaces. One set of the tubes (those from the sheltered section of the exposure frame) were removed, brought to the laboratory and sectioned longitudinally to expose the internal surfaces. Photographs taken of this set of samples are shown in Figure 11. Again, an adequate appreciation of the sample condition cannot be obtained from these black-and-white photographs. However, as is evident, some corrosion of the untreated sample had occurred, whereas the treated sample remained essentially free of corrosion for the two-year exposure period.

The vapor-phase treatment---ML-L-46002---has been effective for approximately two years in protecting the internal surfaces of the pipes. There is slight evidence of corrosion initiation on the lower end caps of the treated samples.

**Control  
(untreated)**

MIL-L-46002

**Figure 11. Interior surfaces of capped carbon steel pipe assemblies from sheltered rack (two year exposure)**

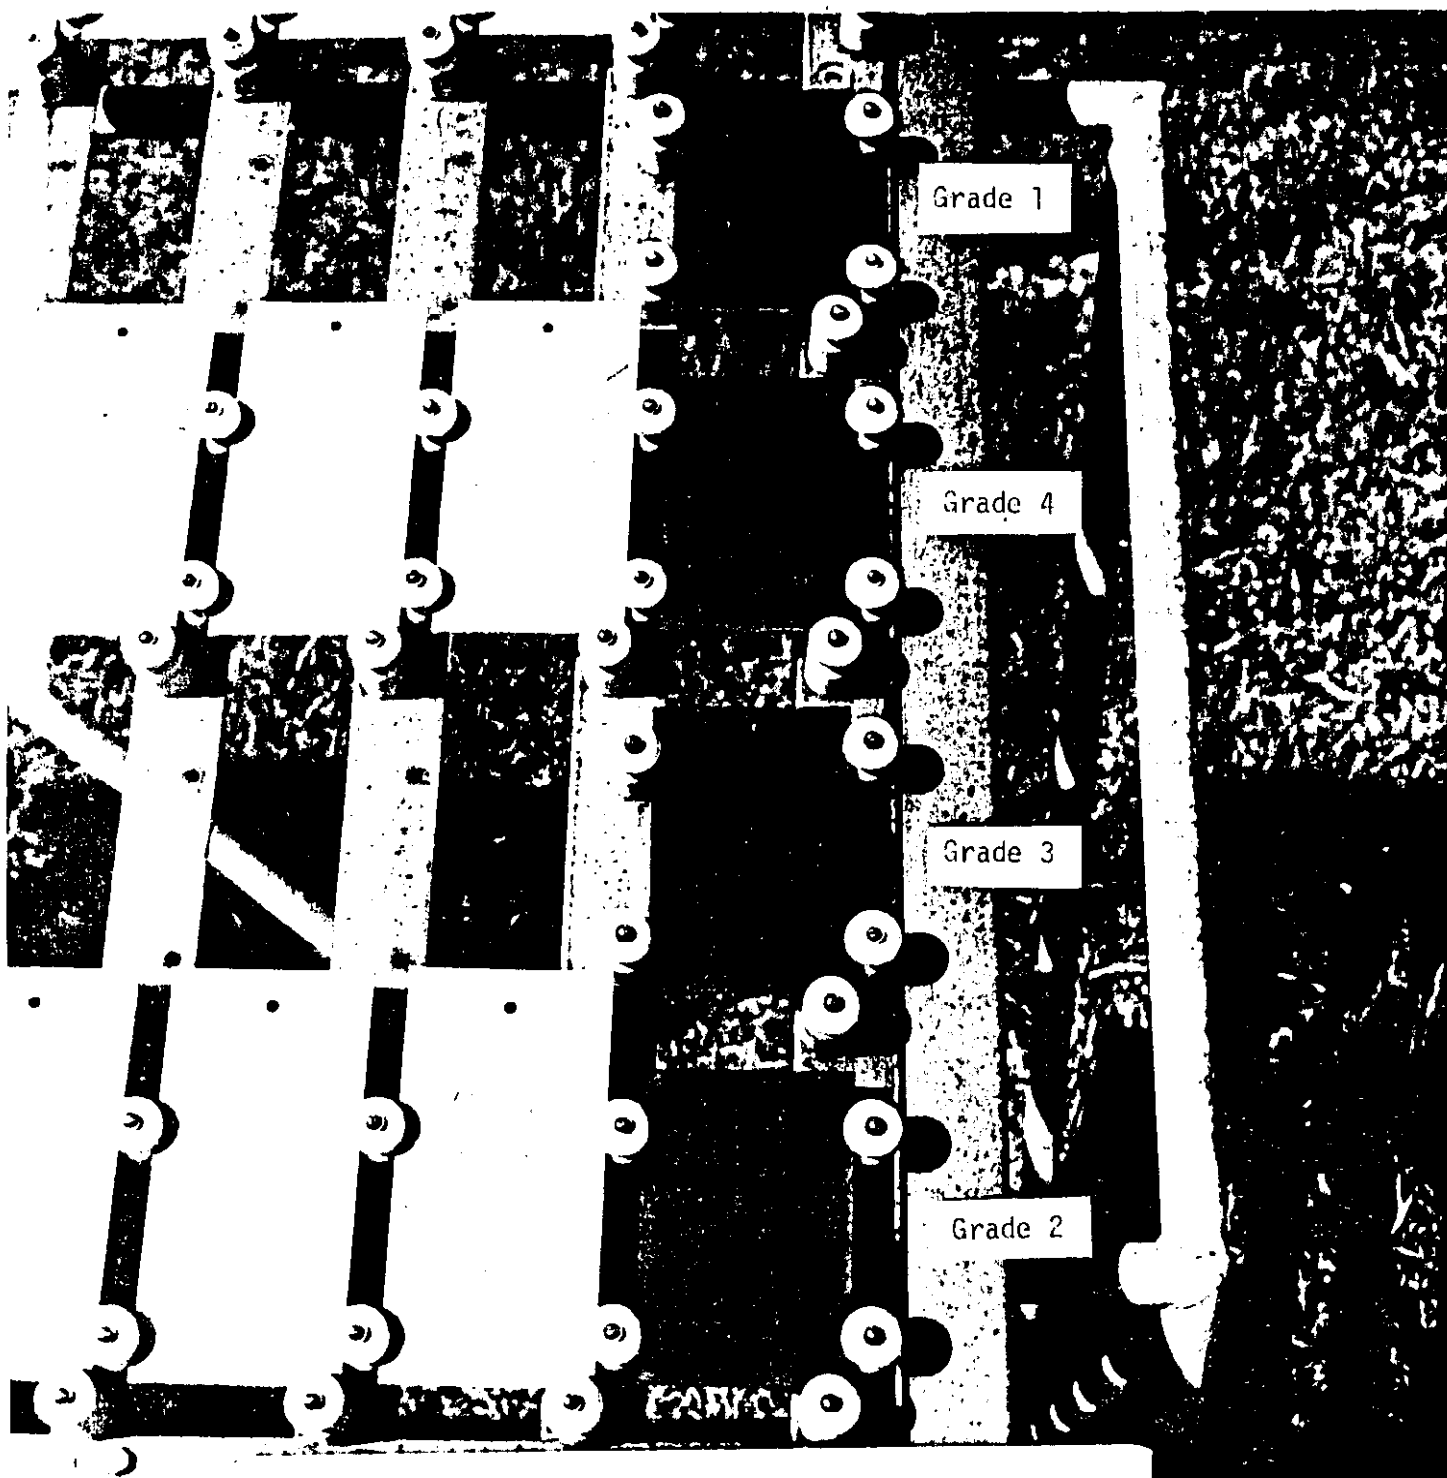
- 3.6 The additional experiments with the solvent cutback corrosion-preventive compounds specified in MIL-C-16173, as described in paragraph 2.6, yielded some interesting and definitive results with regard to selection of the proper grades for different exposure conditions with carbon steels. Figures 12 and 13 show the carbon steel panels coated with four grades---1, 2, 3 and 4---of the material. The exposed specimens are shown in Figure 12 and the sheltered specimens in Figure 13. After about seven months of exposure, the panels coated with Grade 1 and Grade 4 remained in fairly good condition, with corrosion only along the panel edges. Grades 2 and 3 had been completely

removed from the exposed panel, and the panels had undergone extensive corrosion. After an equivalent period, the sheltered specimen coated with the Grade 3 material was badly corroded, and the Grade 1 specimen had corroded extensively. The Grade 4 panel was much less corroded than the Grades 1 and 3 panels, but some penetration of the coating had occurred, and some light corrosion was scattered over the panel surface. The Grade 2 panel showed little or no corrosion away from the panel edges. These results are surprising, in view of the intended applications as stated in the specification (ML-C-16173), with Grade 1 being recommended for the most severe corrosion service. Obviously, the type of exposure involved (that is, the extent of sheltering of the treated objects) has a profound effect on the degree of protection provided by most grades of the compound. If the exposure conditions are complex, or cannot be predicted with assurance, the selection of the Grade 4 material would appear to offer the best compromise.

Figure 12. Unsheltered carbon steel panels coated with four grades of 10-pound IL-6173; after beach exposure for approximately six months.

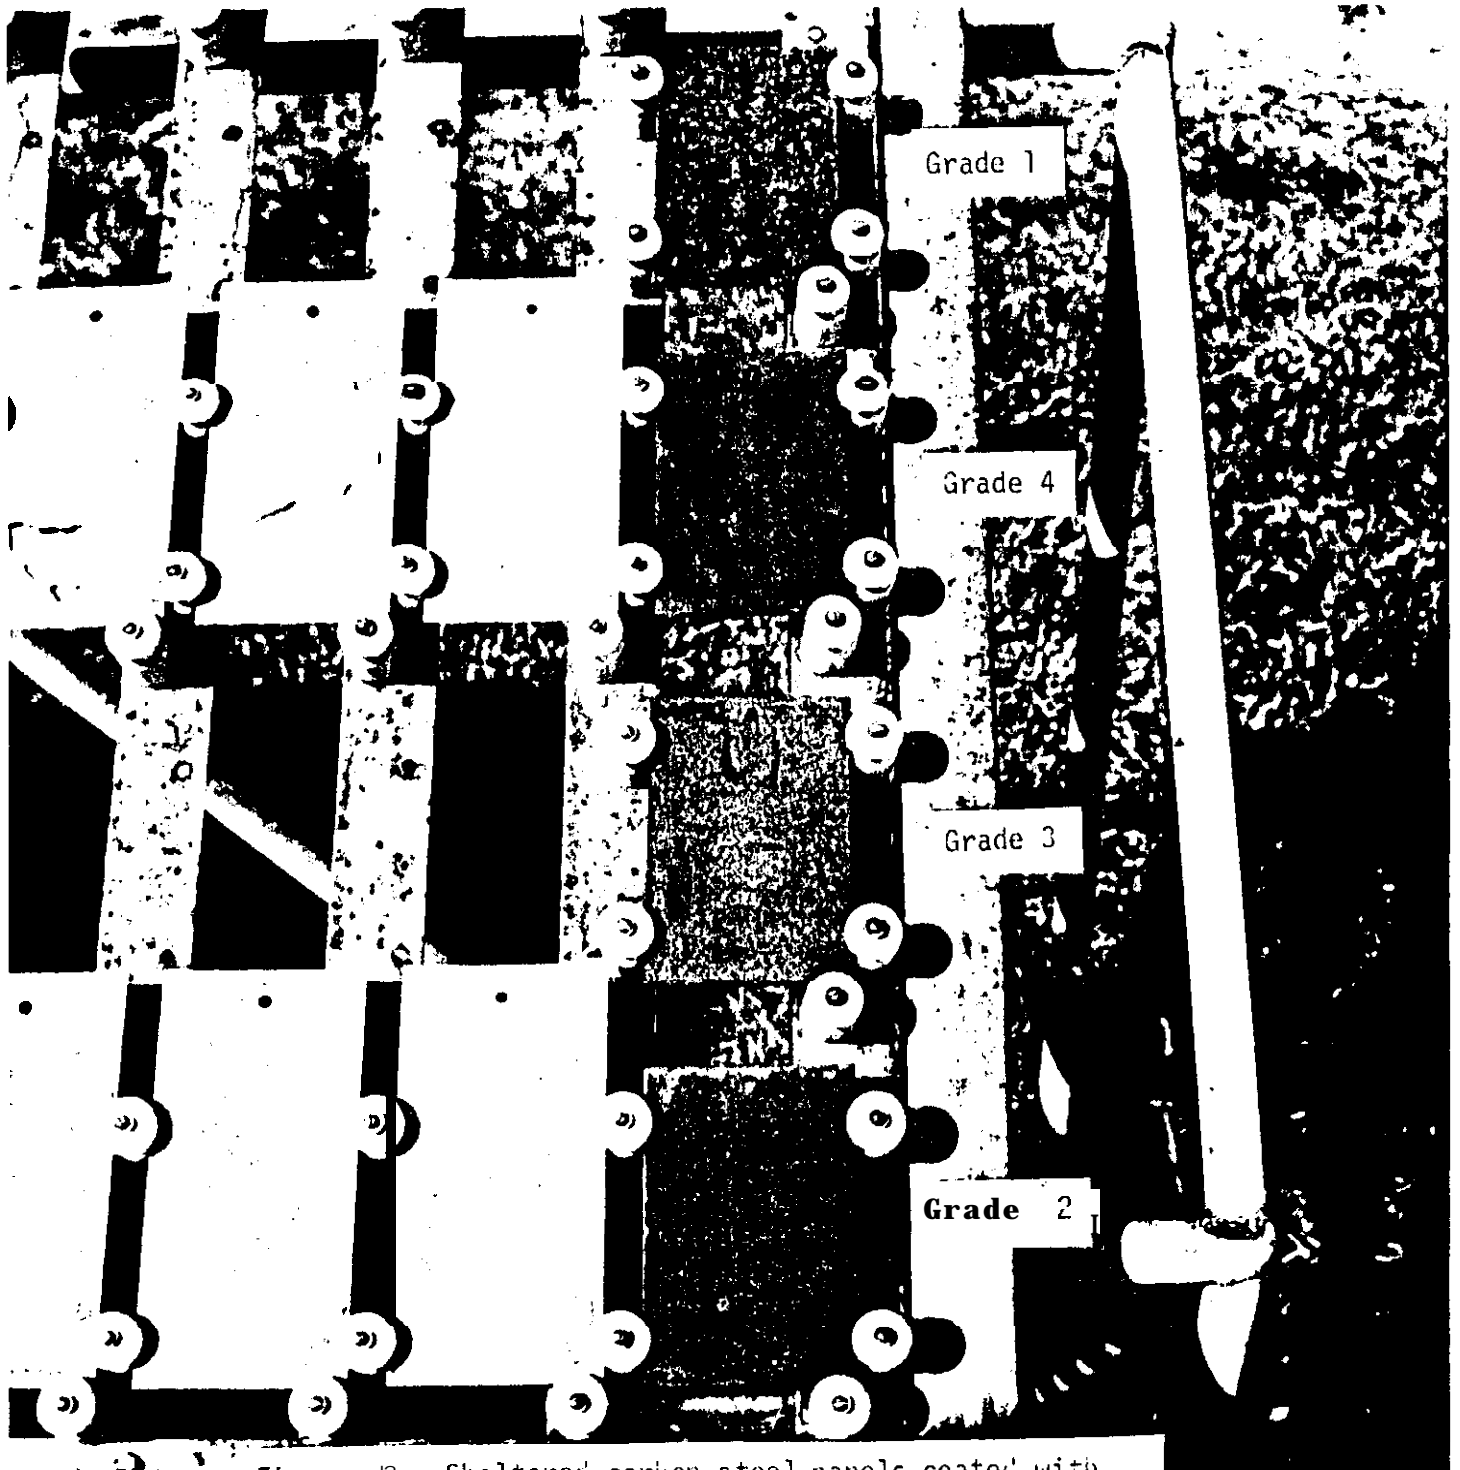
Figure 12. Sheltered carbon steel panels coated with four grades of Compound III-C-16173; after beach exposure for approximately six months.

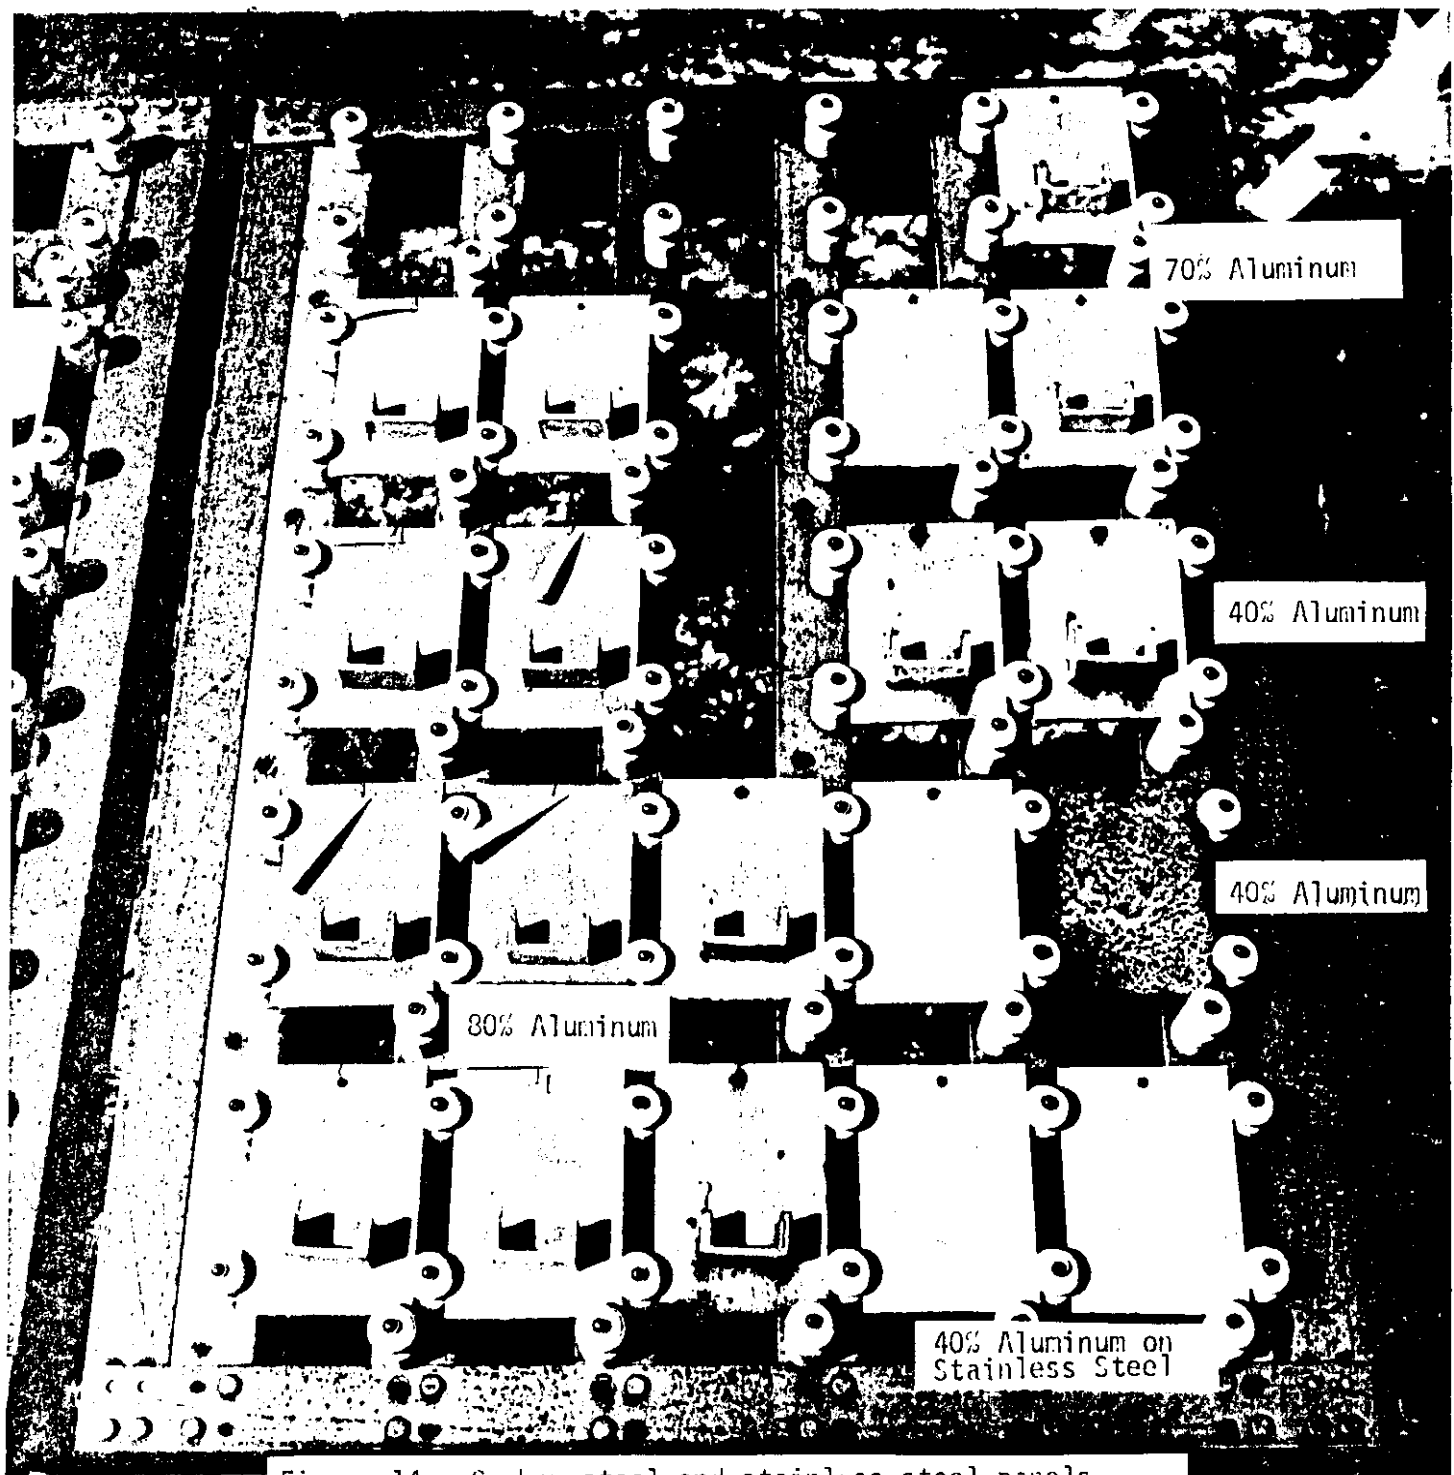
- 3.7 In Figure 14, results of some of the tests involving the application of the aluminized material---Goodrich Aerocoat AR-7---to carbon steel and to stainless steel test panels are shown. These panels had been exposed to the beach environment for approximately six months when the photograph was made. The particular coating formulations are indicated on the Figure. Two stainless steel panels were used in these tests, and they were coated with the 40%-aluminum material. These panels are the two at the lower right corner of the photograph. The effectiveness of this coating in protecting stainless steel is evident. There is only slight evidence of corrosion, and this is seen only along the panel edges, where there was incomplete coverage. The effectiveness of the 40%-aluminum material in protecting carbon steel is highly dependent on the amount of coating applied. Two carbon steel flat panels in the rack are located immediately above the stainless steel panels. The panel on the right, showing extensive corrosive attack, was coated with the 40%-aluminum AR-7 to a thickness of 1 to 2 mils, whereas the panel to its left was coated with the same material to a thickness of 4 to 5 mils. Note that the only evidence of corrosion on this latter specimen is along the panel edges and at the punched hole near the top of the panel. Similarly, the two Tator panels coated with the 40%-aluminum material showed corrosion mainly in the areas of the welded channels, where adequate coating thickness is difficult to obtain. The carbon steel panels coated to a thickness of 5 to 6 mils with the 70%-aluminum material (one flat panel and two Tator panels near the top of the rack) show much less

evidence of corrosion, this being mainly some spots in the channel area of one of the Tator panels. Two Tator panels were coated with 4 to 5 mils of 60% aluminum material, and these are shown at the lower center portion of the sample rack. This material is less effective than the 70%-aluminum material and is probably not as effective as the 40% aluminum material. The poorer corrosion protection of the 60% aluminum coating is attributed, at least partly, to its poor adhesion to the carbon steel base metal, which is in turn probably a result of an excessive amount of aluminum filler. It appears that the 70% aluminum material is probably near the maximum acceptable aluminum content for good adhesion properties.

Figure 14. Carbon steel and stainless steel panels coated with Goodrich Aerocoat AR-7, after approximately six months beach exposure.
