REHABILITATION OF THE HAMMOND BRIDGE IN MARION COUNTY, IOWA

**REPORT COMPILED BY JAN OLIVE NASH
TALLGRASS HISTORIANS L.C., IOWA CITY, IOWA**

2004

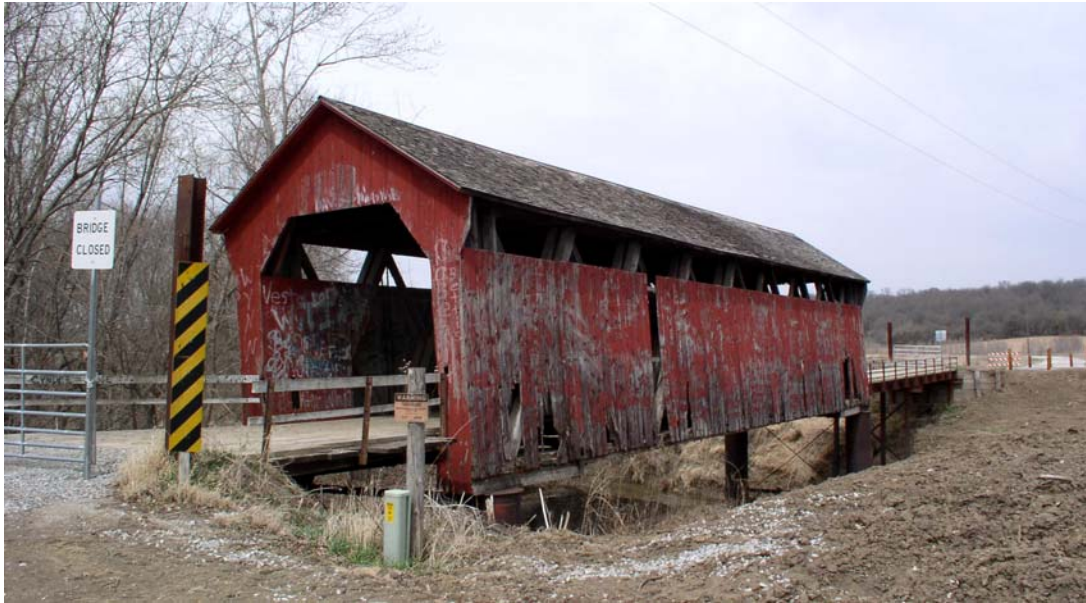
Figure 8 Hammond Bridge just prior to its rehabilitation in April 2003. (Nash photo)

The historic Hammond covered bridge was listed in the National Register of Historic Places in 1998. It is a timber and iron, 8-panel Howe through truss structure with a single, 78-foot long span (Fig. 9). Two more modern approach spans bring the total bridge length to 178 feet. The roadway deck width is 13.3 feet. Supporting this superstructure are concrete-filled metal cylinder piers, though the North Cedar Creek channel no longer flows directly between them. Instead, the stream is rechanneled slightly to the north under the longer of the two approach spans (Fig. 9). The double-span, 80-foot long north approach to the bridge was added in 1952, though as late as 1956 the creek bed carrying water was still directly under the covered span. The timber deck of Hammond Bridge lays on steel stringers. When the bridge was inspected for the Historic American Engineering Record program in 1992, the following additional physical dimensions and construction techniques were noted: “end post: two 4x8 timber posts; upper chord: three 12x8 timber posts; lower chord: three 12x8 timber posts; vertical: two round rods with threaded ends; diagonal: two 6x8, or 8x8, or one 4x8 timber posts; floor beam: I-beam; gabled wood-frame sheathing, with wood roof shingles and vertical wall planks” (Iowa Historic Bridge Inventory/HAER, 1). Physical inspection in 2003 revealed the walls were covered primarily with barn-plank siding applied vertically. Some of the 10- to 12”- wide plank siding was probably original but the lower ends were badly weathered and deteriorated. Underneath the sheathing, joinery of the truss wood members was both by notching and bolts.

Awarded federal funds under the National Historic Covered Bridge Preservation Program, Marion County undertook the renovation of Hammond Bridge in 2003. Plans drawn up in January, 2003 identified 14 tasks to be accomplished, including the following: replacement of damaged and rotted siding, repair of the steel caissons at N.W. corner, restoration of the horizontal bracing in the floor system, replacement of worn or decayed deck planking, restoration of the canopy at north and south ends to original construction, removal and replacement of the cedar shingles, replacement of any rotted roof sheathing, installation of new portal frames at both ends, removal and replacement of any unsound sections of the southeast truss bearing, and replacement of any unsound bridge railing members while repainting of the rest. Additionally, the historic trusses were to be straightened and made plumb and the south end wood header beam was to be repaired. Trees overhanging and in

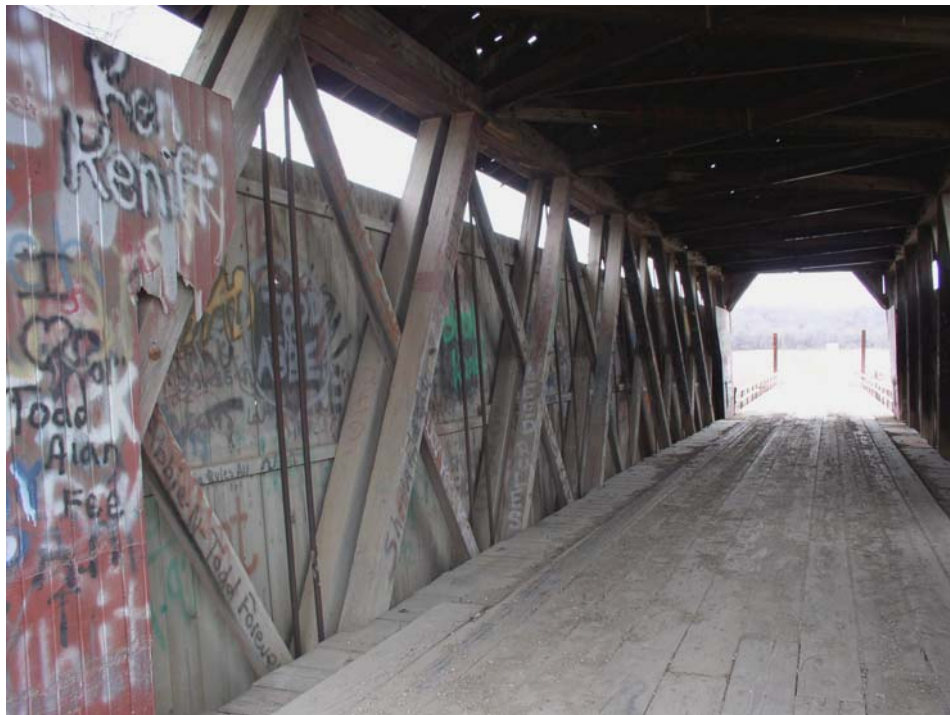
Figure 10 Pre-rehabilitation interior view of “lattice” panels or Howe truss panels, looking north from south end of the bridge. (Nash photo)

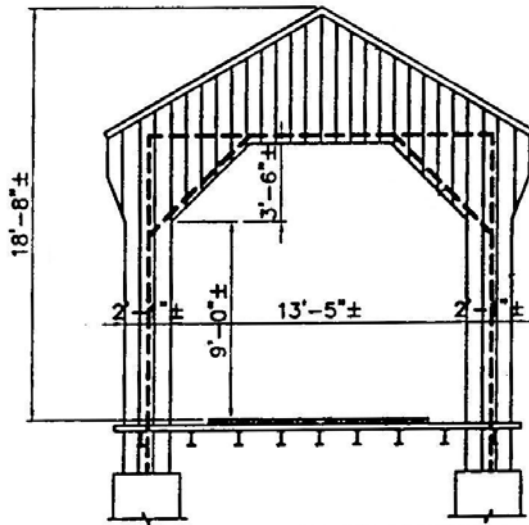
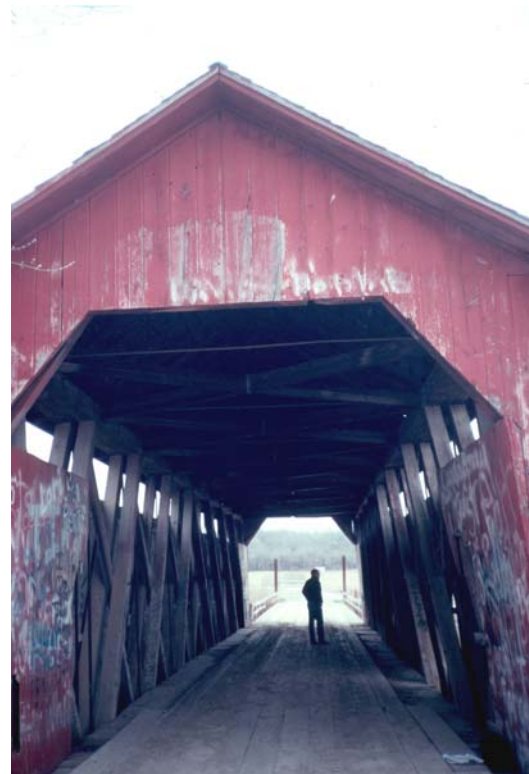
Figures 11 and 12 South portal plan (left) and pre-rehabilitation photo (right), facing north. The north portal is similar. (Drawing adapted from Shuck-Britson Inc. rehabilitation plans dated January 2003; Nash photo on right)

Eighty years after it was constructed, a truck that was too tall for the portal attempted to cross the bridge. The resulting accident closed the bridge between 1977 and 1979 for “minor repairs” (Iowa Historic Bridge Inventory/HAER, 1). The bridge is now closed to motor traffic with the road diverted to a concrete ford just downstream (Fig. 19).

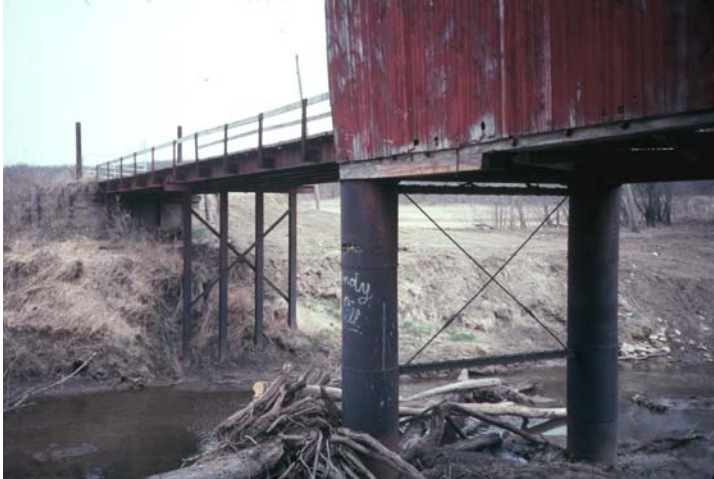
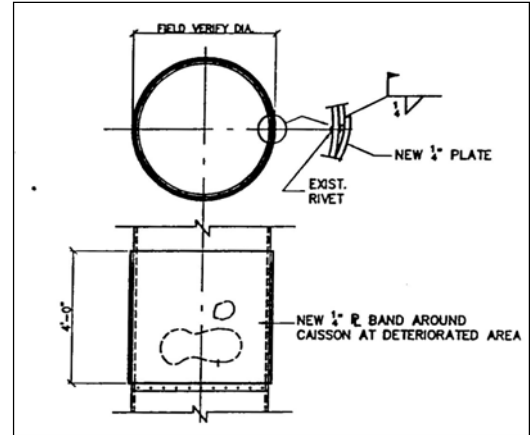
Figures 14 and 15 Northwest cylinder pier and its repair plan.
(Drawing adapted from Shuck-Britson Inc. rehabilitation plans dated January 2003; Nash photo on left)

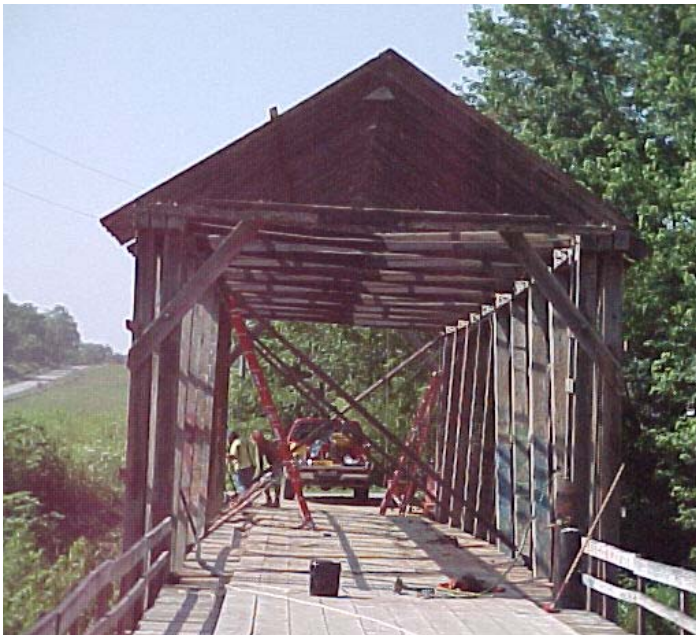
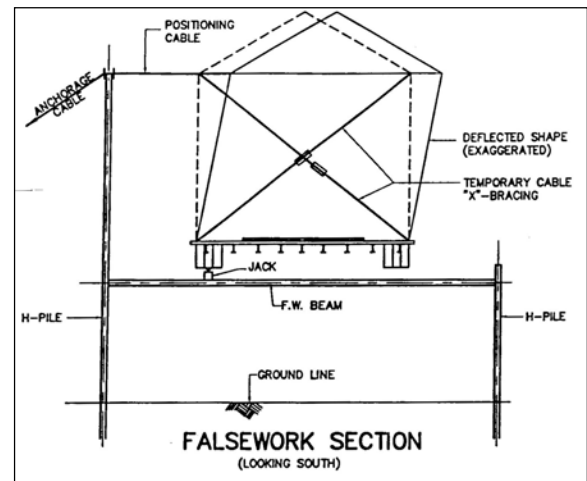
Figures 16 and 17 Straightening the trusses, looking south.
(Drawing adapted from Shuck-Britson Inc. rehabilitation plans dated January 2003; Jay Davis photo on left)

Repair methods throughout the project were performed in such a way as to maintain the original appearance of the bridge. The installation of a “portal frame” was one of the more notable examples. A new steel frame was added between existing wood members to strengthen the structure and keep it from leaning after it was straightened (Figs. 21-29). To do this, a steel framework was welded together and then bolted to the wood structure. The steel was then covered with cedar lumber. Cost for this procedure was \$28,000 (refer also to the table of costs below). Also, the timber member at the northwest caisson or cylinder pier was badly decayed. This decayed section was removed and a similar timber was cut to match the size and shape. Bolts and epoxy were used to secure the repaired timber. The cost for this procedure was \$695. Finally, since the roof rafters were not the standard dimension of today’s lumber, the contractor’s crew cut replacements for the rotten rafters out of timbers, matching the dimensions of the historic lumber (not a separate cost item).

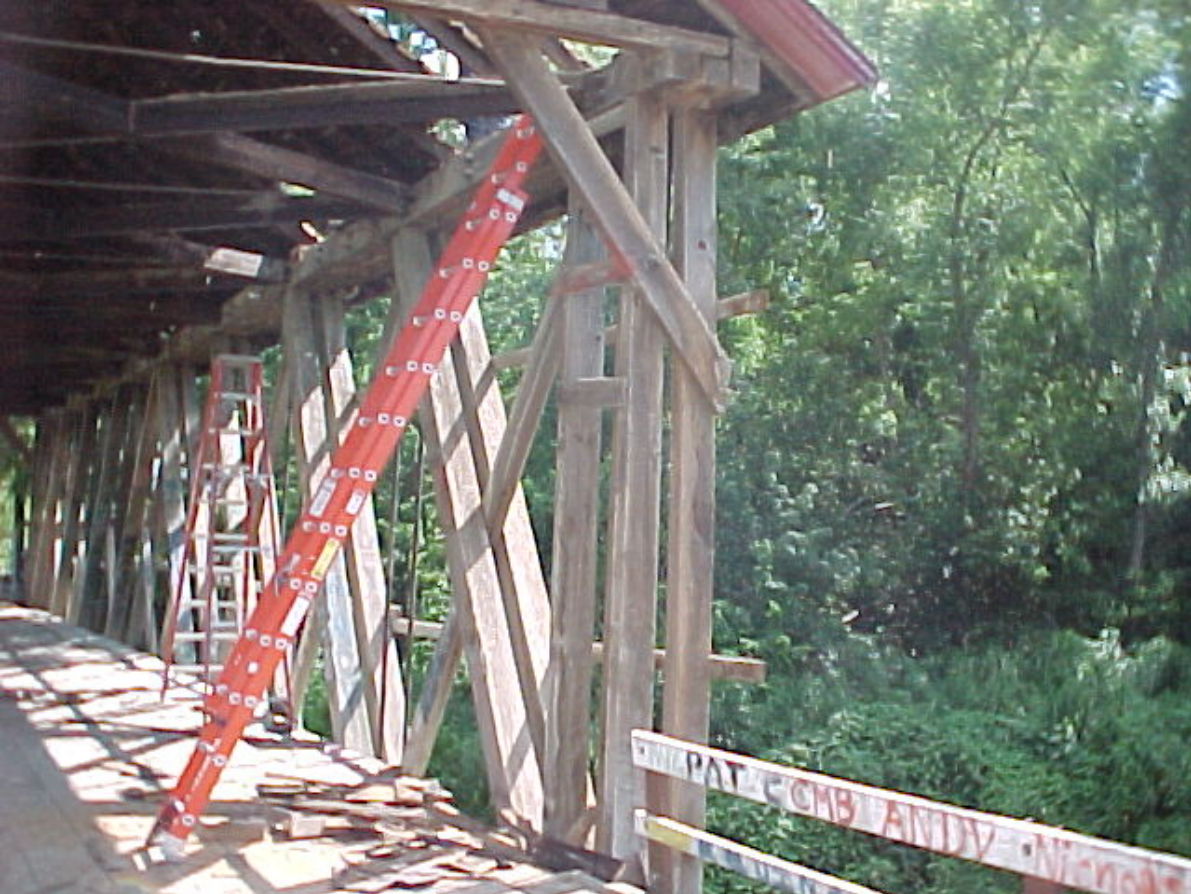
Figure 21 Representative location of the new steel portal frame.

Steel portal frame installation: the following several views show the installation process of this feature, which is intended to strengthen the structure and make it wind resistant. All photos are by Jay Davis.

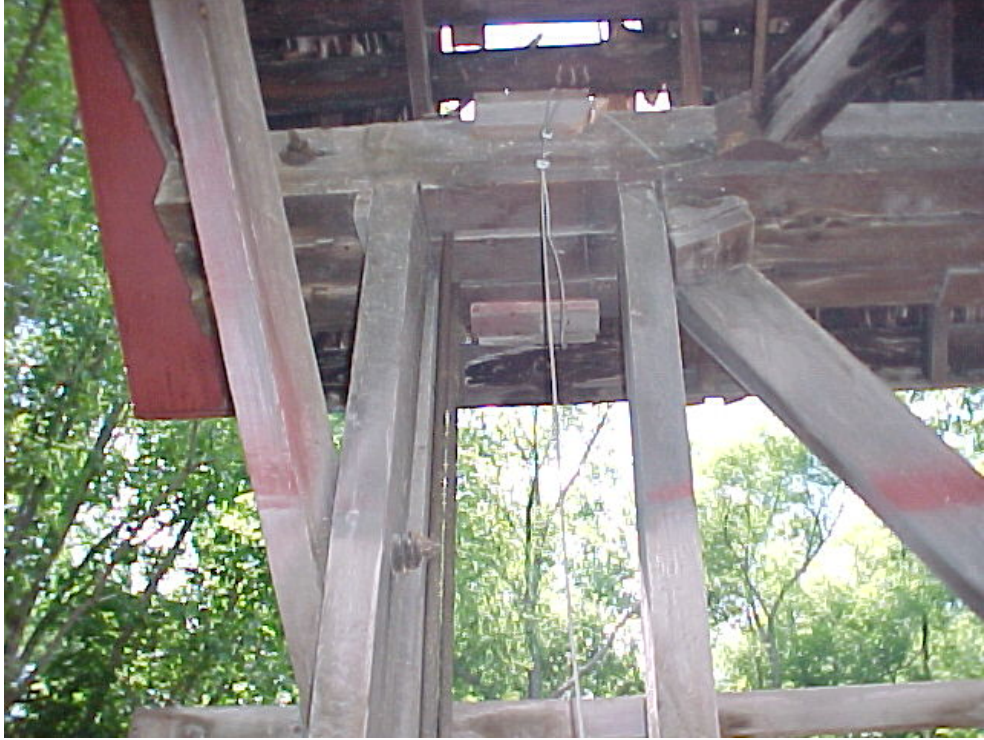
Figure 22 The steel was installed in the space between timber uprights.

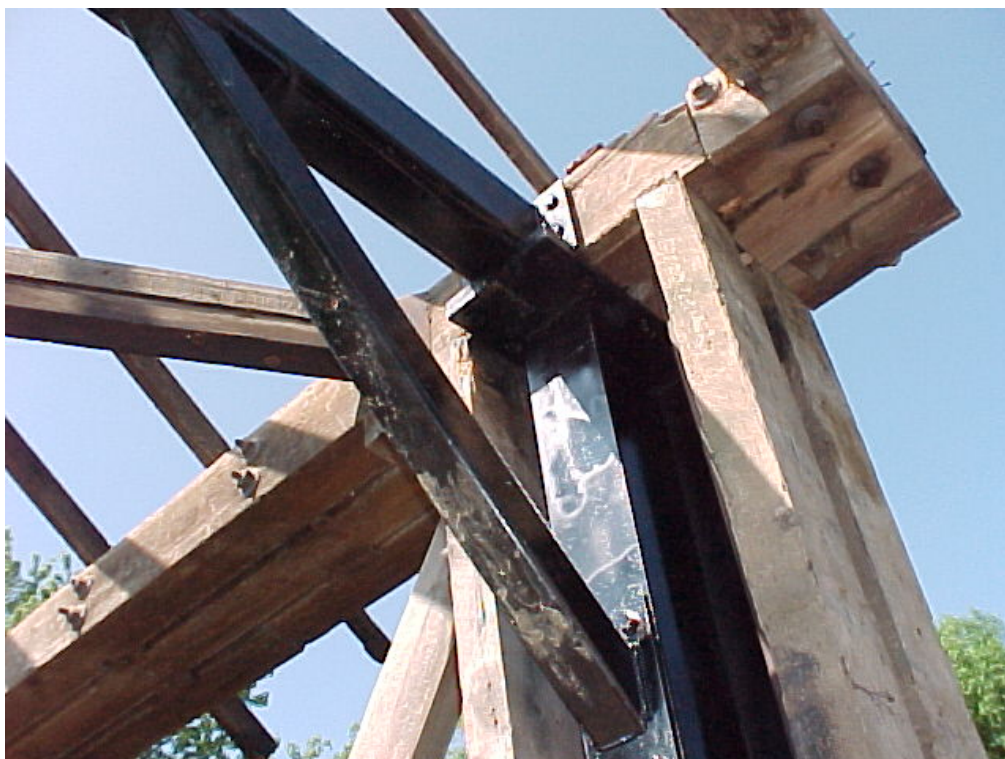
Figure 26 Juncture of the steel portal upright and beam, as bolted to the wooden bridge.

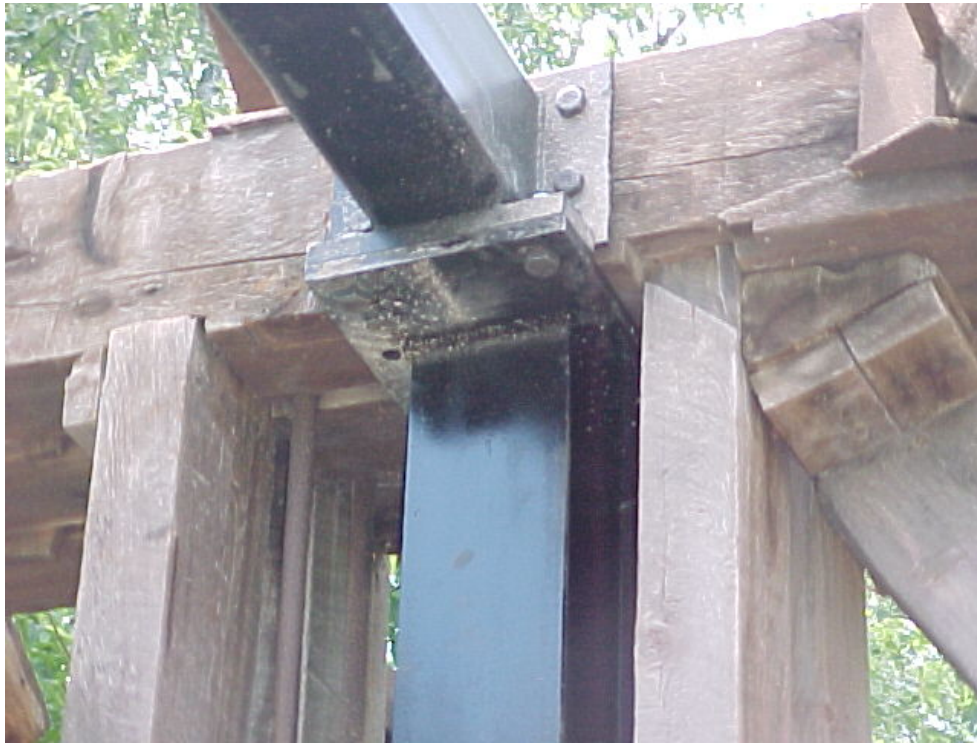
Figure 27 Steel bolted to the historic timber.

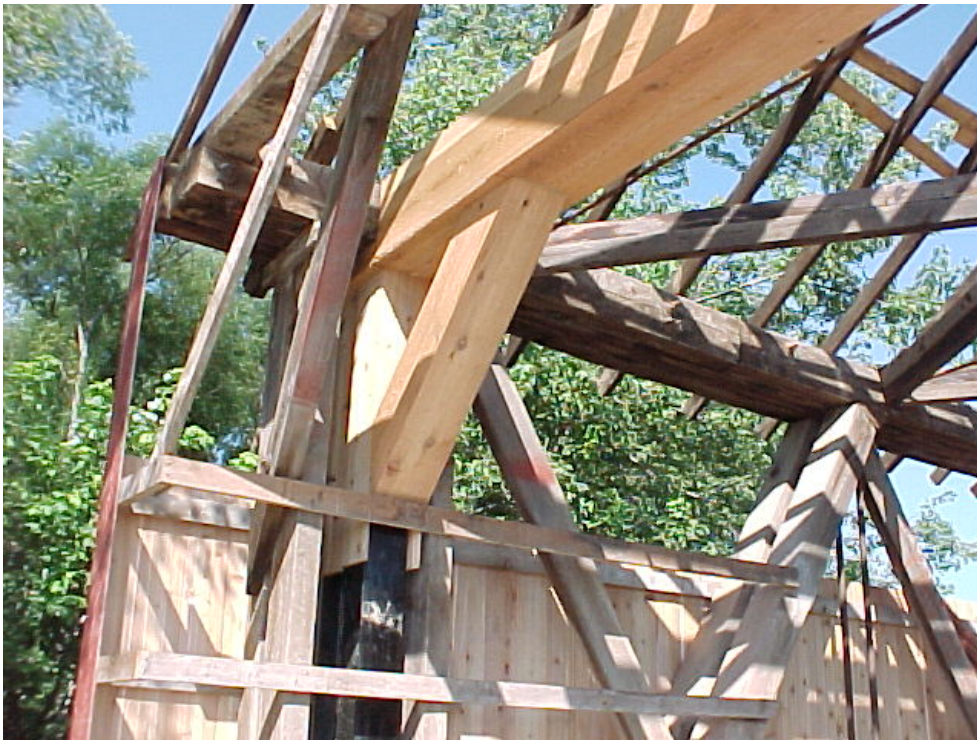
Figure 28 Cedar lumber hides the steel.

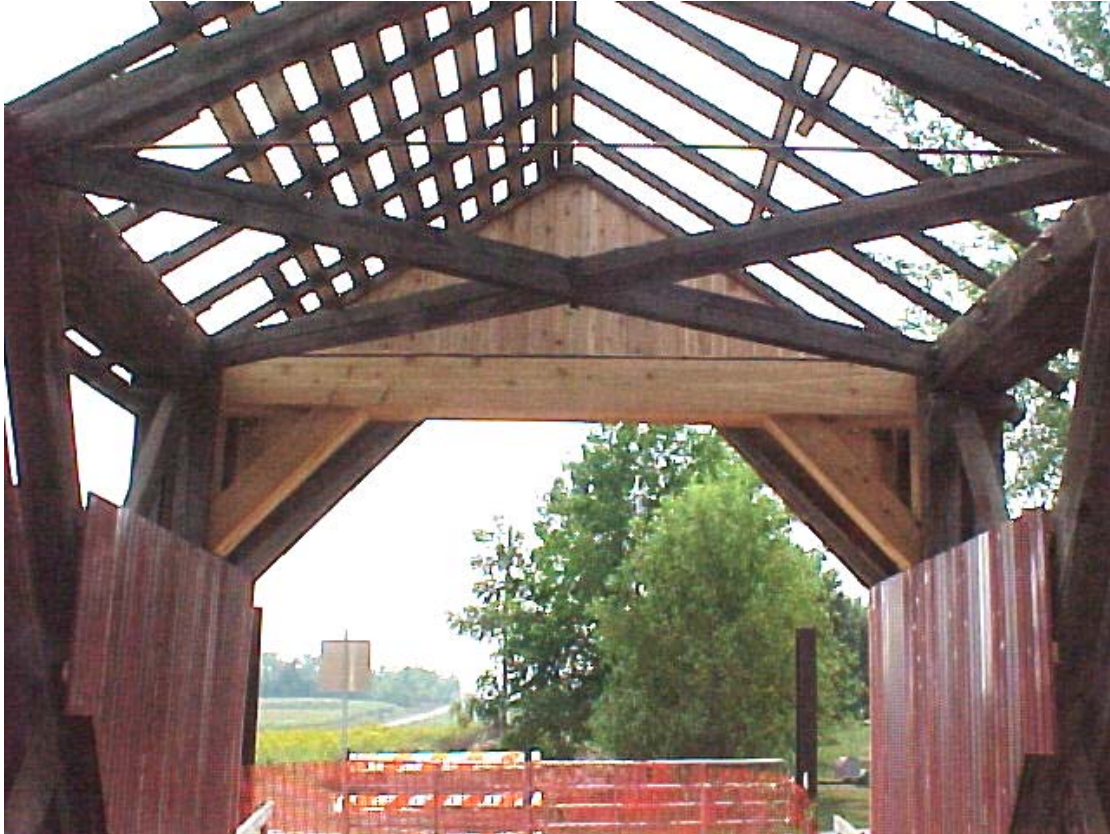
Figure 29 The reinforced southern portal, clad in new cedar.

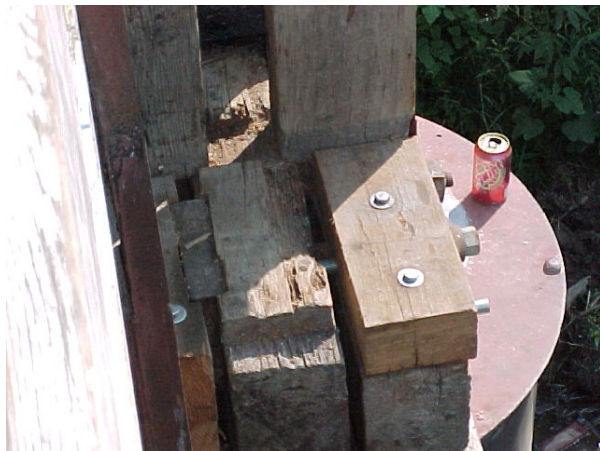
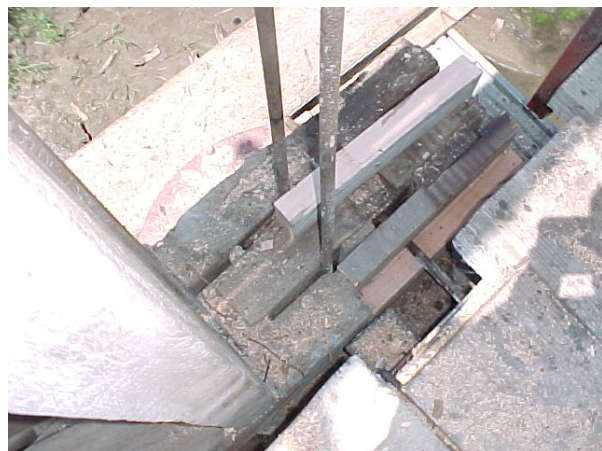
Figures 30 & 31 Floor beam and pier trouble spots.

Caisson area repairs: The following images document the repair work on the cylinder piers or caissons. All photos are by Jay Davis.

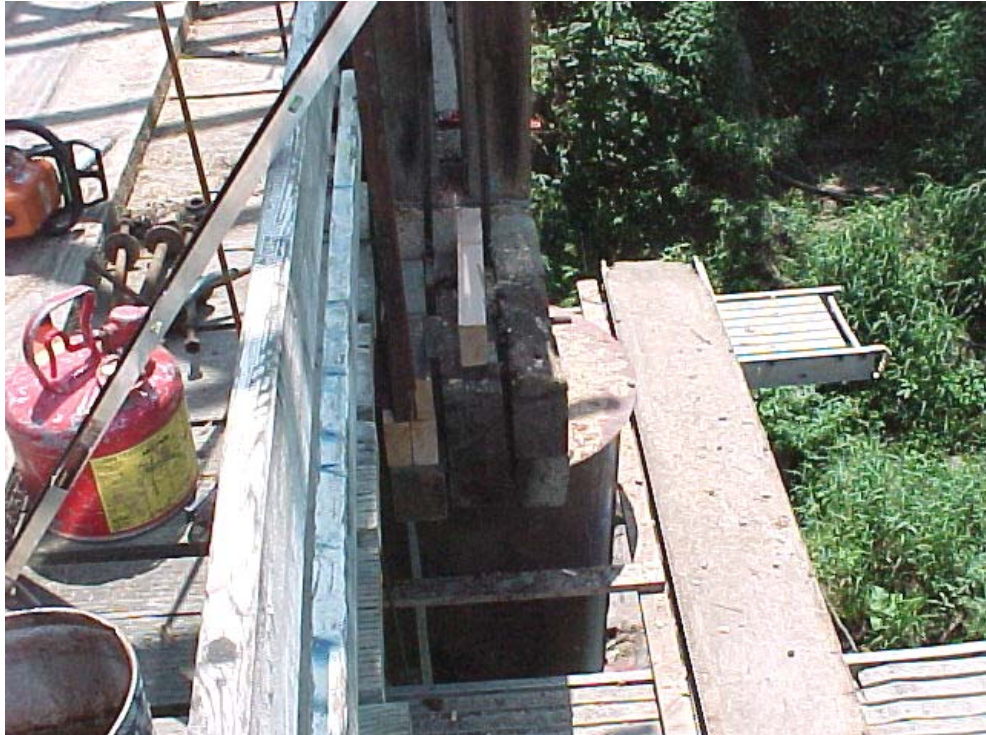
Figure 32 Repairing the rotten wood at the northwest caisson area.

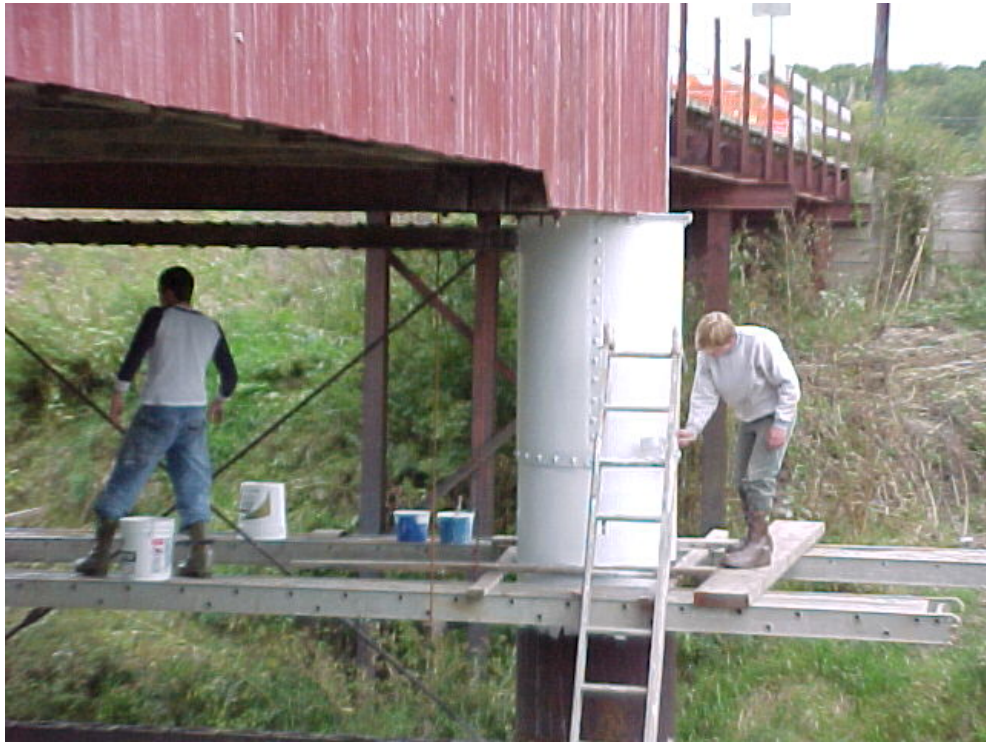
Figure 33 Priming a caisson/cylinder pier.

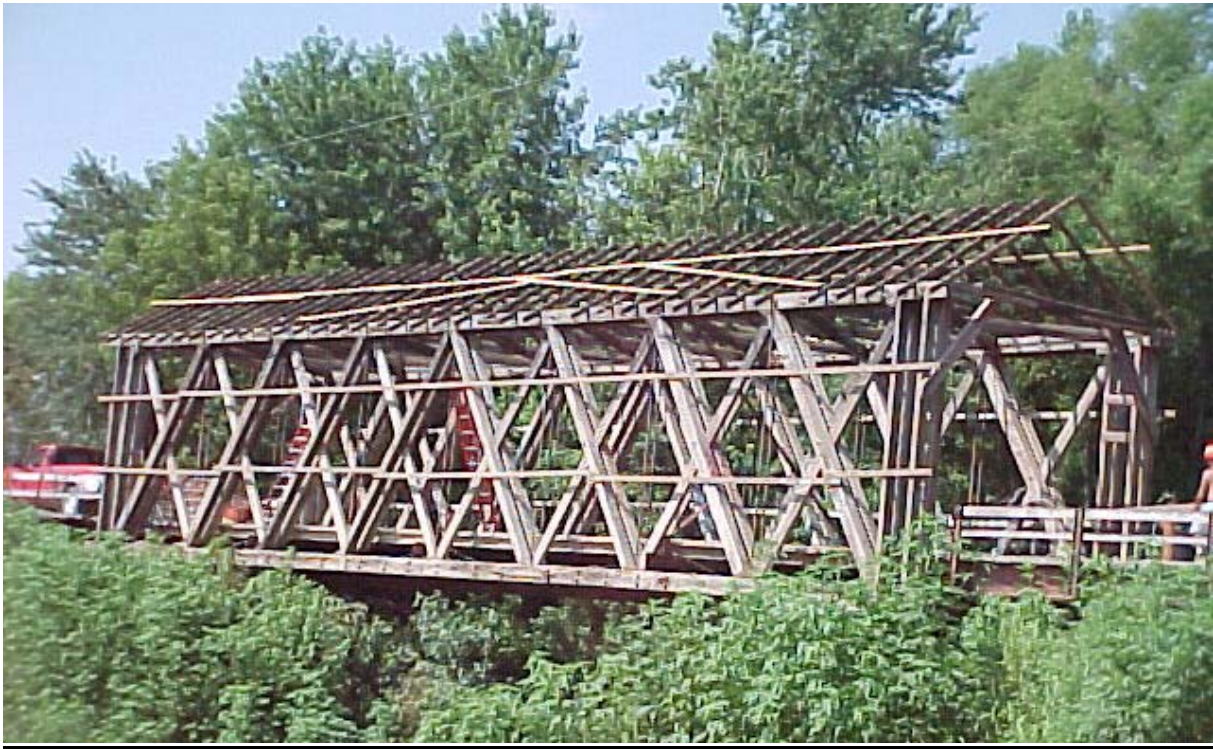
Figure 37 The timber and metal Howe truss system is easy to see with the siding removed. Note the rafters have no ridge board.

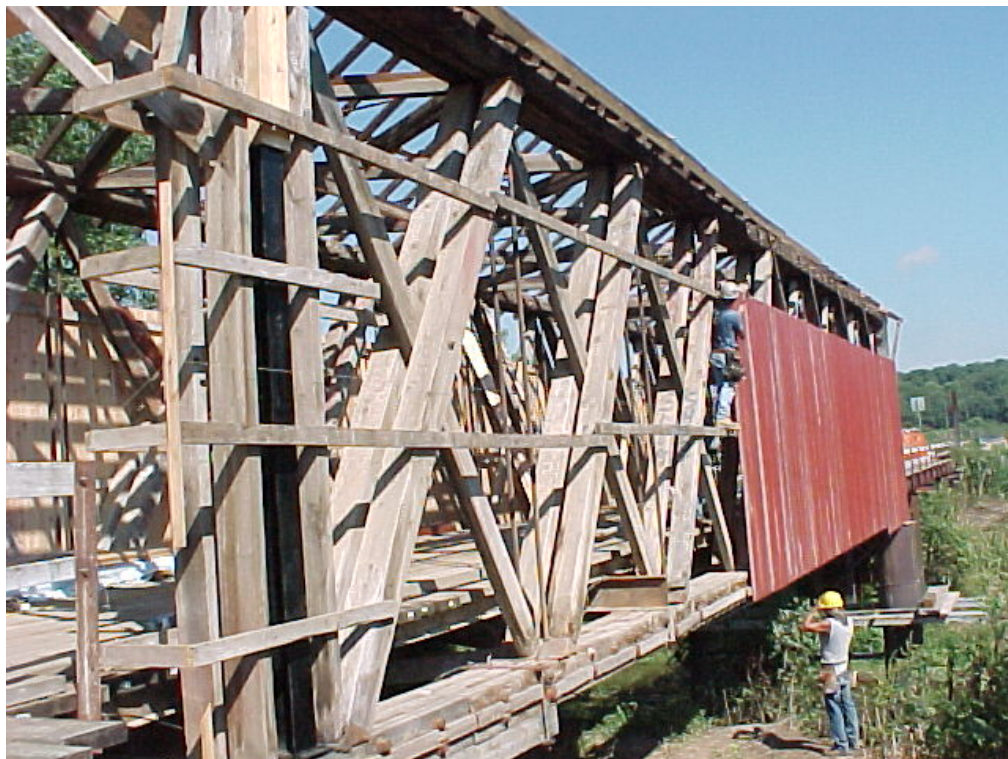
Figure 38 Replacing the siding.

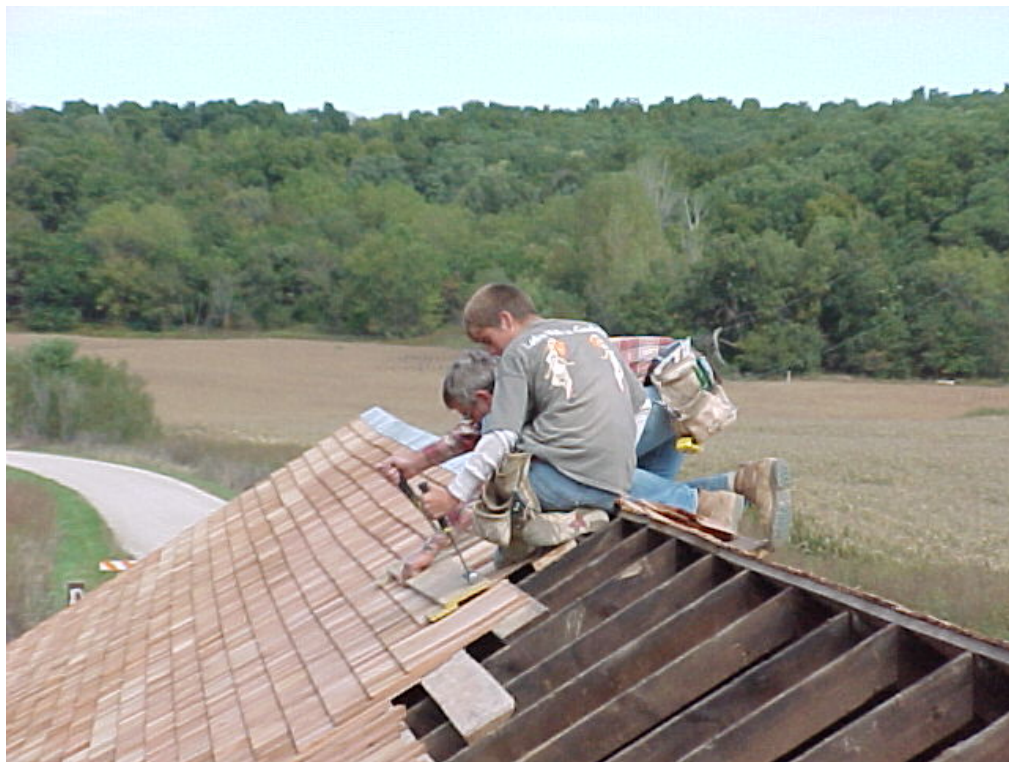
Figure 40 Re-roofing with cedar shingles.
