**An Overview of Mining-Related Environmental and Human Health Issues,
Marinduque Island, Philippines: Observations from a Joint U.S. Geological
Survey – Armed Forces Institute of Pathology Reconnaissance Field Evaluation,
May 12-19, 2000**

U. S. Geological Survey Open-File Report 00-397

Executive Summary

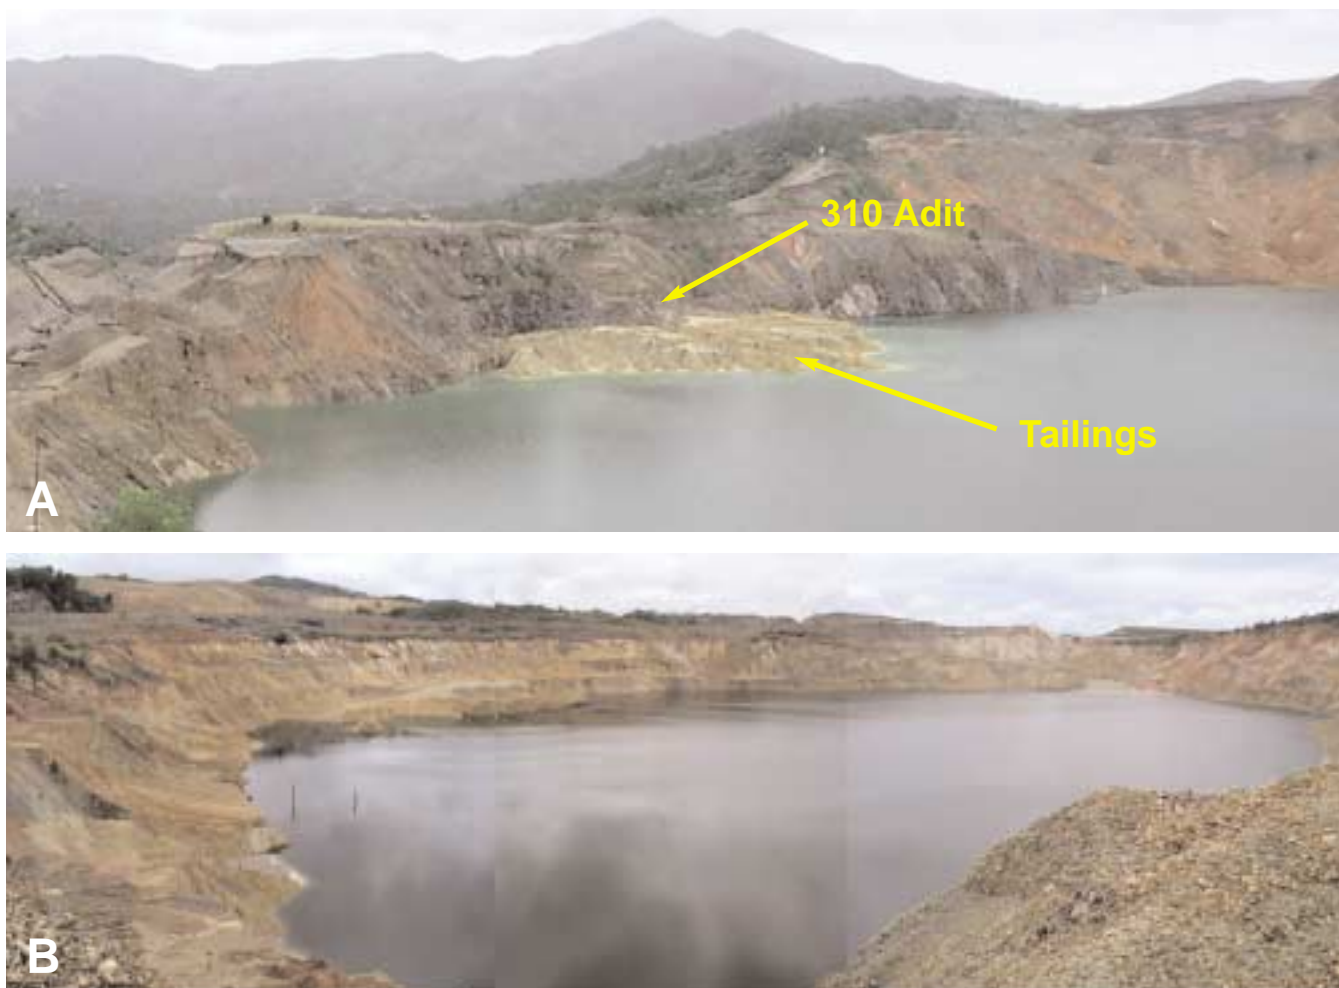
With the cessation of mining at Marcopper and the re-plugging of the Tapián drainage adit in 1996, water started accumulating in both the Tapián and San Antonio open pits (Fig. 5; report cover). According to Marcopper personnel, the water levels of both pit lakes are still rising. The Tapián waters are nearing the elevation of the 310 adit, the access point through which tailings were piped into the pit from the mill from 1990-1996.

The water in both pit lakes at the time of our visit was a deep transparent green color; due to time constraints, we did not collect water samples from either pit lake. According to Marcopper per-

Figure 5. **A.** View looking northeast of the north end of the Tapian pit lake. Remnants of the tailings stored in the lake are visible in the central portion of the figure. A panoramic view of the Tapian pit looking southeast is shown on the cover of this report. **B.** The San Antonio pit lake, looking northwest.

sonnel, the pH of the Tapian pit lake waters at present is around 4; although the pH of the San Antonio pit lake water is unknown, we presume that it is generally similar to that of the Tapian pit water.

reflects an influx of acid waters generated by oxidation of sulfides in the rocks around the open pit, and the gradual neutralization by these acid waters of alkaline chemicals in the mill process waters. The present acid pH of the Tapian pit water is very similar to the pH of mine waters in porphyry-copper deposits in the United States. As we have observed with similarly colored mine waters draining the Summitville, Colorado, gold-copper deposit (Plumlee et al., 1995), it is possible that the clear, deep green color of the Tapian and San Antonio pit waters is indicative of high levels (possibly in excess of 100 ppm each) of dissolved ferrous iron and copper.

from the pit lakes into surrounding surface drainages should be considered only: (a) as a last resort, if catastrophic overtopping of the pit walls or failure of the 310 adit plug is thought to be imminent, or (b) if it can be shown that potential adverse impacts on the environment of such pumping would be minimal.

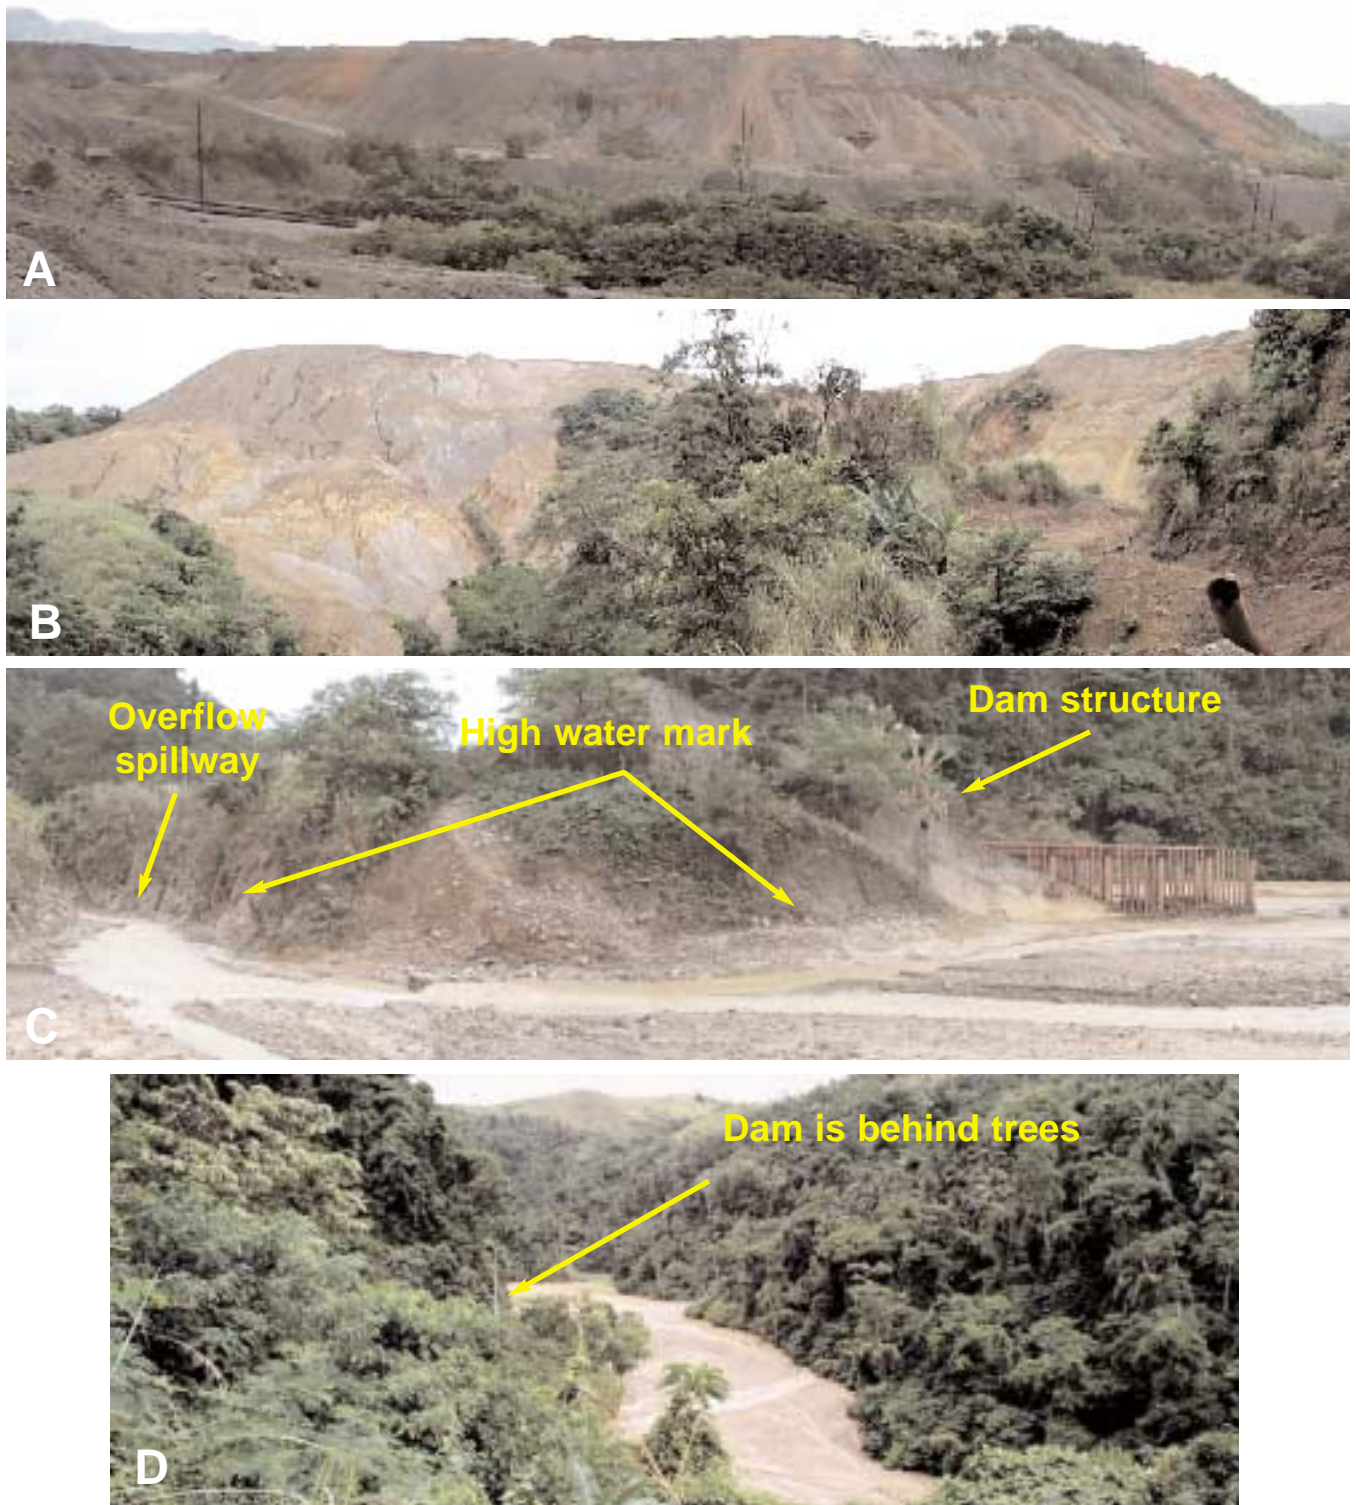
There are a number of large mine waste dumps at the Marcopper mine (Figs. 6A, B). We did not have time to inspect the mine waste piles up close. However, many piles observed from a distance appear to contain abundant gray, sulfide-rich, mineralized rocks. In addition, orange to yellow secondary salts formed by sulfide oxidation and evaporation of acid waters are readily apparent on many of the dumps.

At least one of the Marcopper dumps (Fig. 6A) was turned into an acid-leach heap during the course of mining, where sulfuric acid was added to the dump and the resulting acidic solutions were processed in a cement copper facility to extract the copper (Ante, 1985). Based upon compositions provided by Ante (1985), these acid-leach solutions were even more acidic and metaliferous than most mine-drainage waters. The soils upon which the dump was placed were deemed to be sufficiently impermeable as to not require a clay pad to prevent infiltration of the acid leach solutions into the rocks beneath the dump (Ante, 1985). Acid drainage emanating from other mine dumps was also processed at the cement copper plant (Ante, 1985).

The Maguila-guila siltation dam (Fig. 6C) was installed on a tributary of the Mogpog River approximately 1 km north of the Marcopper mine site to catch sediment eroded from the northern end of the mine. As recounted to us, this siltation dam failed catastrophically during a typhoon in December 1993. The dam failure sent a deadly debris flow down the Mogpog River that report-

Sedimentation: The rapid rate at which the sediment catchment behind the Maguila-guila siltation dam filled up after the rebuilding of the dam indicates that there is very rapid erosion of

Figure 6. **A.** Mine dump that was used as an acid leach dump for copper extraction. **B.** Mine dump north of the San Antonio pit above the Maguila-guila siltation dam. The yellow-to-orange colors on the dump indicate the presence of secondary salts, which show that sulfide-rich rocks (gray) are generating acid drainage. **C.** The Maguila-guila siltation dam, downstream from the dump shown in B, no longer fulfills its purpose to trap sediment eroded from the mine site. Sediment has completely filled the ~25 (?) m high impoundment and water is now flowing out the overflow spillway. Note the high-water mark on the dam, indicating that the overflow spillway is not big enough to prevent debris buildup and backup of waters during high stream flows. **D.** Looking north at sediment trapped behind the Maguila-guila dam.

material from the mine site. Because the dam is no longer trapping sediment, the sediment load on the Mogpog River and its tributary will continue to be substantial. Due to time constraints, we were not able to observe if any other drainages from the mine site have similar sedimentation problems.

Potential failure of siltation dams: A concern was expressed by local residents to us that the Maguila-guila siltation dam could collapse again, leading to another deadly debris flow downstream. Marcopper personnel indicated to us that the dam is regularly inspected for indications of structural integrity. However, the apparent backup of water behind the overflow spillway during high-runoff rain events (Fig. 6), is a potential indication that the dam needs further design scrutiny. It was unclear whether other siltation dams on site are also inspected on a regular basis.

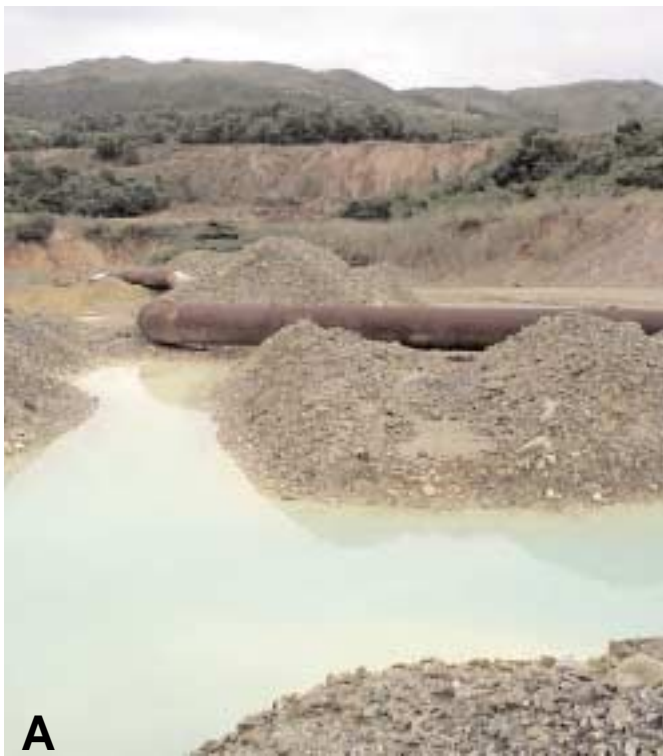
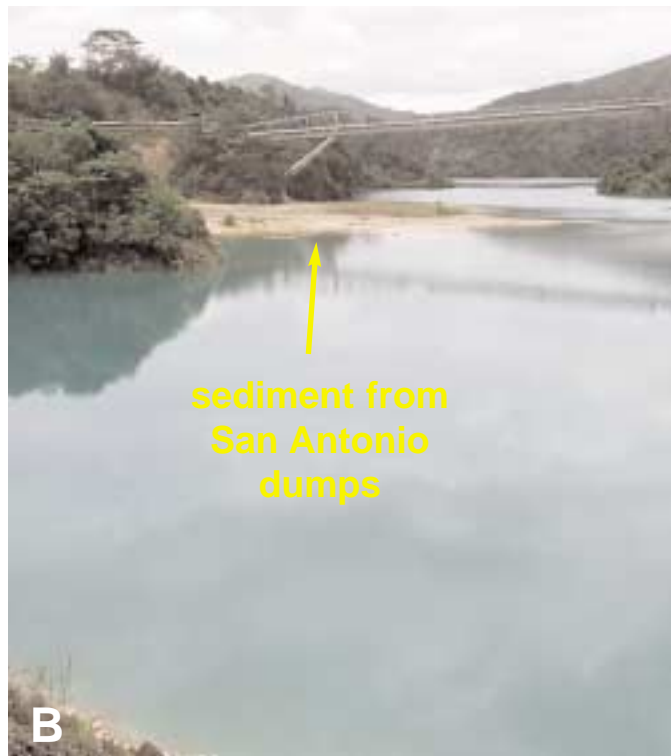
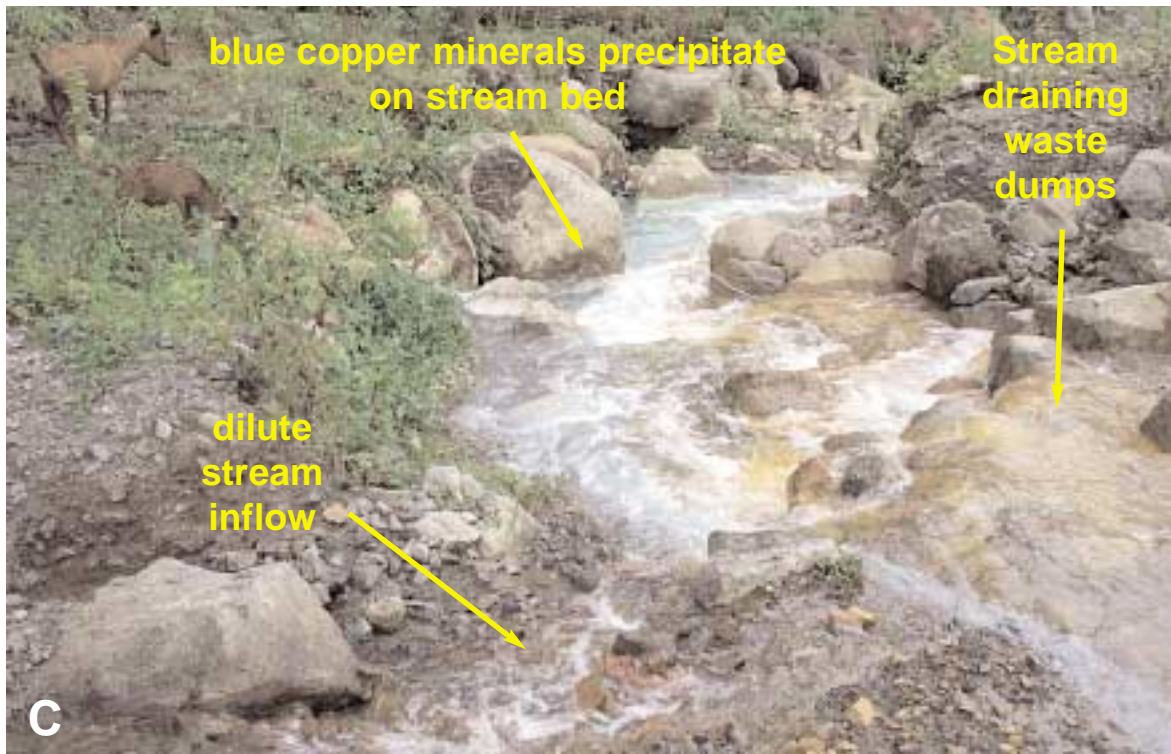
Transient rainfall-derived puddles and ponds on top of the mine dumps commonly display a green tint, indicating that they are acidic and copper bearing (Fig. 7A). The Bol River Reservoir (Fig. 7B), which receives surface waters (and probably ground waters) draining the Tapian and San Antonio pit areas and waste dumps, is a similar deep green color. An acid-drainage stream that flows into the Makulapnit River from substantial mine dumps on the southwestern portion of the mine site (Fig. 7C) has waters with pH around 4.0 and conductivity of 3000 $\mu\text{S}/\text{cm}$. We did not sample these drainage waters. However, high copper concentrations are indicated by the precipitation of a complex assemblage of copper sulfate minerals and a copper silicate mineral on stream-bed rocks where the mine waters are diluted by a near-neutral pH, low conductivity tributary stream (Fig. 7C).

Figure 7. A. Acidic, copper rich puddles form on waste dumps after rains. B. The deep green color of the Bol River Reservoir waters indicate high copper contents. C. Mine waters draining from the Makulapnit siltation dam overflow, below waste dumps on the southwestern side of the mine, have pH 4 and a conductivity of 2000 $\mu\text{S}/\text{cm}$. Orange iron hydroxides are precipitating from the acidic mine waters in the stream bed (right). As these mine-drainage waters are diluted by higher-pH, more dilute waters flowing in from the left of the photo, a complex mixture of blue copper sulfate and copper silicate minerals precipitates on rocks in the stream bed in the upper central portion of the photo.

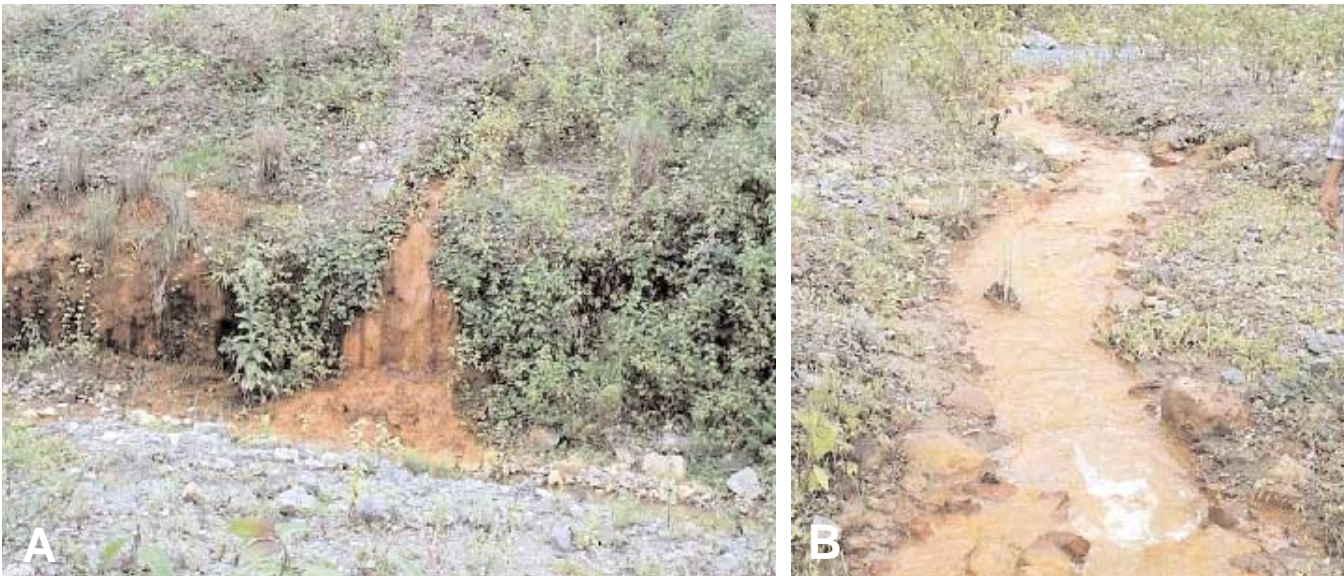
We did not observe the entrance of the 195-m level drainage adit due to vegetation overgrowth. A low-volume seep in the vicinity of the adit had pH of 6 and 3000 $\mu\text{S}/\text{cm}$ conductivity (Fig. 8A). It was unclear to us whether this seep is emanating from the drainage adit or from fractures in the rock near the adit.

Drainage from the adits into the Makulapnit River: At present, drainage from the 195 access adit and from the 195 drainage adit (or nearby fractures) appears to be a relatively minor contribution to the overall metal and acid loadings already entering the river from mine dumps up gradient (Fig. 7). The near-neutral pH but high conductivity of the adit waters indicate that they

Figure 8. **A.** Seep near the portal of the 195 drainage adit. The seep water has a pH of 6.2 and a conductivity of 2000 $\mu\text{S}/\text{cm}$. The seep discharges into the stream draining from the Makulapnit siltation dam. **B.** Discharge from the 195 access adit, pH 6.6, conductivity 2300 $\mu\text{S}/\text{cm}$. The stream from the Makulapnit siltation dam is visible in the central background.

likely are acid-rock drainage waters partially neutralized by dilution or by interactions with carbonate minerals in the rocks hosting the adits.

- ◆ An independent review of the adit plug, in addition to a review of the plug engineering, should also include a review of the engineering geology characteristics (physical strength, amount of mineralization and alteration, etc.) of the rocks hosting the plugs. This review should also include an assessment of earthquake risk and potential earthquake-induced failure of the plug.

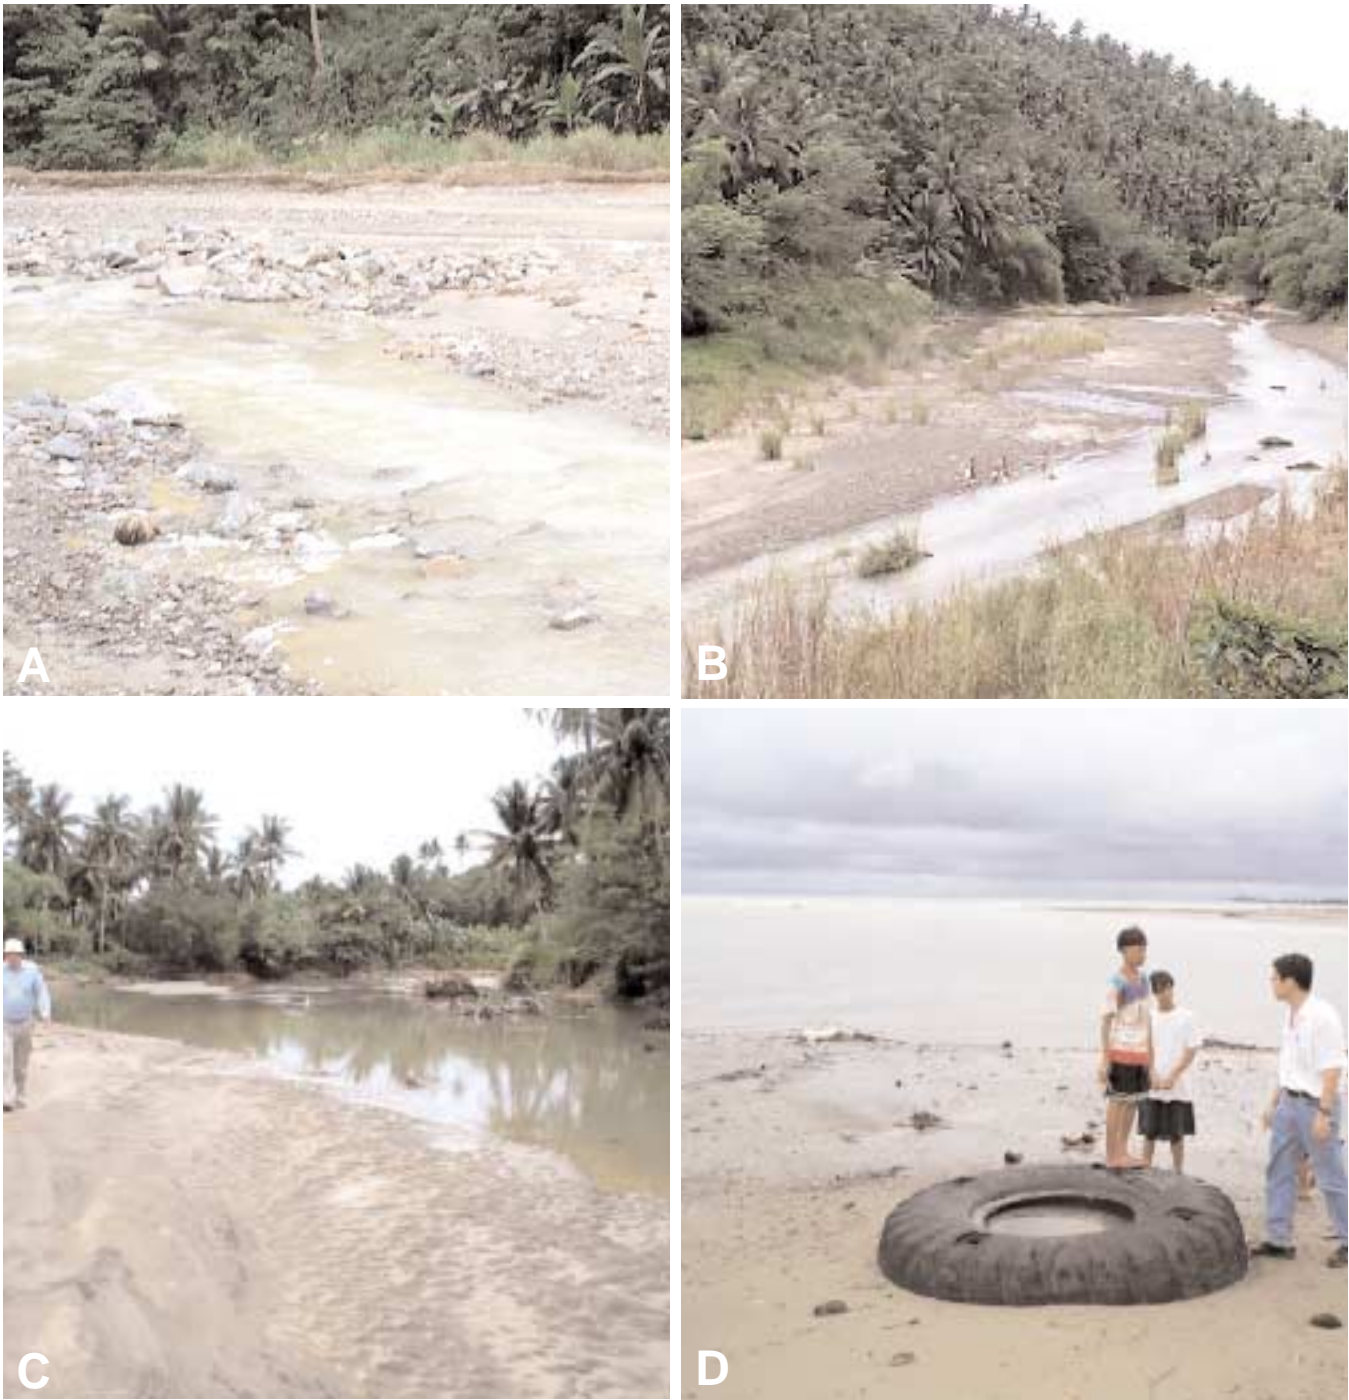
Based on a quick inspection of the active river channel we observed no fish or aquatic invertebrates in the main stem of the Mogpog River. Local residents told us that such aquatic life was present in the river prior to the 1993 siltation dam failure. We did observe a diverse community of aquatic organisms in uncontaminated tributary streams draining into the Mogpog from unmined, unmineralized areas.

Effects of sediments from Marcopper: The high rate of sediment transport from Marcopper will continue to have adverse effects on the aquatic ecosystem, and on the ability of the river system to handle large flood events. We also observed high erosion rates and rapid sediment transport in several other rivers on Marinduque that were not affected by mining. However, the fine-grained, metal-rich, and potentially acid-generating nature of sediments from Marcopper is likely to have been a substantial change from the natural condition of the Mogpog prior to mining. For example, fine-grained sediment from the mine site may fill in the pore spaces of the originally coarser river-bed sediments, thereby adversely affecting the habitat of fish and aquatic invertebrates living on the river bottom.

Figure 9. Photos of the Mogpog River. **A.** The site where we collected a water sample (Table 1), approximately 5 km downstream from Marcopper. The water is a yellowish-tan color due to its high suspended sediment content. **B.** The Mogpog River approximately 10 km downstream from Marcopper. Although difficult to see in the photo, a group of children was swimming in the river at the time the photo was taken. **C.** Mogpog River approximately 2 km from its mouth. The sand bar on which Jack Medlin is walking was under water two nights previously due to a flash flood. Debris piles from the recent flood (and previous floods?) are visible near the right bank of the river. **D.** The Mogpog River mouth. According to locals, the tire (originally from one of the mine's dump trucks) was carried in by the river during a flash flood; however, the tires are used by the mining company to create artificial reefs, and so may have been carried in by the ocean during a storm. Note the milky-orange color of the water due to suspended sediments from the Mogpog.

- ◆ Sediment-laden, acid-rock drainage from the mine site is adversely affecting water quality along the Mogpog River. This underscores the need for more effective sediment control and treatment of acid-rock drainage at Marcopper. This is especially true given the extensive use of the water by residents along the Mogpog River.
- ◆ The potential health effects of Mogpog River water use by local residents and their farm animals should be evaluated. The potential health effects on the aquatic habitat and biota should also be evaluated.

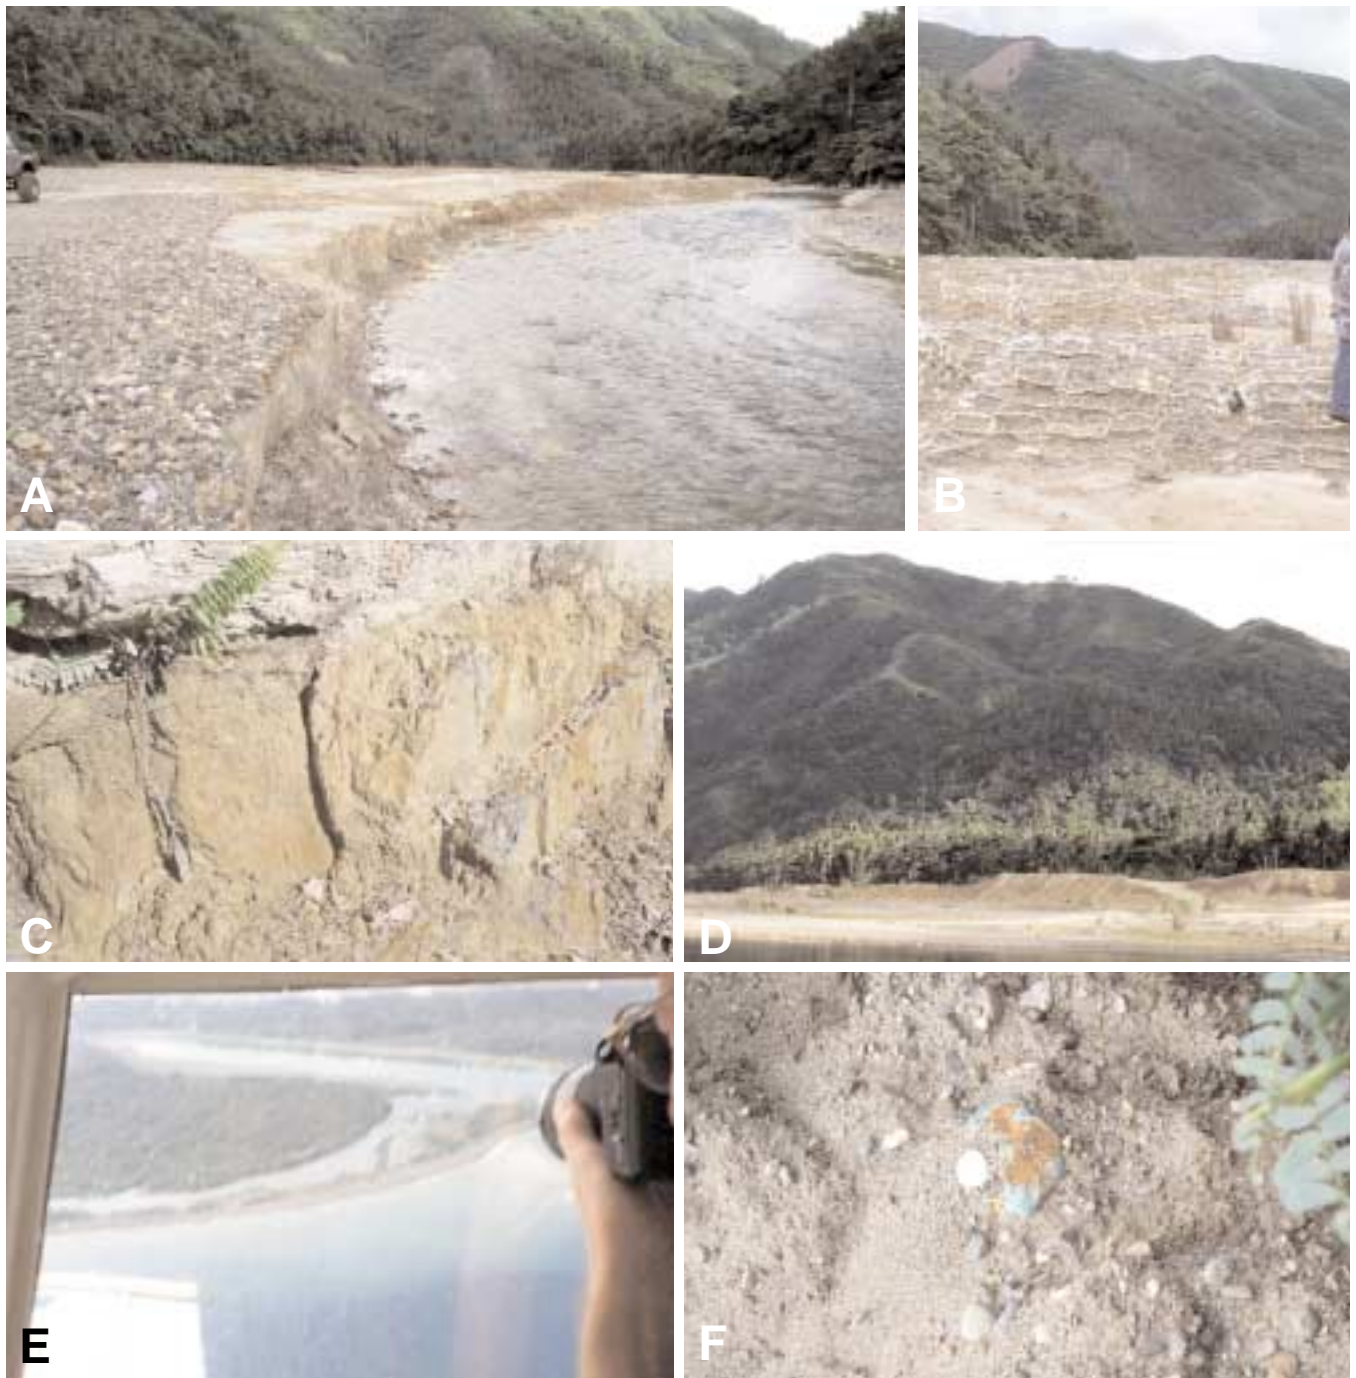
The tailings deposits we observed in the Boac river bed contained visible sulfides, and as a result have a typical grayish color on unweathered surfaces (Fig. 10A). In addition, many of the tailings deposits are coated by abundant white, brown, and yellowish secondary minerals (Figs. 10B, C), including abundant soluble salts. These secondary minerals formed directly from oxidation of sulfides in the tailings deposits, and from evaporation of acid waters generated in the tailings deposits by sulfide oxidation. The tailings deposits are typically hard, like concrete, most due to the buildup of soluble secondary salt cements in the tailings deposits. Little vegetation is growing on the tailings.

We observed a large amount of coarse-grained sediment within the Boac River channel along most of its length, indicating that rapid erosion is occurring in the headwaters of the Boac and its tributaries, and that vigorous transport of coarse sediments occurs during storms (Fig. 10A). Gravels in the middle and upper portions of the Boac have abundant cobbles of altered, mineralized rocks that presumably were eroded from the Marcopper deposit. However, gravels and sands dredged from deep in the Boac River channel near its mouth (Figs. 10E, F), which most likely were deposited well before mining started, have very few mineralized cobbles. This indicates that, prior to mining, there was likely substantial dilution of sediment eroded from the Marcopper

Figure 10. Photos of the Boac River. **A.** An extensive tailings deposit in the middle Boac River. Since 1996, the river has cut a channel down through the tailings deposit, which originally filled most of the river bed. Coarser sediments deposited on top of the tailings indicate rapid rates of erosion in the headwaters of the Boac and high sediment transport during storms. **B.** Soon after the spill, tailings were collected in sandbags and stacked on top of the tailings deposit shown in the photo to the left. Now, the sandbags have corroded due to exposure to sunlight and to acid generated from the tailings. **C.** Closeup of tailings deposited on the edges of the river bed. The yellow oxidation rind on exposed surfaces of the deposit are soluble iron sulfate salts. The gray color of the unweathered tailings is due to the high sulfide content. **D.** Boac River above Boac. Tailings berms visible on the far side of the river were bulldozed by PDTs after the spill to prevent overbank flooding of adjacent farmlands. **E.** View of Boac River mouth from the air, showing the dredge channel (top of photo). **F.** Sedimentary material dredged from the Boac River delta. Mineralized rocks (blue-green mineralized cobble, central portion of the photo) from the Marcopper deposit are only rarely present in the sediments.

deposit by sediment eroded from unmineralized areas in the Boac headwaters. Such observations are important to understand likely pre-mining conditions along the Boac River.

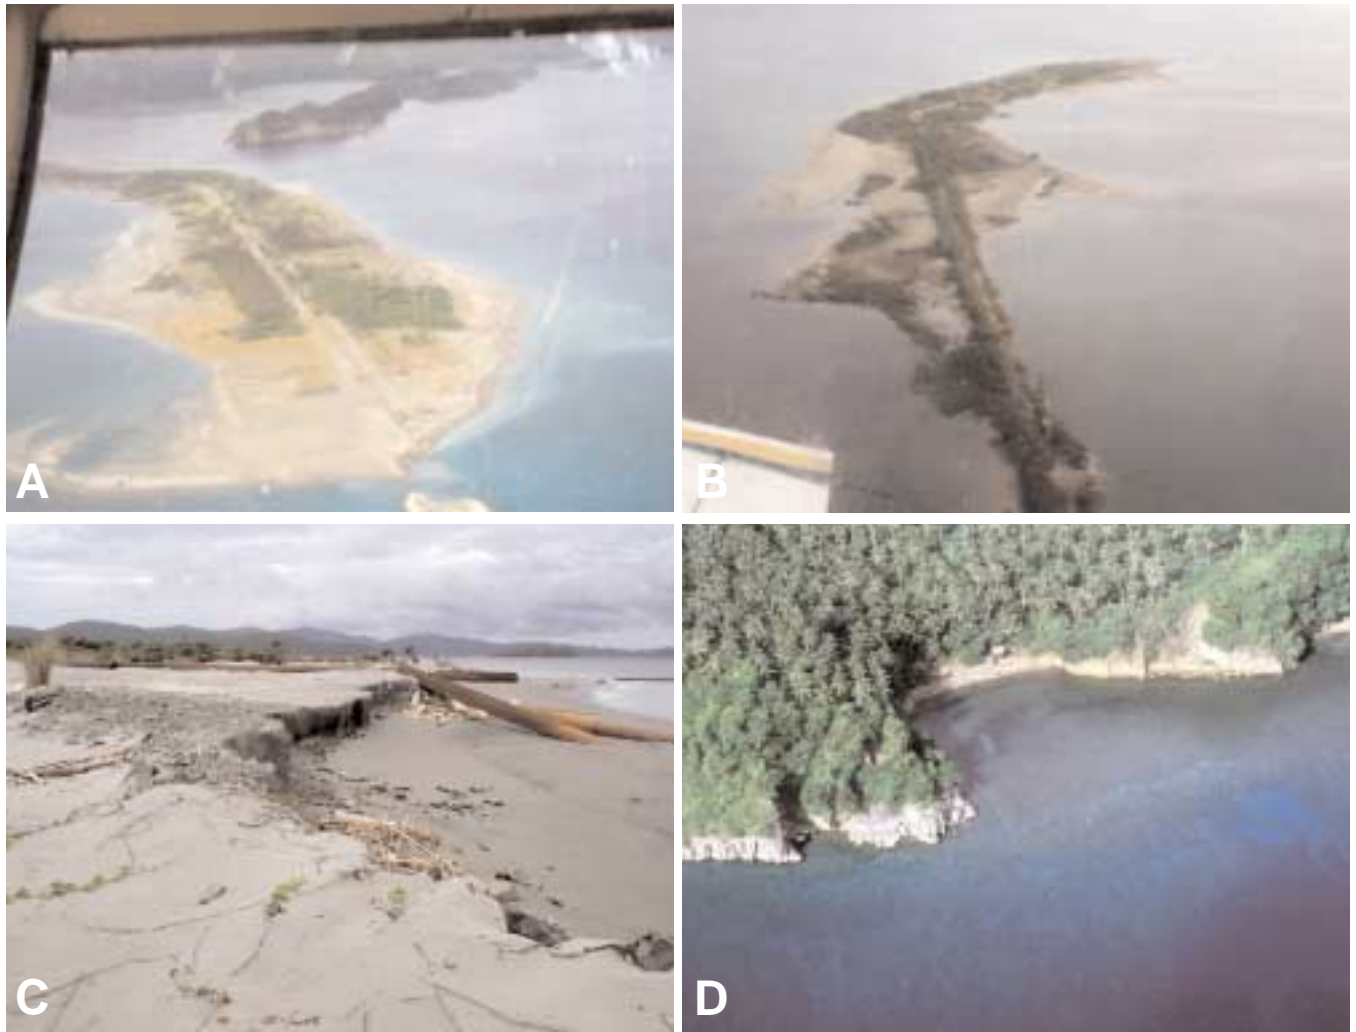
Approximately 16 years of tailings disposal in Calancan Bay resulted in the formation of a tailings causeway extending approximately 6-8 km offshore (Figs. 11, 12), and built up approximately 1-2 m above sea level. The tailings causeway itself is composed primarily of sand-sized particles, with some clay layers. Submarine tailings deposition occurred in a very large area around the causeway (Fig. 11). We did not have access on our trip to detailed bathymetric maps that

Trees, grasses, and other vegetation planted on the causeway appear to be quite healthy in places where the tailings deposits were covered with topsoil prior to planting. However, vegetation growth is minimal in areas without topsoil and in shoreline areas affected by wave action.

With the exception of isolated pods, there is little apparent visible evidence that the Calancan Bay tailings deposits are undergoing sulfide oxidation. The yellowish, acid-generating soluble salts so readily apparent in the Boac River tailings deposits (Fig. 10) are largely absent in the Calancan tailings. Fresh, unoxidized sulfides are visible with a magnifying glass in the Calancan tailings materials. Mineralogical analyses of

Figure 12. Photos of Calancan Bay. **A.** Aerial view looking south of the northern end of the Calancan Bay tailings causeway. The end of the causeway is undergoing active erosion and sediment redistribution, as seen by the suspended sediments (lighter blue shades) in the ocean on both sides of the causeway, and the hook-shaped spits forming on the eastern side of the causeway (left hand side of photo). **B.** Aerial view looking north of the middle and northern portions of the causeway. The erosion of the causeway on both sides is apparent. **C.** From the ground, erosion at the end of the causeway is apparent. Erosion has led to the collapse of the tailings transport pipes into the water. **D.** A Marinduque reef substantially west of Calancan Bay that has not been affected by the tailings.

Calancan tailings samples collected from the east side of the causeway near its terminus identify calcite, an acid-neutralizing calcium carbonate mineral. Calcite was not found in the Boac River tailings samples. It is possible that the Calancan Bay tailings calcite either originated from a calcite-rich zone in the old Tapan orebody, or, more likely, formed as a secondary mineral in the tailings deposit by reactions of calcium-bearing silicates with dissolved carbonate in the sea water. Along with the carbonate alkalinity in the sea

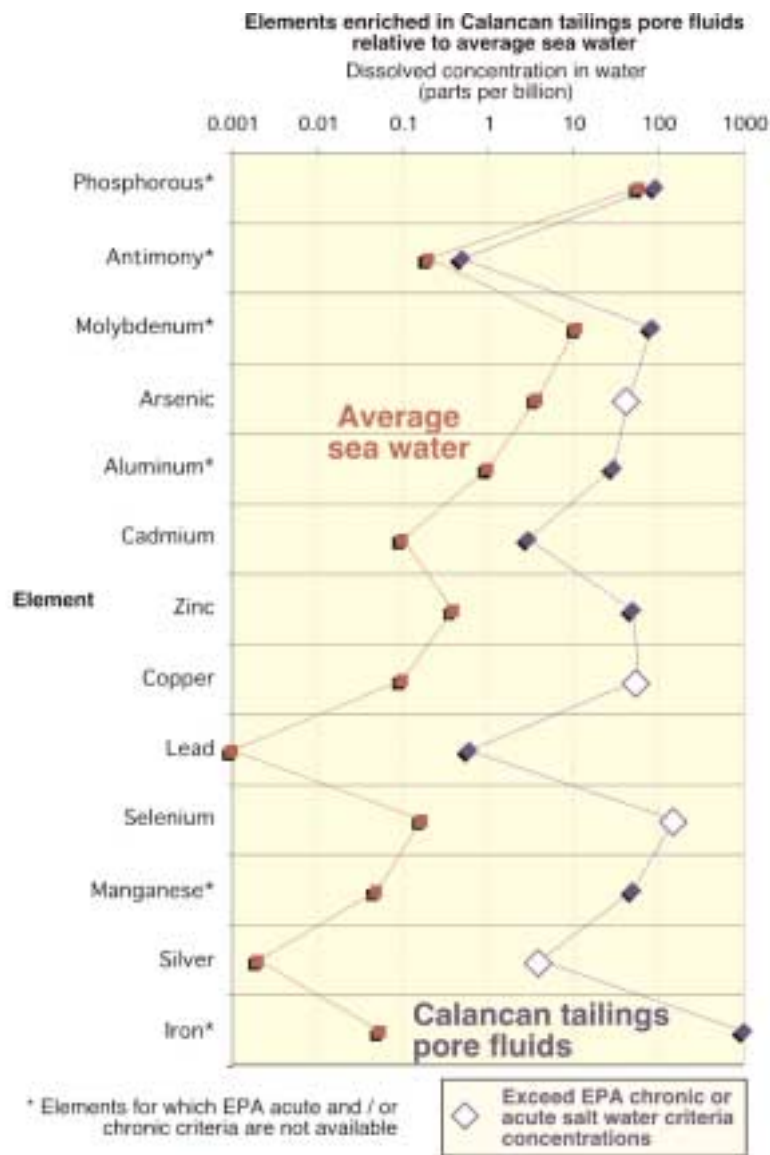
Figure 13. Pore waters collected from the Calancan tailings causeway in the intertidal zone have elevated dissolved concentrations of a number of metals compared to regular sea water (data from Table 1); the elements are plotted from top to bottom in order of increasing difference in concentration. These elevated metal concentrations indicate that sulfides in the tailings are being oxidized by sea water in the tailings pore spaces. Several elements in the tailings pore fluids have concentrations that exceed EPA’s chronic (long-term exposure) or acute (short-term exposure) criteria for salt water (see Table 2). This indicates that the pore waters are potentially toxic to marine organisms that burrow in the tailings.

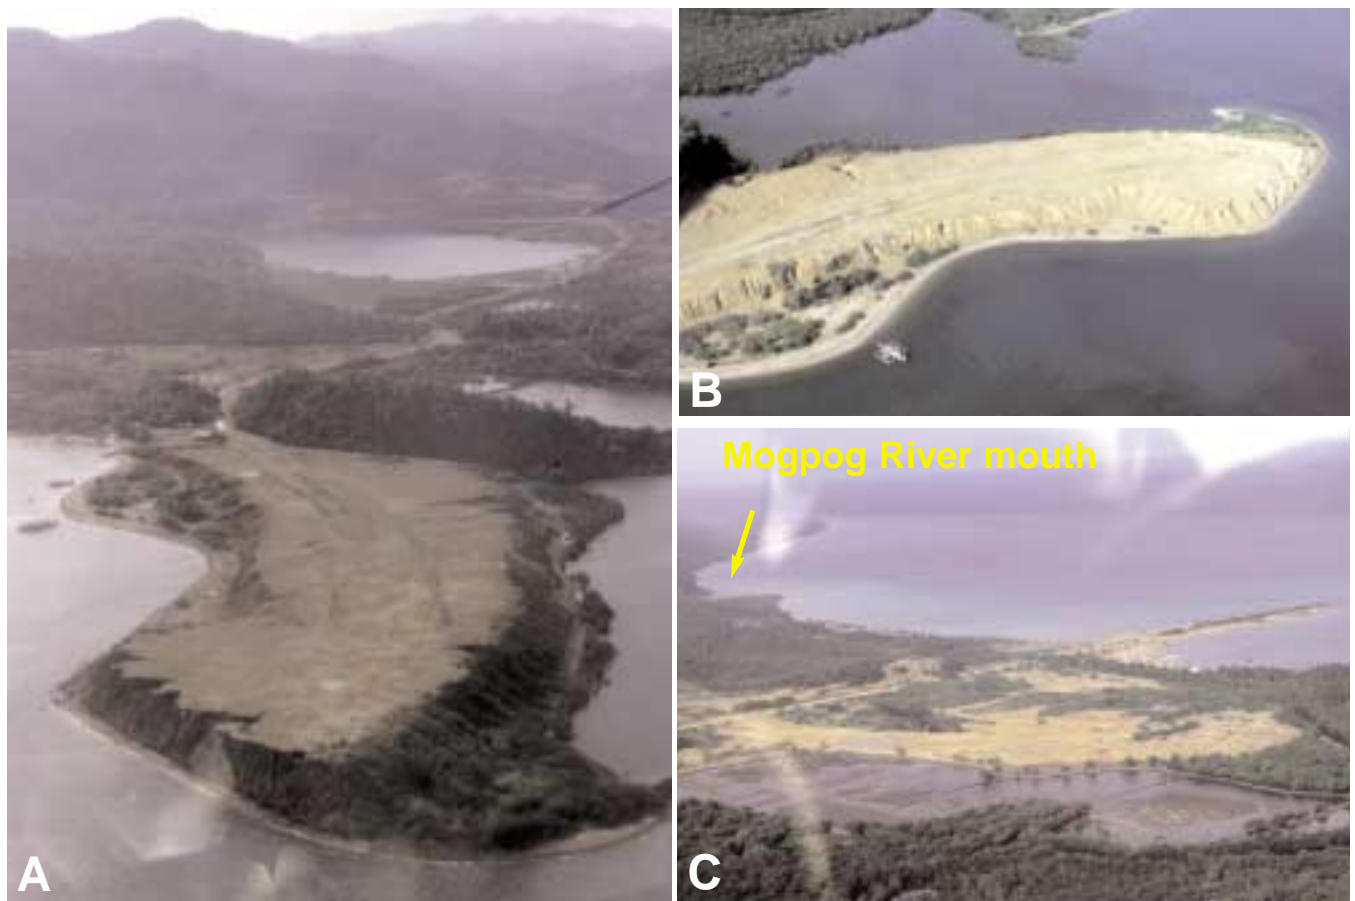
On a very brief stop at the CMI mine dumps, we observed highly acidic water (pH around 3.5) draining one of the mine dumps, as well as an area downhill from the dump where vegetation appears to have been killed by acid-rock drainage. A quick inspection of the rocks on the waste dump indicates that the deposit has characteristics both of porphyry deposits similar to Marcopper and deposits similar to Summitville (Colorado, USA) and Lepanto (Philippines); both deposit types have high geological potential to generate acid-rock drainage.

Signs that some of the CMI dump material had recently been removed by earthmoving equipment were readily apparent on our brief visit to the CMI dump. We subsequently observed the use of what appears to be mine

Figure 14. The CMI Mine near Mogpog. Photos by R. Morton. **A.** Aerial view looking east of the CMI open pit lake (visible in background) and a major mine dump built out into the ocean (foreground). **B.** Yellow oxidation minerals and soluble salts are readily apparent on the same CMI mine dump from the photo on the left. **C.** View looking west-southwest of an extensive flat area south of the major mine dump with weathering mine or milling wastes. Some of this area is covered in a brownish water that may be ARD. The long causeway extending into the ocean in the middle of the photo looks strikingly similar to the tailings causeway in Calancan Bay. If tailings from the CMI mine were disposed in the ocean, then the same potential environmental impacts are likely present here as well, although at a smaller scale. The mouth of the Mogpog River is at the left of the photo.

wastes as road fill material on the main road near the mine between Mogpog and the ferry terminal at Balanacan.
