AMENDED  
REPORT OF INVESTIGATION

Fatal Fall of Roof Accident  
January 13, 2007

Cucumber Mine  
Brooks Run Mining Company, LLC  
Cucumber, McDowell County, West Virginia  
MSHA I.D. No. 46-09066

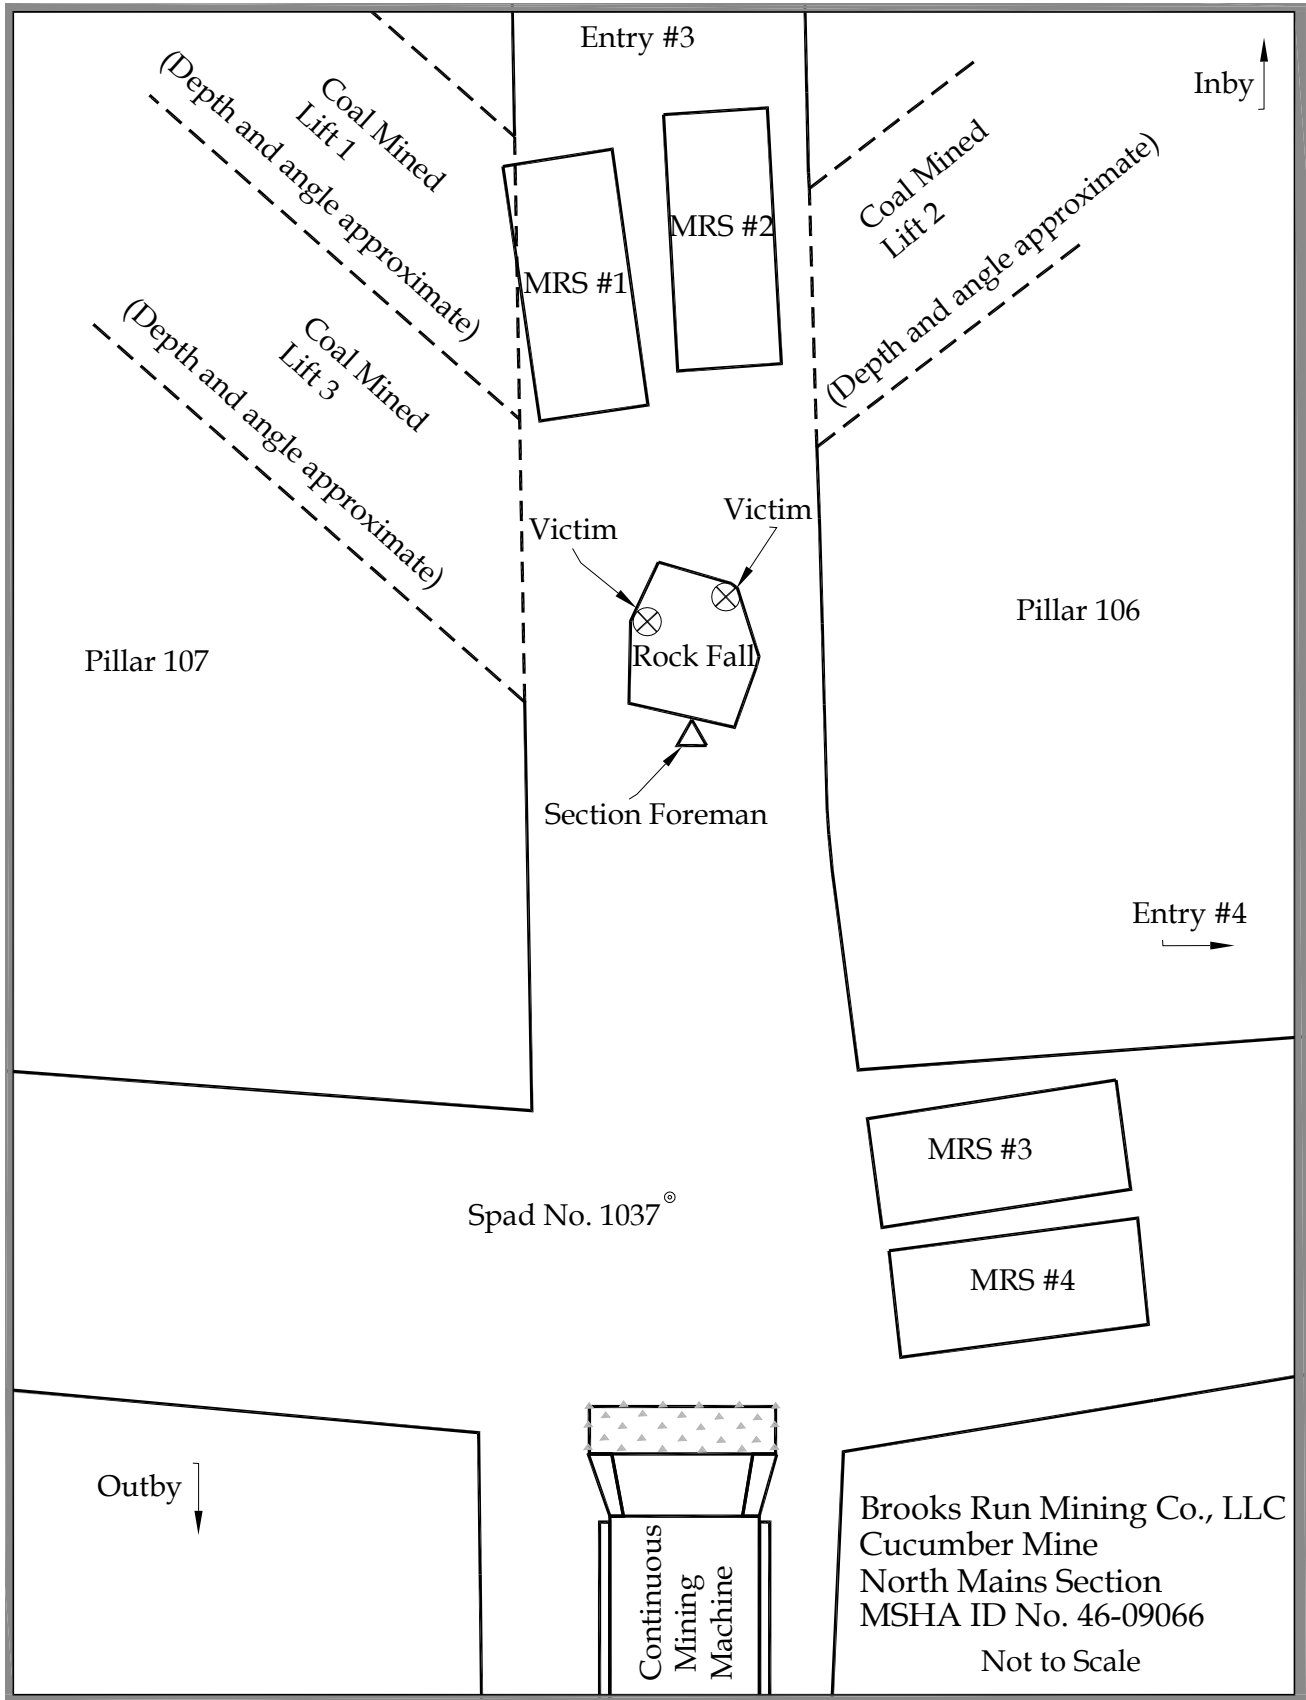
**SKETCH OF ACCIDENT SCENE**

At approximately 10:40 a.m. on Saturday, January 13, 2007, 48-year-old James David Thomas and 33-year-old Pete Poindexter, mobile roof support (MRS) machine operators, were fatally injured when a portion of the mine roof collapsed, pinning both individuals. Thomas and Poindexter had 12 years and 2.5 years of mining experience respectively. Thomas and Poindexter were repositioning MRS machines after the completion of the third lift in the #3 entry while performing retreat mining on the North Section. The slicken-sided portion of the mine roof that collapsed measured approximately 8 feet in width by 9 feet in length and was up to 18 inches thick.
