REPORT OF INVESTIGATION

Fatal Powered Haulage Accident
November 17, 2008

Douds Stone Inc.
Lyle Underground Mine
Hedrick, Keokuk County, Iowa
Mine ID No. 13-02213

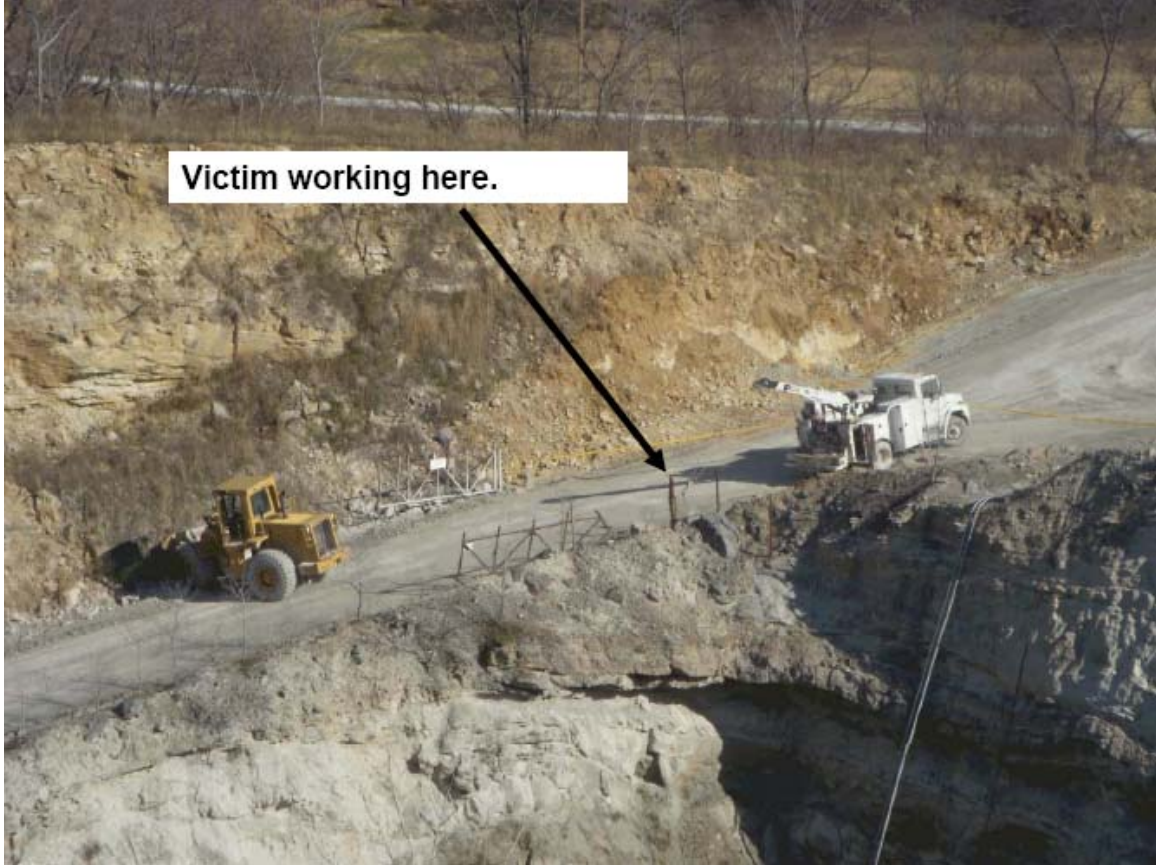
Victim working here.

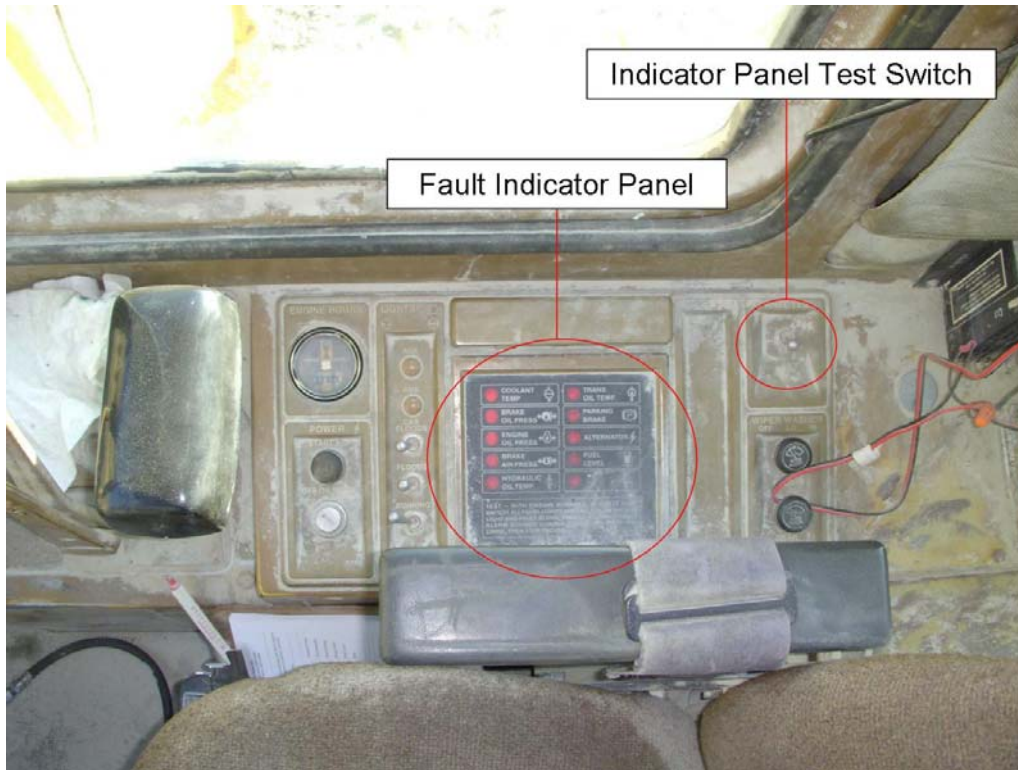
The front-end loader was equipped with an Electronic Monitoring System (EMS) in the operator's cab which consisted of an indicator panel with individual light indicators (see Photo No. 1), a fault light (see Photo No. 2), and an audible fault warning alarm. Sensors and/or switches provided feedback to the EMS to determine what type of fault was present and what the operating conditions were so the system could provide the appropriate fault warning level to the operator.

PHOTO No. 1: Fault Indicator Panel on Right Side of Operator's Seat

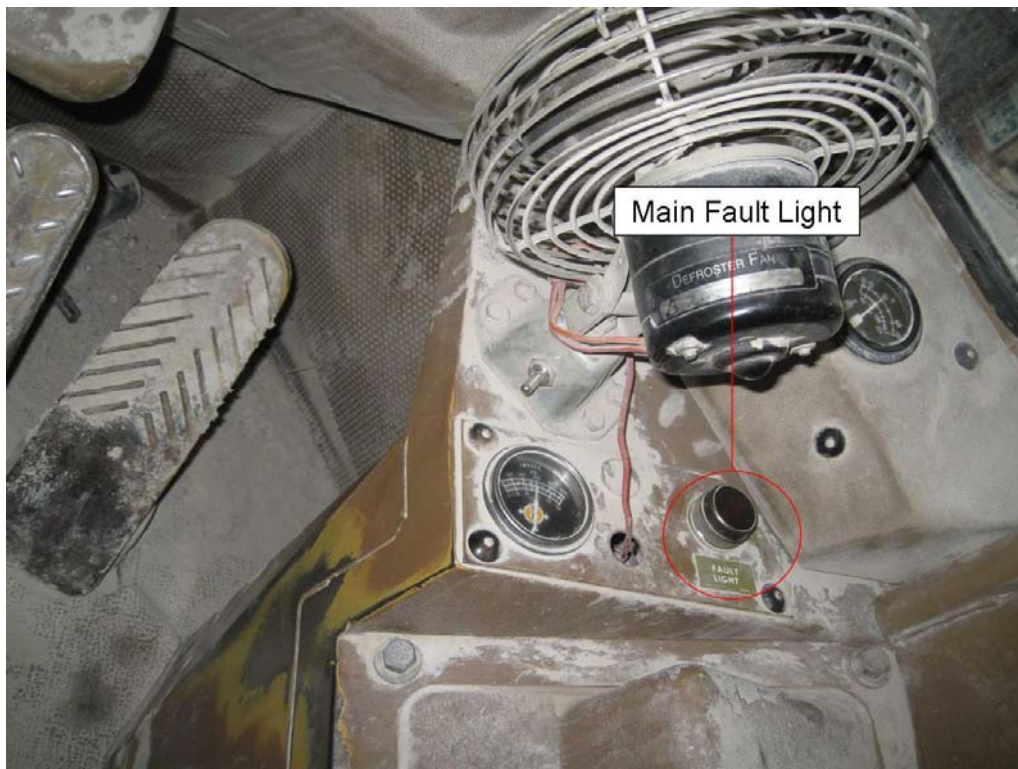
However, investigators determined that with the engine running, the main fault light did not illuminate and the audible warning alarm did not sound when a warning level 3 fault condition existed. Observations and tests indicated that the

bulb for the main fault light was defective and the audible warning alarm's wire harness was disconnected at the electrical connector for the alarm itself (see Photo No. 4). With the engine running and the "brake oil pressure" indicator on, power was being supplied by the bulb socket for the main fault light. The audible warning alarm sounded after the electrical plug was reconnected.

PHOTO No. 2: Main Fault Light in the Forward Right Area of the Operator's Compartment

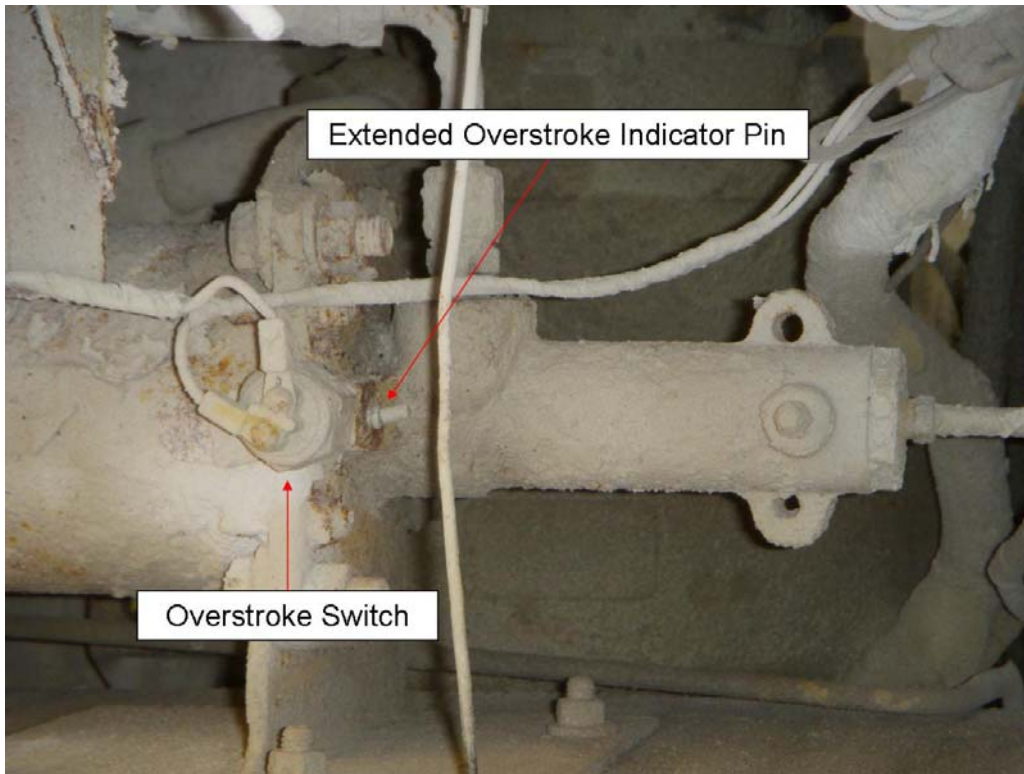
system had experienced a problem in the brake's hydraulic system that needed to be addressed. Each of the two brake converters had an over-stroke pin and switch arrangement to determine if an over-stroke condition was encountered (see Photo No. 3). Once the hydraulic master cylinder reached a stroke near its maximum stroke range, the over-stroke pin would manually actuate, causing the switch to cycle and trigger a warning level 3 fault with the engine running.

Initial visual examination of the front-end loader revealed that the over-stroke pins for both the front and rear brake converters were extended and the "brake oil pressure" indicator was illuminated when the key was turned on without starting the engine. The indicator also stayed illuminated when the engine was running. Electrical tests on the "brake oil pressure" circuit indicated the over-stroke switch for the front axle service brakes was defective because it was electrically open regardless of the position of the switch (depressed or released). The electrical circuit for the indicator was configured that when a condition caused an electrically open circuit, the "brake oil pressure" light would illuminate and a warning level 3 fault would occur provided the engine was running.

Photo No. 3: Example of Overstroke Arrangement on Brake Converter for "Brake Oil Pressure" Fault Indicator

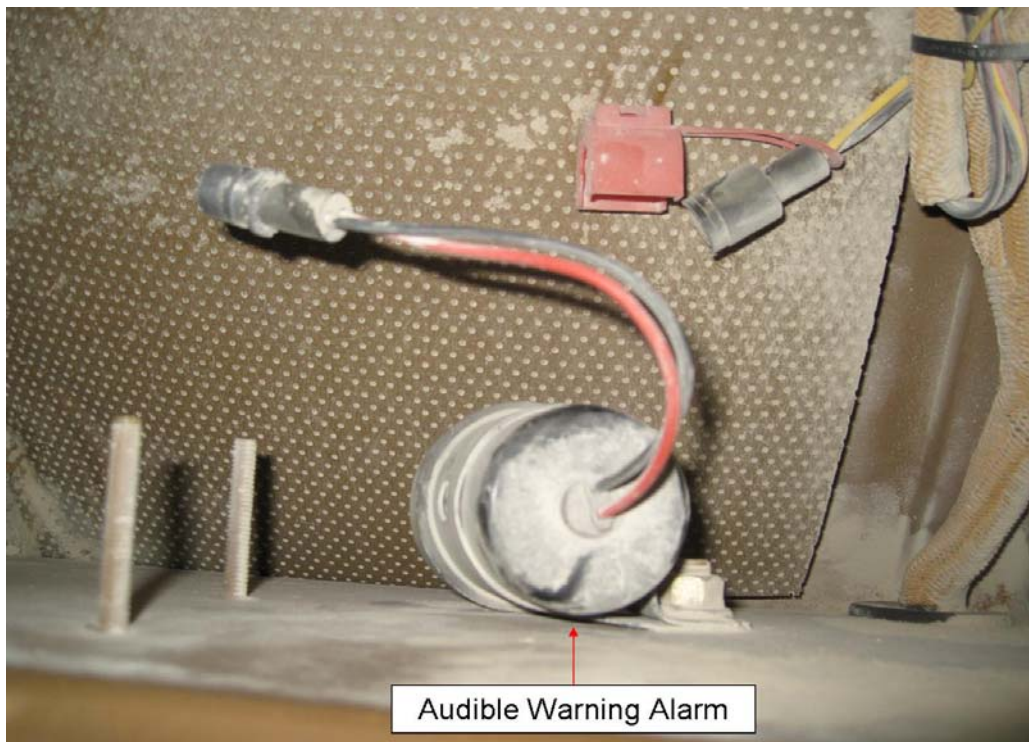
Photo No 4: Condition of Electrical Connection for Warning Level 3's Audible Alarm
