# **General Aviation Airworthiness Alerts**

**AC No. 43-16**

**ALERT NO. 229  
AUGUST 1997**

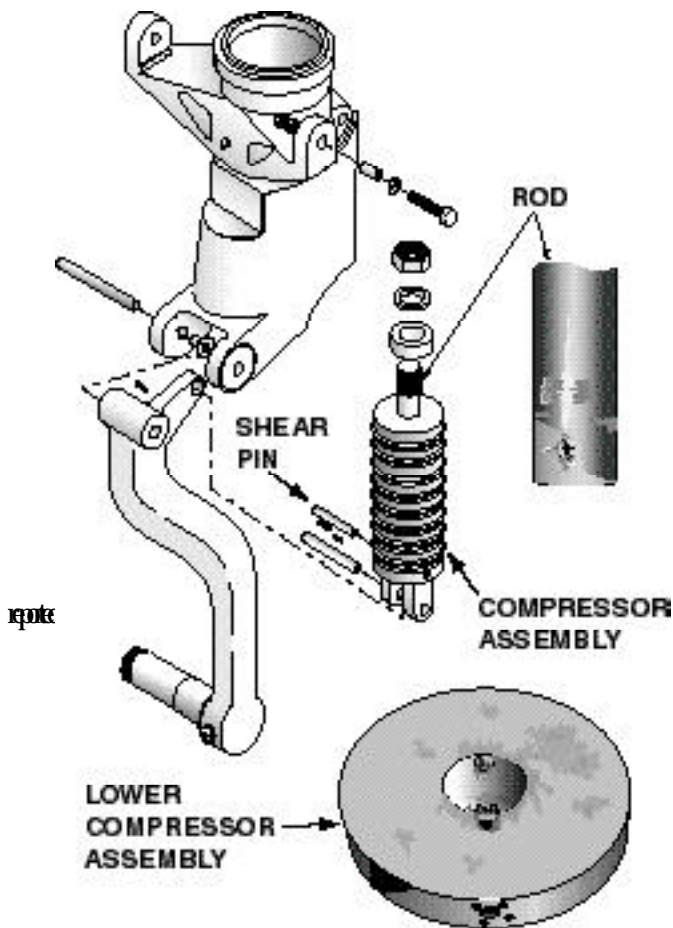
An inspection disclosed the nose landing gear was jammed in the nose gear well. The tire was hitting the end of the wheel well preventing the nose gear from extending. Further inspection revealed the roll pin (P/N MS9048-180) installed in the compressor assembly (P/N 169-380003-7) had sheared. (Refer to the following illustration.) This roll pin holds the rod (P/N 169-810000-111) in the compressor assembly. Installation of these parts, along with the shock absorber pads, in the nose gear housing results in a compression load on the pads and a shear load on the roll pin. Failure of the shear pin allows the pads to expand and the nose gear fork and tire to extend.

When correctly installed the roll pin is not visible. Should the roll pin be visible in the compressor assembly, it may indicate that the nose gear strut is incorrectly adjusted or the roll pin has failed. The only required maintenance check in the manufacturer's maintenance manual is related to "hard landing inspections." The submitter recommended the requirements of the "hard landing inspection" related to the nose strut compressor assembly be accomplished each 100 hours of operation.

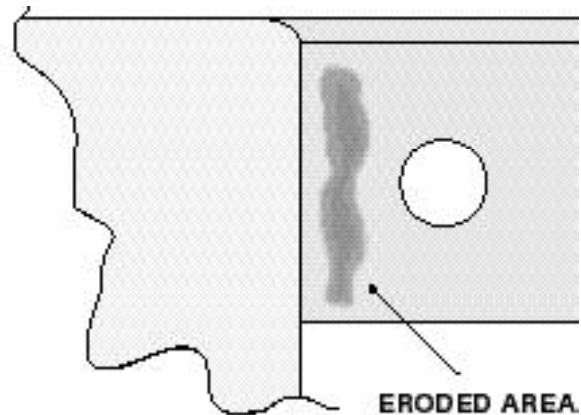
**VIEW OF FORWARD WING-ATTACH FITTING,  
LOOKING AFT**

The right wing main spar attachment fitting was found "eroded" in the area just outboard of

an attachment hole. (Refer to the following illustration.) Additional evidence of similar damage was found at the lower end of the right lift strut. All of the wear found was indicative of a limited fore-and-aft "swing" of the entire wing structure. All of the wing attachment bolts were properly torqued, and there was no fastener hole elongation at the fittings. The submitter could not determine the cause of this defect. It is recommended that this area be given close attention during inspections and maintenance.

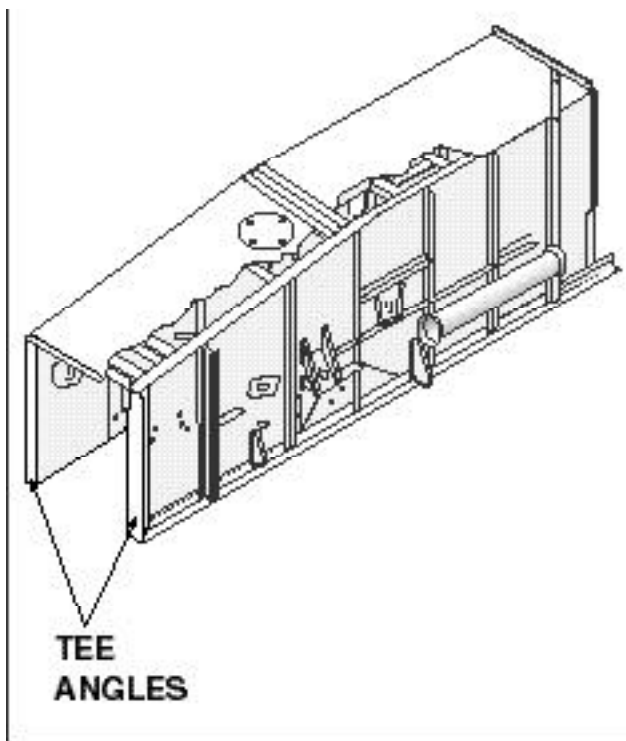
jacked for inspection. The inspection revealed the nosewheel shimmy was caused by both the left and right "tee" extrusions (P/N's 5213040-11 left and 5213040-12 right) being broken. (Refer to the following illustration.) These extrusion "tee" angles are part of the primary structural support for the nose landing gear trunnion. The submitter found another like aircraft with sheared rivets in the same area. This is a critical area and deserves your full attention during inspections and maintenance.

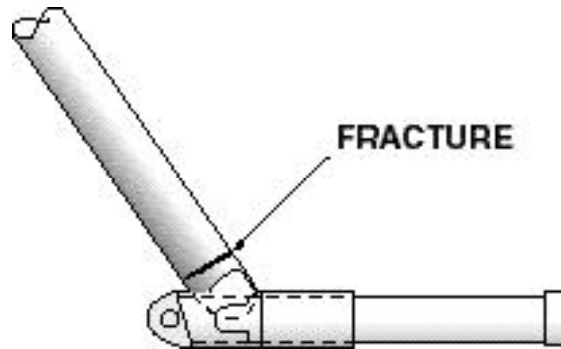
An examination disclosed that the left main gear lower leg (P/N 58383) had broken. There was evidence of severe corrosion inside the bore of the lower gear leg at the point where it attached to the axle. (Refer to the following illustration.) It was speculated that approximately 70 percent of gear leg structure had been consumed by the effects of corrosion at the point of failure. It was believed the corrosion was caused by moisture and possible other contaminants entering the inner core of the gear leg through the landing gear fairing attachment bolt holes. This area is difficult to properly inspect due to the position of the gear fairing and the tie rod clevis. It was recommended this area be stripped of paint and inspected using dye penetrant to detect any cracks or pitting. It was also suggested that the strut be filled with linseed oil, allowed to soak for a time, and then drained. It would be wise to seal the landing gear fairings at the strut attachment holes.

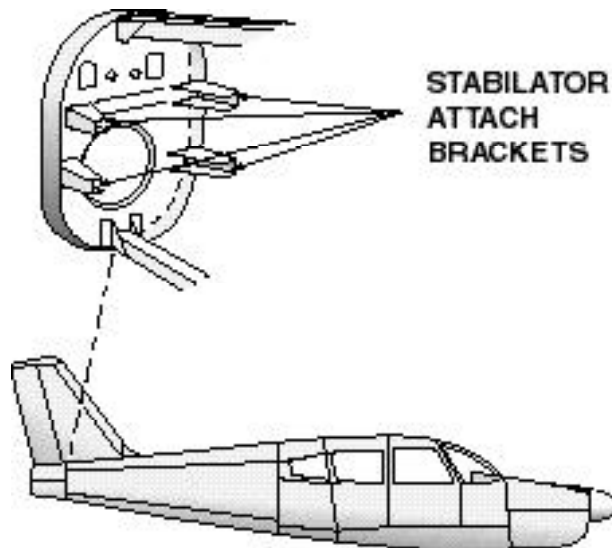
During an annual inspection and compliance with Piper Service Bulletin (SB) 856, corrosion was found at the stabilator attachment fittings.

Two of the four stabilator attachment brackets were severely corroded. (Refer to the following illustration.) The attachment brackets are made of steel and attach to the aluminum stabilator skin. The submitter believed these two metals being in contact with each other caused the corrosion. Eight months prior to this discovery this area had been inspected for corrosion in accordance with SB 856, and no corrosion was present at that time. Therefore, the submitter suggested the manufacturer revise the inspection schedule of SB 856 to 6 months or more often.

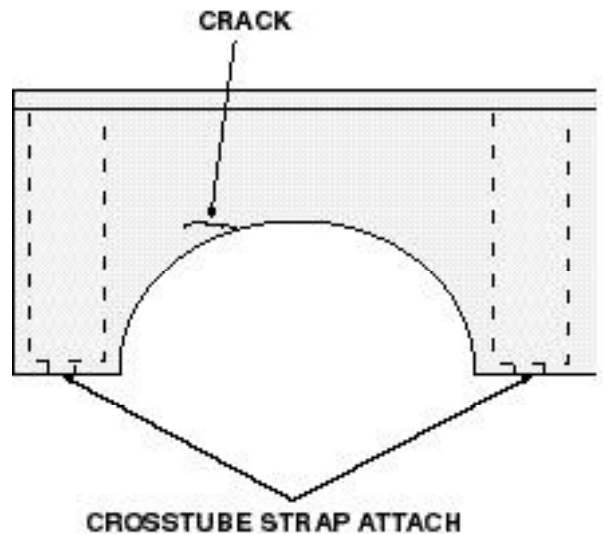
The cross tube attachment bracket (P/N 206-030-104-023) was installed at the forward left position. The crack appeared to have originated at the middle of the bracket radius for the cross tube and extended to the left. (Refer to the following illustration.) The submitter did not offer a cause for this defect and there was no mention of corrosion of the bracket or the cross tube.
