**NATIONAL TRANSPORTATION SAFETY BOARD
OFFICE OF AVIATION SAFETY
WASHINGTON, D.C. 20594**

June 21, 2007

**VANS AIRCRAFT MODEL A SERIES AIRPLANE
NOSE-OVER ACCIDENT
PHOTOGRAPHS**

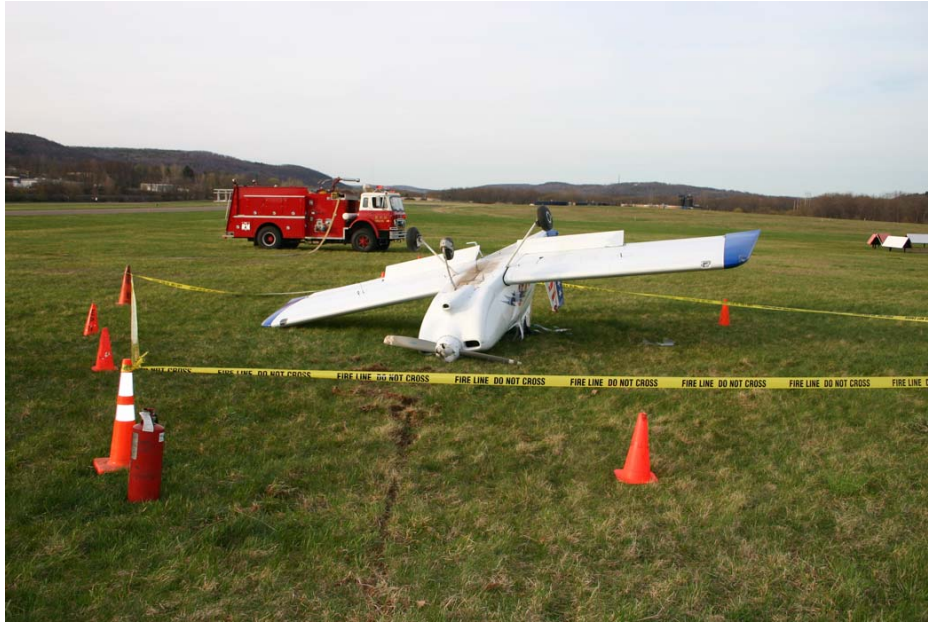
Some accidents exhibit a long, narrow furrow through the ground and grass. The nose gear strut is bent to such a configuration that it can contact the ground and create a furrow. A disruption of the soil may be present at the end of the furrow and the airplane may lie inverted a short distance beyond the disruption of the soil. The long, narrow furrow varies in length for each accident, but the distance from the disruption to the airplane is only a matter of a few feet. ([Figure 1](#), [Figure 2](#), and [Figure 3](#))

Figure 1 – Narrow furrow in foreground created by nose gear strut.
(N448GM Source: FAA)

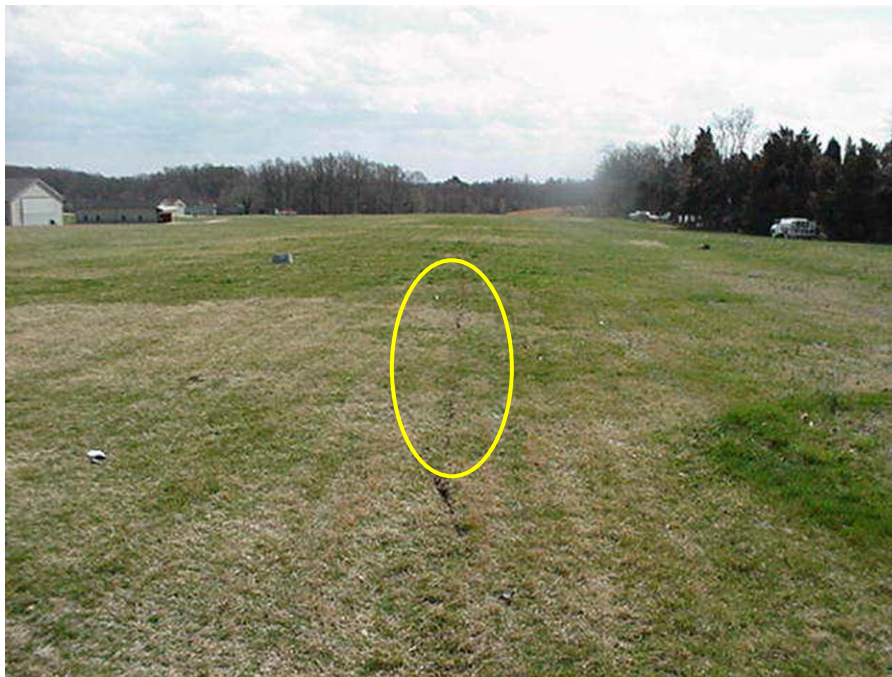
Figure 2 – Long narrow furrow created by nose gear strut. NTSB Case
No. ATLO6LA052

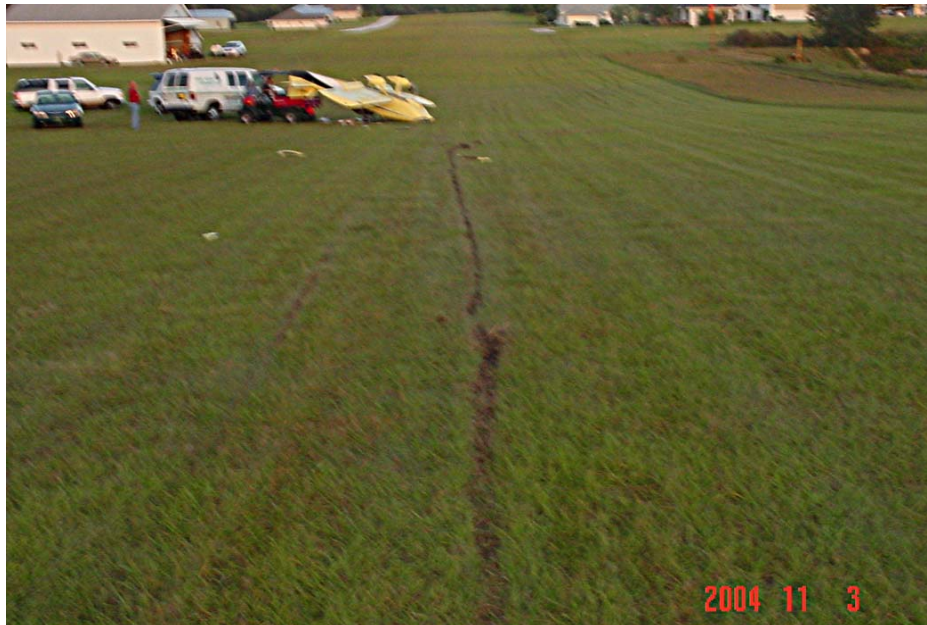
Figure 3 – Wider furrow created by nose gear fork followed by narrow furrow. NTSB Case No. MIA05LA021

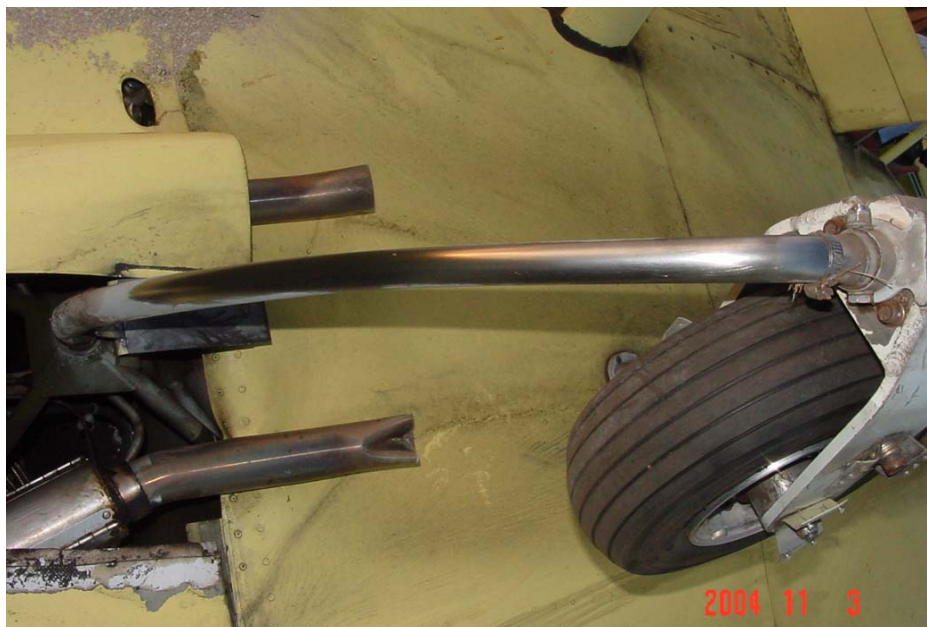
The nose gear strut is bent aft. The bend usually has a smooth radius and there may be a sharper bend at the engine mount. The paint is worn off the front of the strut, about 9 to 15 inches above the fork. The furrow is the result of that portion of the strut contacting the ground. (Figure 4) The nose gear is bent much greater during the event and springs back after the loads have been removed. Photographs show several nose gear struts in a relaxed position after having been bent. (Figure 5, Figure 6 and Figure 7)

Figure 4 – Nose gear strut that is polished by sliding on the ground. NTSB Case No. MIA05LA021

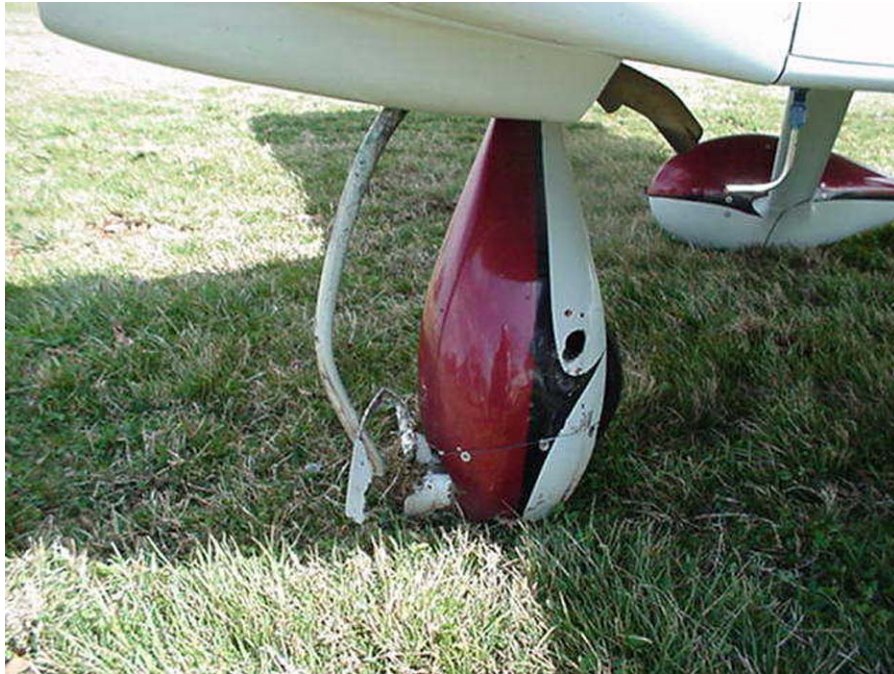
Figure 5 – Nose gear shown in relaxed position. It is bent much further aft during the event. NTSB Case No. ATL06LA052

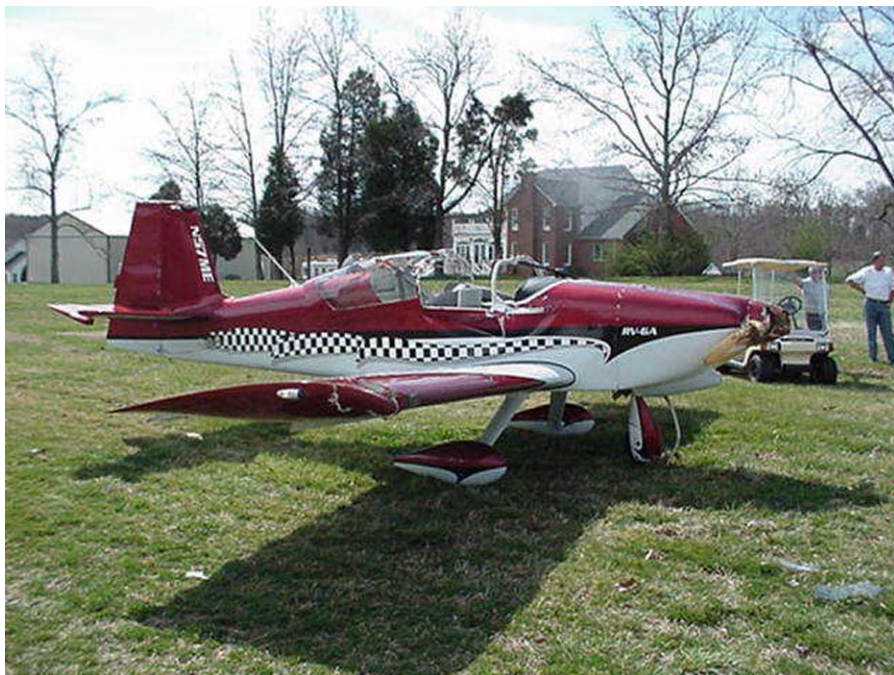
Figure 6 – Nose gear shown in relaxed position. It is bent much further aft during the event. NTSB Case No. ATL06LA052

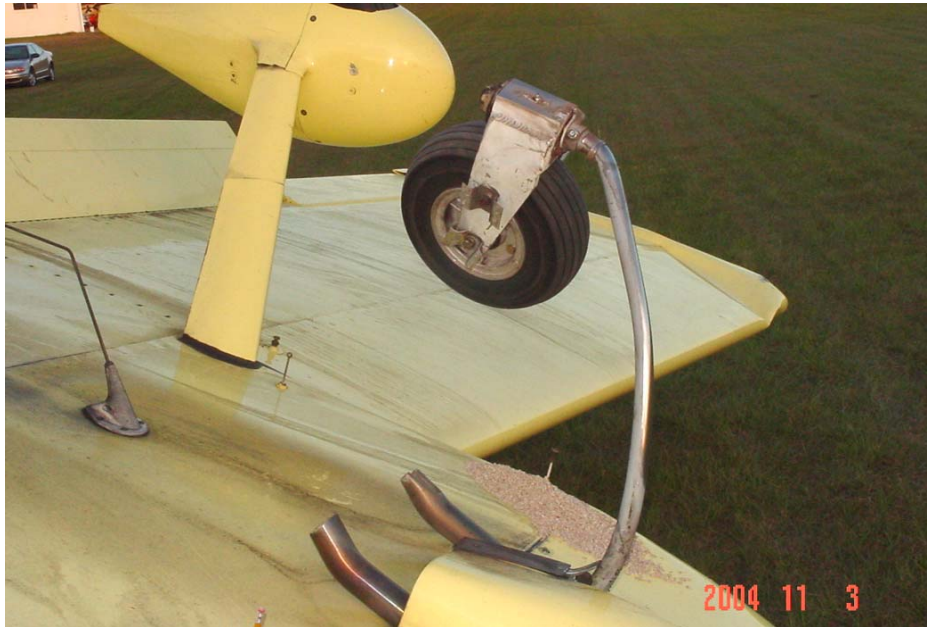
Figure 7 – Nose gear shown in relaxed position. It is bent much further aft during the event. NTSB Case No. MIA05LA021

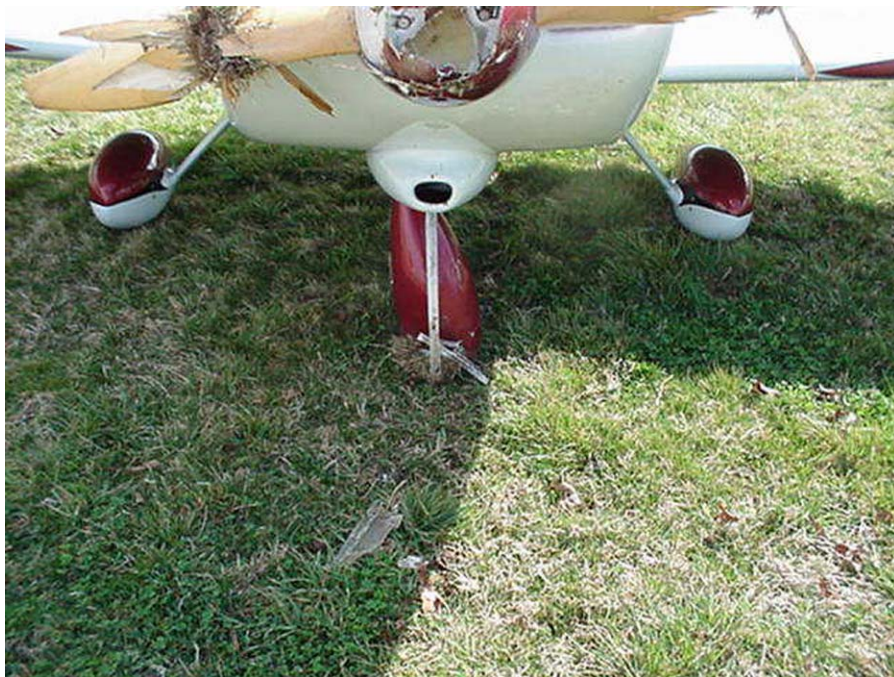
Grass and dirt are imbedded in the forward portions of the nose gear fork. Figure 8 shows grass and dirt on the front and top of the fork. This gear was fully bent aft with the fork pointed down. Figure 9 shows grass only at the lower portion of the fork. This gear was not bent fully aft during the taxi event. Figure 10, Figure 11, and Figure 12 show that the spinner is compressed in an aftward direction and the engine inlet is undisturbed.

Figure 8 – The forward and top portions of the nose gear fork exhibit evidence of having been imbedded in the turf. NTSB Case No. ATL06LA052

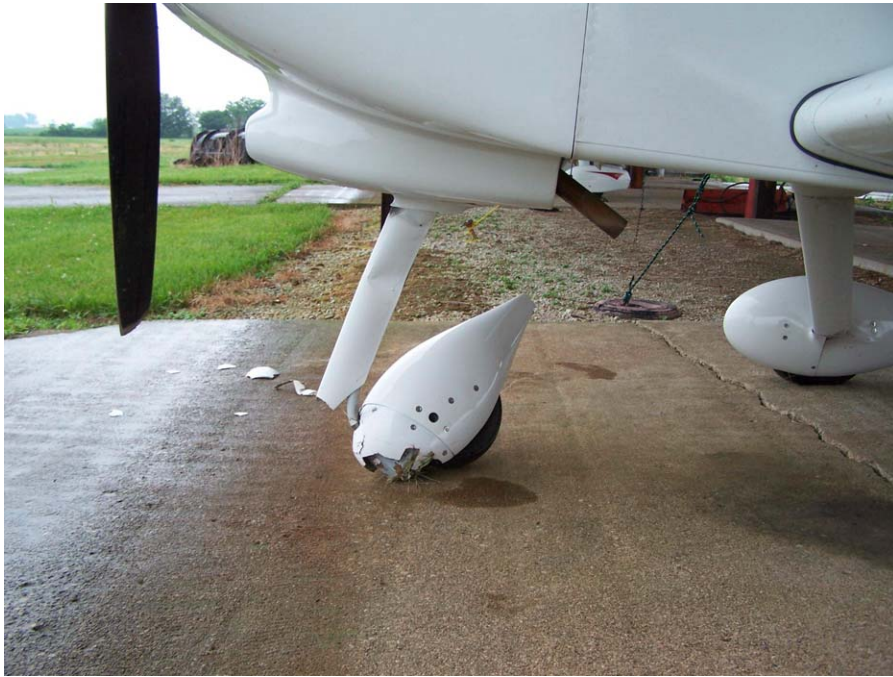
Figure 9 – The forward portion of the nose gear fork exhibit evidence of having been imbedded in the turf. (Source: owner of airplane)

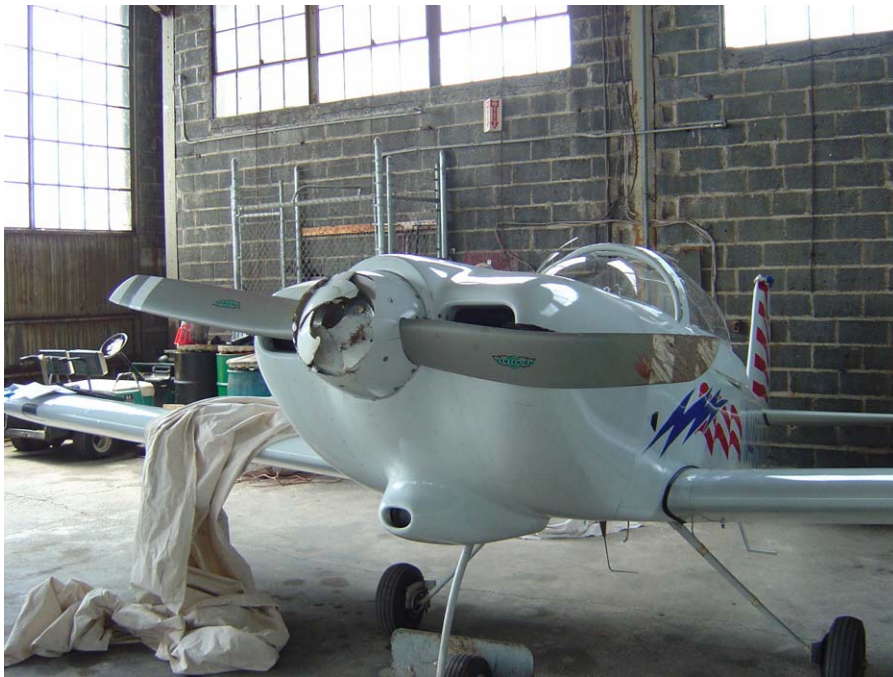
Figure 10 – The propeller spinner is compressed aft and the engine inlet is essentially undamaged. (N448GM Source: FAA)

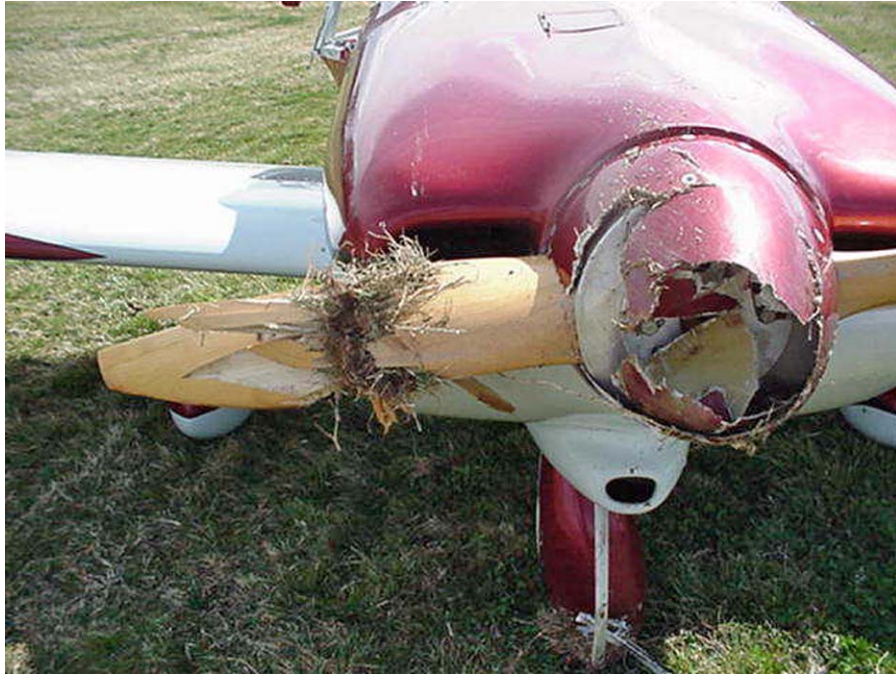
Figure 11 – The propeller spinner is compressed aft and the engine inlet is essentially undamaged. NTSB Case No. ATL06LA052

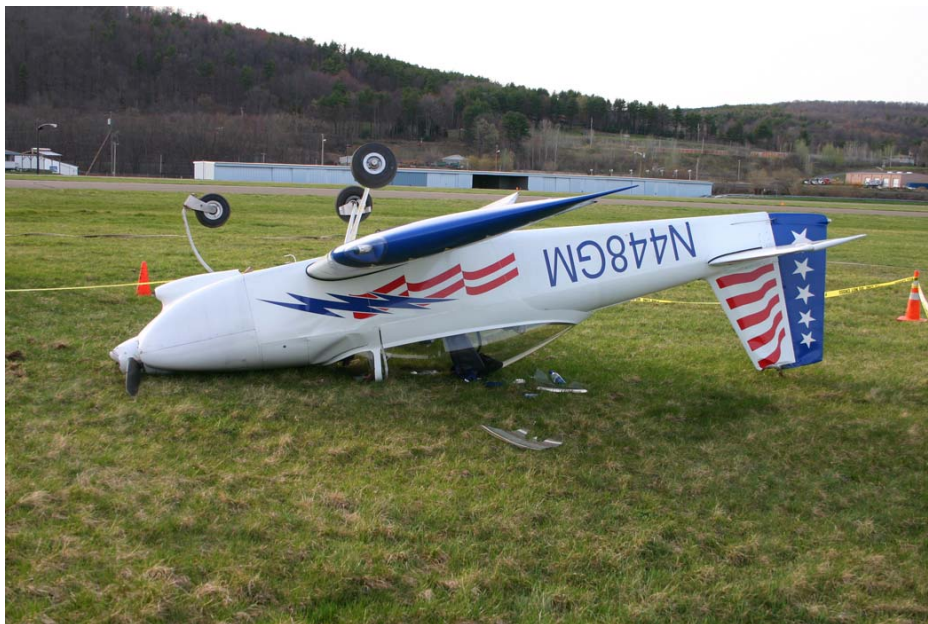
Figure 12 – The propeller spinner is compressed aft and the engine inlet is essentially undamaged. (N448GM Source: FAA)

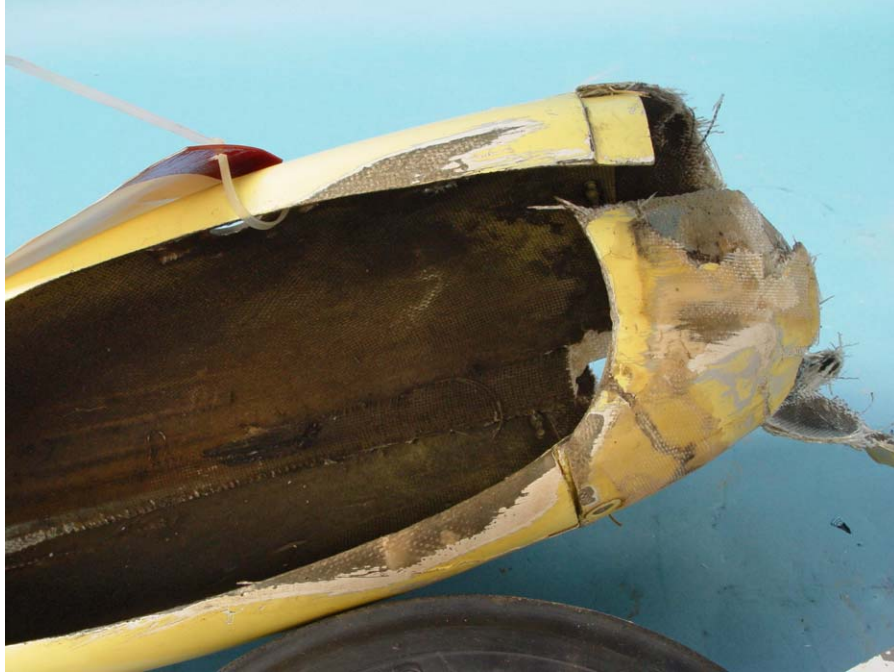
The nose gear fairing has scrapes on the bottom, as if the fairing was level to the ground when the scrapes occurred. The fairing is normally separated from the fork. (Figure 13).

Figure 13 – The bottom of the nose gear fairing exhibit scraping along the bottom. NTSB Case No. MIA06LA021

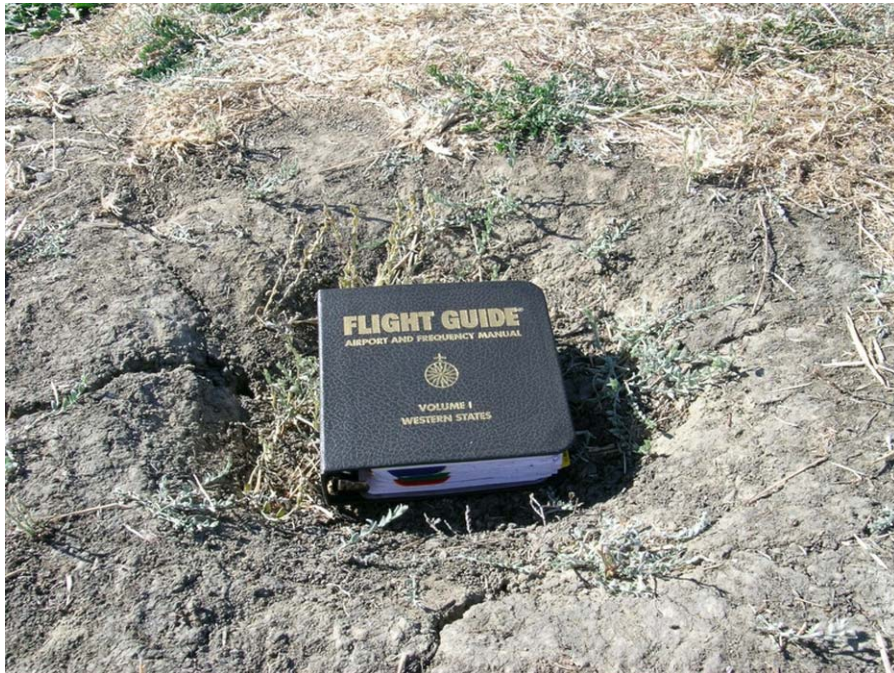
There have been several incidents in which the nose gear moved far aft or collapsed while the airplane was moving very slowly. In one case, the nose gear dropped into a tie down depression. The fairing was imprinted while the fork was digging into the side of the depression. In another case, it was reported that the airplane was moving very slowly and encountered a washboard area; the nose gear collapsed and dug in. In these cases, the fork is digging into the ground and initiating the sequence. Since the speed is low, the aft force on the gear is sufficient to bring the airplane to a stop. (Figure 14, Figure 15, Figure 16, and Figure 17).

Figure 14 – Encounter with depressed tie-down. The airport manual depicts the depth of the depression. (N994W Source: public web site)

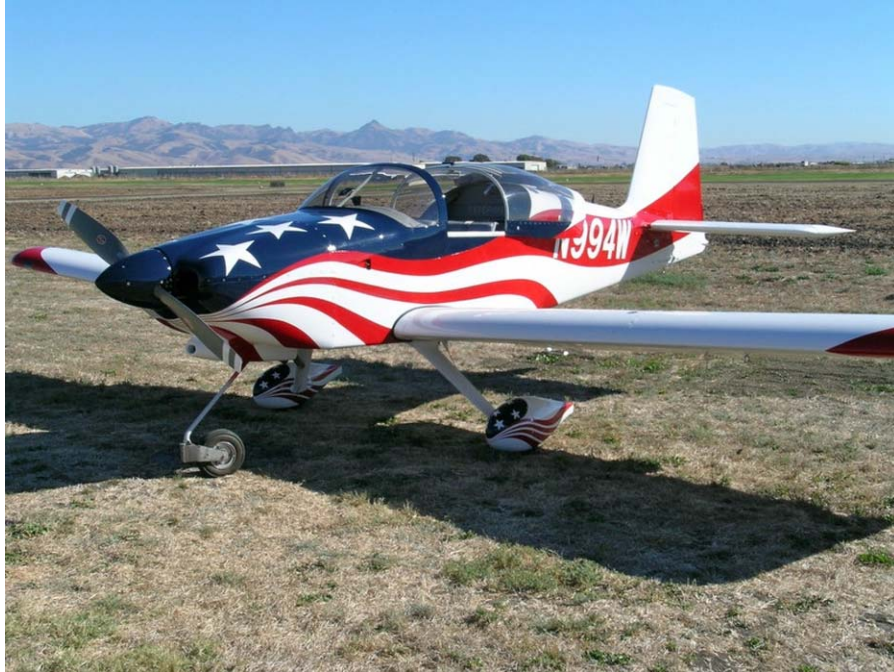
Figure 15 – The airplane nose gear was not permanently deformed.
(N994W Source: public web site)

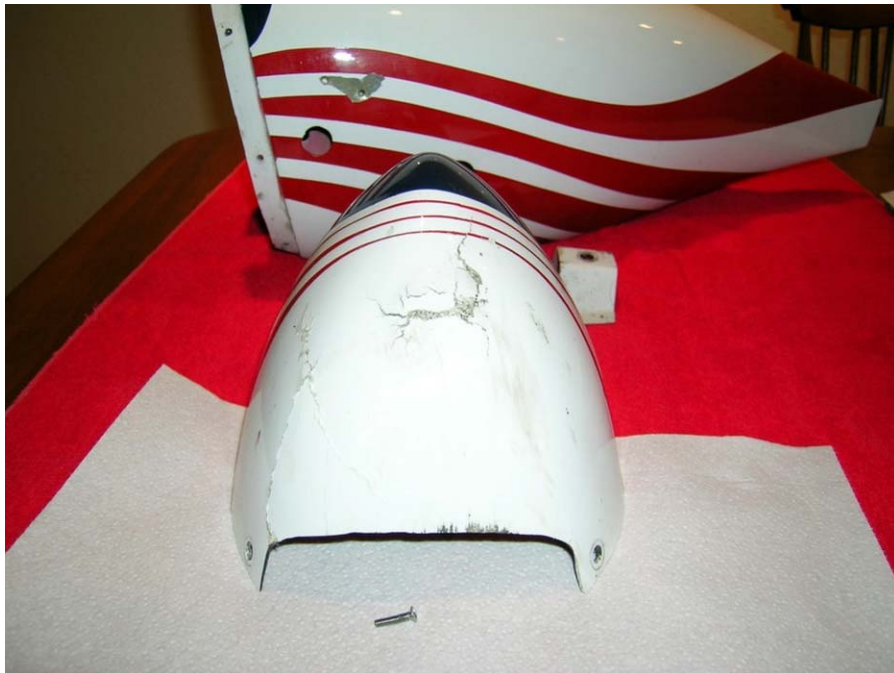
Figure 16 – The cap on the nose gear fairing exhibits the impression from the fork and nut. (N994W Source: public web site)

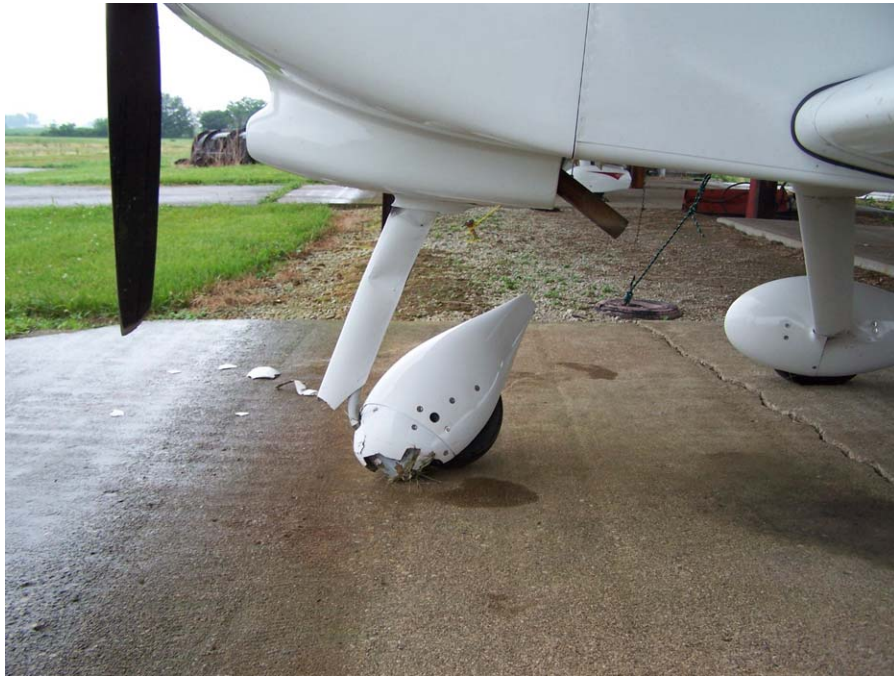
Figure 17 – Damage from a slow speed taxi event. (Source: owner of airplane)

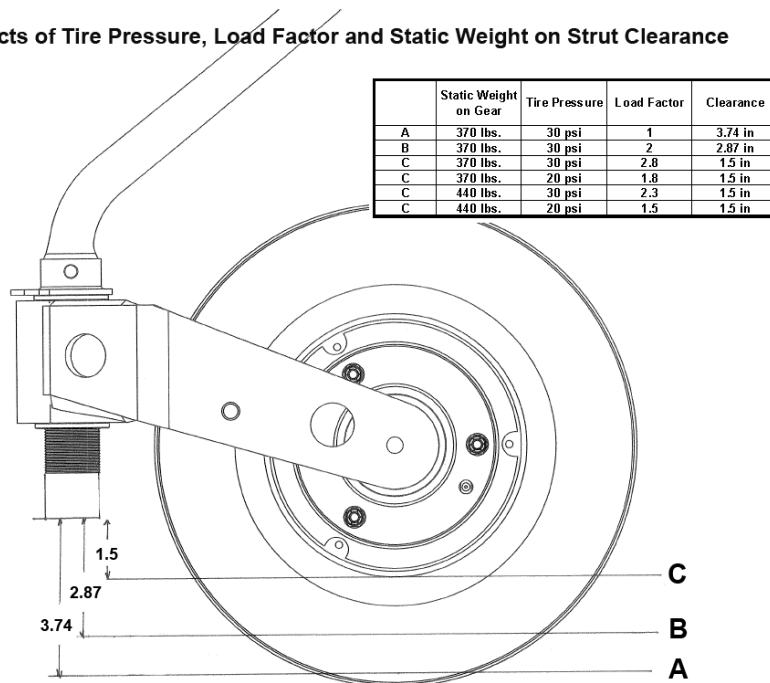
The calculations are simplified but illustrate the effects of tire pressure on the resulting height of the strut and fork above the ground (tire shape and dynamics are very complicated). Figure 18 shows a new fork design profile. The height from the ground to the strut is about 5 inches when the tire is unloaded. The threaded area in the drawing is extended about 1 inch to be consistent with the 4-inch ground clearance of the original strut and fork design.

The weight on the nose gear at empty weight is about 370 pounds. At 30 psi tire pressure, the tire foot print would be 12.3 square inches (370/30). The tire is about 3.7 inches wide at the tread, thus the flat spot on the tire would be about 3.3 inches, when viewed from the side. In order to achieve a 12.3 square inch contact patch, the tire would compress about $\frac{1}{4}$ inch leaving the strut about 3.74 inches from the ground. See Figure 18. A 2X load (740 pounds) on the nose gear would require 6.7 inches of tire contact when viewed from the side. Because of the geometry, the compression is significantly

greater to get twice the tire footprint. In this case, the fork is now 2.9 inches from the ground (1/4 inch loss at 1X and 1.13 inch loss at 2X).

At 20 psi, each footprint has to be 50% greater at each load factor. A load factor of 1X results in a fork to ground clearance of 3.4 inches. At a load factor of 2X, the ground clearance is 0.8 inches by calculation. However, the dynamics associated with a compressed tire and wheel diameter undoubtedly affect the actual height of the strut and fork.

A heavy engine/propeller combination will add to the tire compression. Seventy extra pounds has little effect on the ground clearance if the load factor is 1X and the tire is inflated to 30 psi. A 2X load factor would result in a ground clearance of 2.3 inches. A 2X load factor and 22 psi would result in the fork contacting the ground (by calculation).

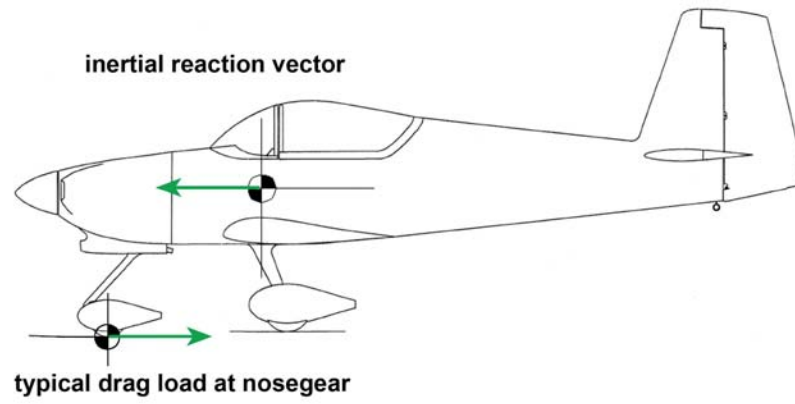
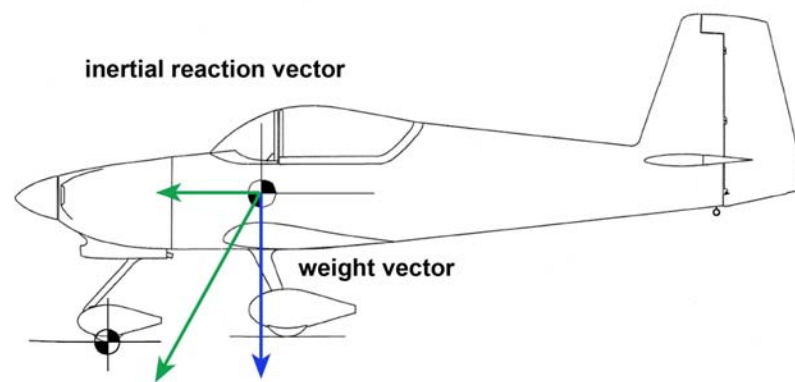
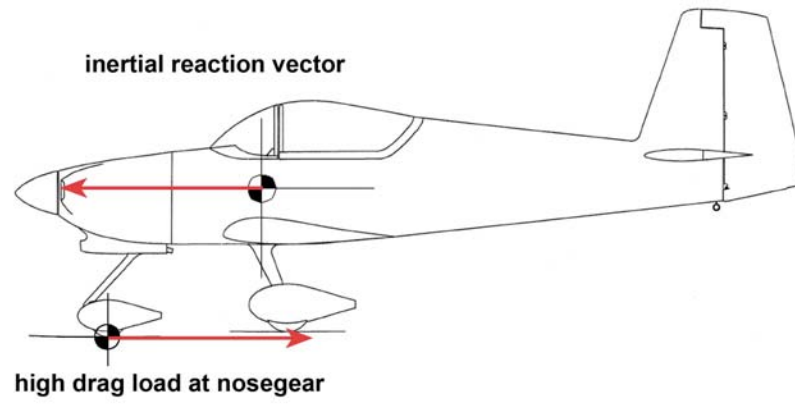
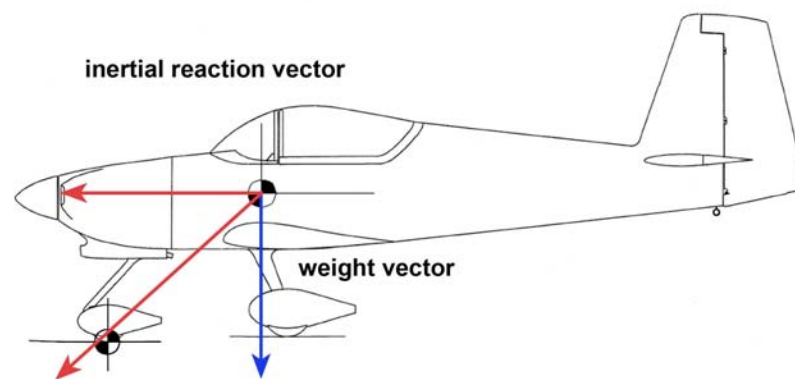
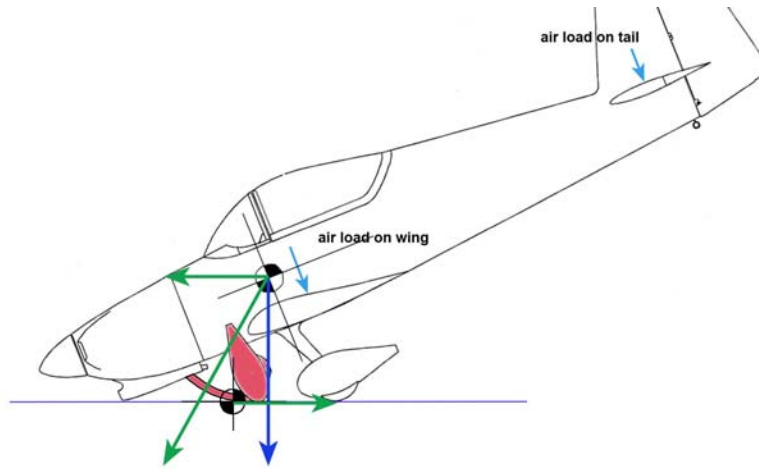
Figures 19 through 23 present a simplified explanation of overturning moments about the nose gear (other forces acting on the airplane are not considered). [Figure 19](#) depicts an aft force at the nose gear and an inertial reaction vector through the CG. [Figure 20](#) depicts the resultant vector that is the sum of the weight vector and inertial reaction vector. If the resultant vector falls behind the nose gear, the moment is not sufficient to overturn the airplane. [Figure 21](#) depicts a high aft force at the nose gear and the correspondingly high inertial reaction vector. [Figure 22](#) depicts a resultant vector that falls forward of the nose gear. Thus, a high drag load at the nose gear may produce a sufficient moment to overturn the airplane. The drag force would have to be about equal to or greater than the weight of the airplane. [Figure 23](#) shows the effect of the collapsed nose gear. The pitch-down attitude moves the CG forward and the contract point (nose gear strut) is much closer to the CG. Thus, the drag load at the strut or fork may only be 1/3 to 1/2 the weight of the airplane to produce an overturning moment. [Figure 23](#) also shows that aerodynamic loads on the wing and horizontal stabilizer resist the overturning tendency.
