Inland Oil Spill – Well Blowout, 2004

Abstract

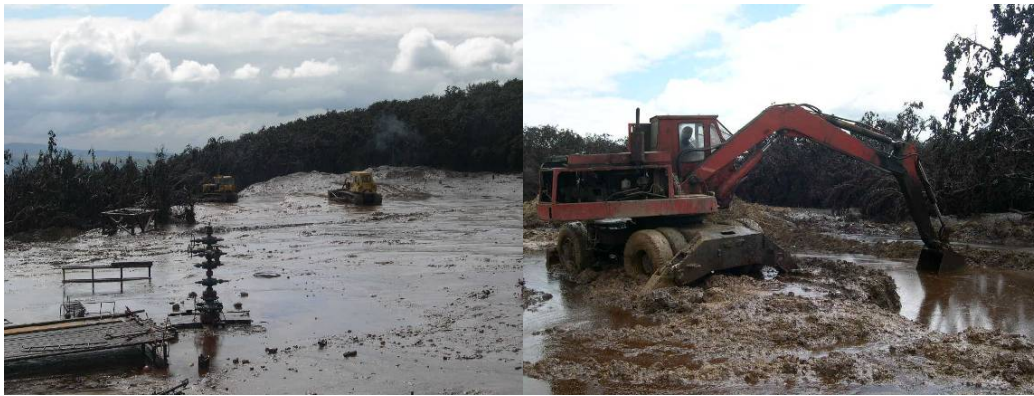
The initial assessment revealed the extent of the damage caused in the four days before the well was capped. In addition to the effects of the spill itself, the actions taken in the four days until OSRL's arrival had exacerbated the impact. Large earth moving equipment was used to create earthen bunds and collection pits in an attempt to prevent the bulk of the oil migrating down the hillside (Fig. 1). Unfortunately this had limited success; the oil was mixed into the clay substrate and the pits were

inundated by the volume of oil. A large volume of oil migrated down the hillside, following a natural ravine to the village, 2km away.

Figure 1. Showing wellhead operations prior to OSRL's arrival to the spill site.

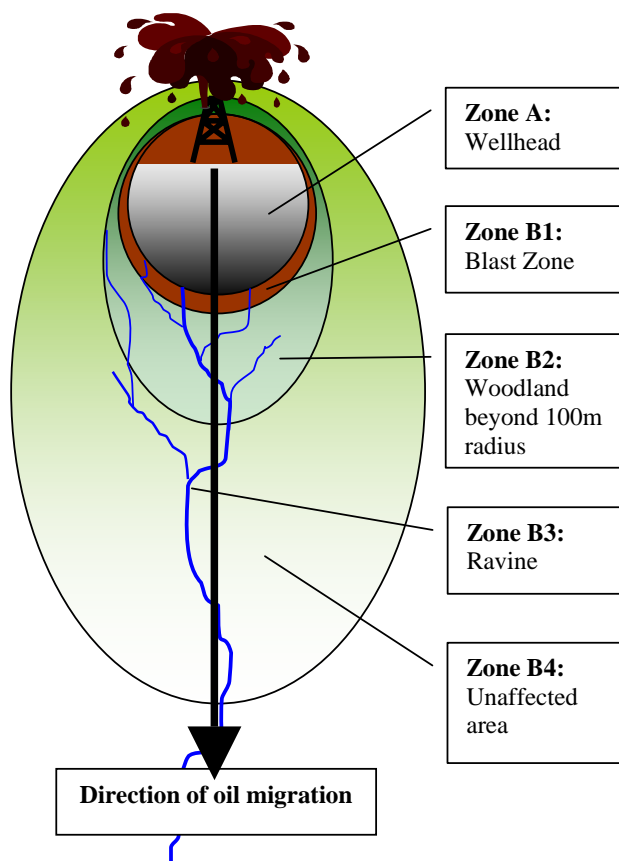
The only mitigating measure conducted in this area by the client was the building of storage pits and earthen bunds as mentioned above. The hillside is characterised by its dense mixed deciduous trees and shrubs which suffered different degrees of disturbance dependant on the distance from the wellhead. This zone was, therefore, sub-divided.

Trees at the edge of the wellhead clearing suffered the most direct damage, with leaves and branches being stripped from some. To the south of the well the topography slopes steeply toward the village. Both airborne and surface flowing oil migrated in this direction, funnelled and concentrated into the ravine. Here oil coverage was almost complete, from tree-top to leaf-litter layer. This highly polluted area extended south for about 100m from the tree line.

At approximately 100m from the tree-line the intensity of the pollution began to lessen, with trees and the leaf-litter layer suffering a less intense coverage. Coverage of the leaf litter layer was shallow, with only the top layer being affected.

The ravine cuts through the hillside in a southerly direction down to the village. Free flowing oil was present along the entire length of the ravine. The ravine's clay substrate, acted to prevent infiltration of oil. At the time of the survey a small flow of water was present which mobilised the stranded oil.

Figure 2. Showing the subdivision of Zone B.

The felling of trees was considered a viable option in Zone B1 due to the number of trees condemned during the survey. Removal of these trees would reduce the threat of secondary contamination and chronic oiling from the remobilisation of oil and improved access to areas where bulk surface oil removal was required. The trees identified to be felled were clearly marked prior to felling, thus avoiding unnecessary removal and ultimately more waste.

Coppicing was recommended for trees within Zone B2 that were partly oiled and so presented a higher chance of recovery. This option resisted the removal of the entire tree, maintaining soil stability through root binding and allowing the ingress of opportunistic species through increased light fill. Following the coppicing, any remaining bulk oil was removed, followed by manual clean-up of residual oil on trees.

Due to the inaccessibility of this area it was recommended that low pressure / high volume flushing be used to drive the mobile oil down the ravine. This mobilised oil was captured in pits constructed on the outskirts of the village. It was deemed preferable to conduct this in a controlled fashion using recycled water from the flushing of the wellhead than wait until the rains of fall or the snowmelt of spring.

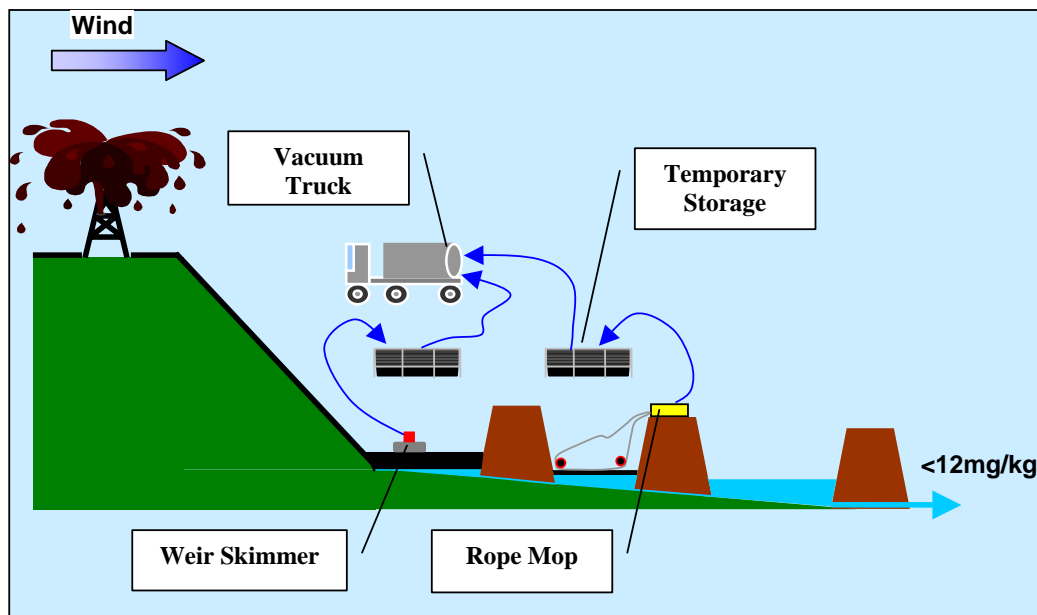
The initial actions taken by the client had trapped large quantities of oil in one area, at an elevation 200m below the wellhead where the ravine emerged from the woodland in the form of a small stream. The damming of this stream had temporarily interrupted the downstream movement of water through the village.

Figure 3. Diagrammatic representation of the oil / water separation pits.

In an attempt to reinstate the stream's flow, the pre-existing pit was split into three to produce a crude oil/water separation facility (Fig.3). The top pit was used to collect and concentrate oil mobilised from the ravine, while allowing the separation of water and oil. The bottom water level was then allowed to decant at a controlled rate to the next pit, which was again allowed to settle and allowed any oil to accumulate on the surface for removal. Again the water was decanted into the third and final pit where sorbants were used to remove any trace of sheen ready for release downstream once hydrocarbon levels of 12mg/l or lower were reached. This level was given as the acceptable limit after consultation with the Ministry of Environment and levels were monitored by an independent agency.

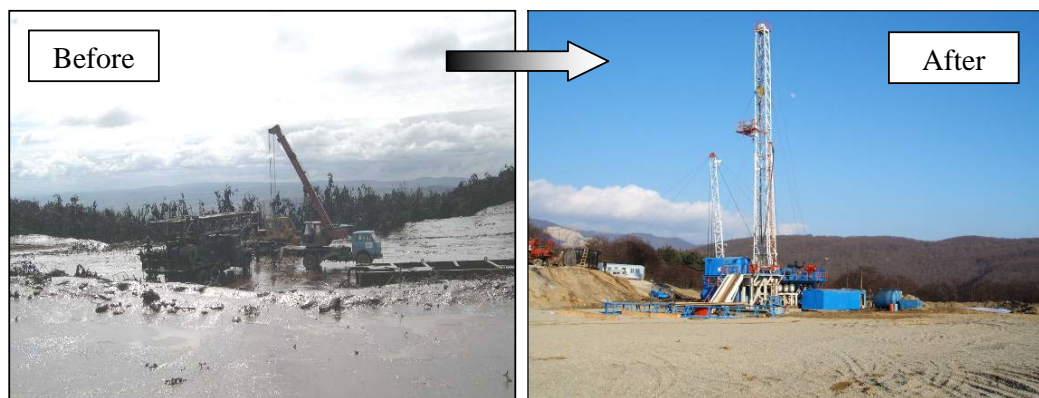
Figure 3. Showing the wellhead site immediately after the spill and four months after.

role in this structure, working intimately with the client. Of primary concern to the client was getting the wellhead site sufficiently clean to allow pumping operations to be resumed from the rejuvenated well (Fig. 3). Daily meetings allowed a constant information flow between the on scene commander and operations manager, ensuring logistical requirements for the following days operations were met.

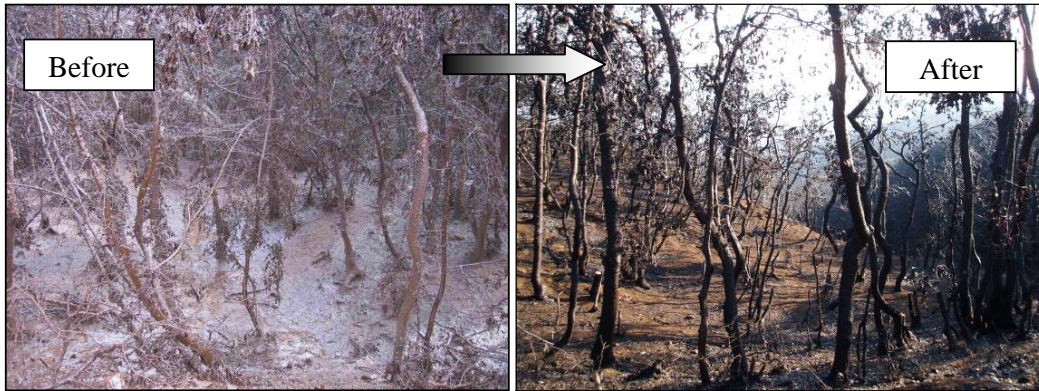
Figure 4. Showing the woodland site immediately after the spill and four months after.

The environmental action plan written by OSRL had been closely followed. Selective felling and the removal of oiled leaf litter, fallen branches and badly damaged trees had been removed as prescribed in the action plan (Fig. 4). The remaining trees within this area still showed signs of surface oiling but the majority of oiled leaves had fallen and been removed, thereby reducing the risk of chronic re-oiling.

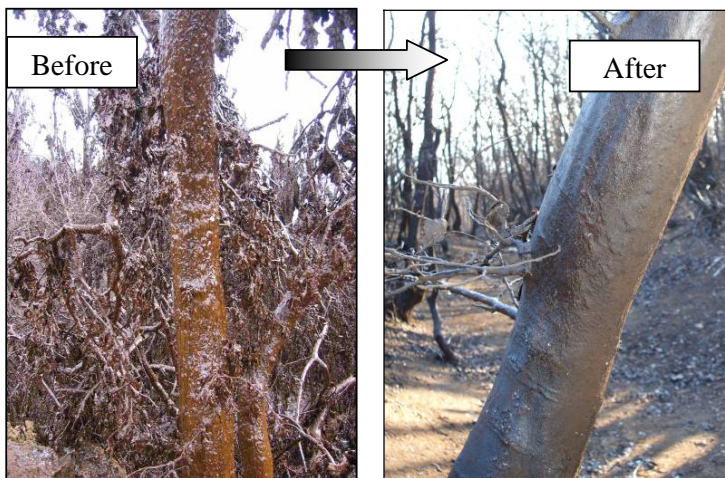
Figure 5. Showing the *in-situ* weathering of oil on a tree in the main fallout area.

Two deciduous trees that suffered the same exposure to the well blow out. A weathered surface deposit still remains on the bark, but it is thought that this will not have an effect on the survival chances of the tree. Of more concern is the infiltration of oil into the root system, which was limited by the thick leaf litter layer and clay substrate.

The weathering of any oil that was left *in-situ* was slowed due to the low temperatures experienced during the winter. It is thought that with the coming of summer the weathering process will accelerate and perhaps some remobilisation of oil will occur, for this reason the separation pits will remain as a permanent feature.

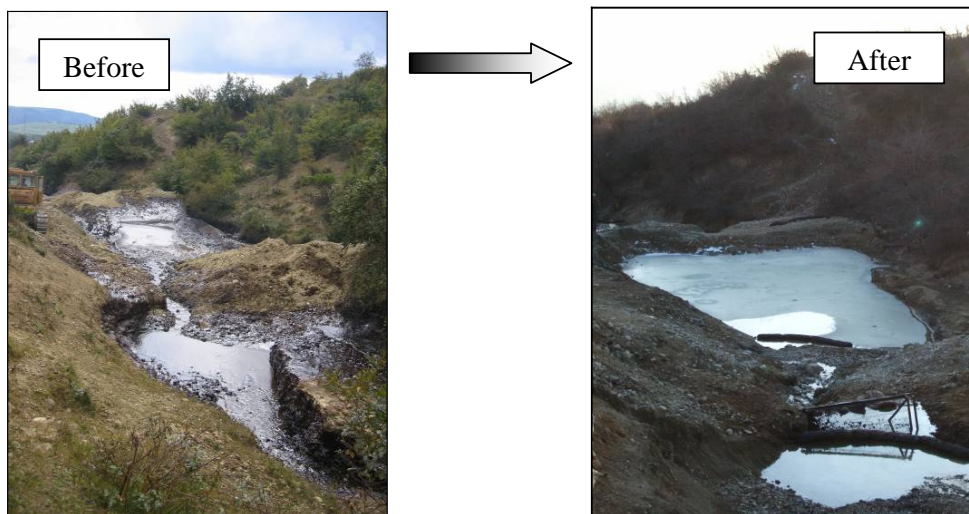
The pits remain in place and are manned in order to monitor the water flow and manually skim any sheen from the surface. The upper pits are still showing some surface sheen, though it is unclear whether this is as a result of oil mobilised from the ravine or chronic oiling from the pit itself. It is predicted that this sheen may increase during the wetter, warmer months as oil is remobilised and transported down the ravine.

Figure 4. Showing a separation pit during and after the response.

The client has also planned to landscape the pit area to create a permanent facility for the collection and separation of runoff for this watershed using concrete pits and larger sluice gates. An independent hydro-geologist has been consulted to design this facility in order to withstand a 1 in 100 year event.
