# **SANDIA REPORT**

SAND2006-2451

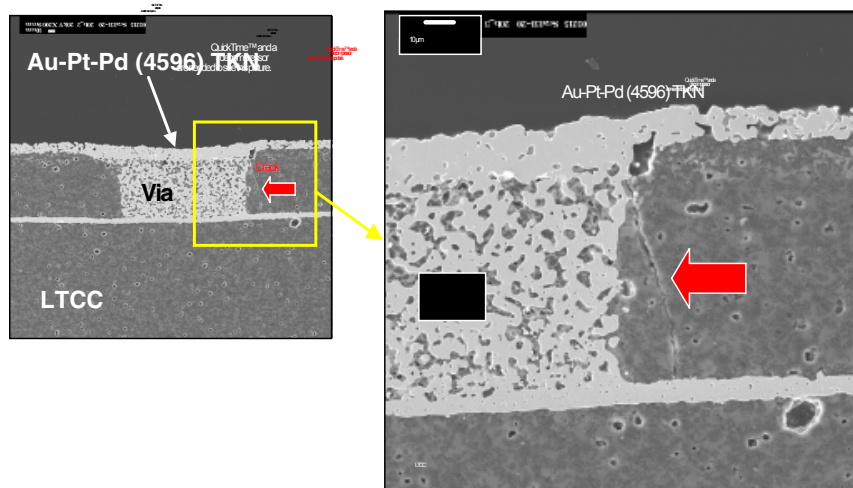
**Fig. 1** SEM/SE image of the a crack in the sidewall of a via over which, was deposited Au-Pt-Pd (4596) a thick film pad.

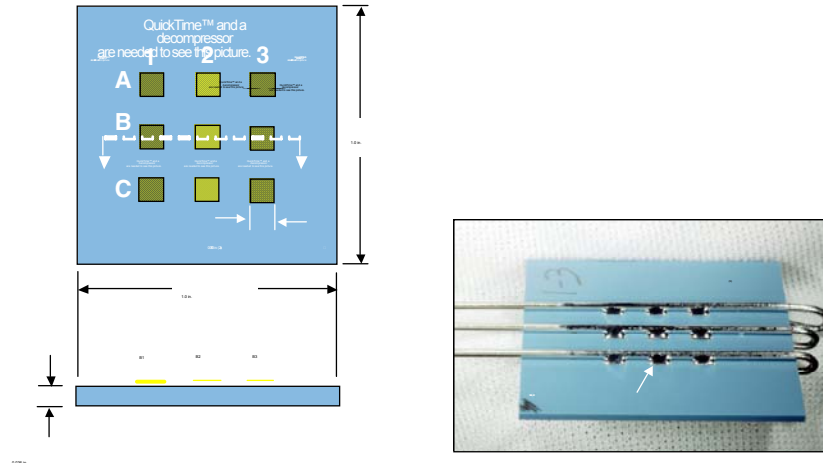
**Fig. 2** (a) Schematic diagram showing the geometry of the LTCC pull test substrate. (b) Stereo photograph of the test specimen after soldering, but prior to cutting the leads for pull testing.

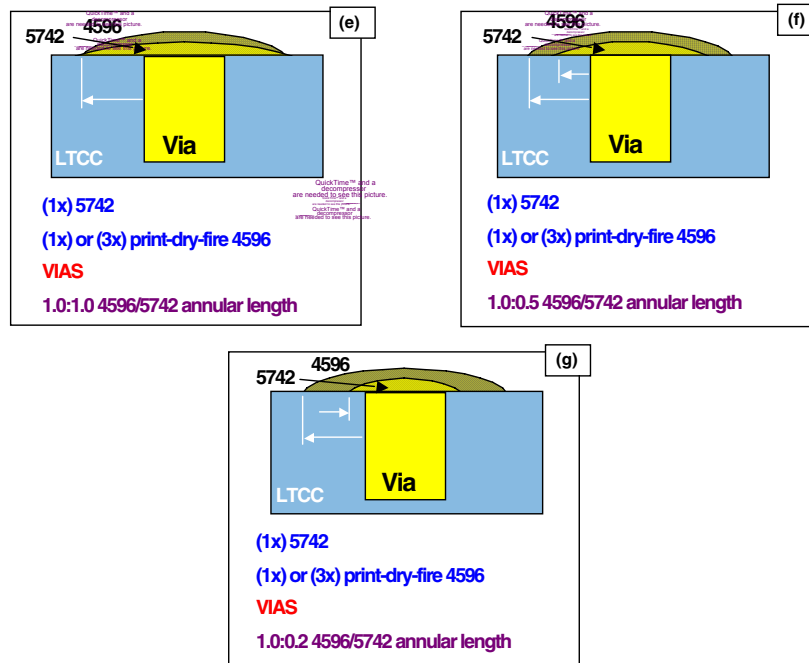
**Fig. 3** Schematic diagrams showing the different 4596 and 5742 thick film combinations and pad geometries. Note that the annular widths defined the ratios of the thick film footprints, which were expressed as (4596/5742):1.0:1.0, 1.0:0.5, and 1.0/0.2.

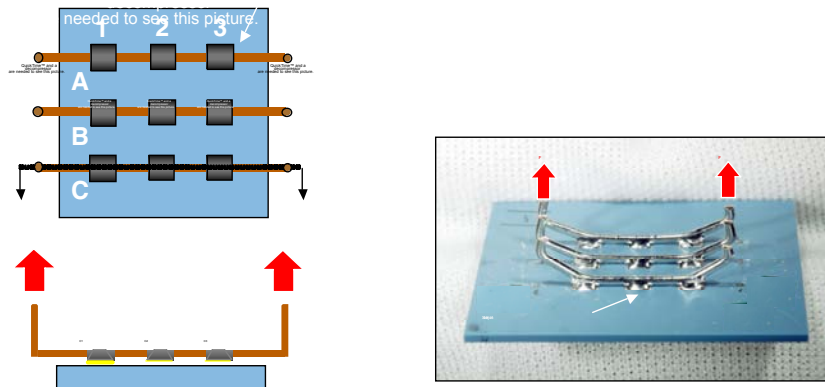
**Fig. 4** (a) Schematic diagram showing the configuration of the pull test sample after the shepard's hook and excess length had been clipped away from the Cu wire, followed by bending the leads upwards for the pull test (red arrows). (b) Stereo photograph of the test specimen after the pull test had been performed. The red arrows and "F" indicate the point of application and the direction of the pull load applied by the test frame.

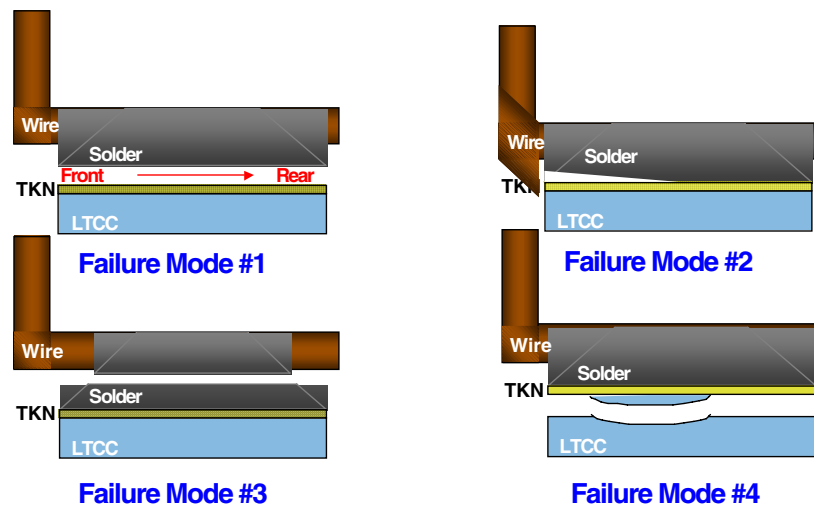
**Fig. 5** Schematic diagram showing the failure modes that were determined from *visual inspection* of the pull test sites. In the failure mode analysis based on metallographic cross sections, the front and rear locations of the joints were considered.

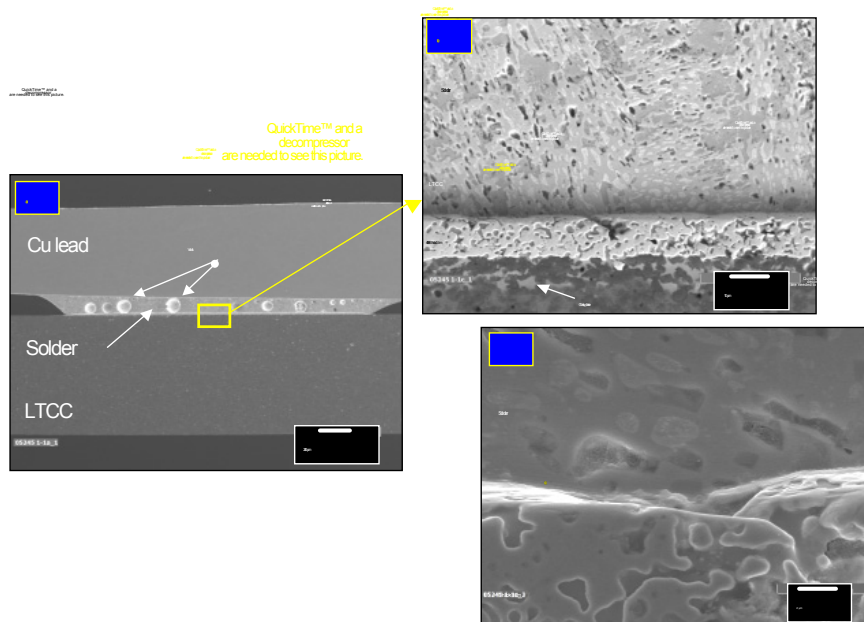
**Fig. 6** SEM/SE images of the untested solder joint fabricated with the single print (1x) of 4596 thick film (no vias): (a) low magnification view of the entire interconnection; (b) medium magnification showing the solder joint gap; and (c) a high magnification image of the solder/thick film interface.

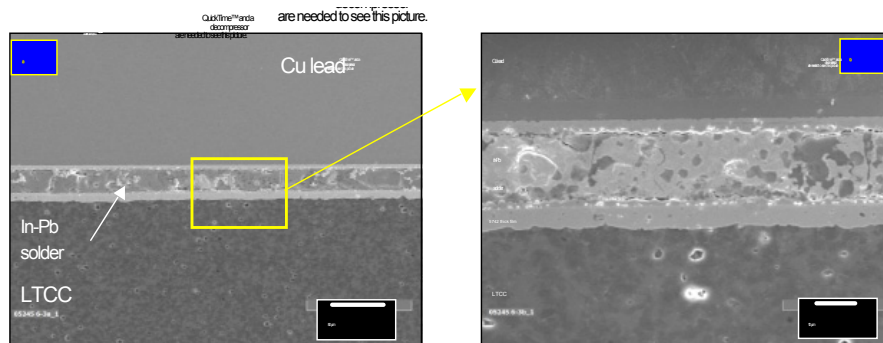
**Fig. 7** SEM/SE images of the untested solder joint fabricated with a single print of the 5742 thick film. This area was away from the via: **(a)**, low magnification view of the interconnection; **(b)** a high magnification image of the solder joint gap region.

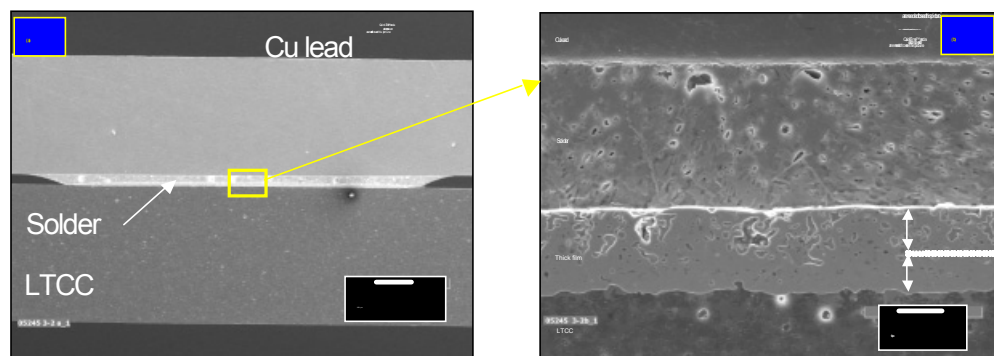
**Fig. 8** SEM/SE images of the untested solder joint fabricated with single prints of both the 4596 and 5742 thick films. No vias were present in the LTCC: (a), low magnification view of the entire interconnection and (b) a high magnification image of the solder joint gap region and thick film layers.

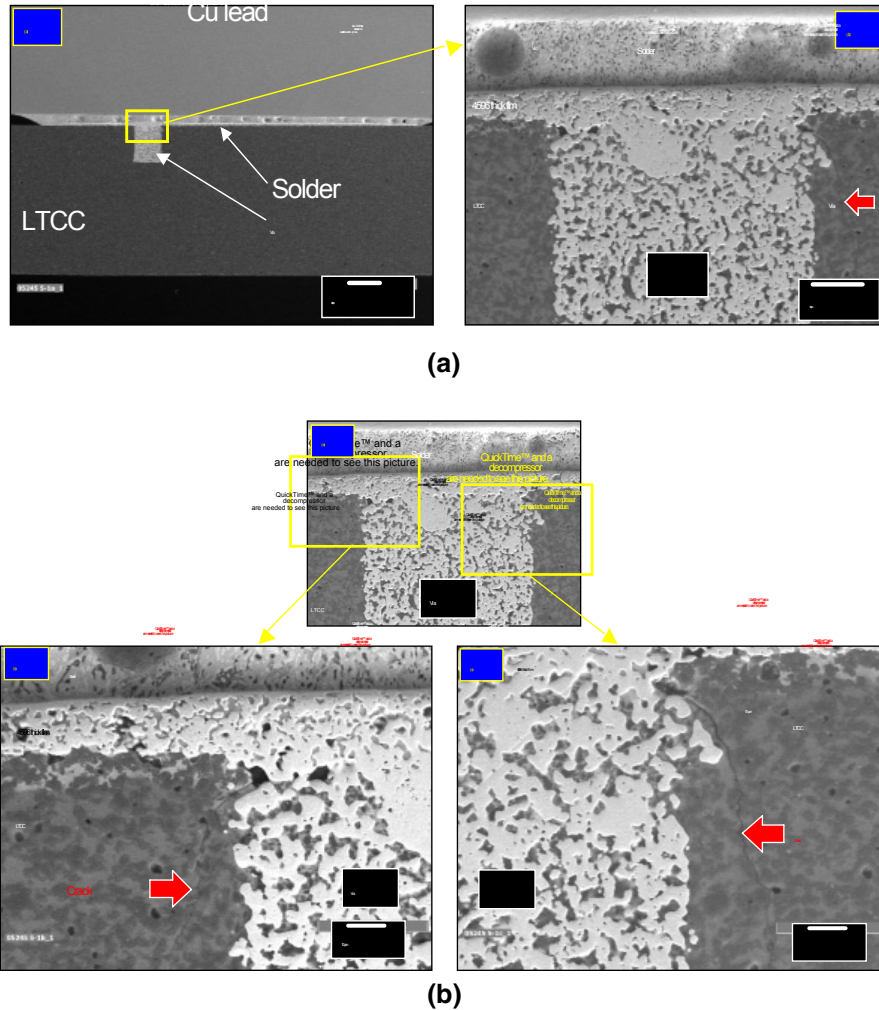
**Fig. 9** SEM/SE images of the untested solder joint fabricated with a single print (1x) of the 4596 thick film over a via: (a) (a) Low magnification image of the solder joint. (b) (b) Medium magnification photographs showing the via and the solder joint above it. The red arrow indicated the location of the side wall crack. (b) (a) Repeated low magnification image of the via identifying the side wall locations that were viewed at higher magnification in (b) and (c) and that show more clearly the side wall cracks.

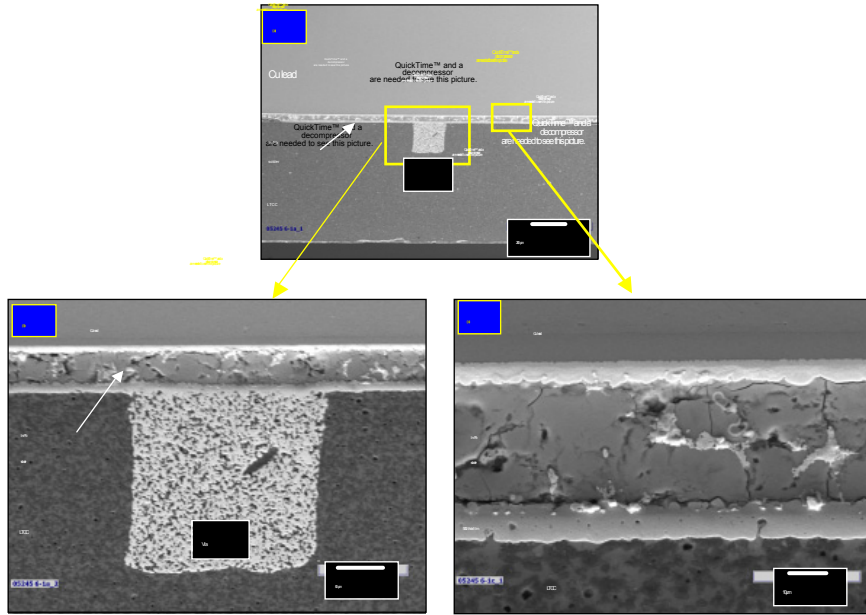
**Fig. 10** SEM/SE images of the untested 50In-50Pb solder/5742 thick film joint over a via. (a) Low magnification photograph showing the overall solder joint; (b) Medium magnification of the solder joint over the via structure. Side wall cracks were absent from around the via. (c) High magnification photograph showing the excellent integrity of the solder/thick film and thick film/LTCC interfaces away from the via.

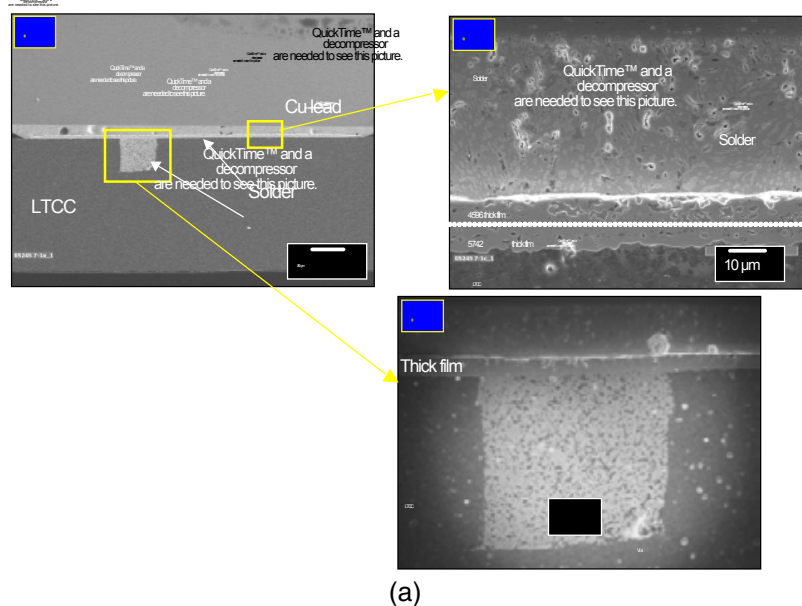
The SEM/SE photograph in Fig. 11a (c) showed that side wall cracking was absent from around the via. The observation was further substantiated through the higher magnification photographs provided in Fig. 11b that examined, specifically, the side wall regions of the LTCC. The 4596 glassy phase, as well as voids that have appeared at the via-fill/LTCC wall interface and suspected to play a role in the initiation of sidewall cracks, were not observed in Fig. 11b.

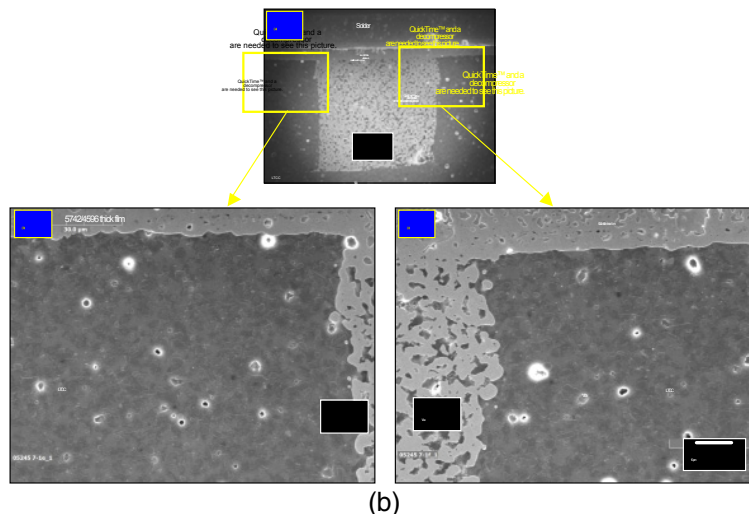
**Fig. 11** SEM/SE images of the untested solder joint fabricated from single prints of both 4596 and 5742 thick films over a via. The ratio of 4596/5742 was equal to 1.0:1.0: (a) (a) Low magnification photograph of the overall solder joint. (b) High magnification photograph showing the solder, thick film, LTCC, and interface structures at a location away from the via. (c) Low magnification photograph of the via and solder joint directly above the via. (con't)

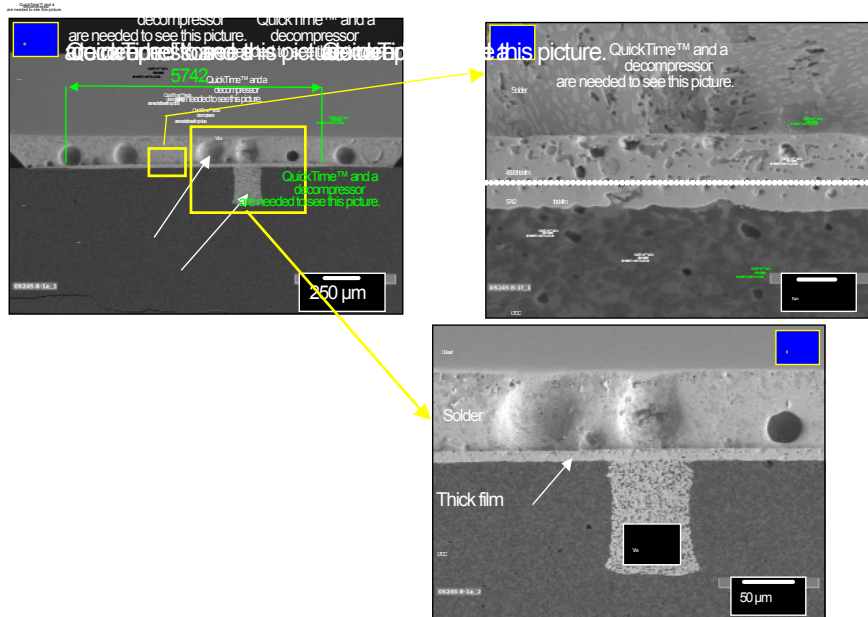
The next sample configuration was that in which, the footprint of the 1x 5742 thick film had one-half the annular radius of the 1x 4596 layer. That is the case of the 4596/5742 ratio of 1.0:0.5 (Fig. 3f). Shown in Fig. 12a (a) is a low magnification, SEM/SE photograph of the untested solder joint. There appeared to be more voids in this solder joint than the previous cases. As in previous instances, the voids were not correlated to the position of the via. The greater propensity for voids was likely due to the wider gap coupled with flux volatilization. There was no reason to believe that the ratio of 4596/5742 equal to 1.0:0.5 would have explicitly caused a greater propensity for voids in the solder. The extent of void development would not have impacted the physical or mechanical functionality of the joint.

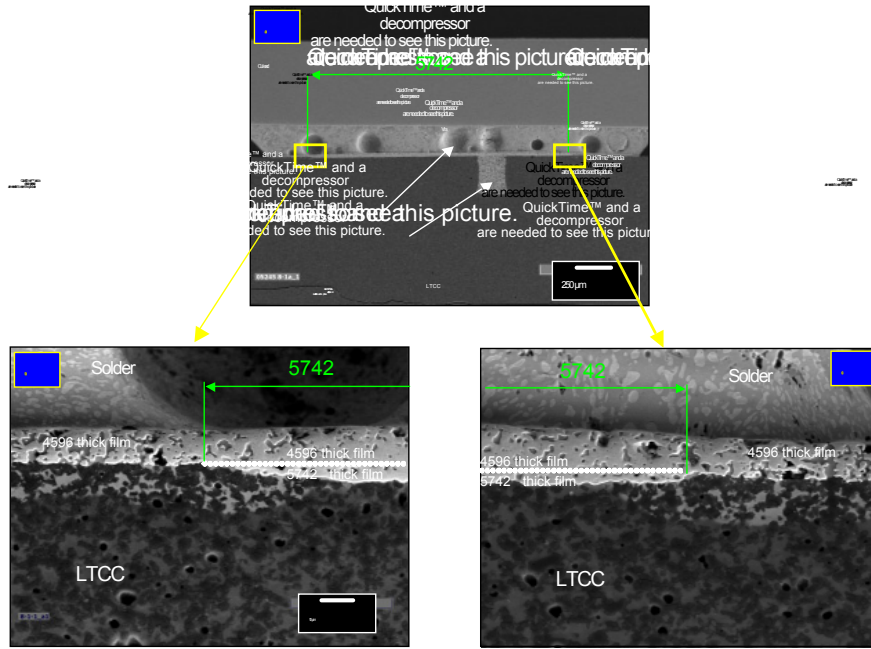
**Fig. 12** SEM/SE images of the untested solder joint fabricated from single prints of both 4596 and 5742 thick films over a via and at a 4596/5742 ratio equal to 1.0:0.5: (b) (a) Low magnification view of the via, identifying the side wall locations that were examined at higher magnification in (b) and (c). The red arrows indicate horizontal cracks in the LTCC. (c) The photograph in (a) was a repeat, low magnification view of the via used to identify the location examined in (b) at higher magnification that shows horizontal cracks in the LTCC material next to the via. (con't)

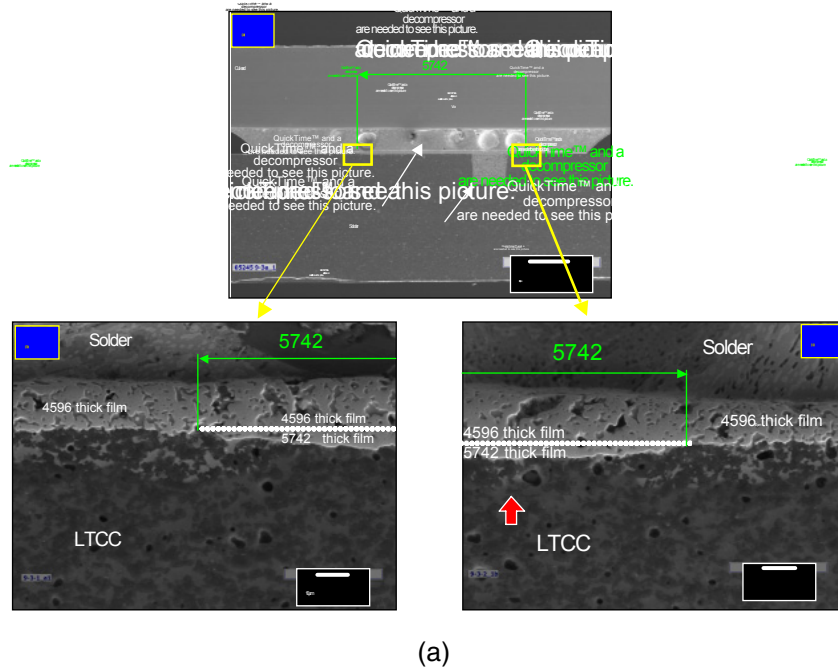
**Fig. 13 (a) (a)** Low magnification SEM/SE image showing the structure of the untested solder joint fabricated from 1x 5742 and 1x 4596 thick films over a via, having 4596/5742 ratio equal to 1.0:0.2. The termination points of the 5742 layer were identified by the green lines. The SEM photographs (b) and (c) showed the outer boundaries where the 5742 thick film layer. The red arrow in (c) pointed to an isolated region of the 4596 glassy phase that developed further away from the boundary. (con't)

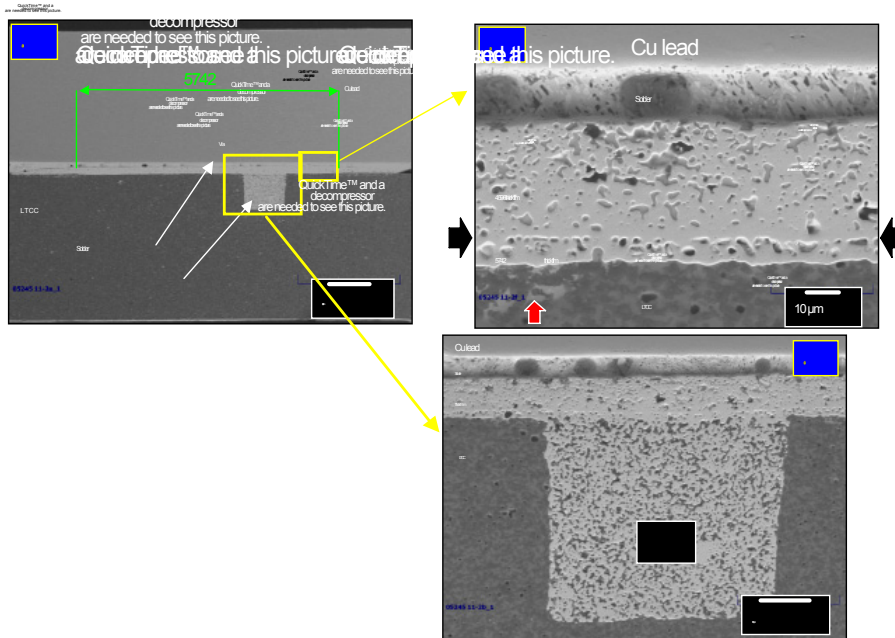
The analysis began with an evaluation of the test specimen having the 4596/5742 ratio of 1.0:0.5. The sample having the ratio of 1.0:1.0 showed microstructural features very similar to those described below for the 1.0:0.5 ratio specimens. Shown in Fig. 14a (a) is a low magnification SEM/SE photograph of the untested solder joint made with a 1x 5742 layer and 3x 4596 thick film over a via. The boundaries of the 5742 layer were marked by the green lines

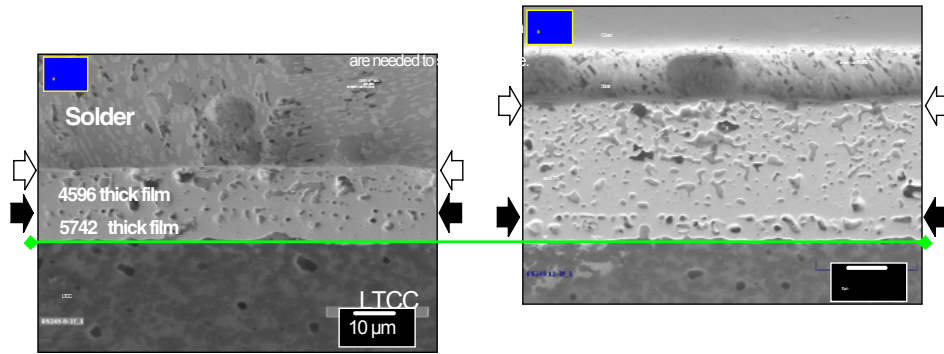
**Fig. 15 (a)** SEM/SE image showing the microstructure of the untested solder joint fabricated from a single print of 5742 thick film and a single layer of 4596. (No via was present in this sample.) **(b)** SEM/SE image showing the microstructure of the untested solder joint fabricated from a single print of 5742 thick film and three layers of 4596 thick film. (This sample had a via and a 4596:5742 ratio of 1.0:0.5.) The green line marked the interface between the 5742 layer and the LTCC base material. The black arrows indicated the approximate position of the interface between the 5742 layer and the 4596 layer. The white arrows showed the position of the interface between the 4596 layer and the Sn-Pb solder.

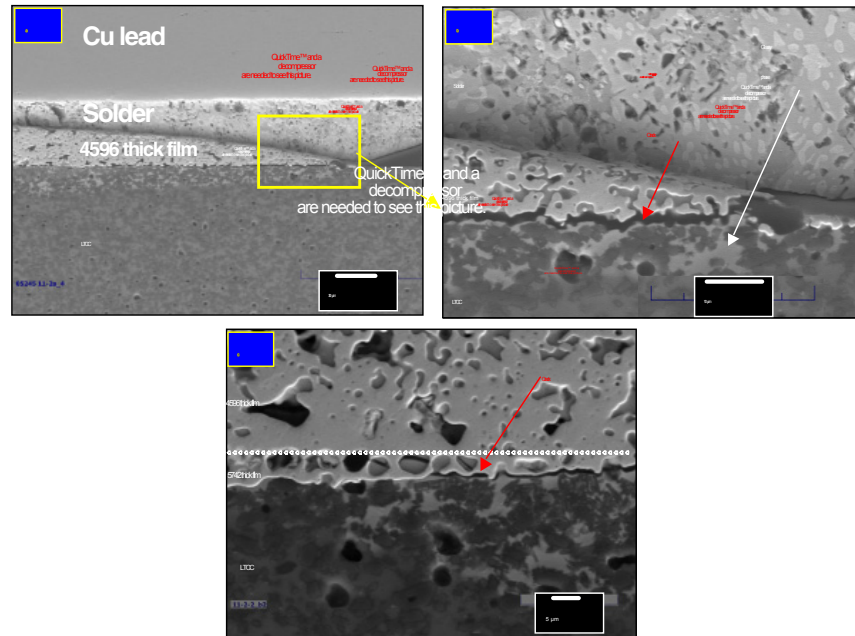
**Fig. 16** (a) SEM/SE image showing the crack observed in the untested solder joint fabricated with the 1x 5742 and 3x 4596 thick film layer. (This sample a 4596:5742 ratio of 1.0:0.5 and vias.) (b) SEM/SE image showed the crack initiation point and fracture microstructure. (c) SEM/SE showing the termination point of the crack.

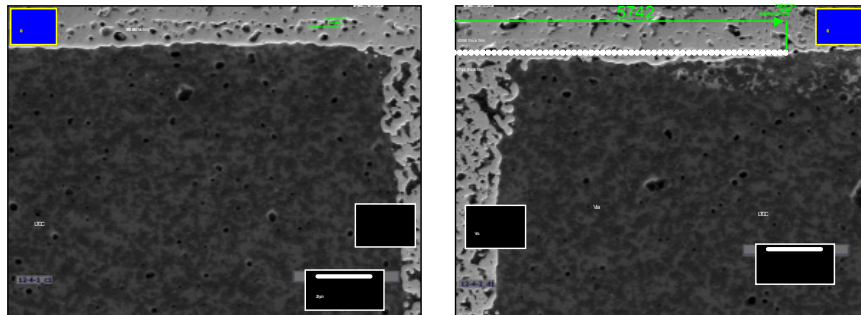
**Fig. 17 (a) and (b):** SEM/SE images showing the sidewalls of the vias attached to the untested solder joint fabricated from a single print of 5742 thick film and three layers of 4596 thick film. The sample had a 4596:5742 ratio of 1.0:0.2 and vias underneath the pads.

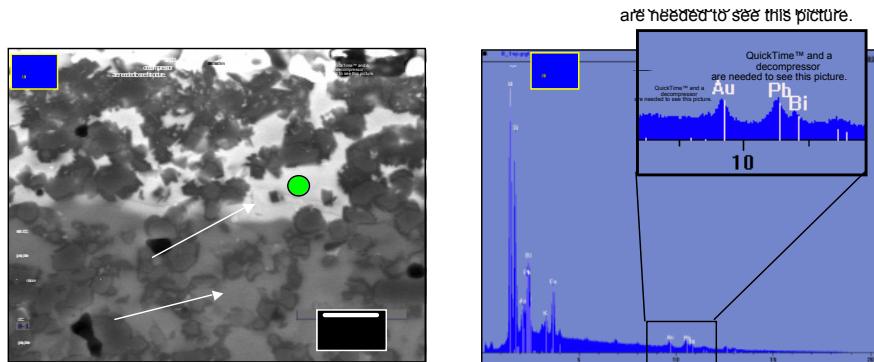
**Fig. 18 (a)** High magnification SEM/SE photograph that shows the boundary between 4596 glassy phase and the LTCC. **(b)** Energy dispersive x-ray analysis (EDXA) of the 4596 glassy phase showing the Au, Pb, and Bi peaks. This particular sample was made of single prints of both 4596 and 5742 thick films over a via at a ratio of 4596/5742 equal to 1.0:0.5.

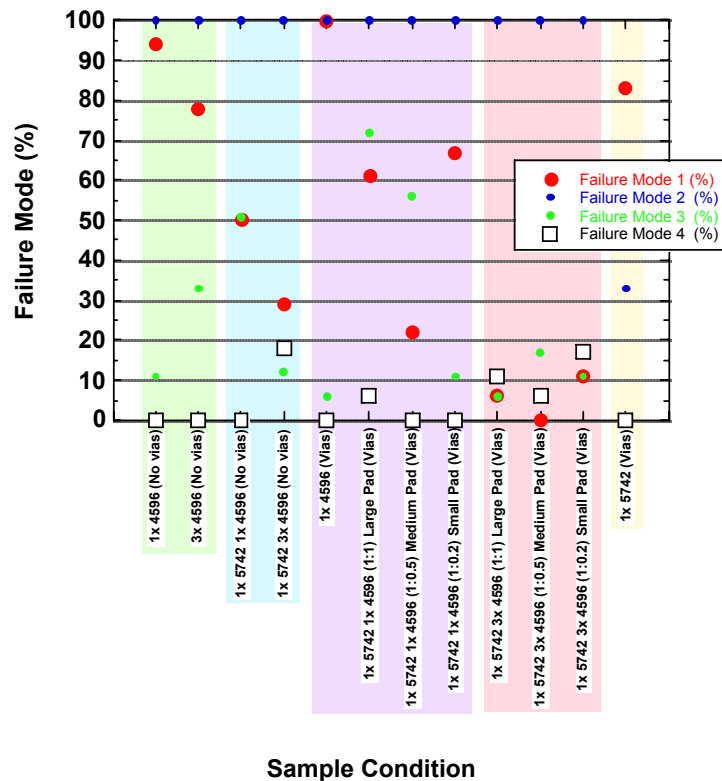
**Fig. 20** Failure mode analysis of the pull test samples. The percentage values reflect the percentage of the eighteen (18) solder joints that had that particular failure mode.

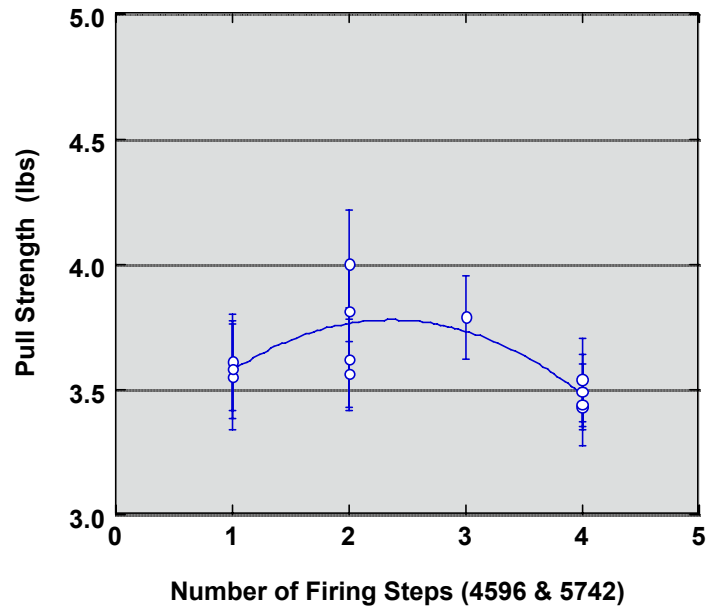
**Fig. 21** Pull strength as a function of the number of firing steps used to deposit the 5742 layer, if present, and the 4596 layer(s), combining all of the data taken in this study.

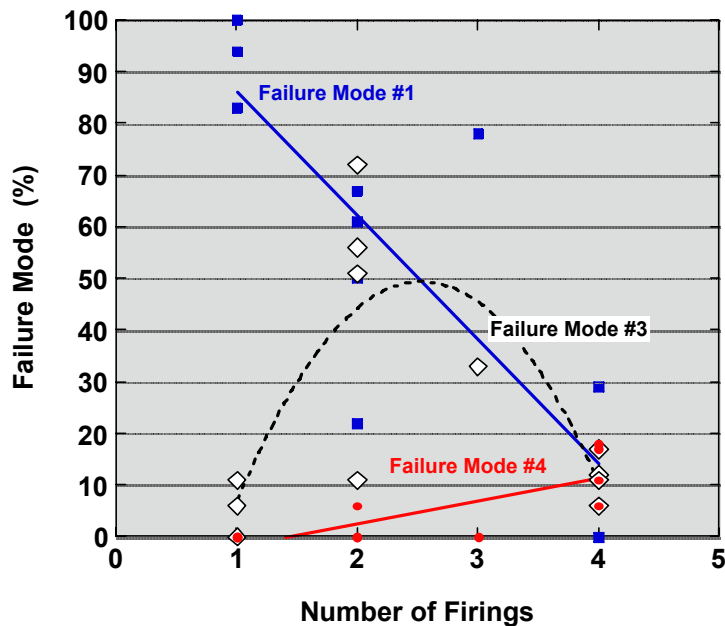
**Fig. 22** Failure mode as a function of the number of firing steps used to deposit the 5742 and 4596 layers, combining all of the data taken in this study. The failure mode #2 was omitted from the analysis.

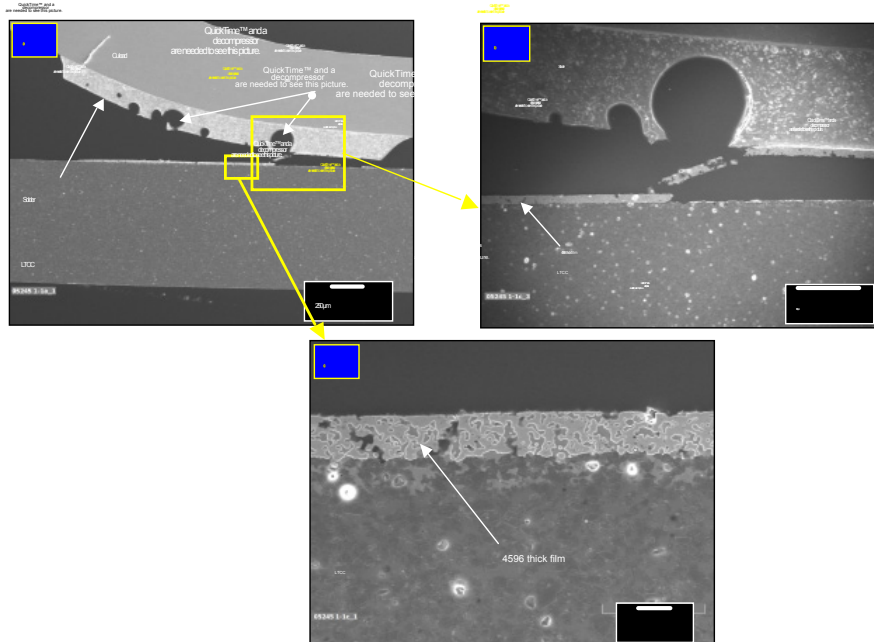
The second pull-tested solder joint, which was provided in the cross section, was depicted by the SEM/SE photographs appearing in Fig. 23b. In this case, the failure propagated from the right to the left. The low magnification image in Fig. 23b (a) showed the three failure modes present in the joint: (a) solder/thick film separation; (b) thick film/LTCC separation; and (c) an LTCC divot. A significant number of voids were observed in the joint. Although, generally speaking, the voids did not appear to have affected the fracture morphology at the interface, it was noted that below each void, the thick film layer had formed a vertical separation. The vertical cracks were probably caused by bending of the joint during testing and the absence of solder causing a lack of mechanical reinforcement for the thick film.

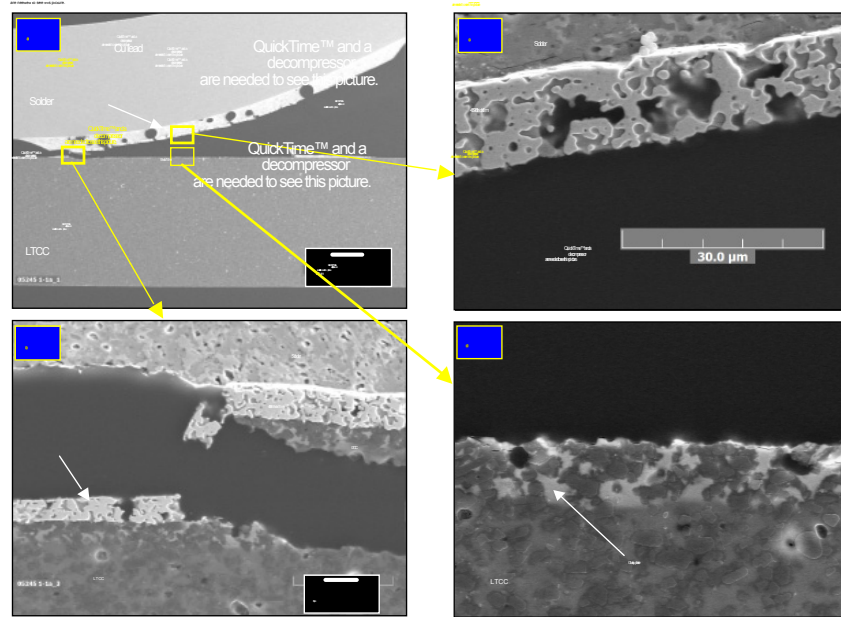
**Fig. 23** (a) **(a)** Low magnification SEM/SE image of the cross section of the pull tested solder joint from the test sample having a single 4596 layer and no via. The fracture progressed from left-to-right. **(b)** High magnification SEM/SE photograph showing the transition point between the solder/thick film interface failure to the thick film/LTCC interface failure. **(c)** High magnification SEM/SE photograph of the solder/thick film failure interface. *(con't)*

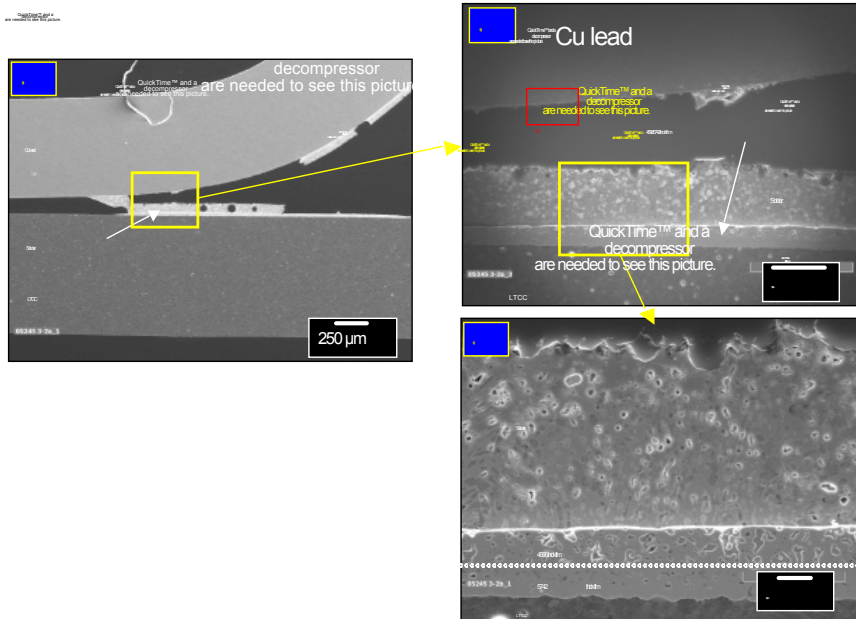
**Fig. 24** (a) Low magnification SEM/SE image showing the cross section of one of the pull tested solder joints made with single layers of 5742 and 4594 thick films; there was no via. (b) Medium magnification view of the failure site at the interface between the solder and the Cu lead. The red box indicated the solder/Cu lead interface where a significant layer of solder remained attached to the Cu lead. (c) High magnification SEM/SE photograph of the solder and thick film structures in the tested joint.

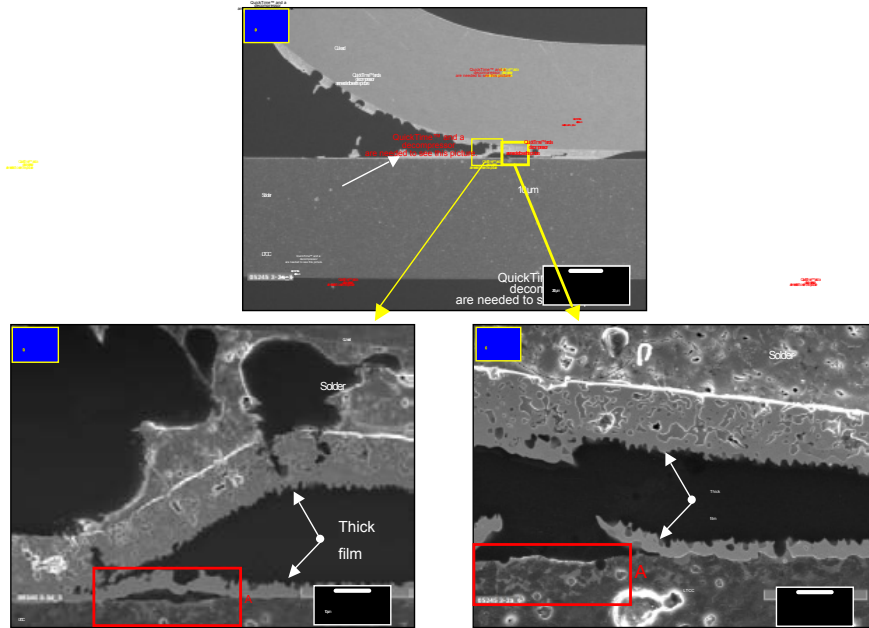
place in the solder (30% of the bond line) was greater than the number of voids that were present at the time of fabrication. That is, several voids were generated by the void coalescence process that characterized ductile deformation in the solder.

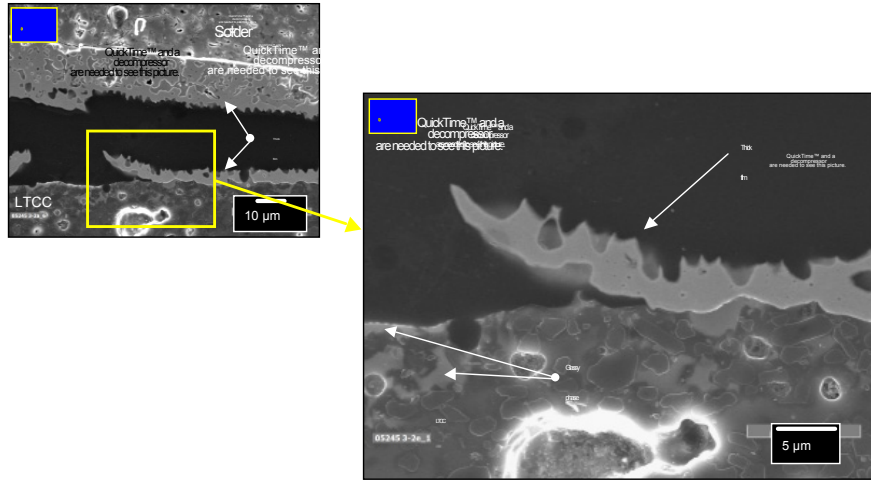
**Fig. 25** (a) (a) Low magnification SEM/SE image showing the cross section of the second pull tested solder joint made with single layers of 5742 and 4596 thick films; there was no via. The fracture progressed from left-to-right. (b) and (c) High magnification SEM/SE photographs showing the failure mode between the 5742 and 4596 thick film layers. The red box labeled “A” indicated a region of failure at the thick film (5742)/LTCC interface and the observation of glassy phase that had originated from the 4596 layer. (con’t)

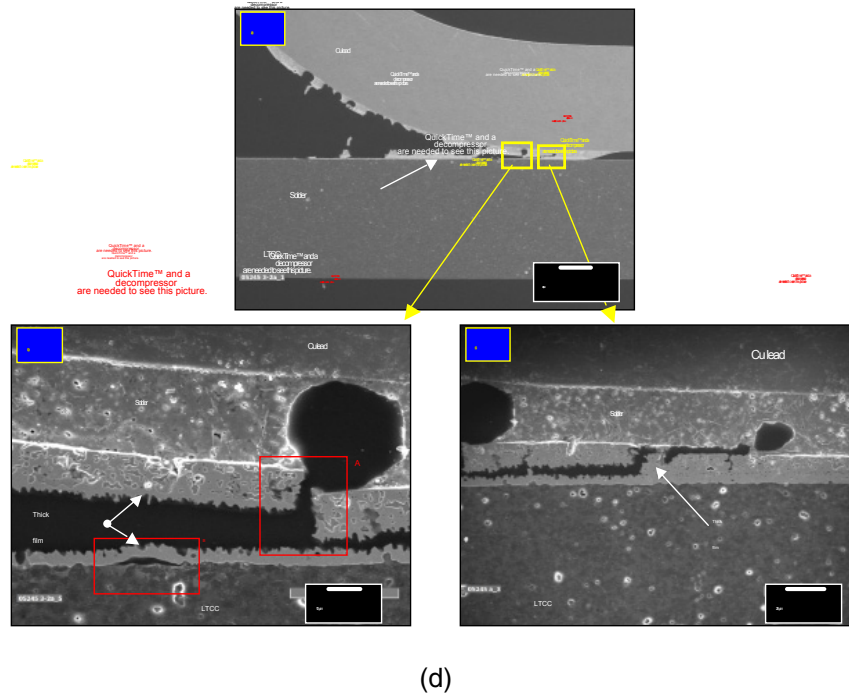
**Fig. 25** (b) Single layers of 5742 and 4596 thick films; there was no via. The fracture progressed from left-to-right. (a) and (b) Medium and high magnification SEM/SE images identifying the transition region between the thick film/LTCC failure and failure between the 5742 and 4596 layers. (c) Low magnification SEM/SE images (a) and (c) and high magnification photographs (b) and (d) that illustrated the morphology of the fracture surface when failure occurred between the 5742 and 4596 layers. (con't)

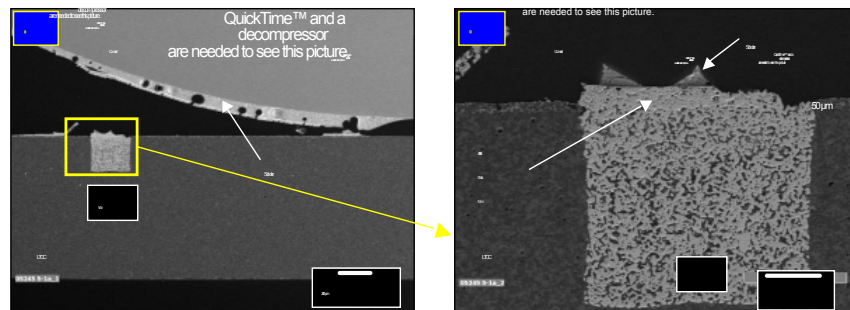
The pull test failure modes were examined for those samples having a single printing of 4596 thick film over a via. The SEM/SE image in Fig. 26a (a) shows one of the two pull tested joints. A number of voids were observed in the solder of both joints; however, their propensity did not affect the fracture of the interconnection, except for the small vertical cracks in the thick film layer that were described earlier. At the test site shown in Fig. 26a (a), approximately 70% of the fracture occurred along the thick film/LTCC interface. The remaining 30% of the failure mode was separation at the solder/thick film interface. The fracture morphology of the other sample was 50% for both the thick film/LTCC and solder/thick film modes.

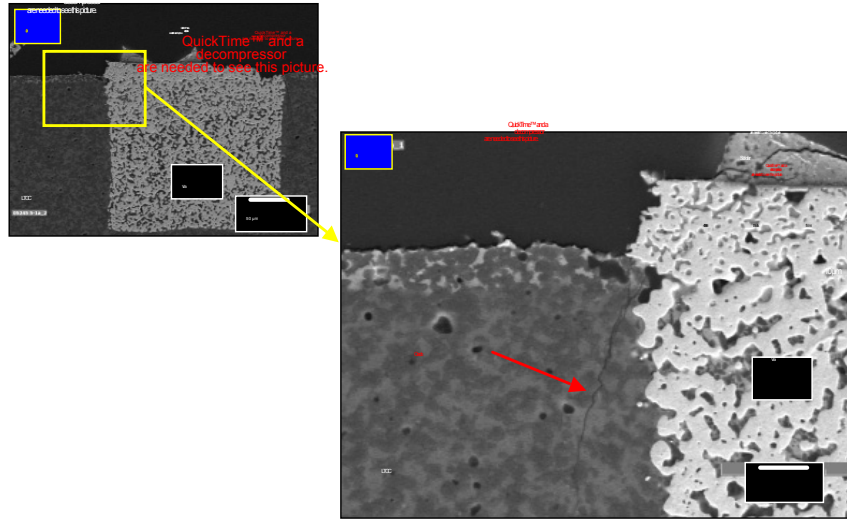
**Fig. 26** (a) (a) Low magnification SEM/SE image showing the cross section of one of the pull tested solder joint made with a single layer of 4596 thick film over a via. The fracture progressed from left-to-right. (b) High magnification SEM/SE photographs showing the failure modes associated with via structure under the solder joint. (con't)

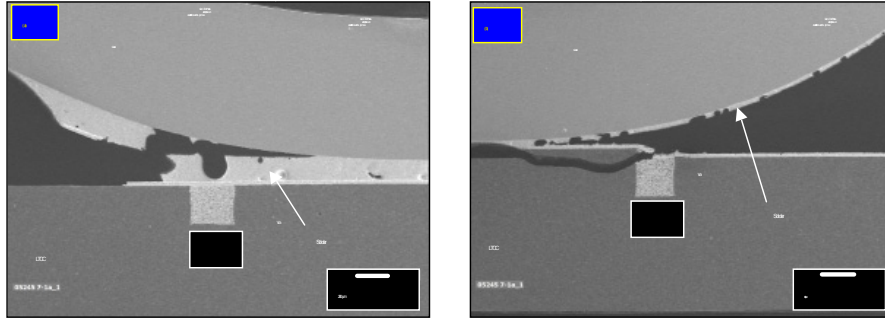
**Fig. 27 (a) and (b)** Low magnification SEM/SE photographs showing failure of the two solder joints constructed with single layers of 5742 and 4596 over LTCC that contained a via under the interconnections. This specimen had the footprint ratio, 4596/5742, of 1.0:1.0.

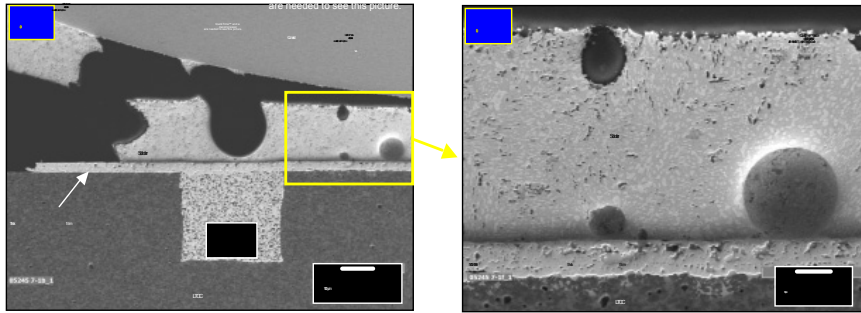
The second solder joint, which was shown in Fig. 27 (b), exhibited failure that was entirely along the solder/thick film interface. A low magnification SEM/SE photograph of the joint was provided in Fig. 29 (a); a high magnification view of the fracture surface was shown in Fig. 29 (b). The approximate demarcation between the 5742 and 4596 layers was noted in the photograph.

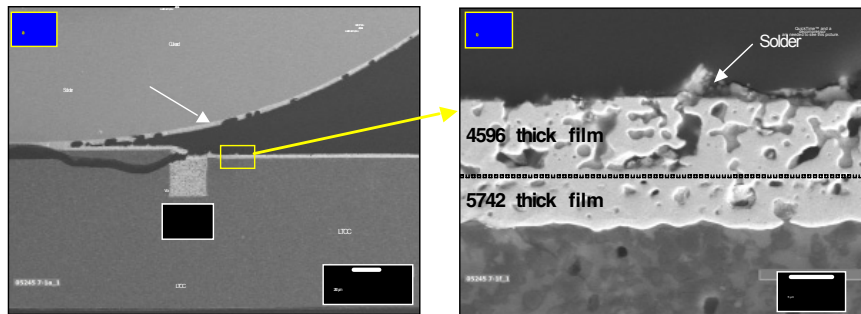
**Fig. 29** (a) Low magnification SEM/SE photograph of the failure of the joint having single layers of 5742 and 4596 over a via. The footprint ratio was 4596/5742, of 1.0:1.0. (b). High magnification SEM/SE image of the solder/thick film fracture morphology.

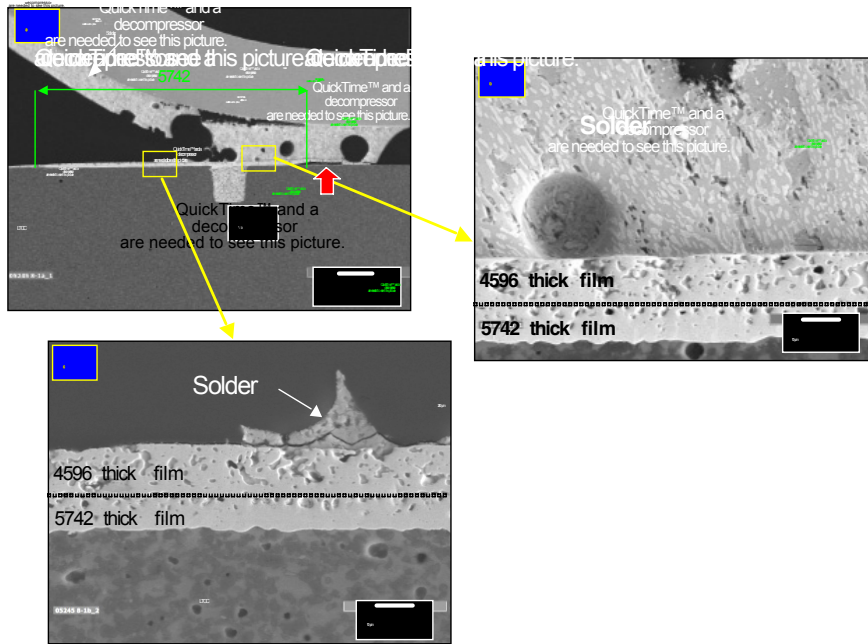
The pull tested samples were examined, which had a ratio of 1.0:0.5 for the annular regions of the 4596 and 5742 thick film footprints. Shown in Fig. 30a (a) is a low magnification SEM/SE image of one of the two solder joints. The extent of the 5742 layer was noted by the green lines. The fracture path progressed from the left to the right of the image. In this particular sample, approximately 60% of the bond line exhibited the solder/thick film failure mode; 30% was failure in the solder at its interface with the Cu lead; and the final 10% (red arrow) was failure at the thick film/LTCC interface. In the last case, the 4596 thick film was located on the LTCC as that layer extended beyond the 5742 footprint.

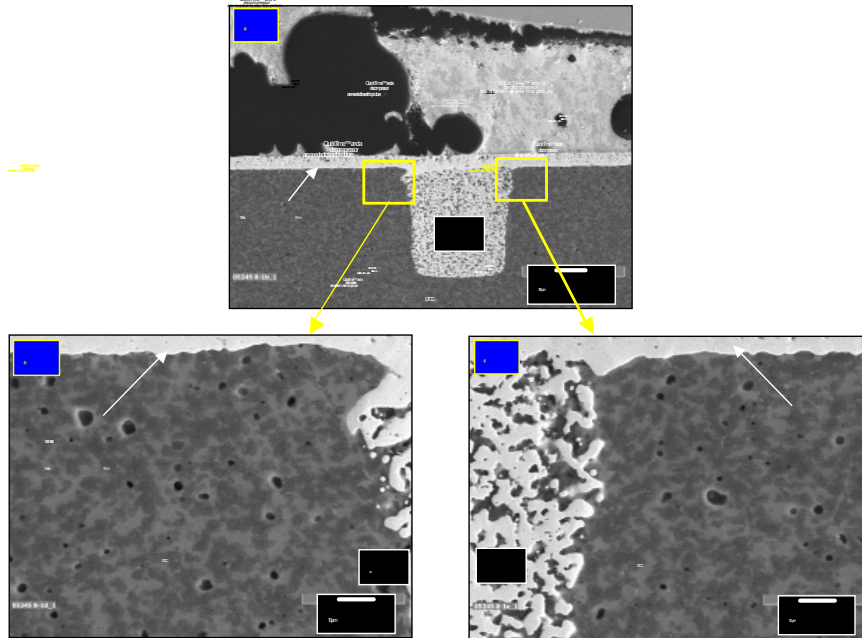
**Fig. 30** (a) **(a)** Low magnification SEM/SE photograph of the pull tested sample having single layers of 5742 and 4596, and footprint ratio of 4596:5742 equal to 1.0:0.5. **(b)** High magnification image showing the solder joint structure to the right of the via. **(c)** High magnification photograph showing the solder/thick film fracture surface. Pieces of solder remained attached to the thick film surface. (*con't*)

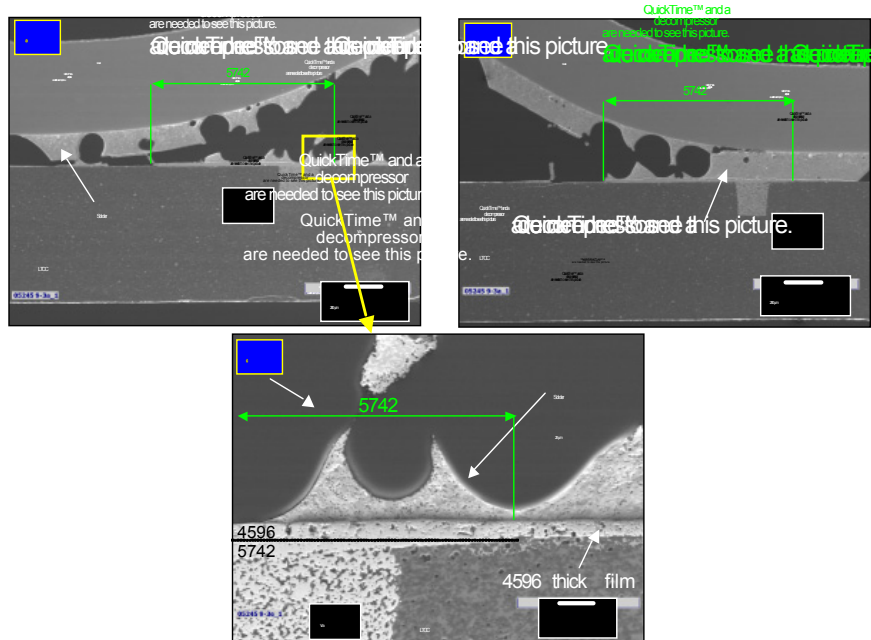
**Fig. 31 (a) and (b)** Low magnification SEM/SE photographs of two pull tested solder joints on a sample having single layers of 5742 and 4596, but with a footprint ratio of 4596:5742 equal to 1.0:0.2. **(c)** High magnification photograph showing the solder joint structure at the via.

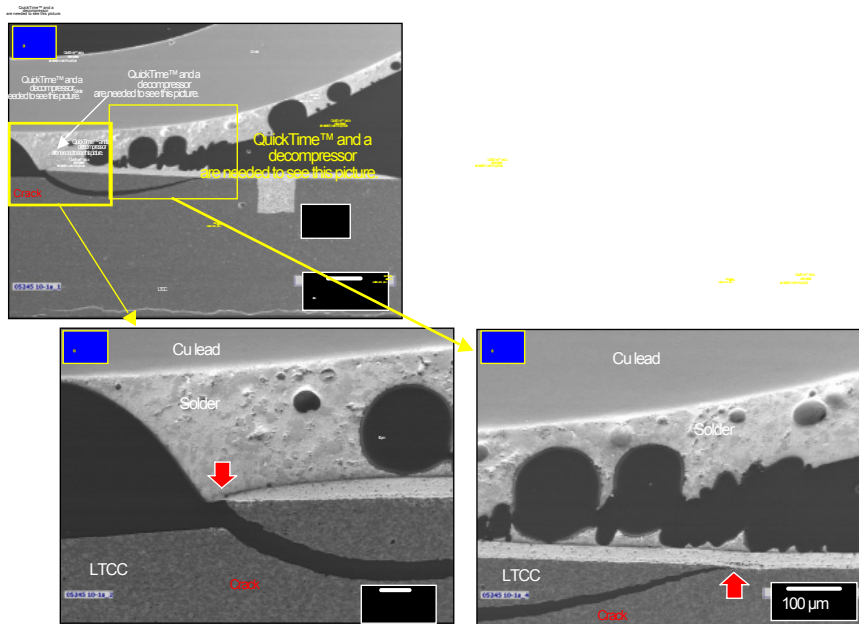
The companion pull tested solder joint to that in Fig. 32 exhibited a 75% solder/thick film failure mode. The remaining 25% of the fracture surface was culmination of fracture in the LTCC; ductile separation between the 5742 and 4596 layers where the LTCC crack terminated as was observed in Fig. 32a (c); and solder/thick film failure. That fracture morphology is shown in Fig. 33. The pull test crack progressed from left to right.

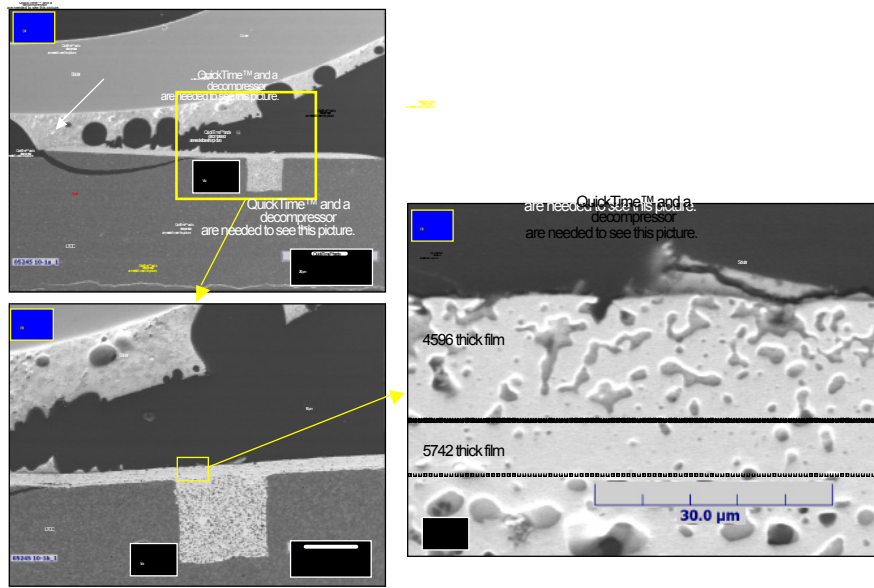
**Fig. 32** (a) (a) Low magnification SEM/SE photographs of the pull tested solder joint on a sample having a single layer of 5742 and three layers of 4596 thick film over the via. The footprint ratio of 4596:5742 was equal to 1.0:1.0. (b) and (c) High magnification photographs showing the initiation and termination points, respectively, of the LTCC crack as indicated by the red arrows. (con't)
