# **SANDIA REPORT**

SAND2006-2451

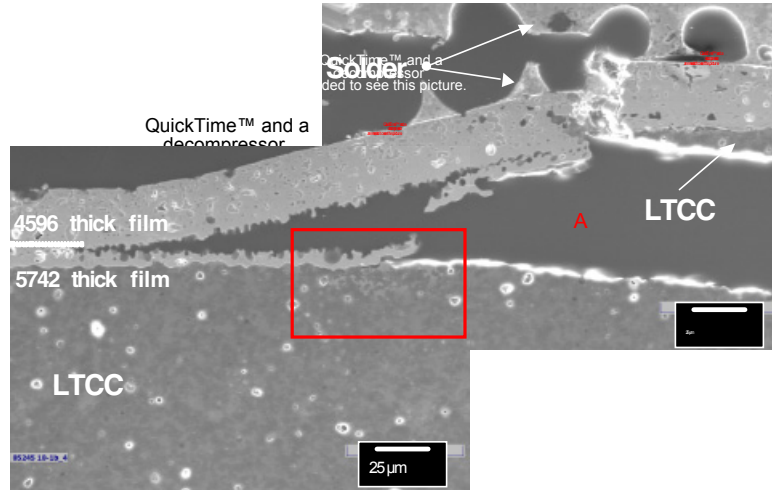
**Fig. 33** SEM/SE photograph of the second pull tested solder joint on a sample having a single layer of 5742 and three layers of 4596 thick film over the via. The fracture path of the *overall* interconnection progressed from left-to-right. The area showed the combination of the following failure modes: solder/thick film interface separation; fracture between the 5742 and 4596 thick film layers; and a divot crack in the LTCC base material. The red box labeled “A” indicated a region of 4596 glassy phase diffusion into the LTCC, which coincided with the initiation of the LTCC divot crack.

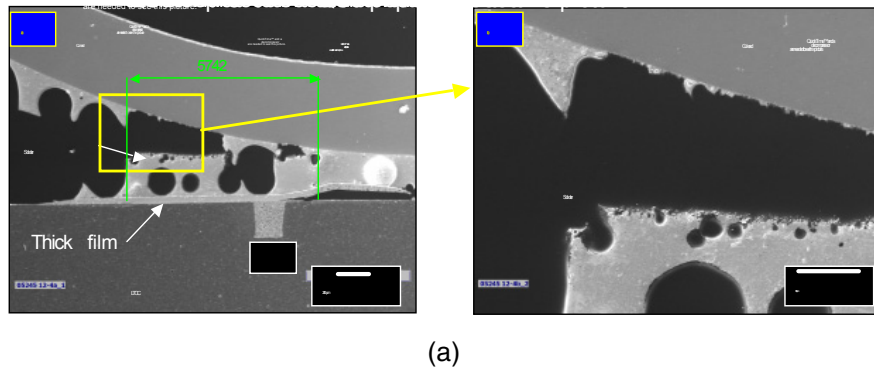
**Fig. 35** (a) (a) Low magnification SEM/SE photograph of the pull tested solder joint on a sample having a single layer of 5742 and three layers of 4596 thick film over the via. The footprint ratio of 4596:5742 was equal to 1.0:0.2. The green lines indicate the location of the 5742 thick film footprint. (b) High magnification image of the solder/Cu lead failure mode. (con't)

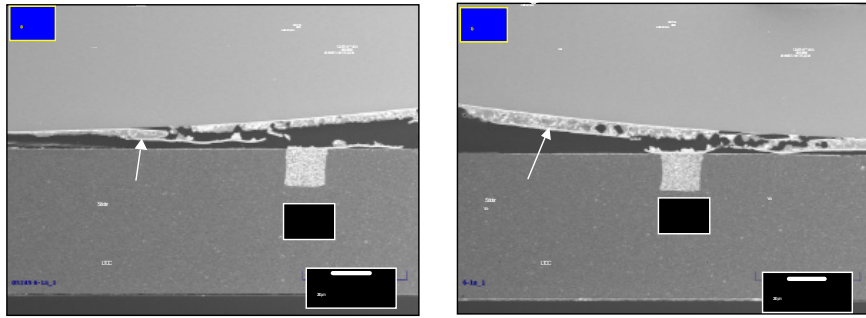
**Fig. 36 (a) and (b)** Low magnification SEM/SE photographs showing the pull tested solder joints on samples having a single 5742 thick film layer over a via. The solder was the 50In-50Pb (wt.%) composition.

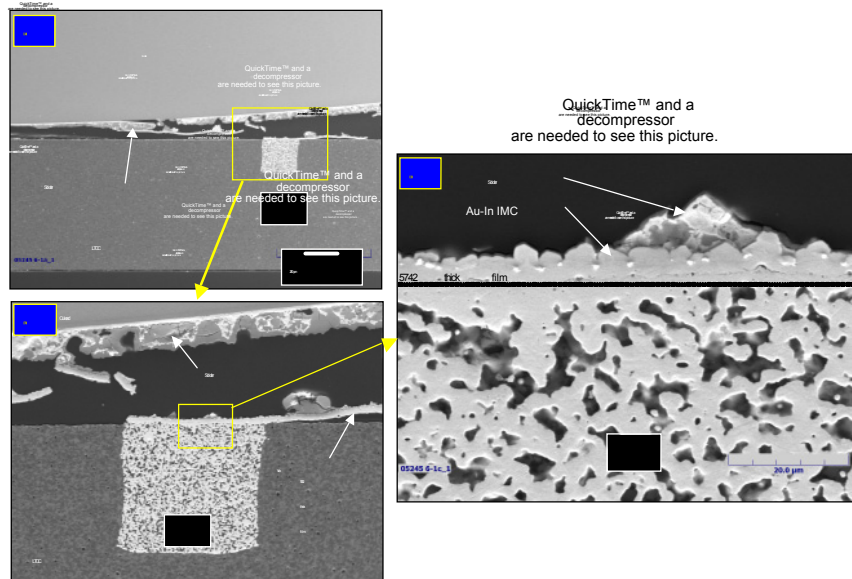
The micrograph (b) in Fig. 38b showed a crack next to the via, which had the same morphology of the side wall cracks typically associated with the 4596 thick film. A similar crack was not observed on the diametrically opposing position as shown in Fig. 38b (b). Therefore, if that crack was, in fact, a manifestation of the traditional side wall crack, then it was of a lesser magnitude since it did not propagate around the entire circumference of the via. Otherwise, no other degradation was recorded in the interconnections shown in Figs. 37 and 38.

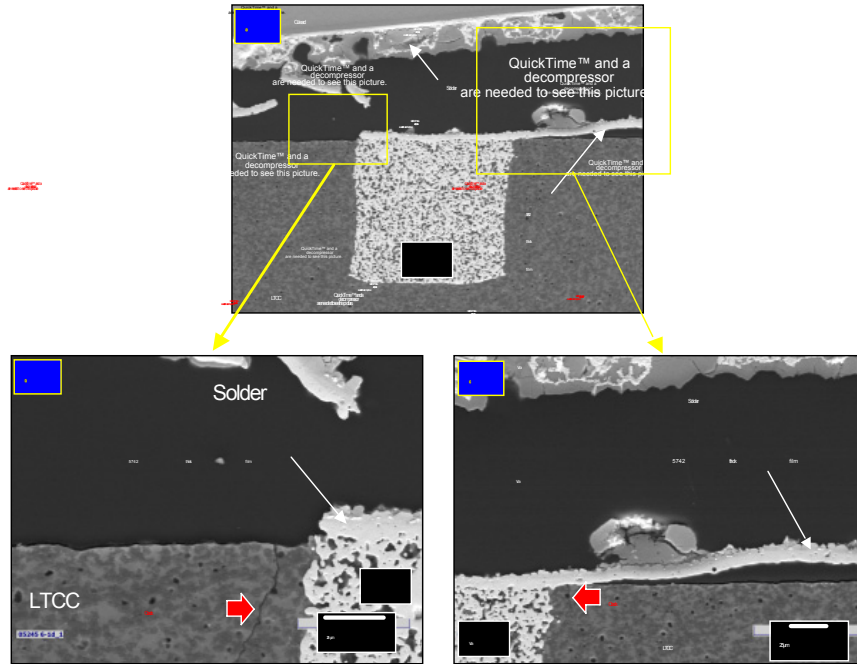
**Fig. 37** (a) (a) Low magnification SEM/SE photograph of the pull tested solder joint on a sample having a single layer of 5742 and made with the 50In-50Pb solder (over a via). (b) and (c) High magnification images showing the fracture path above the via. (con't)

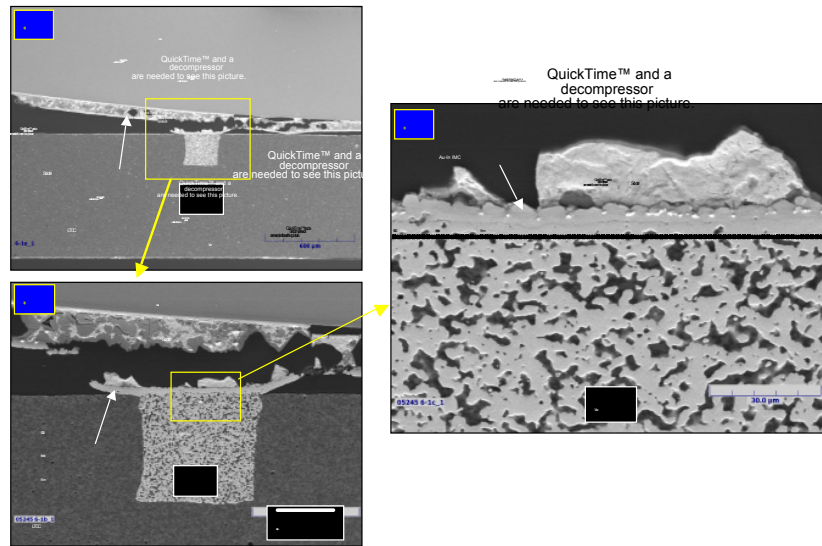
**Fig. 37** (b) **(a)** Low magnification photograph identifying the fracture path to either side of the via. **(b)** and **(c)**, High magnification SEM/SE images showing the top side regions of the via side wall. Cracks were identified by red arrows. (The sample had a single layer of 5742 and made with the 50In-50Pb solder (over a via).

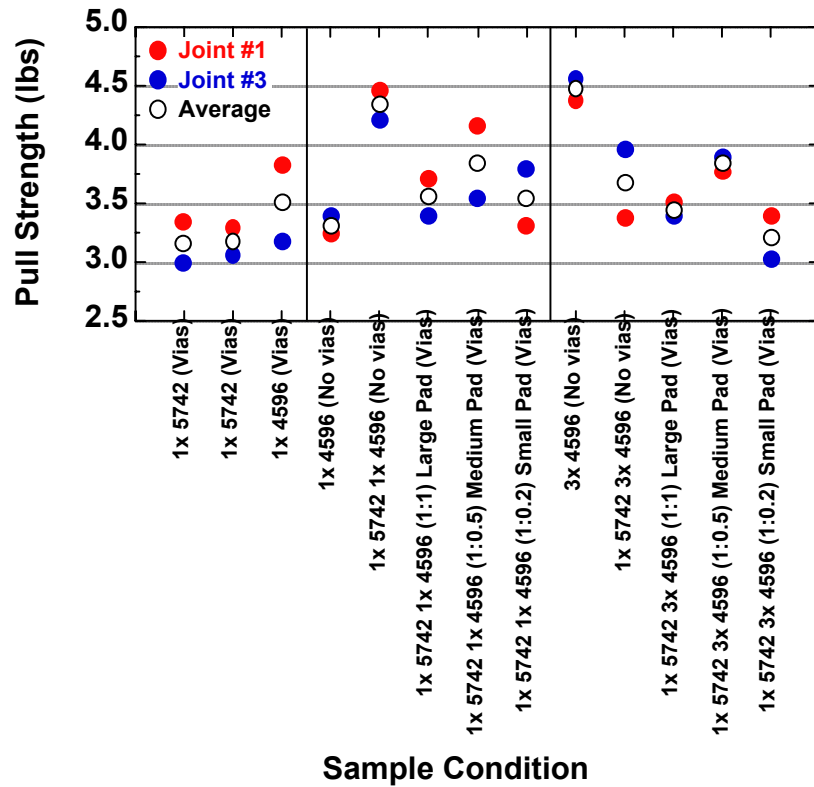
**Fig. 39** Plot of the individual and average pull strengths of the cross-sectioned test sites as a function of the solder joint structure. The two pull tested joints in the two cross sections were designated Joint #1 and Joint #3.

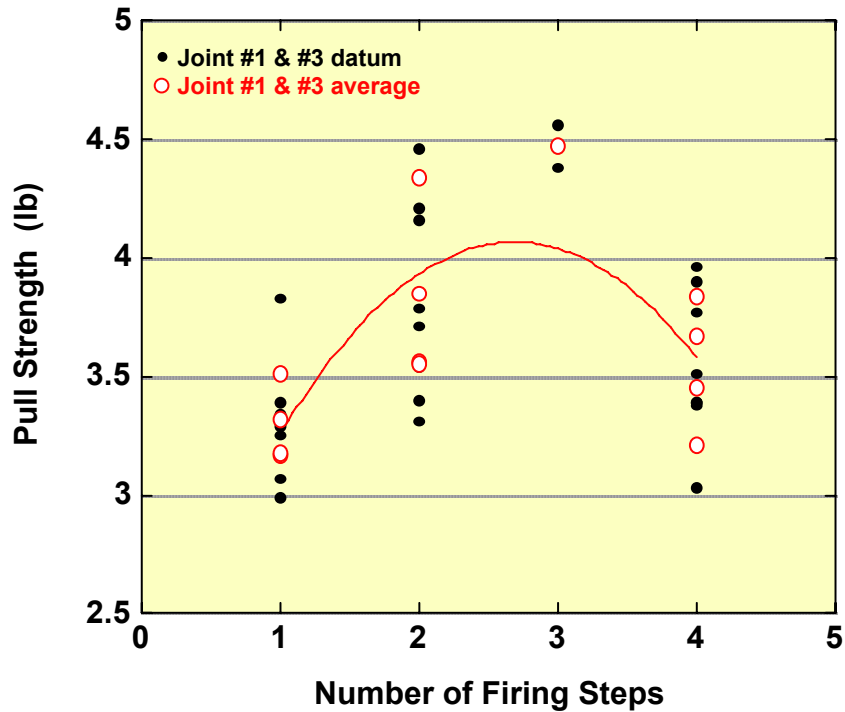
**Fig. 40** Plot of the individual and average pull strengths of the pull tested joints designated Joint #1 and Joint #3 as a function of the total number of firings used to create the 5742 and 4596 thick film layers.

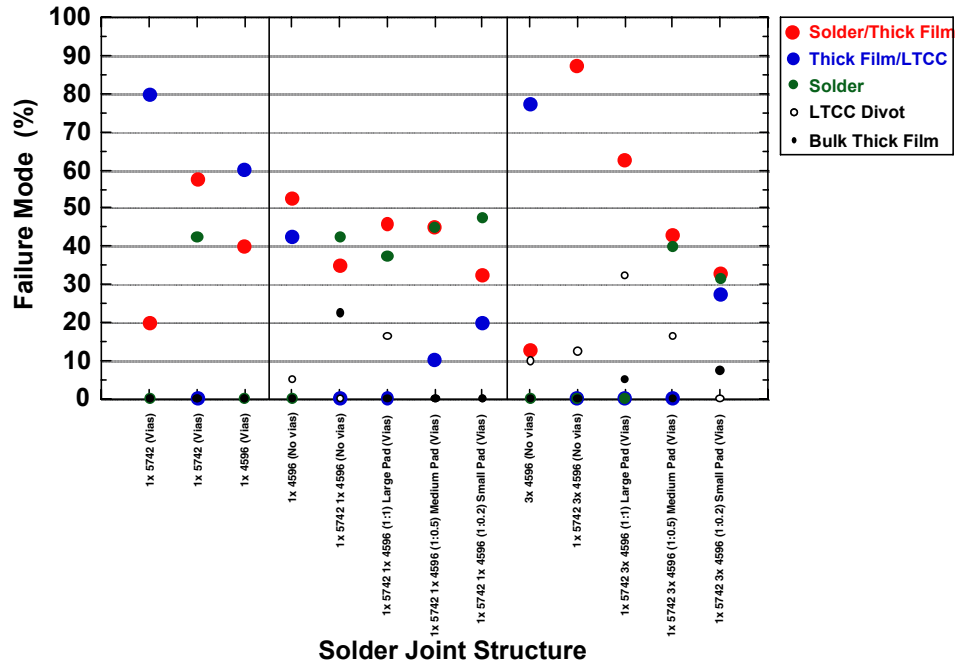
**Fig. 41** Plot of the percentages of the failure modes as a function of solder joint structure as determined from the metallographic cross sections. The failure mode percentages were averaged together, which came from cross section Joints #1 and #3.

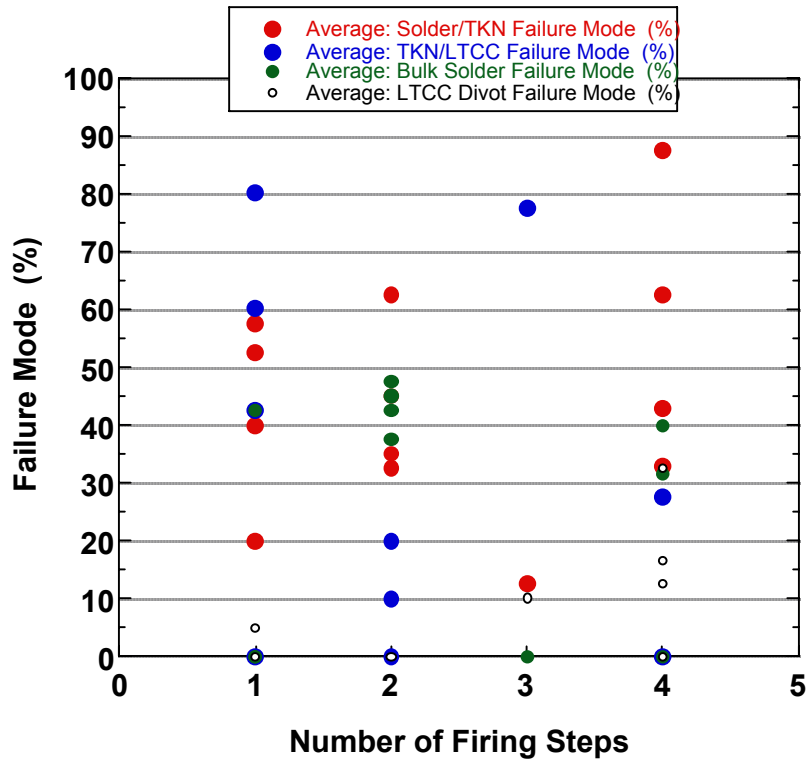
**Fig. 42** Plot of the percentages of the five failure modes, as determined from the metallographic cross sections and averaged for both joints #1 and #3 versus the number of firing steps

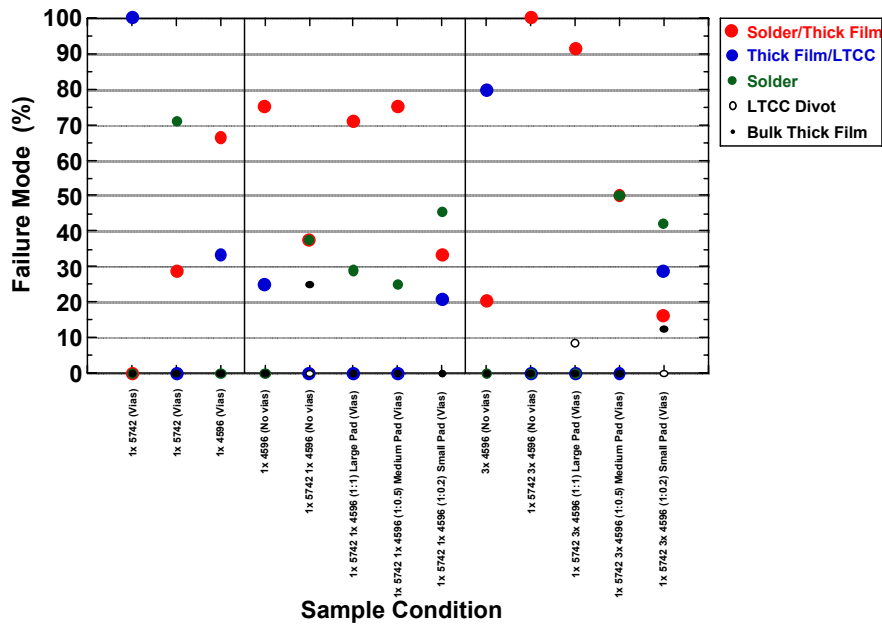
**Fig. 43** Plot of the percentages of the five failure modes, as determined from the metallographic cross sections representing the *front portion* of the joint, versus solder joint structure. The failure mode percentages, came from cross section of the individual Joints #1 and #3 and were averaged together.

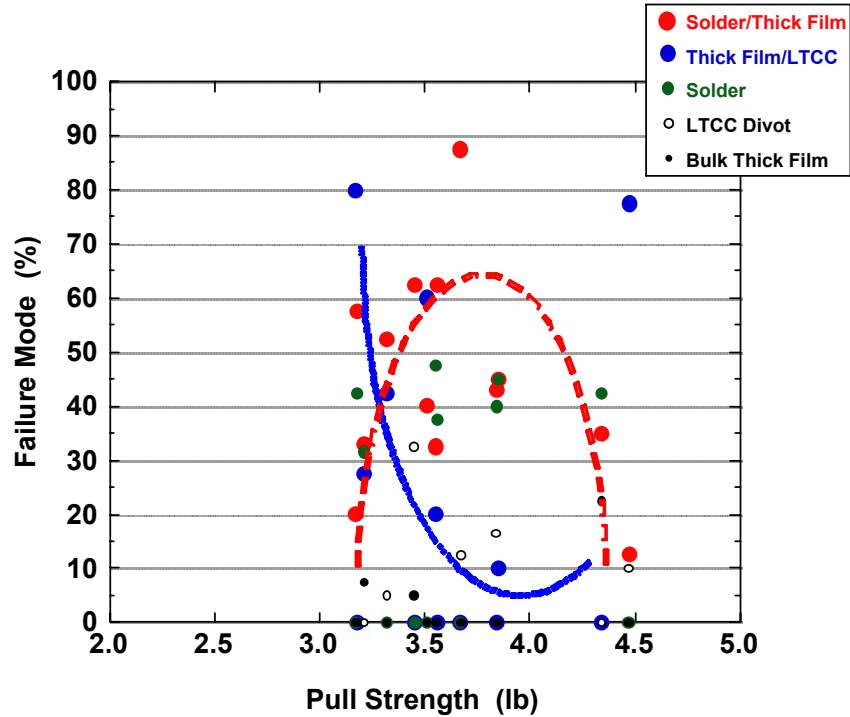
**Fig. 44** Plot of the failure mode percentages (entire joint), as determined from the metallographic cross sections. The failure mode percentages and pull strengths, which came from cross section Joints #1 and #3, were averaged together. The red and blue dotted lines represented the trends in the solder/thick film and thick film/LTCC failure modes, respectively, as qualitatively estimated by the author.

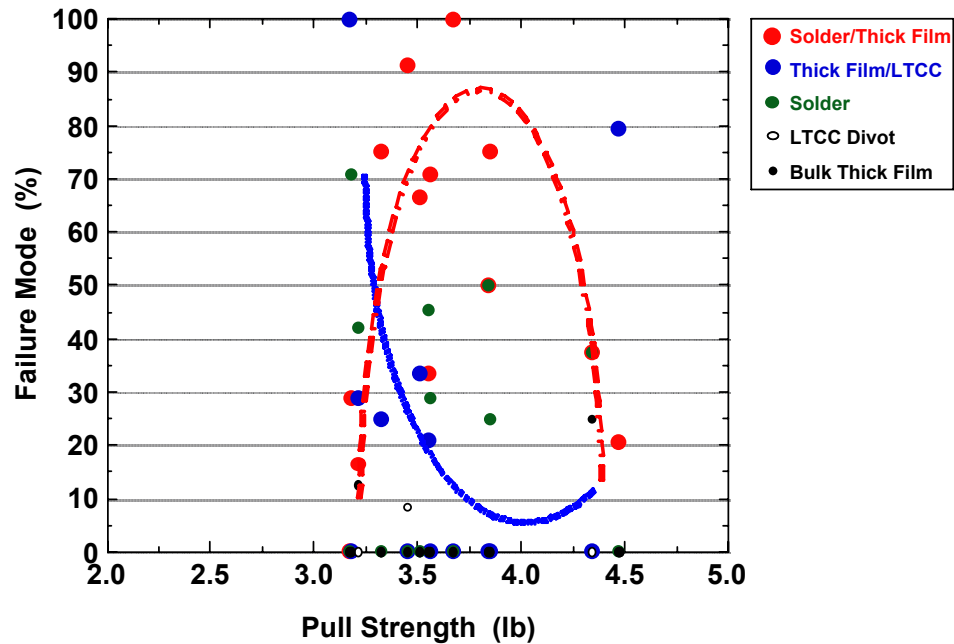
**Fig. 45** Plot of the failure mode percentages for the *front portion (60%)* of the solder joint (metallographic cross sections) versus pull strength. The pull strengths were the average values between Joints #1 and #3. The red and blue dotted lines represented approximate trends in the solder/thick film and thick film/LTCC failure modes, respectively, as determined by the author.
