**METALLURGICAL
EVALUATION OF
DOT-E7042-3000
CYLINDER D-99604**

U.S. Department of Transportation
400 Seventh Street S.W.
Washington D.C. 20590

Timothy R. Smith, Ph.D., P.E.
310 Montgomery Street
Alexandria, VA 22314

08/27/98

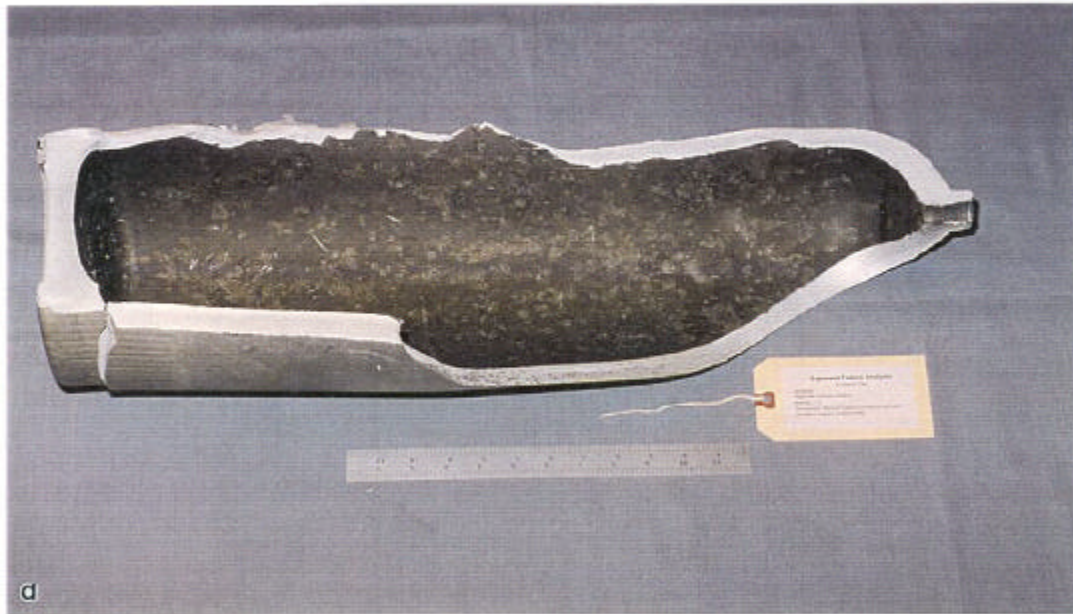
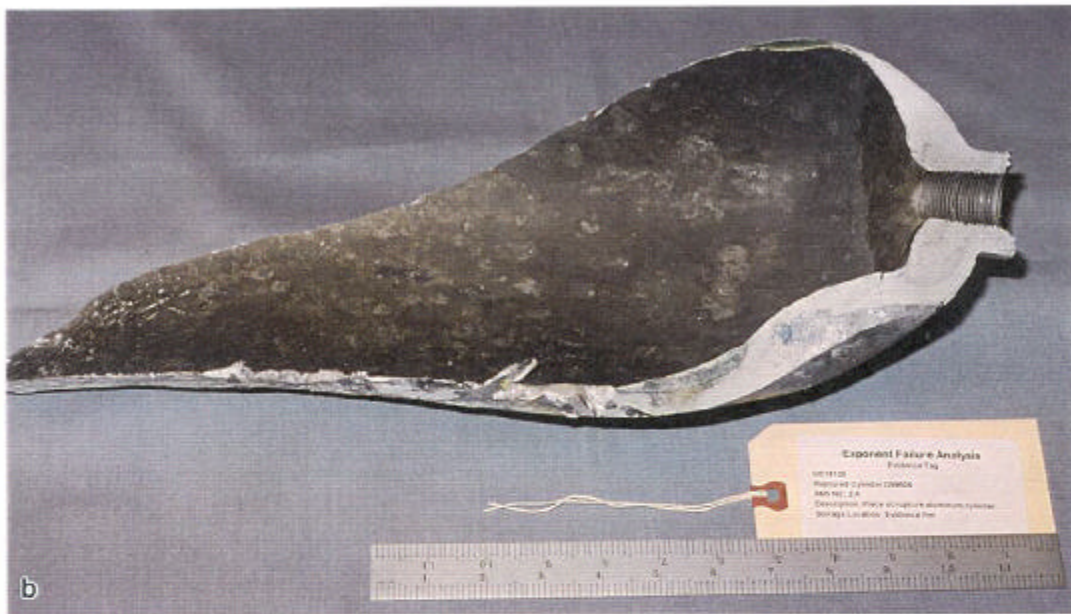
A visual examination of the cylinder remains was performed. The remains are shown in Figures 1 and 2, in the as-received condition. The cylinder broke apart into four pieces, designated 1A, 2A, 3A and 4A by FaAA.

Figure 1: Cylinder remains, as received
(a) Fragment 1A. Photo ID: DC18129-R1E2.
(b) Fragment 2A. Photo ID: DC18129-R1E21.

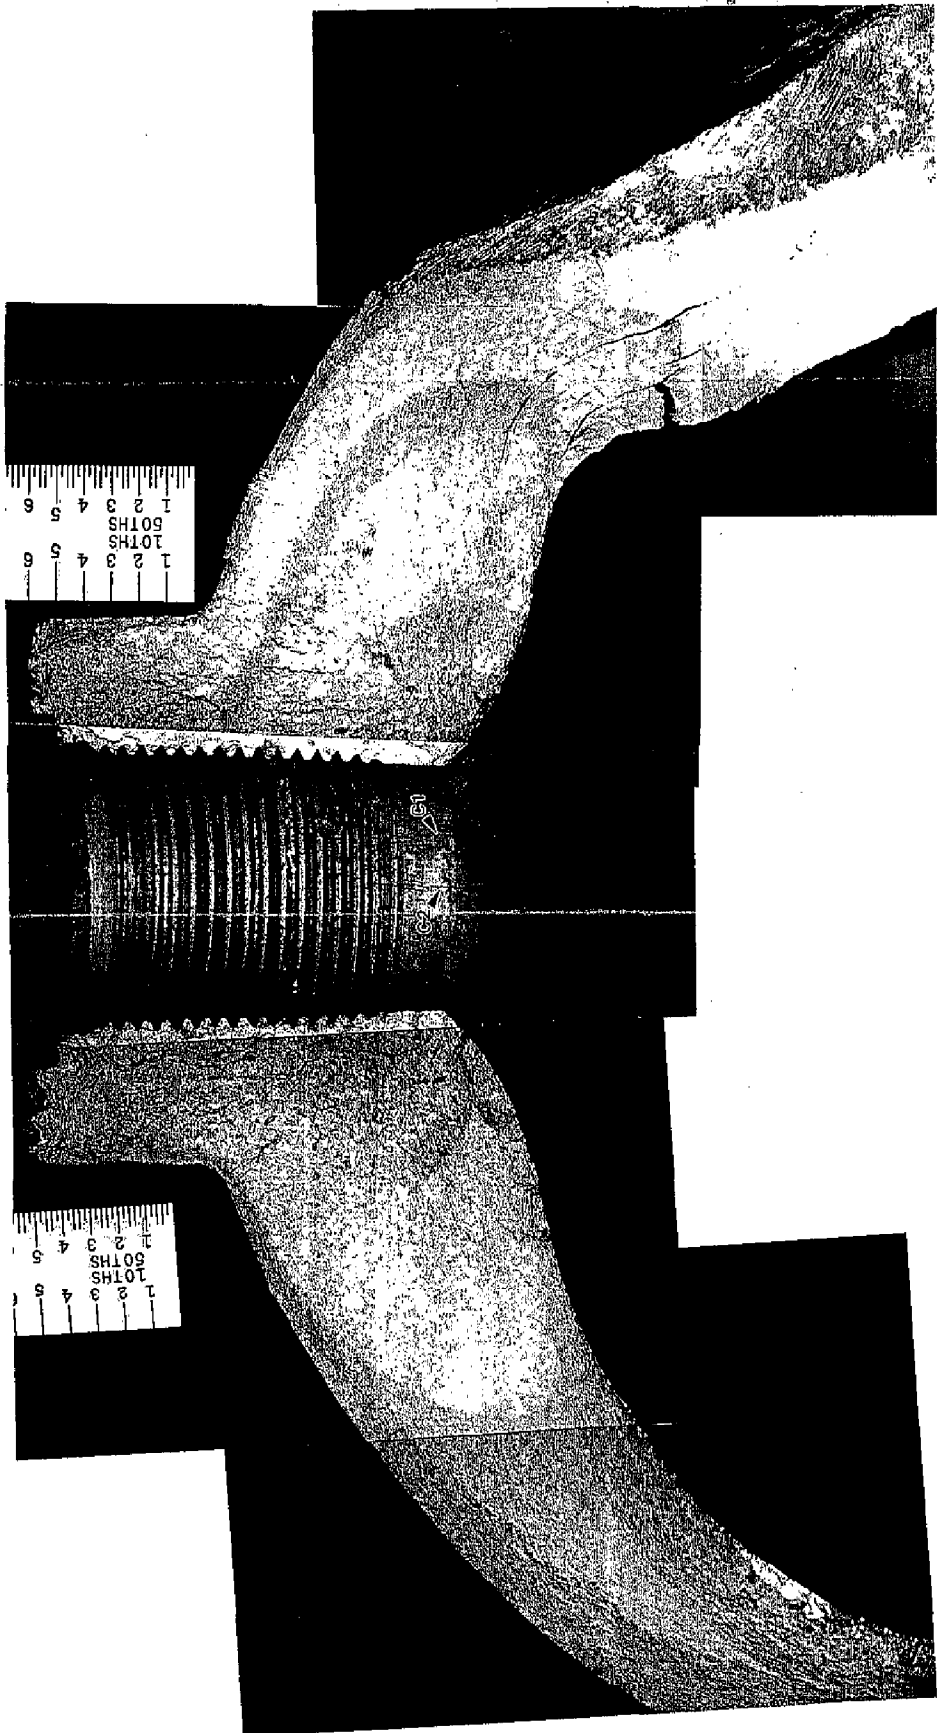
The fracture surfaces of the cylinder present on each of the four fragments were inclined (i.e., non-radial with respect to the cylinder axis) shear-type, except in the neck region where the fracture surfaces were flat and radial with respect to the axis of the cylinder. The main fracture surface ran through essentially a full diameter of the inlet hole in the neck region. Figure 3 shows a photomontage of the fracture surface in the neck region. Note the beach marks emanating from the inlet hole.

In the neck region, the inside wall of the cylinder in this region shows multiple folds (or cusps) from the original manufacturing process (see Figure 3). The fracture surface on both sides of the inlet hole appears to pass through folds of this type. On fragment 2A, there were at least two cracks, labeled C1 and C2 on Figure 3, originating from these folds.

The wafer containing the flat-faced fracture surface shown on the right in Figure 3 (section 2A-1A) was examined optically and in the scanning electron microscope (SEM). The optical examination revealed that the flat-faced region of the fracture surface shows little macroscopic ductility. Just outside of this region, the fracture surface transitioned to an inclined shear-type of fracture. The region just below the inlet hole threads and close to the inside of the cylinder contained some of the coating used to line the cylinder, suggesting that a deep fold was present at this location at the time of manufacture.

Fractography of the wafer also shows several beach marks (see Figure 3) in the flat-faced region, indicating progressive crack growth. Figure 12 shows a series of SEM fractographs taken from this fracture surface. Regions A-F are all flat-faced.

Figure 3. Photo montage of the fracture surface at the neck from fragment 2A. Photo ID: DCI8129-R4B11,12,13,15,16. Note the beach markings emanating from the inside diameter at the bottom of the inlet hole on one side and emanating from the threaded area of the inlet hole on the other. The pattern of these marks is asymmetric about the cylinder axis. Note also the cracks in the neck marked C1 and C2.

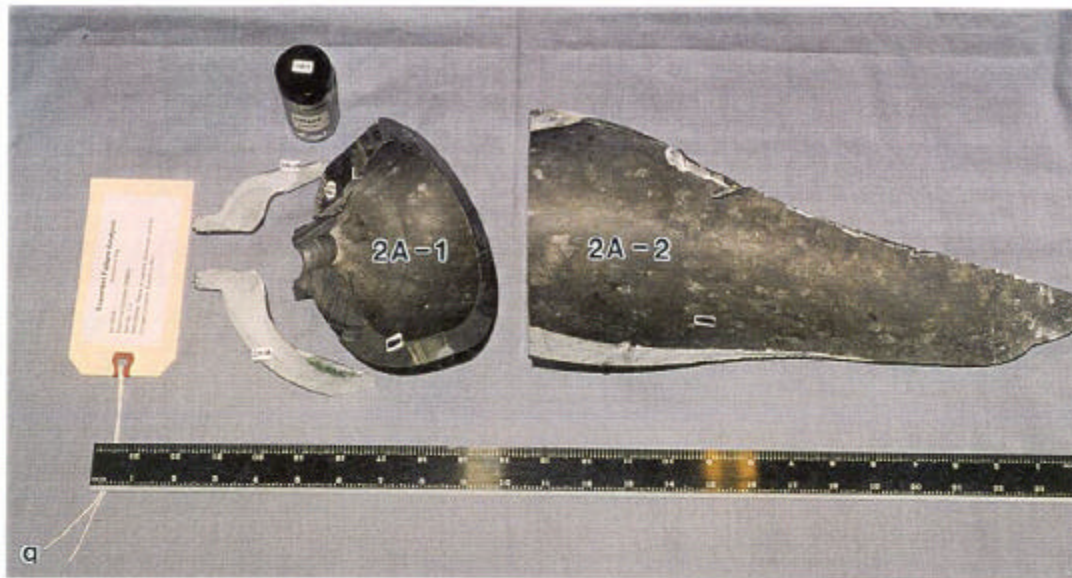
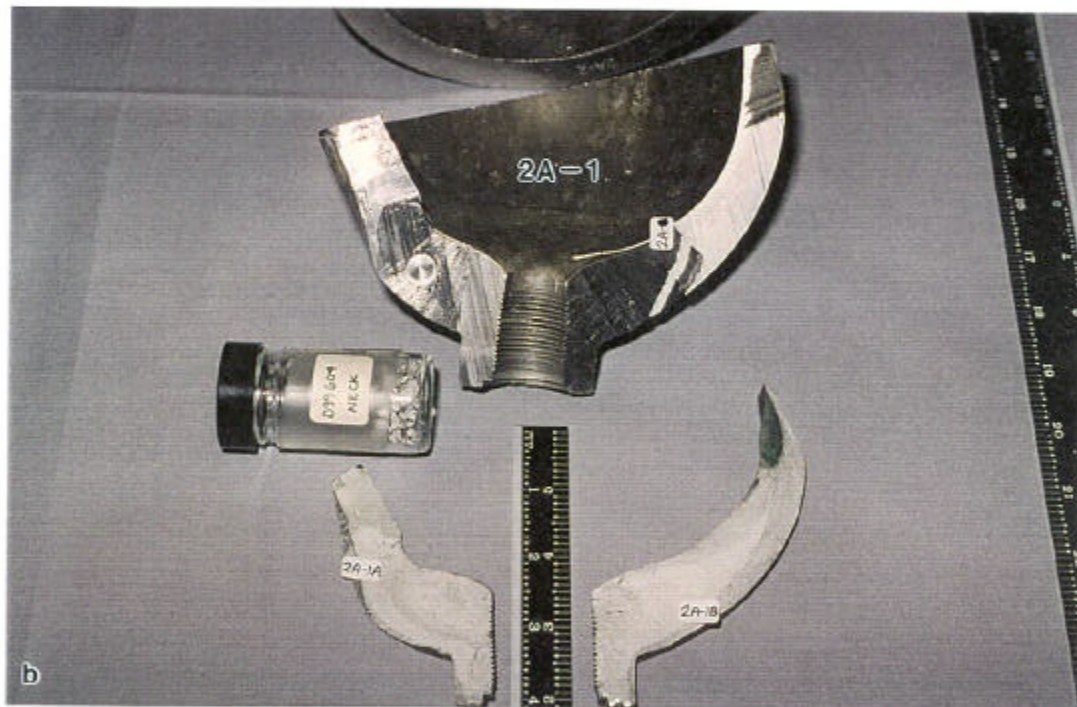
Figure 4 shows the sections cut from cylinder fragment 2A. Sections of the fracture surface on both sides of the inlet hole were cut such that the flat-faced portion of the fracture surface was separated from the fragment. Two wafers were generated in this process.

Figure 4. Sectioning of fragment 2A
(a) Overall view. Photo ID: DC18129-R3E4.
(b) Close up of neck region. Photo ID: DC18129-R3E8.
Note: the fracture surface portions that were removed and the drilling taken to determine chemical composition.

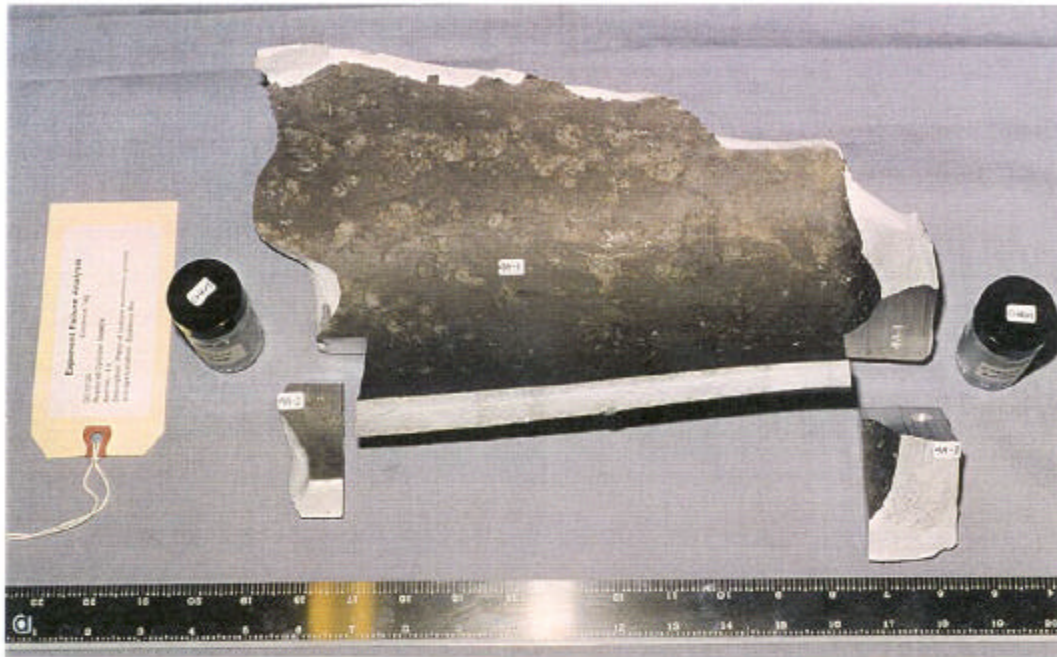
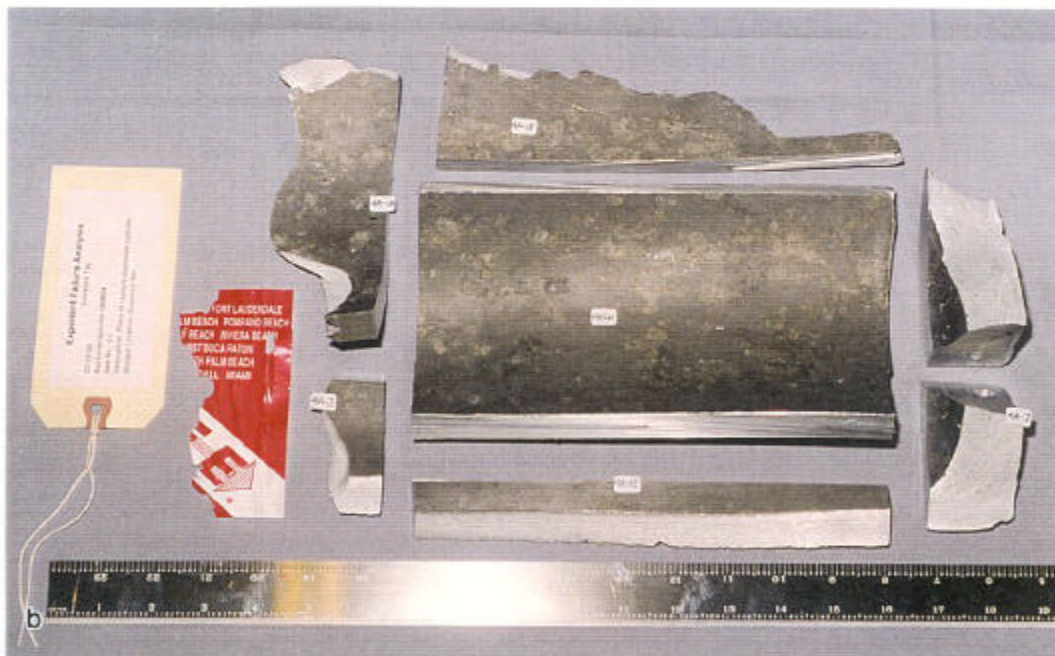
Figure 5. Sectioning of fragment 4A.
 (a) Initial cuts showing the locations of drilling for chemical composition determination. Photo ID: DC18129-R3E16.
 (b) Sectioning showing separated fracture surfaces and the portion used for tensile testing. Photo ID: DC18129-R5E3.

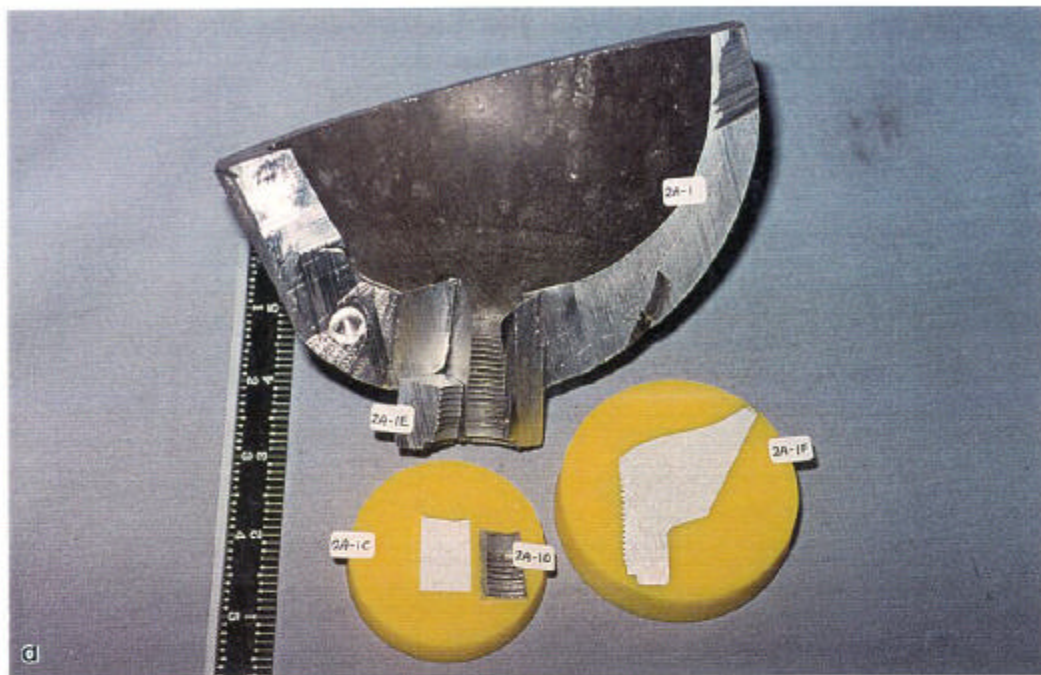
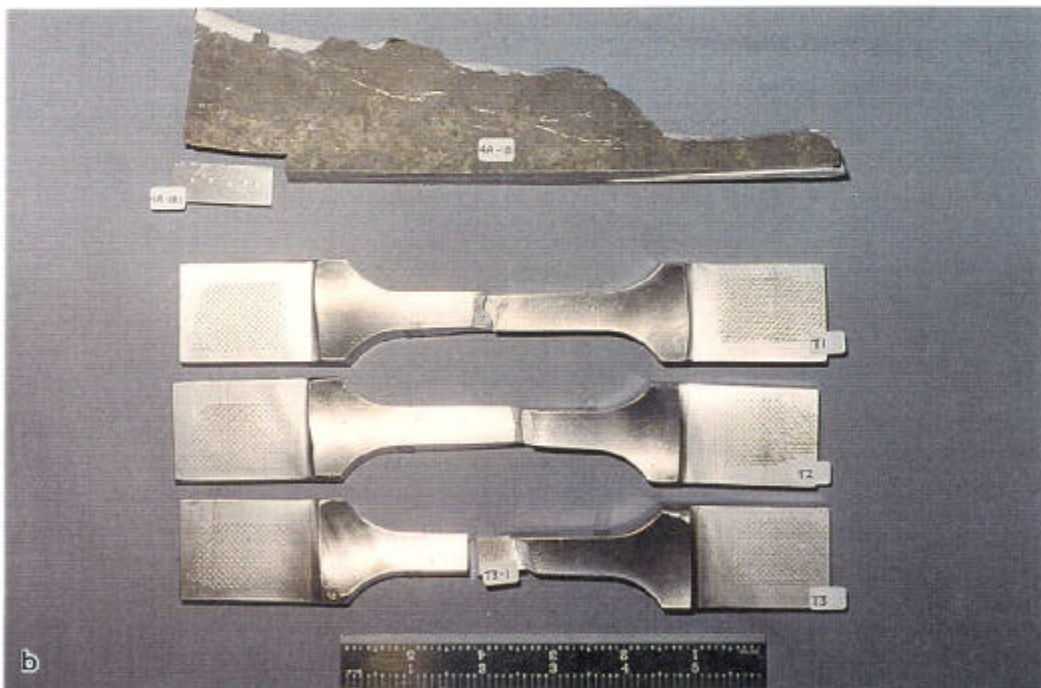
Figure 6. Additional sectioning of fragments 2A and 4A.
(a) Fragment 2A, neck region. Photo ID#: DC18129-R6E7.
(b) Fragment 4A, mechanical property samples.
Photo ID#: DC18129-R6E5.

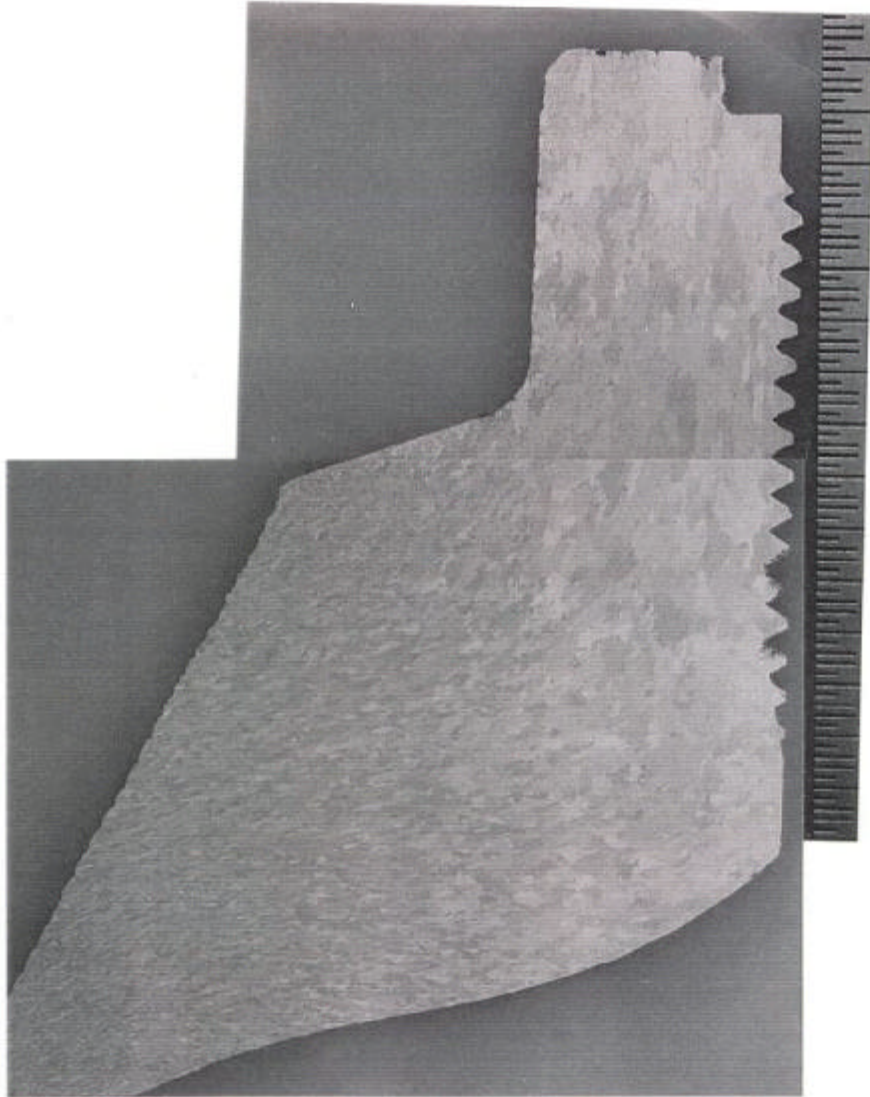
Figure 6 shows the further sectioning performed on fragment 2A-1 from the neck region. A section (2A-1F) was sliced in the neck region and then polished and etched to reveal its microstructure, Figure 7. Note that the grain size is relatively small, compared to the thickness at the neck. Figure 8 shows a higher magnification view of the thread area from Figure 7, about 2/3 of the way down the inlet hole. Note that there is corrosion pitting damage to the threads in this region.

Figure 7. Section 2A-1F showing the microstructure in the neck region. Note the scale is in 0.05 inch increments. HF-H₂SO₄-H₂O etch. Photo ID: DC18129-PAL-1,2-7/28/98.

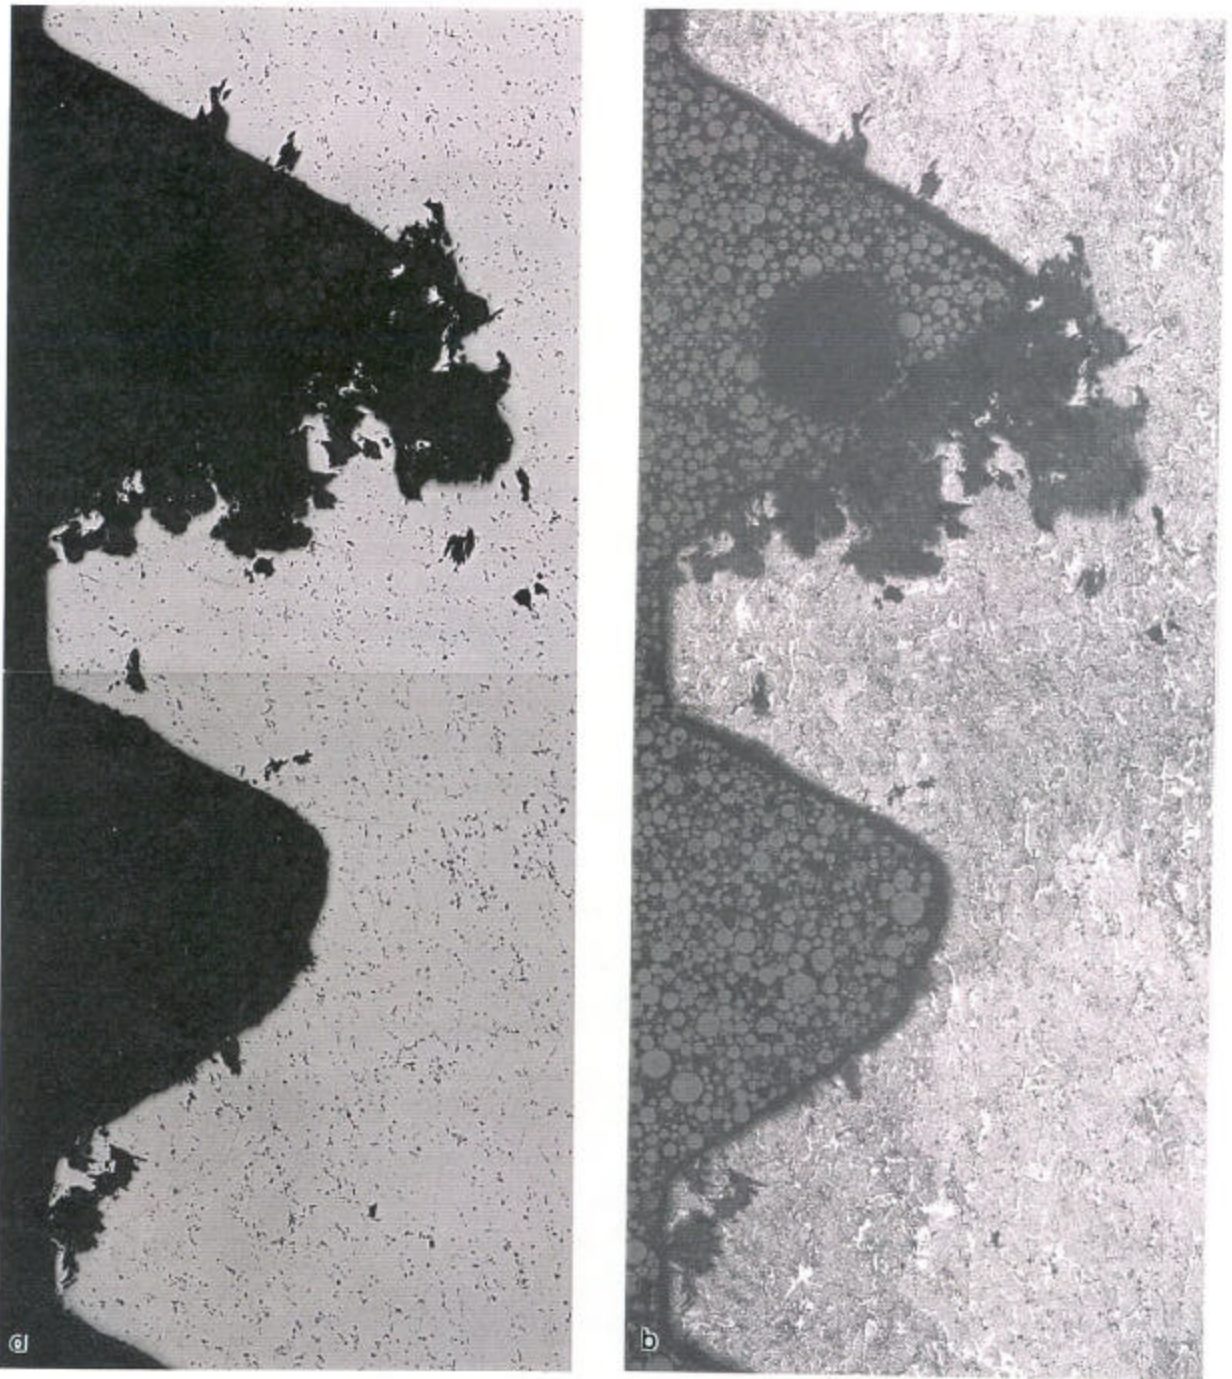
Figure 8. Close-up of thread area shown in Figure 7.
(a) 50X. Photo ID: DC18129-PAL-5,6-7/28/98.
(b) 50X. HF-H₂SO₄-H₂O etch. Photo ID: DC18129-PAL-9,10-7/28/98.
Note the corrosion pitting damage to the thread area.

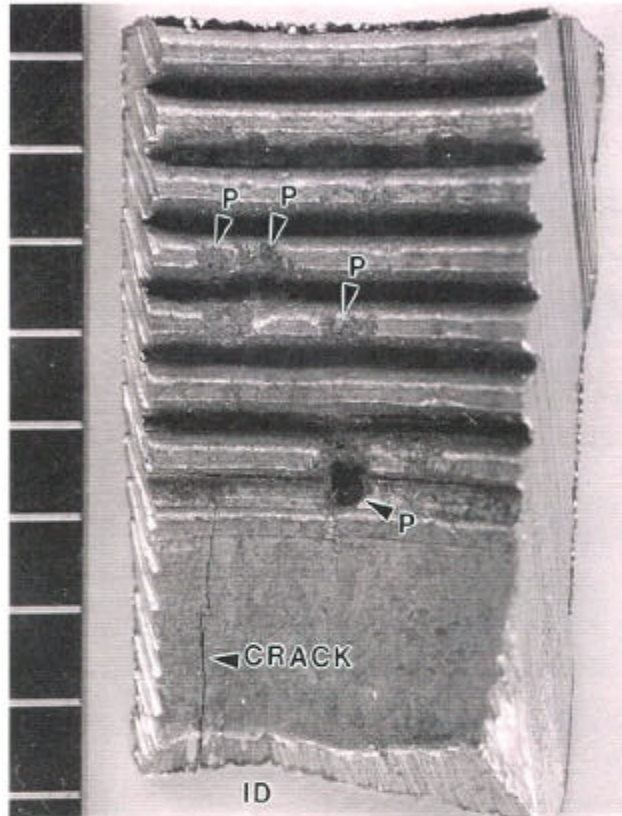
The crack C1 at the inlet hole from Figure 3 was selected for further study. The crack was sectioned just below the inlet hole threads (Section 2A-1C) and then polished to reveal its morphology. Figure 9 shows the portion of the inlet hole threads that was separated in the sectioning process. Note that the crack C1 (marked "crack") and also several corrosion pits are shown. Figure 10 shows energy dispersive spectra (EDS) taken from at or near the corrosion pits shown in Figure 9. Note the O, Ca, Cl, Fe, and Cu peaks, all of which are corrosion product or contaminants. The Cu and Fe are most probably from the threaded end of the regulator assembly that was screwed into the inlet hole during service.

Figure 9. Close-up of portion of the inlet hole threads showing cracking and corrosion pits. Example pits are labeled "P". Scale is in 0.05 inch increments. Section 2A-1C was taken just behind this slice. Note that one pit forms a well-developed hole through this slice. Photo ID#: DC18129-TRS-1-8/5/98.

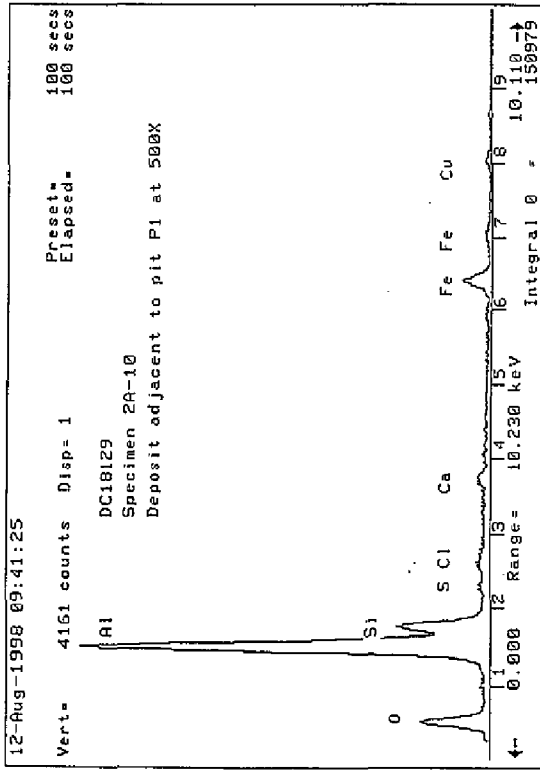
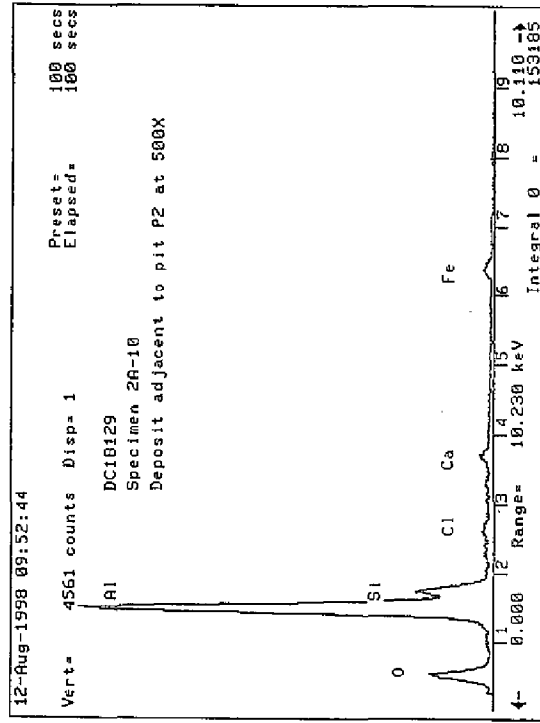
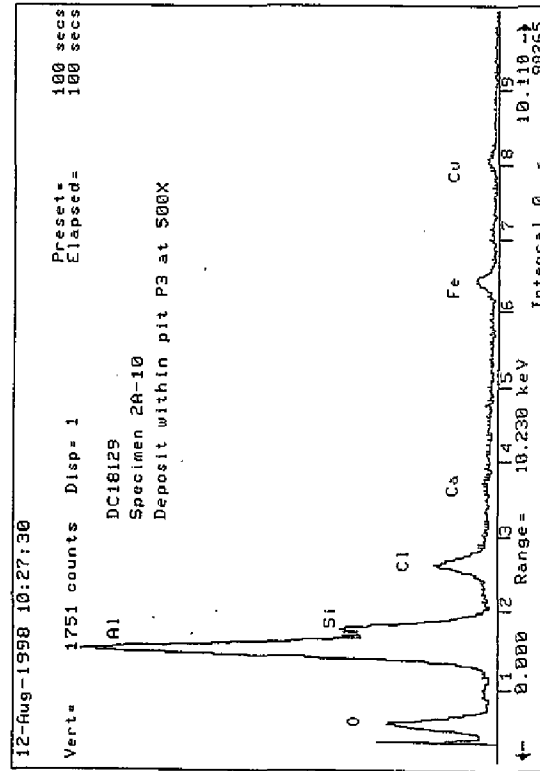
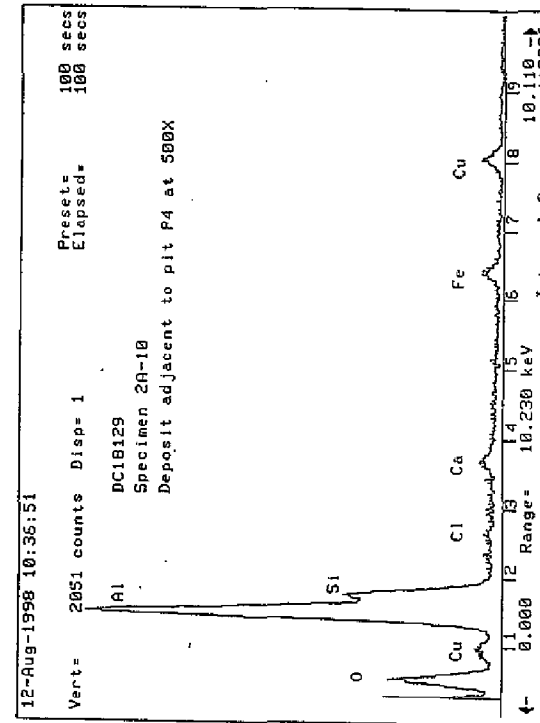
Figure 10. Energy dispersive spectra taken from at or near the pits shown in Figure 9.

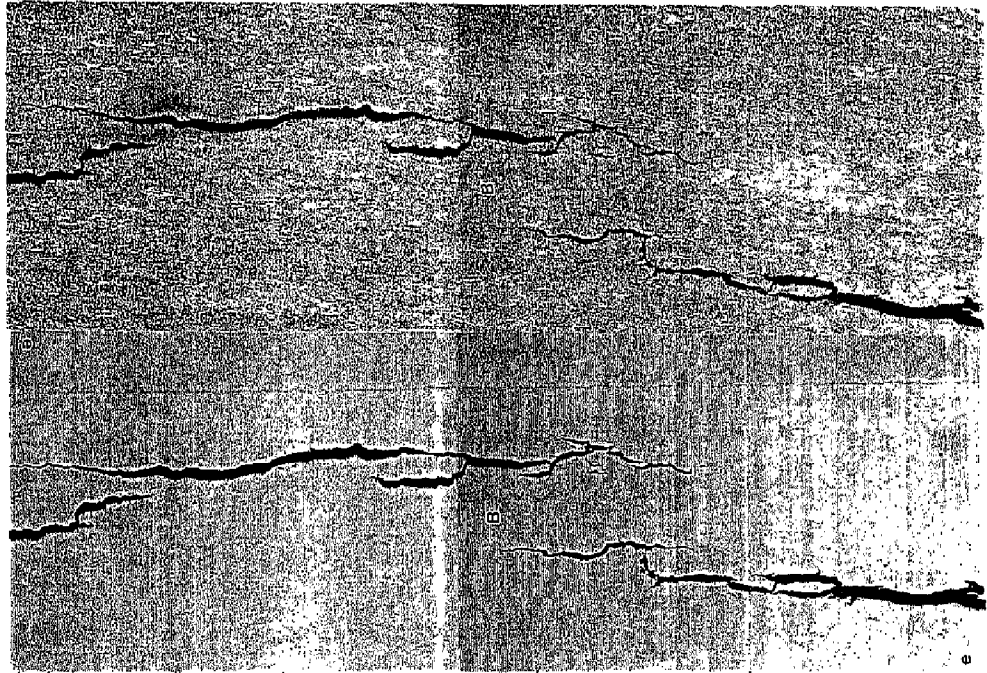
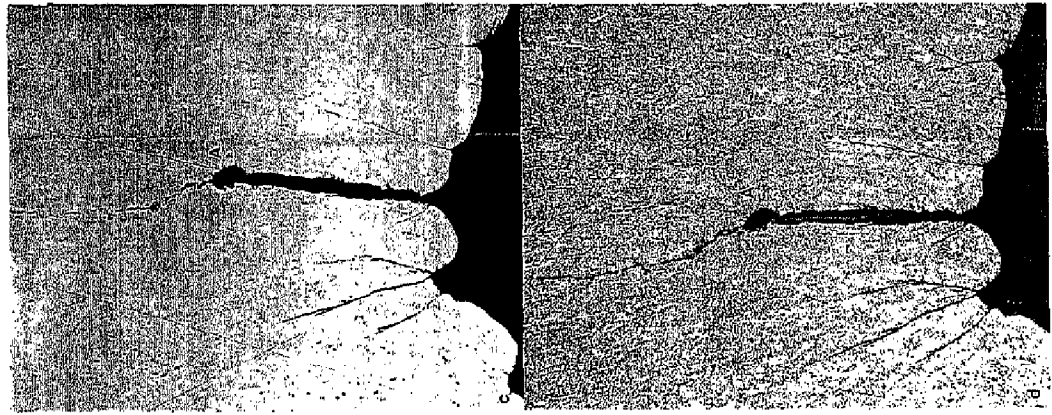
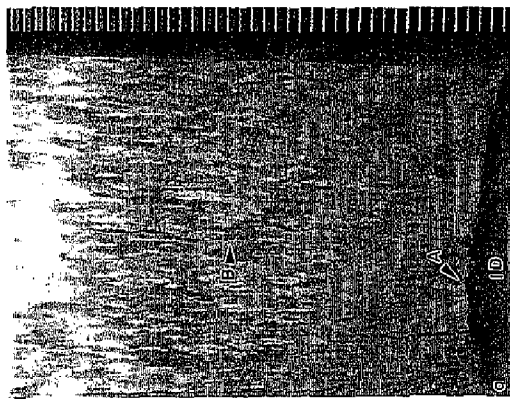
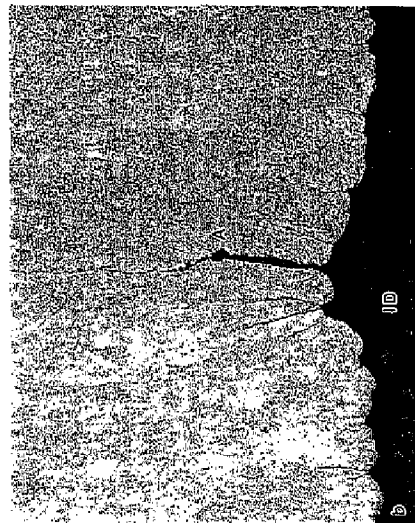
Figure 11 shows section 2A-1C containing crack C1 taken parallel to the inlet hole, just below the wafer shown in Figure 9. Note the multiple folds at the inside surface and multiple branched cracks emanating from these folds. Figure 11(a) shows the section after preparation with a HF+H₂SO₄+H₂O etch. The microstructure is typical for AA6351 in the T6 temper condition [2]. Figure 11b-d show higher magnification view of the crack in Region A in Figure 11a. Note that the cracks show fine-scale branches. Figure 11e-f shows the cracks from Region B on Figure 11a. This region corresponds to the corrosion pitting noted in Figure 9 and is at a similar depth down the inlet hole to those shown in Figure 8. Note also that the crack appears to be discontinuous.

Sectioning of the cylinder wall just below the threads at the inlet hole revealed multiple cracks from multiple origins at folds (or cusps) in the inside wall. These branched cracks are consistent with cracks found in the neck region of other DOT-6498, DOT-3Al, and DOT-7235 aluminum cylinders [4]. Since no fatigue striations or evidence of stress-corrosion cracking (SCC) were found, the observed cracks are more consistent with studies of "sustained-load cracking" reported in the literature for similar Al alloys [3, 6-10] than a fatigue or SCC sub-critical crack growth mechanism.

- Figure 11. Section 2A-1C taken parallel to the inlet hole, just below the threads.
- (a) Overall view of the section. HF-H₂SO₄-H₂O etch. Scale is in 0.05 inch increments. Note cracks in Regions A and B. Photo ID: DC18129-PAL-18-7/28/98.
 - (b) Close up of Region A. 50X. HF-H₂SO₄-H₂O etch. Note the folds on the surface. Photo ID: DC18129-PAL-18-7/28/98.
 - (c) Close up of Region A. 100X. Note the multiple branched cracks emanating from the folds on the surface. Photo ID: DC18129-PAL-21-7/28/98.
 - (d) Same as (c) in the etched condition. 100X. HF-H₂SO₄-H₂O etch. Photo ID: DC18129-PAL-22-7/28/98.
 - (e) Close up of Region B. 50X.. Photo ID: DC18129-PAL-28,29-7/28/98.
 - (f) Close up of Region B. 50X.. HF-H₂SO₄-H₂O etch. Photo ID: DC18129-PAL-30,31-7/28/98.

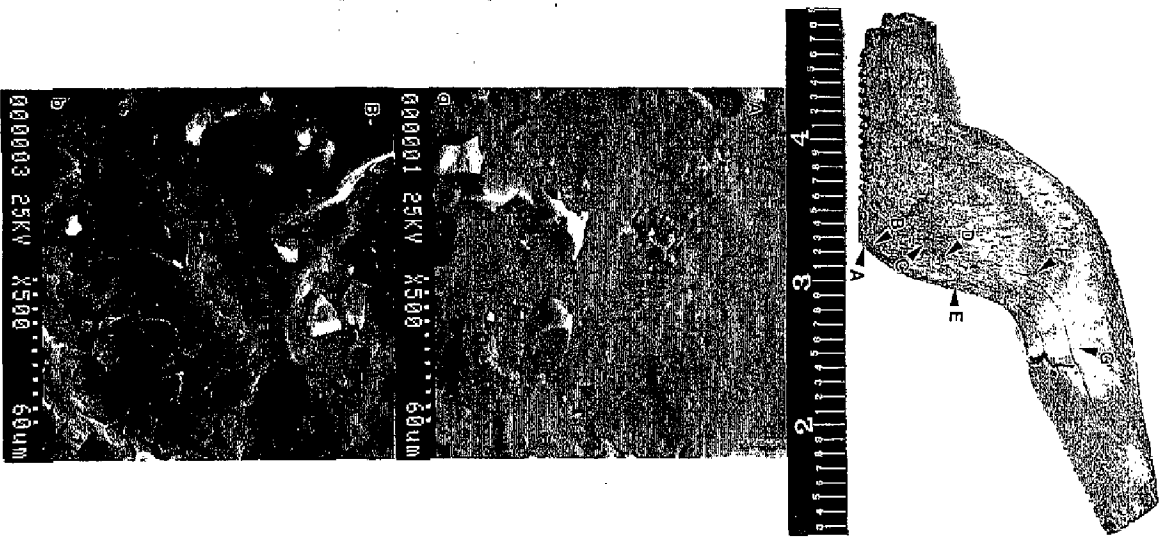
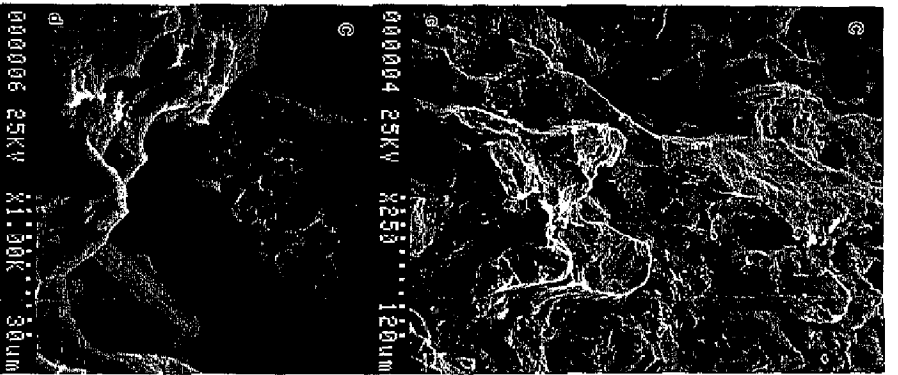
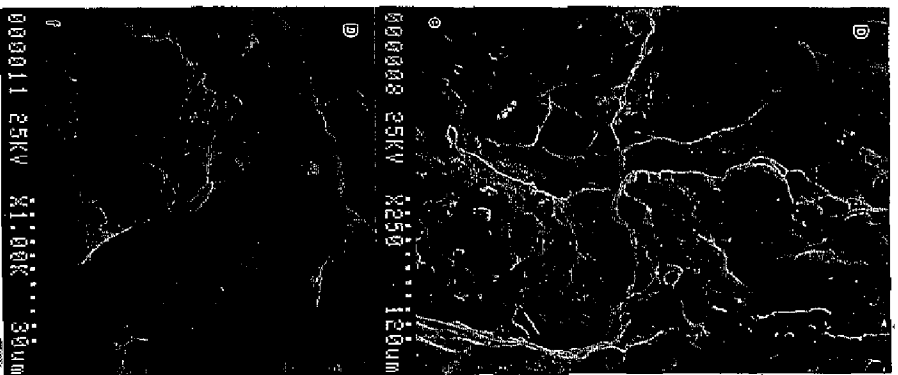
Region A (Figure 12a) was from near the inside of the tank, close to the threads at the inlet hole. Region B was close to Region A and contained a surface scale (Figure 12b) that obscured the fractographic details. Higher magnification views of Region C are shown in Figure 12c-d. This region contains predominantly intergranular fracture, with very fine-scale dimples on the faceted surfaces. In Regions D, E and F (Figures 12e-j), the fracture surface contains intergranular facets with very fine-scale poorly-formed dimples, but also contains progressively larger-scaled dimples at the locations further away from the inlet hole. Region G (Figure 12k-l) is in the shear-lipped region outside of the flat-faced portion of the fracture. This region shows predominantly dimpled rupture.

The shape and location of the beach marks on the fracture surface segments studied in detail (Figures 12 and 14) suggests that the cracks propagated sub-critically (i.e., slowly) for the majority of the flat-faced region. This continued up to the extent defined by the last beach mark on each side of the inlet hole. The morphology of the beach marking is asymmetric suggesting that the crack origins were not the same on each side. The fracture on the right side of Figure 3 (Section 2A-1A) propagated from an origin at the inside surface at the inlet hole and below the threads. The presence of the darkened region, similar in color to the inside of the cylinder, on the fracture surface shows that the origin of the crack was a fold in the inside cylinder wall. The fracture on the left side of Figure 3 (Section 2A-1B) appear to have originated in the lower half of the threads at the inlet hole. This region is the site of localized pitting corrosion damage (such as seen in Figures 7, 8 and 9). Apart from the initial origin, the cracks that developed on both sides of the inlet hole show very similar characteristics and appear to have grown by the same mechanism.

- Figure 12. Fractography of section 2A-1A. Overall optical micrograph view shows the regions examined in the SEM. Photo ID: DC18129-TRS-1-6/25/98.
- (a) Region A showing the coating. 500X. Photo ID: DC18129-PAL-1-6/25/98.
 - (b) Region B showing deposits on the fracture surface. 500X. Photo ID: DC18129-PAL-3-6/25/98.
 - (c) Region C. 250X. Photo ID: DC18129-PAL-4-6/25/98.
 - (d) Region C. 1000X. Photo ID: DC18129-PAL-6-6/25/98.
 - (e) Region D. 250X. Photo ID: DC18129-PAL-8-6/25/98.
 - (f) Region D. 1000X. Photo ID: DC18129-PAL-11-6/25/98.
 - (g) Region E. 250X. Photo ID: DC18129-PAL-15-6/25/98.
 - (h) Region E. 1000X. Photo ID: DC18129-PAL-17-6/25/98.
 - (i) Region F. 250X. Photo ID: DC18129-PAL-19-6/25/98.
 - (j) Region F. 1000X. Photo ID: DC18129-PAL-21-6/25/98.
 - (k) Region G. 250X. Photo ID: DC18129-PAL-23-6/25/98.
 - (l) Region G. 1000X. Photo ID: DC18129-PAL-25-6/25/98.

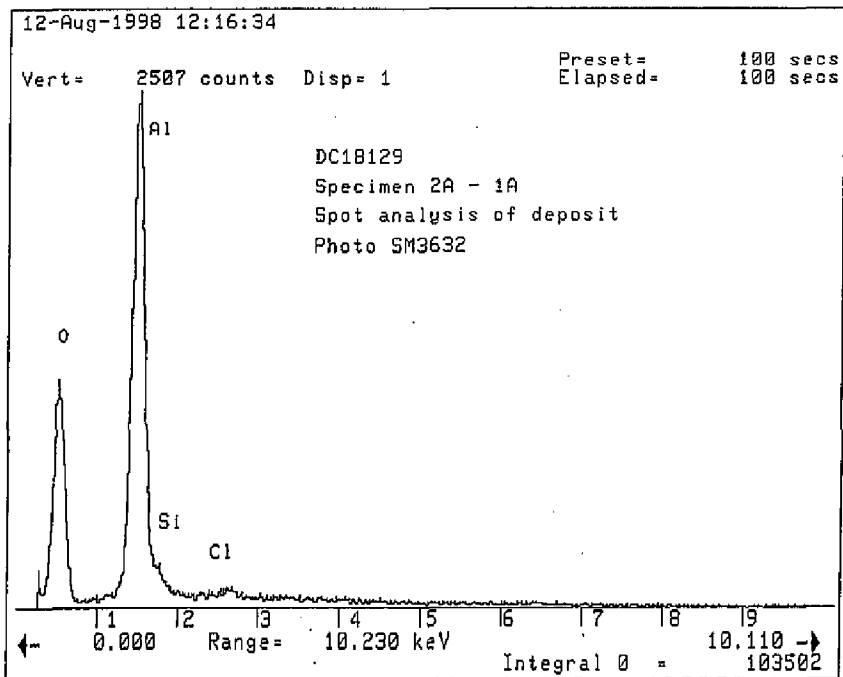
Figure 13 shows energy dispersive spectra (EDS) taken from the fracture surface of Figure 12. Figure 12a shows the spectrum for the region "A" which appears to be a coating of some sort. The spectrum shows Al and a small O peak, indicating that the coating is Al-based, perhaps formed by anodizing of the cylinder interior. Figure 13b shows the spectrum from the deposits found in Region "B", Figure 12b. The Cl, Si and O peaks indicate corrosion product or contaminants.

Figure 13. Energy dispersive spectra captured from the fracture surface of Figure 12.
(a) Spot analysis of coating region "A".
(b) Spot analysis of surface deposits from region "B"

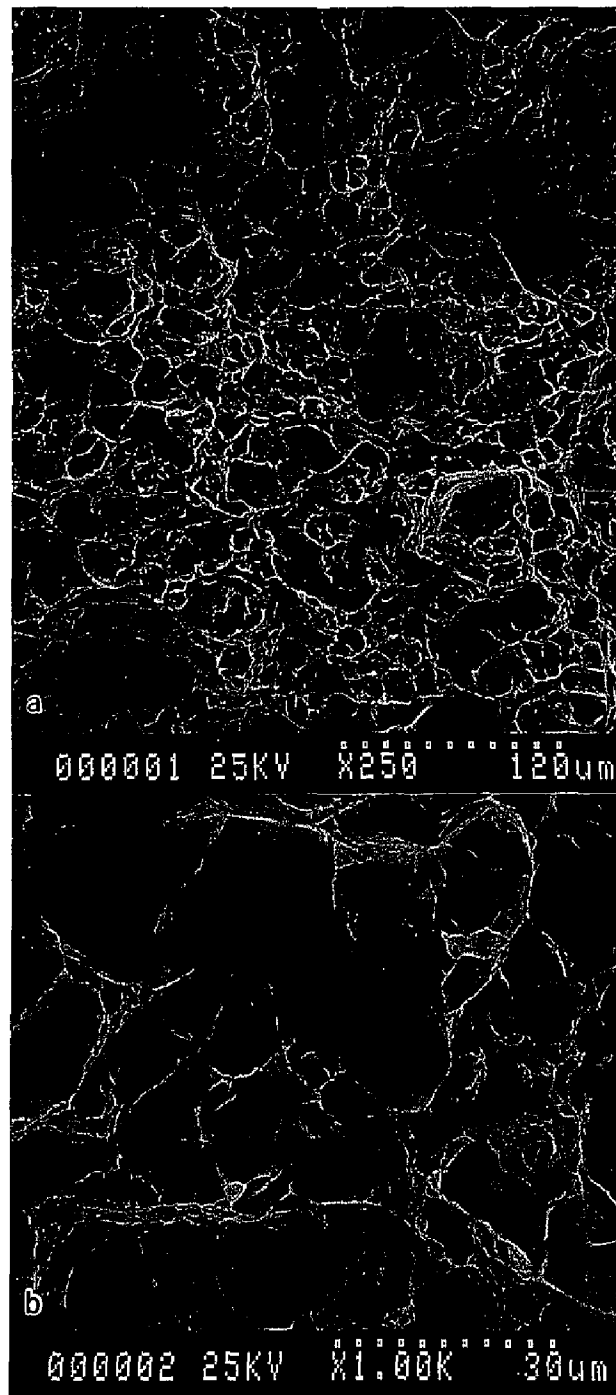
Figure 15 shows SEM fractographs of the fracture surface from one of the tensile specimens (Specimen T-3) used for mechanical property determination. Note that the fracture surface is primarily ductile dimpled rupture, with both macro and micro dimples, and some intergranular faceting, with microdimpling on these facets. This morphology is consistent with fractographic studies of similar Al alloys in tensile and toughness testing [3]. This morphology compares well with Figure 12k-l and 14l-m.

Figure 15. Fractography of tensile specimen T-3.
(a) 250 X. Photo ID: DC18129-PAL-1-8/4/98.
(b) 1000X. Photo ID: DC18129-PAL-2-8/4/98.
