# 4. How and Why the Blackout Began

This chapter explains the major events—electrical, computer, and human—that occurred as the blackout evolved on August 14, 2003, and identifies the causes of the initiation of the blackout. It also lists initial findings concerning violations of NERC reliability standards. It presents facts collected by the investigation team and does not offer speculative or unconfirmed information or hypotheses. Some of the information presented here, such as the timing of specific electrical events, updates the Sequence of Events<sup>1</sup> released earlier by the Task Force.

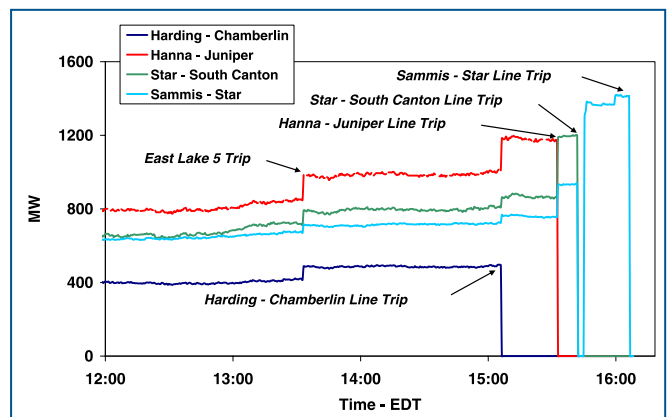
Figure 4.5. FirstEnergy 345-kV Line Flows

A short-circuit occurred on the Harding-Chamberlin 345-kV line due to a contact between the line conductor and a tree. This line failed with power flow at only 43.5% of its normal and emergency line rating. Incremental line current and temperature increases, escalated by the loss of Harding-Chamberlin, caused enough sag on the Hanna-Juniper line that it contacted a tree and faulted with power flow at 87.5% of its normal and emergency line rating. Star-South Canton contacted a tree three times between 14:27:15 EDT and 15:41:33 EDT, opening and reclosing each time before finally locking out while loaded at 93.2% of its emergency rating at 15:42:35 EDT.

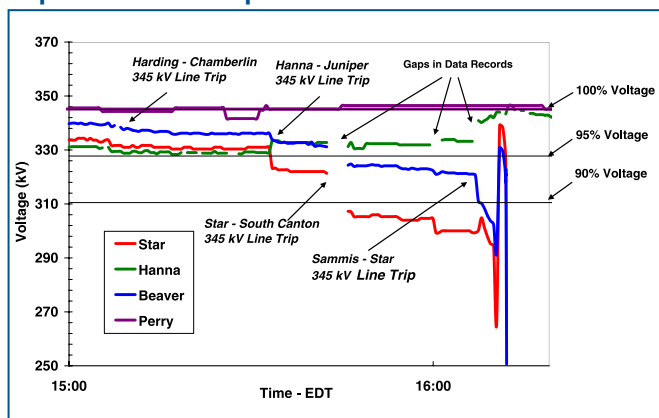
**Figure 4.6. Voltages on FirstEnergy’s 345-kV Lines: Impacts of Line Trips**

Hanna-Juniper was loaded at 87.5% of its normal and emergency rating when it tripped. With this line open, almost 1,000 MVA had to find a new path to reach its load in Cleveland. Loading on the remaining two 345-kV lines increased, with Star-Juniper taking the bulk of the power. This caused Star-South Canton's loading to rise above its normal but within its emergency rating and pushed more power onto the 138-kV system. Flows west into Michigan decreased slightly and voltages declined somewhat in the Cleveland area.

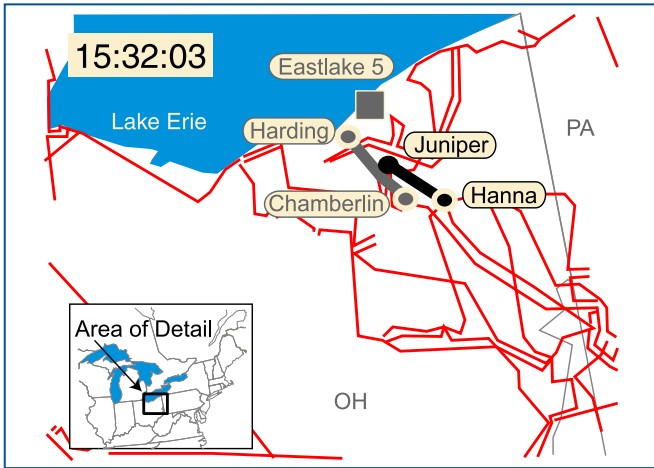
**Figure 4.9. Hanna-Juniper 345-kV Line**

At 15:32:03 EDT the Hanna-Juniper line (Figure 4.9) tripped and locked out. A tree-trimming crew was working nearby and observed the tree/line contact. The tree contact occurred on the South phase, which is lower than the center phase due to construction design. Although little evidence remained of the tree during the field team's visit in October, the team observed a tree stump 14 inches in diameter at its ground line and talked to an individual who witnessed the contact on August 14.<sup>26</sup> FE provided photographs that clearly indicate that the tree was of excessive height. Surrounding trees were 18 inches in diameter at ground line and 60 feet in height (not near lines). Other sites at this location had numerous (at least 20) trees in this right-of-way.

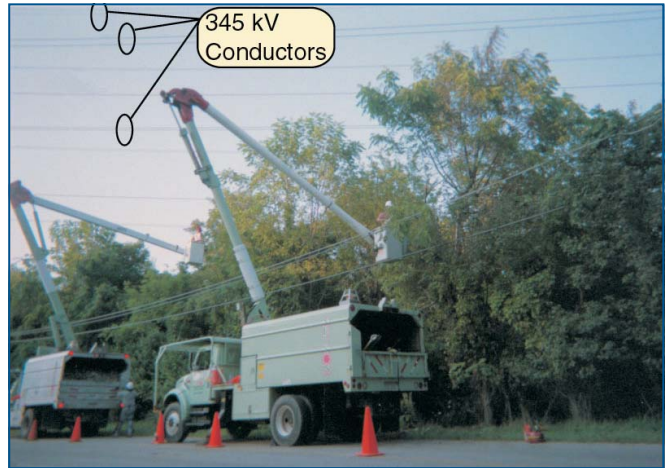
**Figure 4.10. Cause of the Hanna-Juniper Line Loss**

This August 14 photo shows the tree that caused the loss of the Hanna-Juniper line (tallest tree in photo). Other 345-kV conductors and shield wires can be seen in the background. Photo by Nelson Tree.

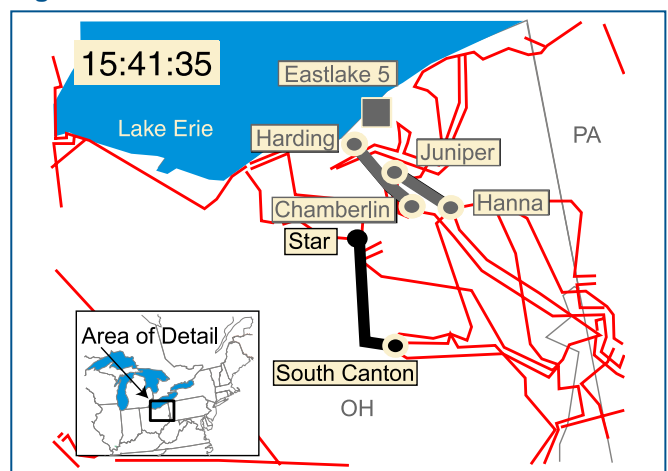
**Figure 4.11. Star-South Canton 345-kV Line**

**System impacts of the 345-kV failures.** The investigation modeling team examined the impact of the loss of the Harding-Chamberlin, Hanna-Juniper and Star-South Canton 345-kV lines. After conducting a variety of scenario analyses, they concluded that had either Hanna-Juniper or Harding-Chamberlin been restored and remained in-service, the Star-South Canton line might not have tripped and locked out at 15:42 EDT.

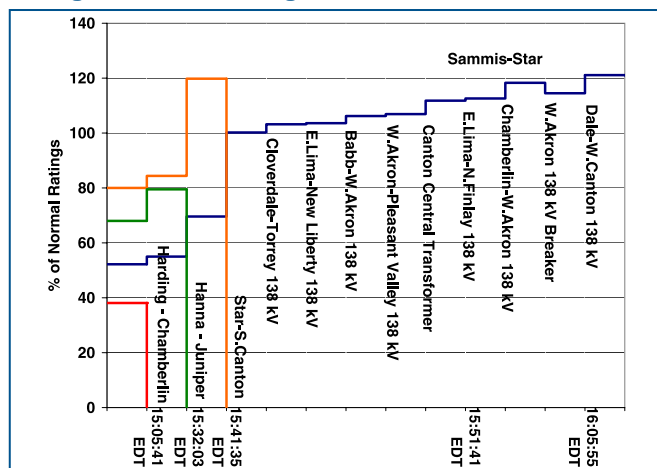
**Figure 4.12. Cumulative Effects of Sequential Outages on Remaining 345-kV Lines**

According to extensive investigation team modeling, there were no contingency limit violations as of 15:05 EDT prior to the loss of the Chamberlin-Harding 345-kV line. Figure 4.12 shows the line loadings estimated by investigation team modeling as the 345-kV lines in northeast Ohio began to trip. Showing line loadings on the 345-kV lines as a percent of normal rating, it tracks how the loading on each line increased as each subsequent 345-kV and 138-kV line tripped out of service between 15:05 EDT (Harding-Chamberlin, the first line above to stair-step down) and 16:06 EDT (Dale-West Canton). As the graph shows, none of the 345- or 138-kV lines exceeded their normal ratings until after the combined trips of Harding-Chamberlin and Hanna-Juniper. But immediately after the second line was lost, Star-South Canton's loading jumped from an estimated 82% of normal to 120% of normal (which was still below its emergency rating) and remained at the 120% level for 10 minutes before tripping out. To the right, the graph shows the effects of the 138-kV line failures (discussed in the next phase) upon the two remaining 345-kV lines—i.e., Sammis-Star's loading increased steadily above 100% with each succeeding 138-kV line lost.

Following the loss of the Harding-Chamberlin 345-kV line at 15:05 EDT, contingency limit violations existed for:

- ◆ The Star-Juniper 345-kV line, whose loadings would exceed emergency limits if the Hanna-Juniper 345-kV line were lost; and
- ◆ The Hanna-Juniper and Harding-Juniper 345-kV lines, whose loadings would exceed emergency limits if the Perry generation unit (1,255 MW) were lost.

Operationally, once FE's system entered an N-1 contingency violation state, any facility loss beyond that pushed them farther into violation and into a more unreliable state. After loss of the Harding-Chamberlin line, to avoid violating NERC criteria, FE needed to reduce loading on these three lines within 30 minutes such that no single contingency would violate an emergency limit; that is, to restore the system to a reliable operating mode.

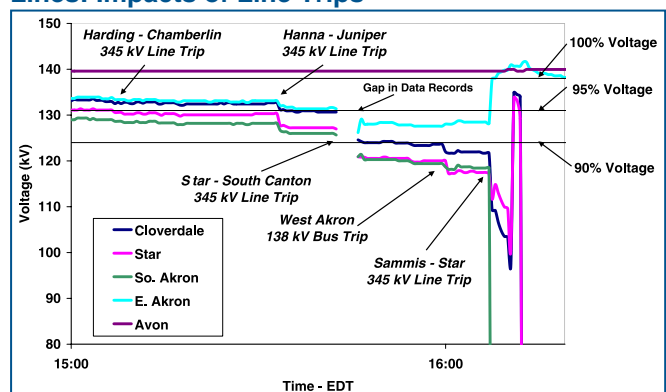
**Figure 4.14. Voltages on FirstEnergy’s 138-kV Lines: Impacts of Line Trips**

As each of FE’s 345-kV lines in the Cleveland area tripped out, it increased loading and decreased voltage on the underlying 138-kV system serving Cleveland and Akron, pushing those lines into overload. Starting at 15:39 EDT, the first of an eventual sixteen 138-kV lines began to fail. Figure 4.14 shows how actual voltages declined at key 138-kV buses as the 345- and 138-kV lines were lost. As these lines failed, the voltage drops caused a number of large industrial customers with voltage-sensitive equipment to go off-line automatically to protect their operations. As the 138-kV lines opened, they blacked out customers in

Akron and the areas west and south of the city, ultimately dropping about 600 MW of load.

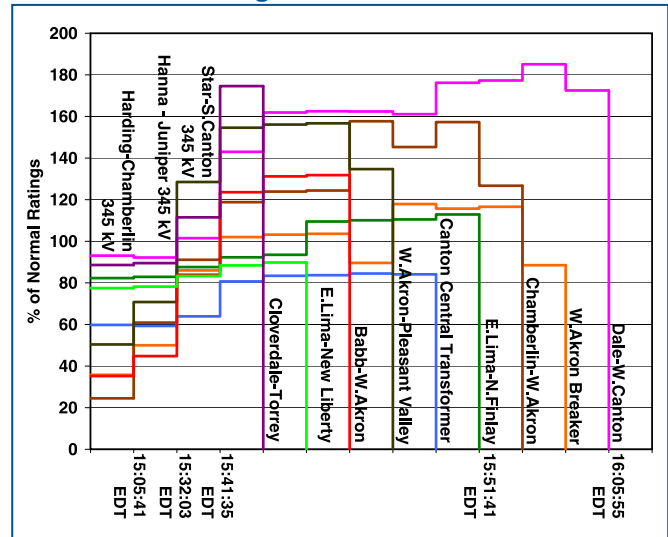
**Figure 4.15. Simulated Effect of Prior Outages on 138-kV Line Loadings**

FE's 345- and key 138-kV northeast Ohio lines as the line failures progressed. All lines were loaded within normal limits after the Harding-Chamberlin lock-out, but after the Hanna-Juniper trip at 15:32, the Star-South Canton 345-kV line and three 138-kV lines jumped above normal loadings. After Star-South Canton locked out at 15:41 EDT, five 138-kV and the Sammis-Star 345-kV lines were overloaded and Star-South Canton was within its emergency rating. From that point, as the graph shows, each subsequent line loss increased loadings on other lines, some loading to well over 150% of normal ratings before they failed. The Sammis-Star 345-kV line stayed in service until it tripped at 16:05:57 EDT.
