## PART 1. DEVELOPMENTAL HISTORY

### **The Roots of Mission 66**

### **Build in haste, repair at leisure**

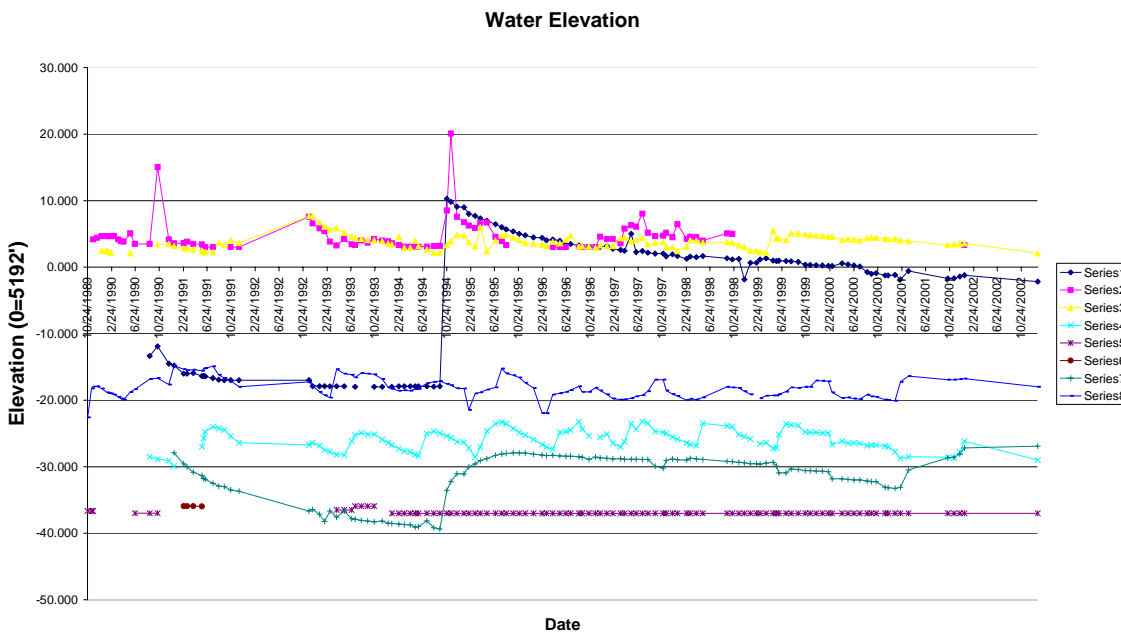
Measured Groundwater Elevations in Site Borings Since 1989

Soil borings made by Chen-Northern for their investigation were lined with PVC pipe in order to allow ground water accumulation to be monitored. Water accumulated in only 2 of the 13 holes. A hole under the mechanical room accumulated fluctuating levels of water while a hole just north of the building at midlength was originally dry but accumulated water to a depth 24 feet below top of hole. The park maintenance staff continued monitoring these wells on a monthly basis for twelve years. The records indicate 4 of the holes have remained essentially dry while the others accumulate fluctuating depths of water over time.
