NASA/TM—1999-209399

Analyses of Contaminated Solar Array Handrail Samples Retrieved from Mir

Kim K. de Groh
Glenn Research Center, Cleveland, Ohio

Prepared for the
34th Intersociety Energy Conversion Engineering Conference
sponsored by the Society of Automotive Engineers
Vancouver, British Columbia, Canada, August 1-5, 1999

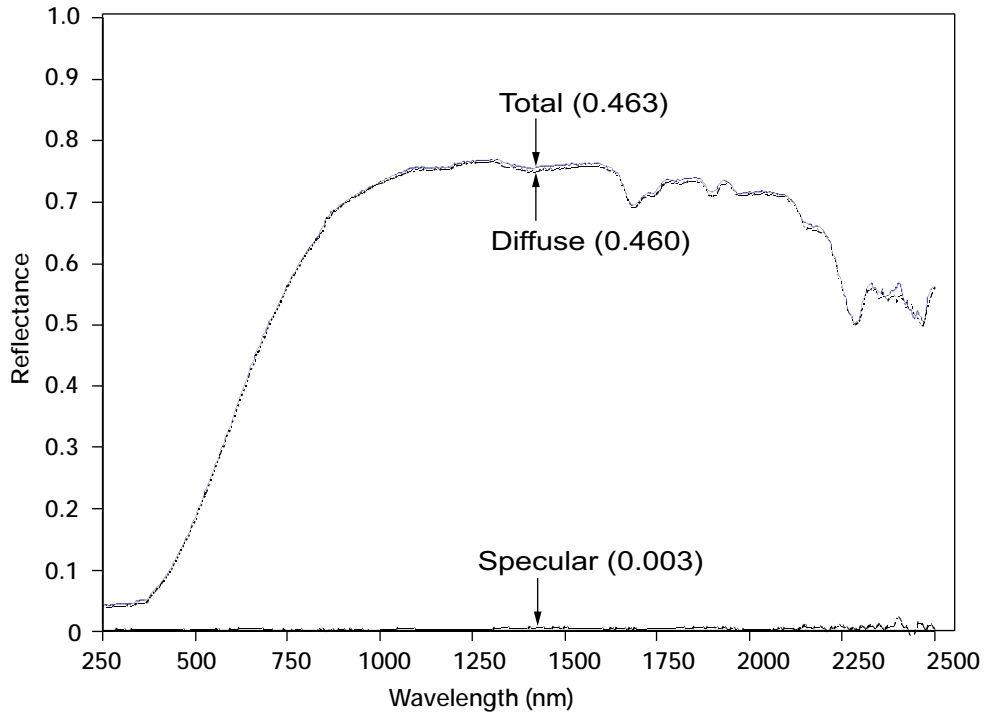
Figure 7. Spectral reflectance for the solar array facing side (side A) of the rigid handrail sample.

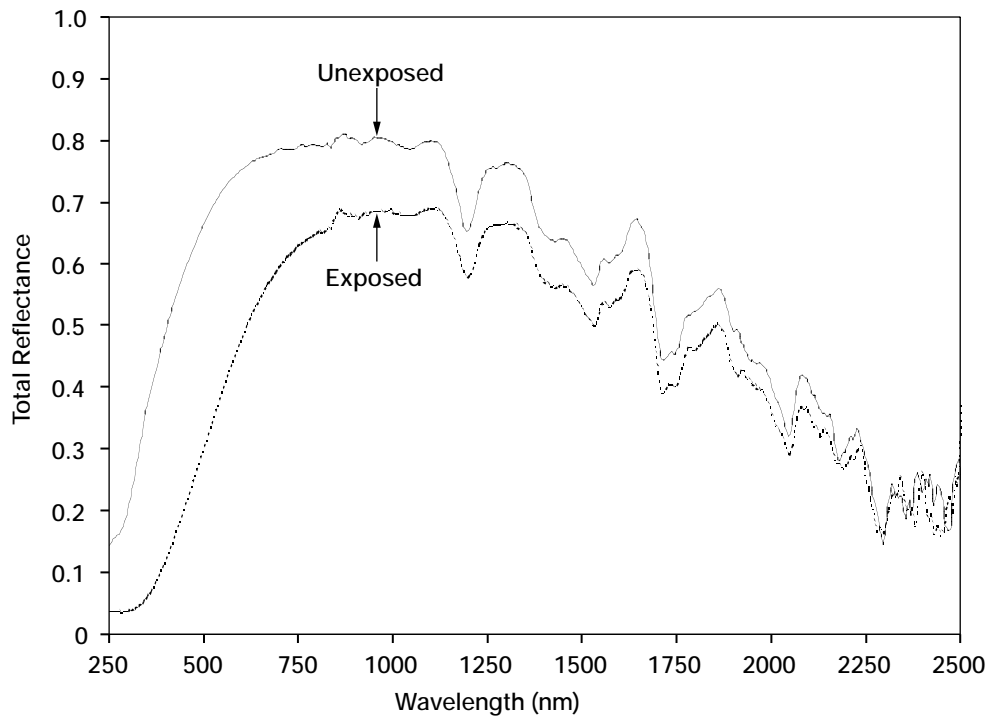
Figure 8. Total reflectance for unexposed ($\alpha_s=0.330$) and exposed ($\alpha_s=0.465$) areas of the flexible handhold tape over-wrap fabric.

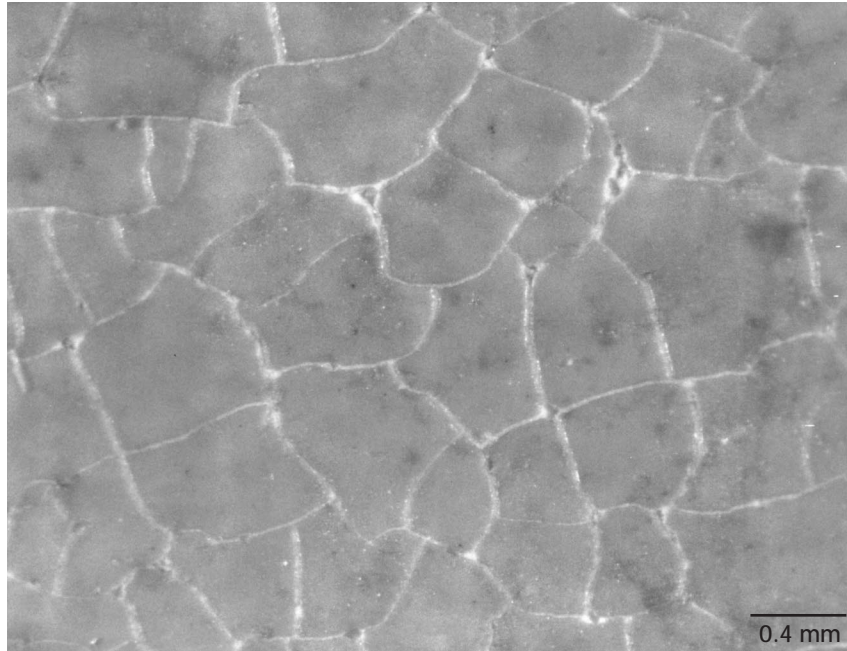
Rigid Handrail Sample (Flat Section). The uniformly dark brown side (array facing side) of the flat handrail sample had a rainbow hue and was clearly crazed, as can be seen in figure 9. Although the space-facing side of the handrail was also brown, its surface did not have a rainbow hue and was not crazed, as can be seen in figure 10. Surface “holes” were observed on the space-facing side (see fig. 10). These holes are believed to be the result of air pockets produced during the painting process. After close examination, these holes appear present on the array facing side, faintly visible underneath the thick contaminant layer.

Figure 9. Side A (array-facing side) of the rigid handrail showing crazing of the brown contaminant layer.

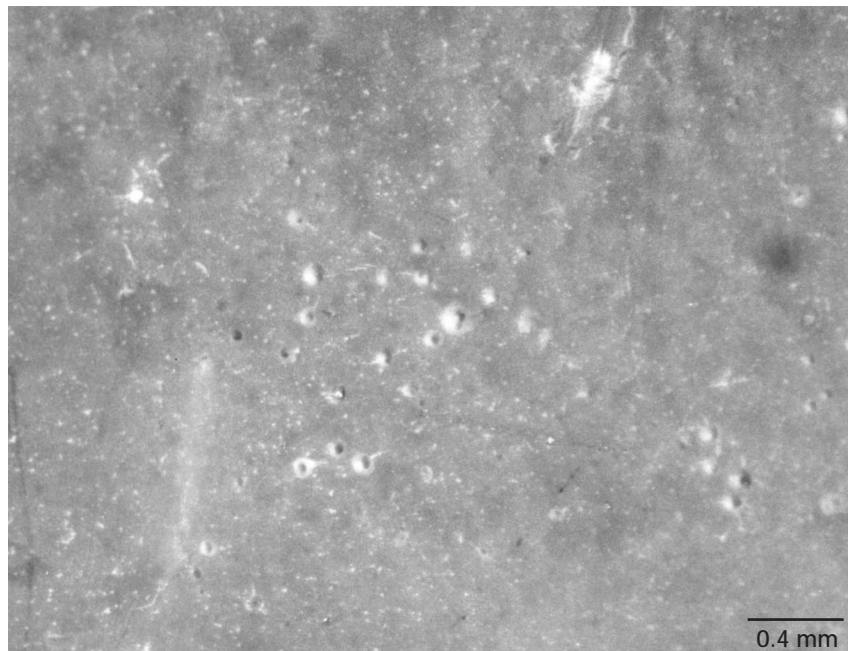
Figure 10. Side B (space-facing side) of the rigid handrail. The brown contaminant layer is not crazed on this surface.

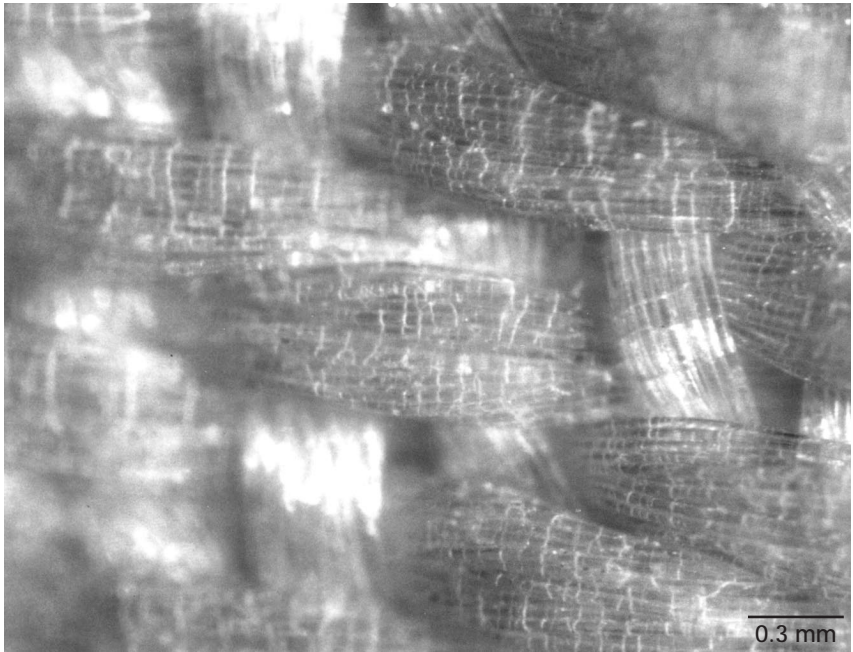
Flexible Handhold Over-Wrap Tape. Optical microscopy examination of the exposed, brown region of the handhold tape fabric revealed micro-crazing of a contamination layer, as shown in figure 11. This crazed layer is not present on the protected, unexposed region that has an off-white color (see fig. 12).

Figure 11. Micro-crazing of the brown contaminant layer on the exposed area of the flexible handhold over-wrap tape fabric.

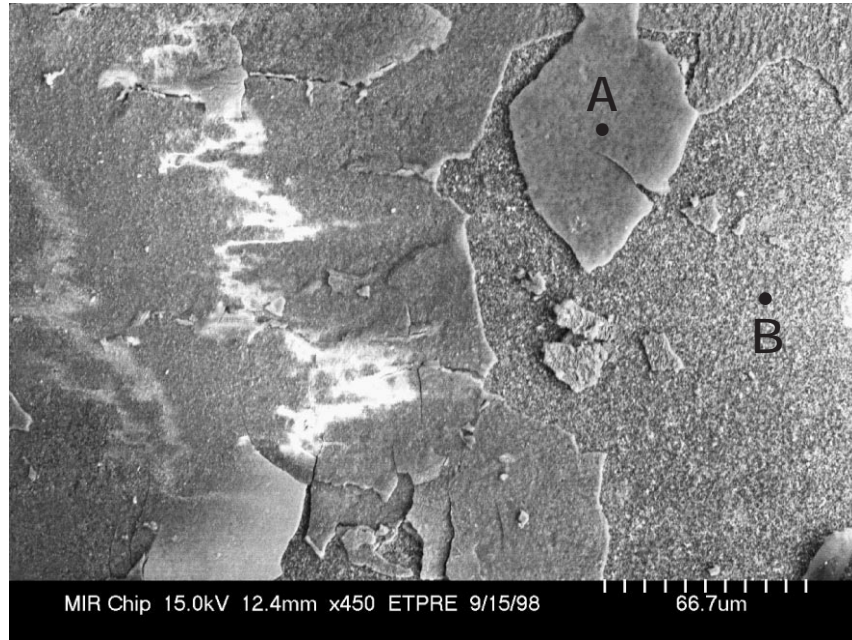
An image of the brown contaminated surface of the paint chip is shown in figure 15. There appears to be a contaminant layer that is crazed and has spalled off the surface in areas. EDS point spectra were taken on a flaked-off contaminant piece (point A) and on an area where the contaminant layer appears to be missing (point B), as shown in figures 16 and 17, respectively. The contaminant layer is composed primarily of oxidized silicon (from silicone contamination). These results are consistent with electron spectroscopy for chemical analysis (ESCA) measurements reported by Visentine, et al. (ref. 1). Point B is composed of C, O, Zn and Ti, with small amounts of Si, Al and an unknown element, possibly Pb. The oxidized silicon layer has spalled off the surface in this region, and the surface has a strong C and O presence.

Figure 15. Brown stained area on the surface of the rigid handrail sample. The contaminant layer is crazed and has lifted up, or spalled off, in certain areas.

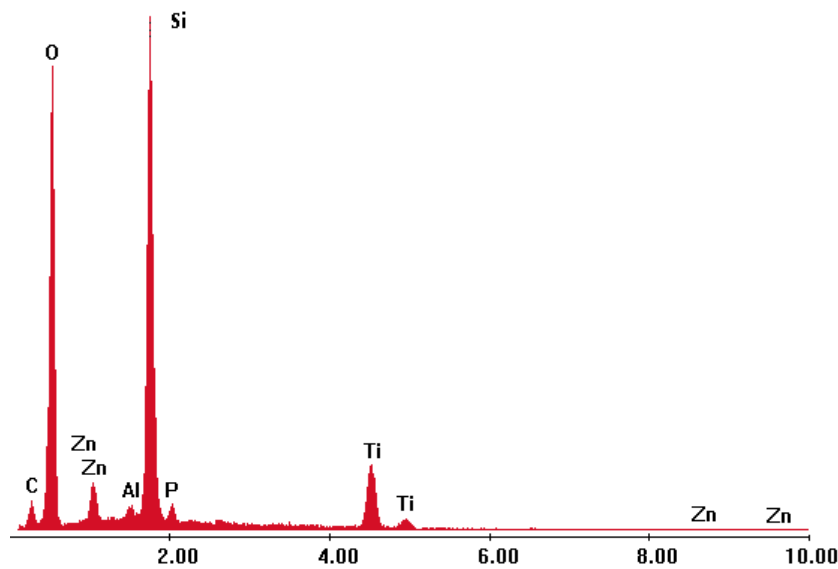
Figure 16. EDS spectra taken at point A in Figure 15. Spectra shows the presence of oxidized silicone contamination.

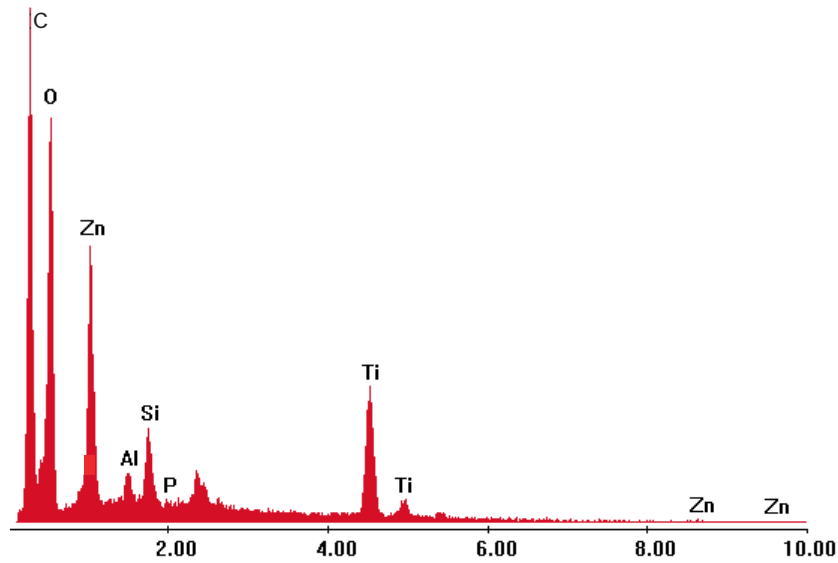
Figure 17. EDS spectra taken at point B in Figure 15. Spectra similar to the cross-sectioned area, but with much larger C and O peaks.

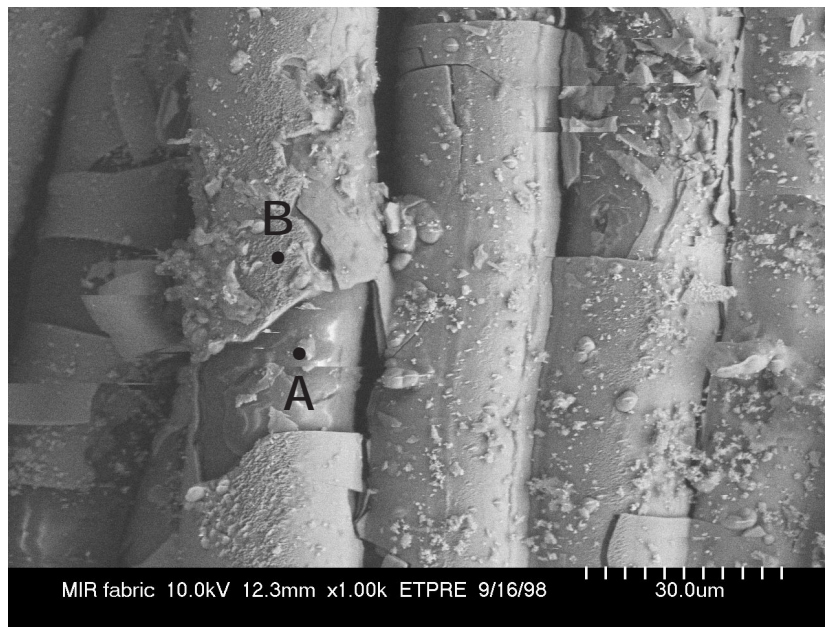
The exposed brown stained area of the fabric was imaged and revealed a very thick layer of contaminant that has spalled off in some areas (possibly due to post-retrieval handling), as shown in figure 20. A near cross-section of the contaminant layer is seen in this image (to the right of point A), and at higher magnification the thickness was measured to be ~1.6 μm thick. EDS point spectra were obtained at two locations in figure 20, one at an area where the contaminant has spalled-off (point A), and the second on top of the thick contaminant layer (point B). The corre-

Figure 20. Brown exposed region of the flexible handhold fabric showing the presence of a very thick contaminant layer that has crazed and spalled off in certain areas.

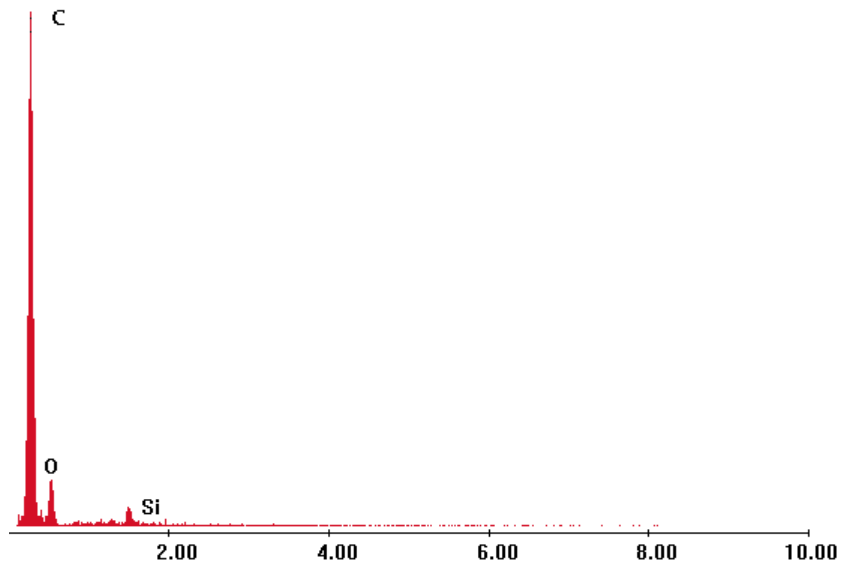
sponding spectra for points A and B are shown in figures 21 and 22, respectively. Point A, where the contaminant has spalled off looks primarily like the unexposed fibers, mostly C with some O. A very small Si peak is present. Point B, focused on the contaminant film, is Si and O, with almost no C present. The thick contaminant layer is clearly oxidized silicon, similar to the contaminant layer on the rigid handrail.

Figure 21. EDS spectra taken at point A in Figure 20.

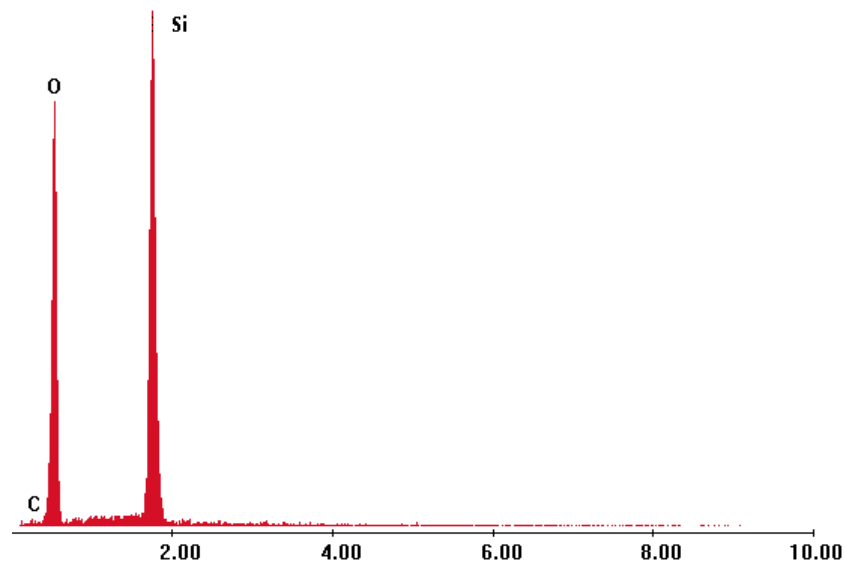
Figure 22. EDS spectra taken at point B in Figure 20. Spectra shows that the contaminant layer is oxidized silicon.

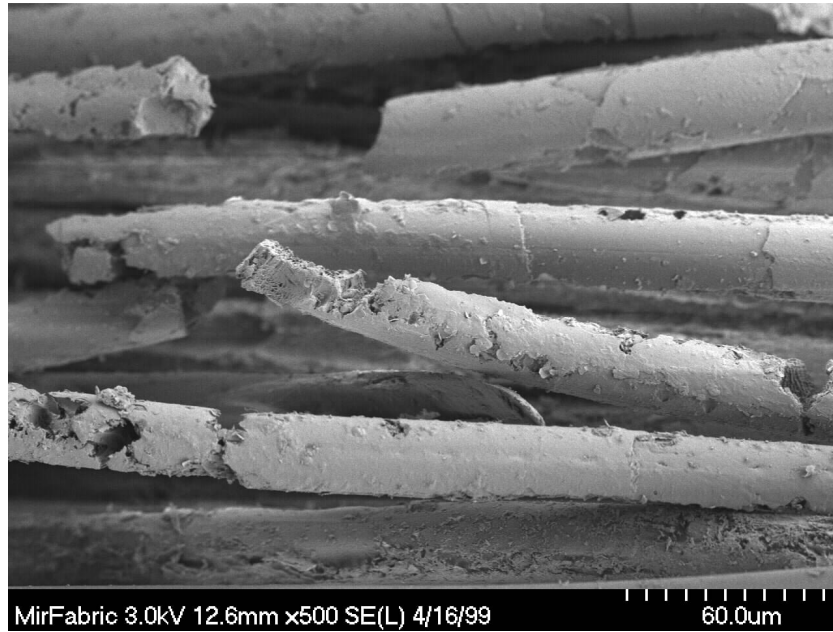
Figure 23 shows an area where the contaminant layer has spalled off the fibers in various locations while in space, and atomic oxygen has eroded the organic fibers. Several sections of fibers have been completely eroded away. This shows that the contaminant layer, which is resistant to atomic oxygen erosion, has become so thick that it became a source of particulate contamination in space.

Figure 23. FESEM image of the contaminated flexible handhold tape fabric fibers. Atomic oxygen erosion has occurred in-space at locations where the contaminant layer has spalled off.

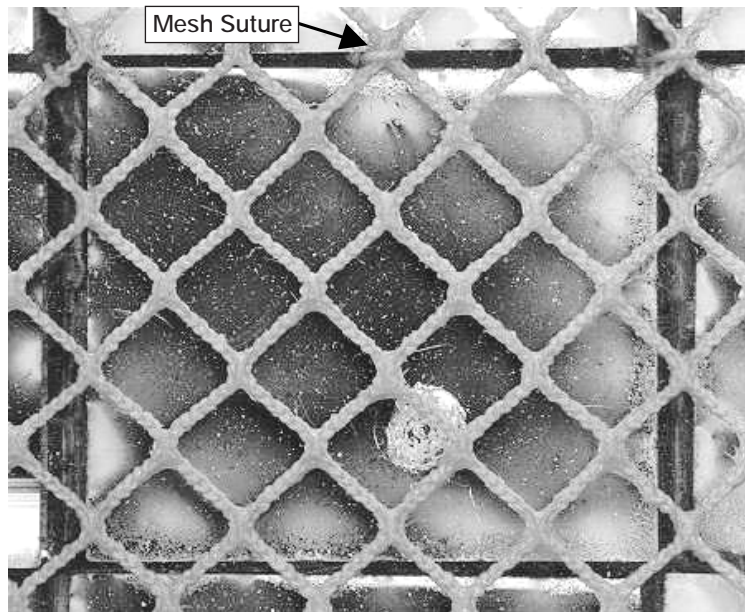
Figure 24. Backside of Mir solar cell (16-6) with mesh backing in place. Contaminant shadow lines (shaded by particulate pieces) point back towards the mesh suture at the top center of the cell (ref 7).

As previously mentioned, the entire array was coated with contaminant films. The cover slides and the optical solar reflectors (OSR) on the backside of the arrays were covered with a nonuniform diffusely reflecting film (refs. 1 and 6). Figure 24 is a photograph of the backside of a solar cell (cell 16-6), and shows a structural mesh backing which was present over the OSR. The matte contaminant layer is clearly visible and appears to be thicker on the edges of the cell. The solar cells (front and back sides) were found to be contaminated by an organic silicone film which was converted to a silica coating by atomic oxygen exposure (refs. 1 and 6). Silicone compounds used to laminate the solar array panel are believed to be the source of contamination on the panels. For example, the source of the silicone contamination on the front and back of the cells visually appears to have evolved where reinforcement threads penetrated silicone potting strips between the cells (ref. 1). This can be seen in figure 24 by examining the suture thread holding the mesh backing in place at the top of the cell. Line-of-site contaminant shadows point towards the suture.

Based on these solar cell findings, and the fact that the handrail section facing the array appeared to be more contaminated than the space facing side, the source of contamination on the handrail samples appears to be primarily from silicones in the arrays themselves.
