U.S. Fire Administration/Technical Report Series

Twelve-Fatality Nursing Home Fire

Norfolk, Virginia

USFA-TR-034/October 1989

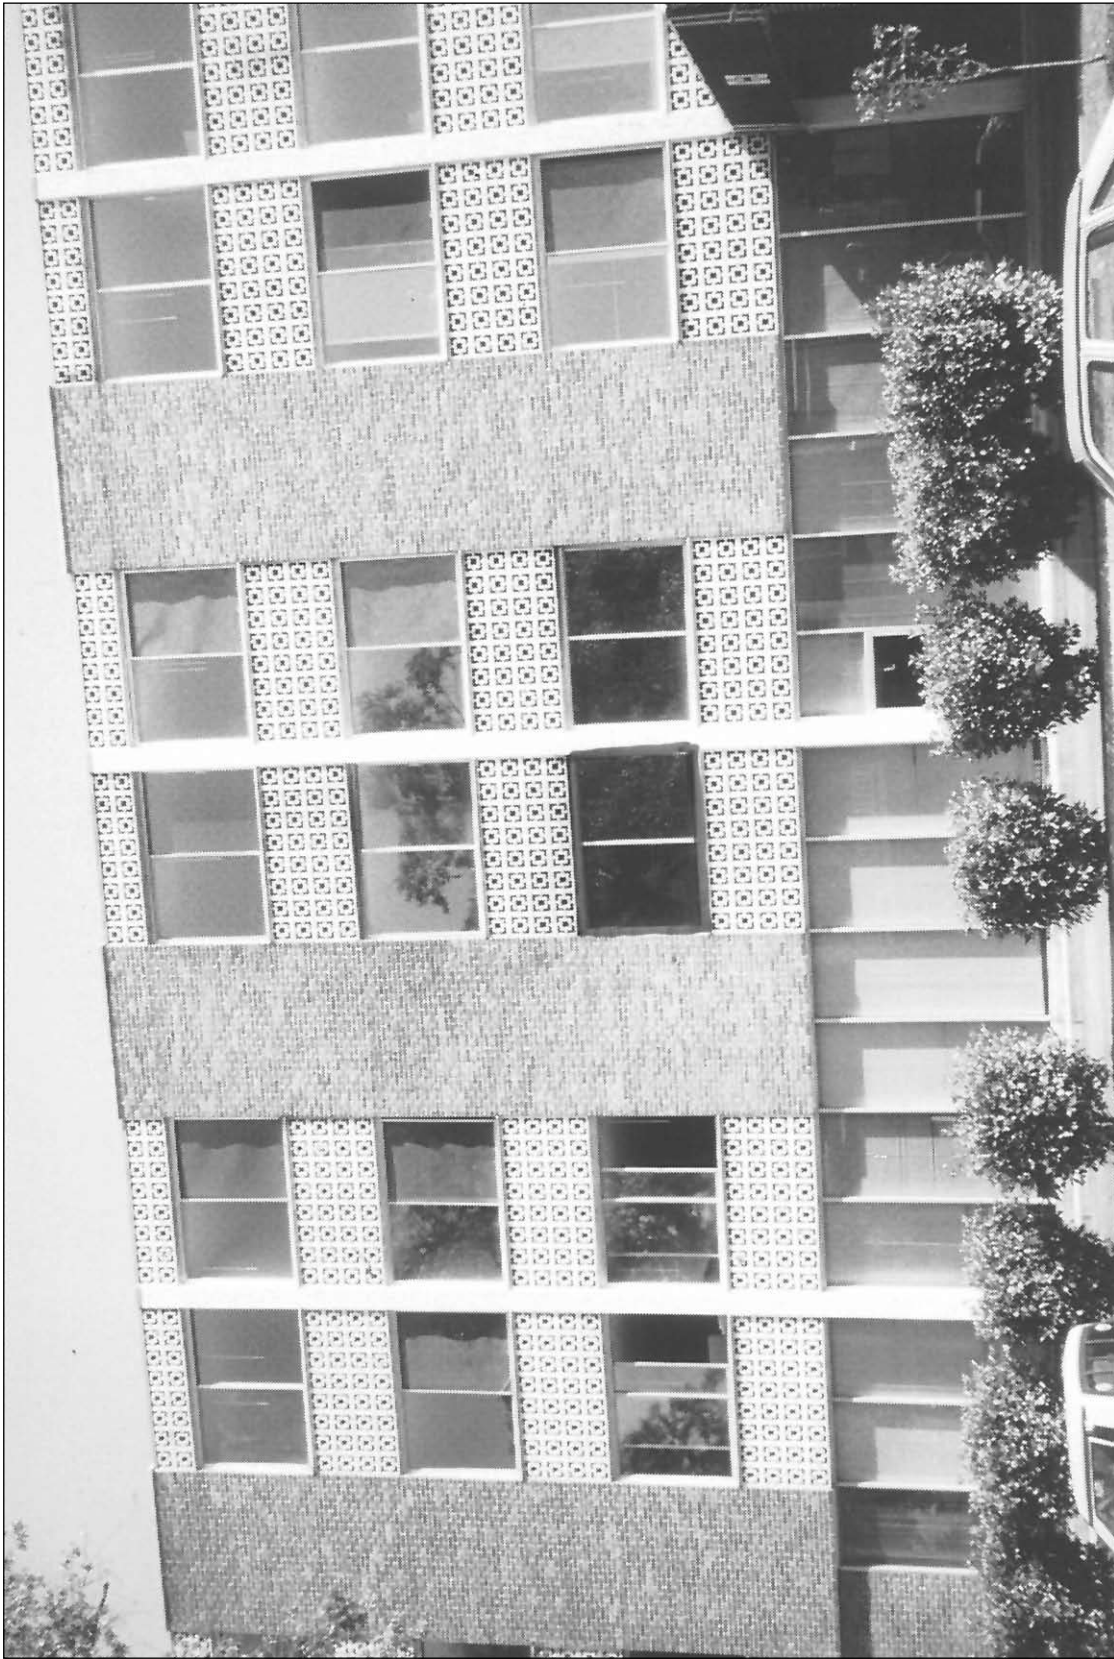
The fire originated in Room 226, believed to be as a result of patient accidentally discarding a lighted match onto his bed (after missing the waste can) and igniting the bed linen and the polyurethane mattress pad, which is a highly combustible and smoke-generating material when subjected to open flame. The fire intensified very rapidly, generating tremendous heat and smoke buildup. It was known that the patient was a smoker. The night before the fire he had been caught with cigarettes in his room, which was against the facility's rules.

3. South end of building, indicating second floor window where fire originated.

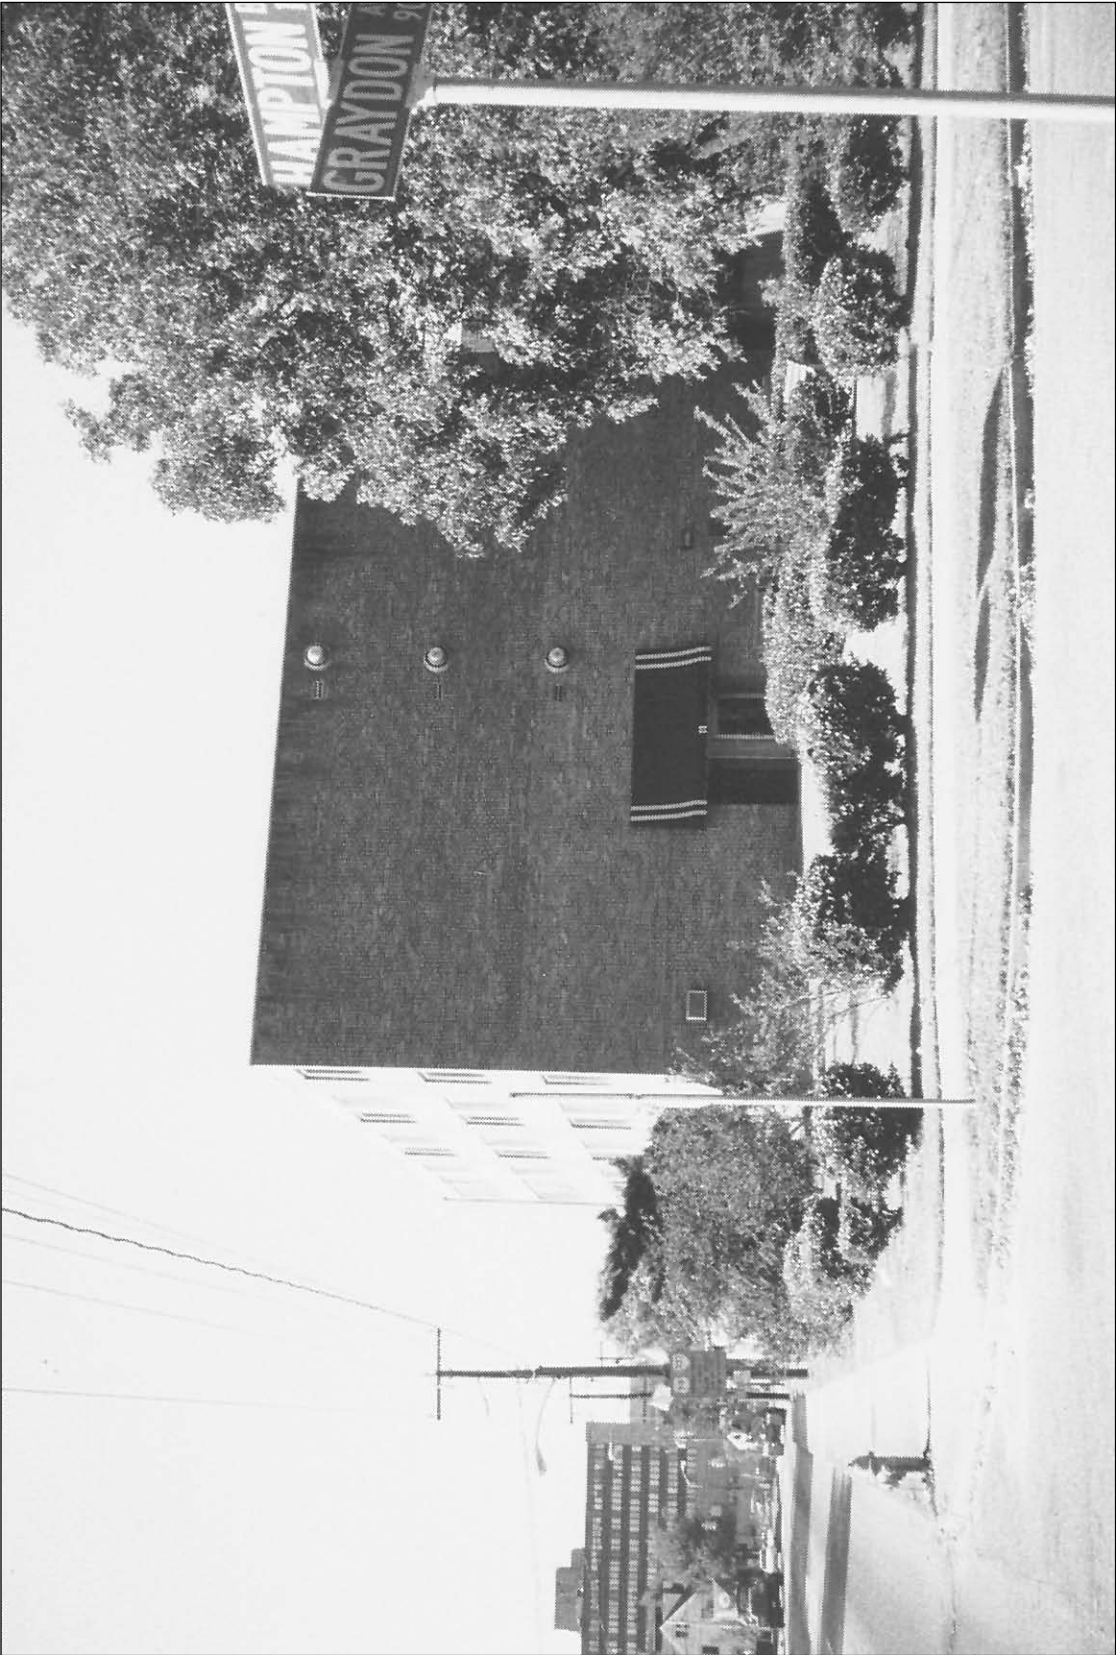
5. Northeast end of building looking southwest (note defective fire hydrant).

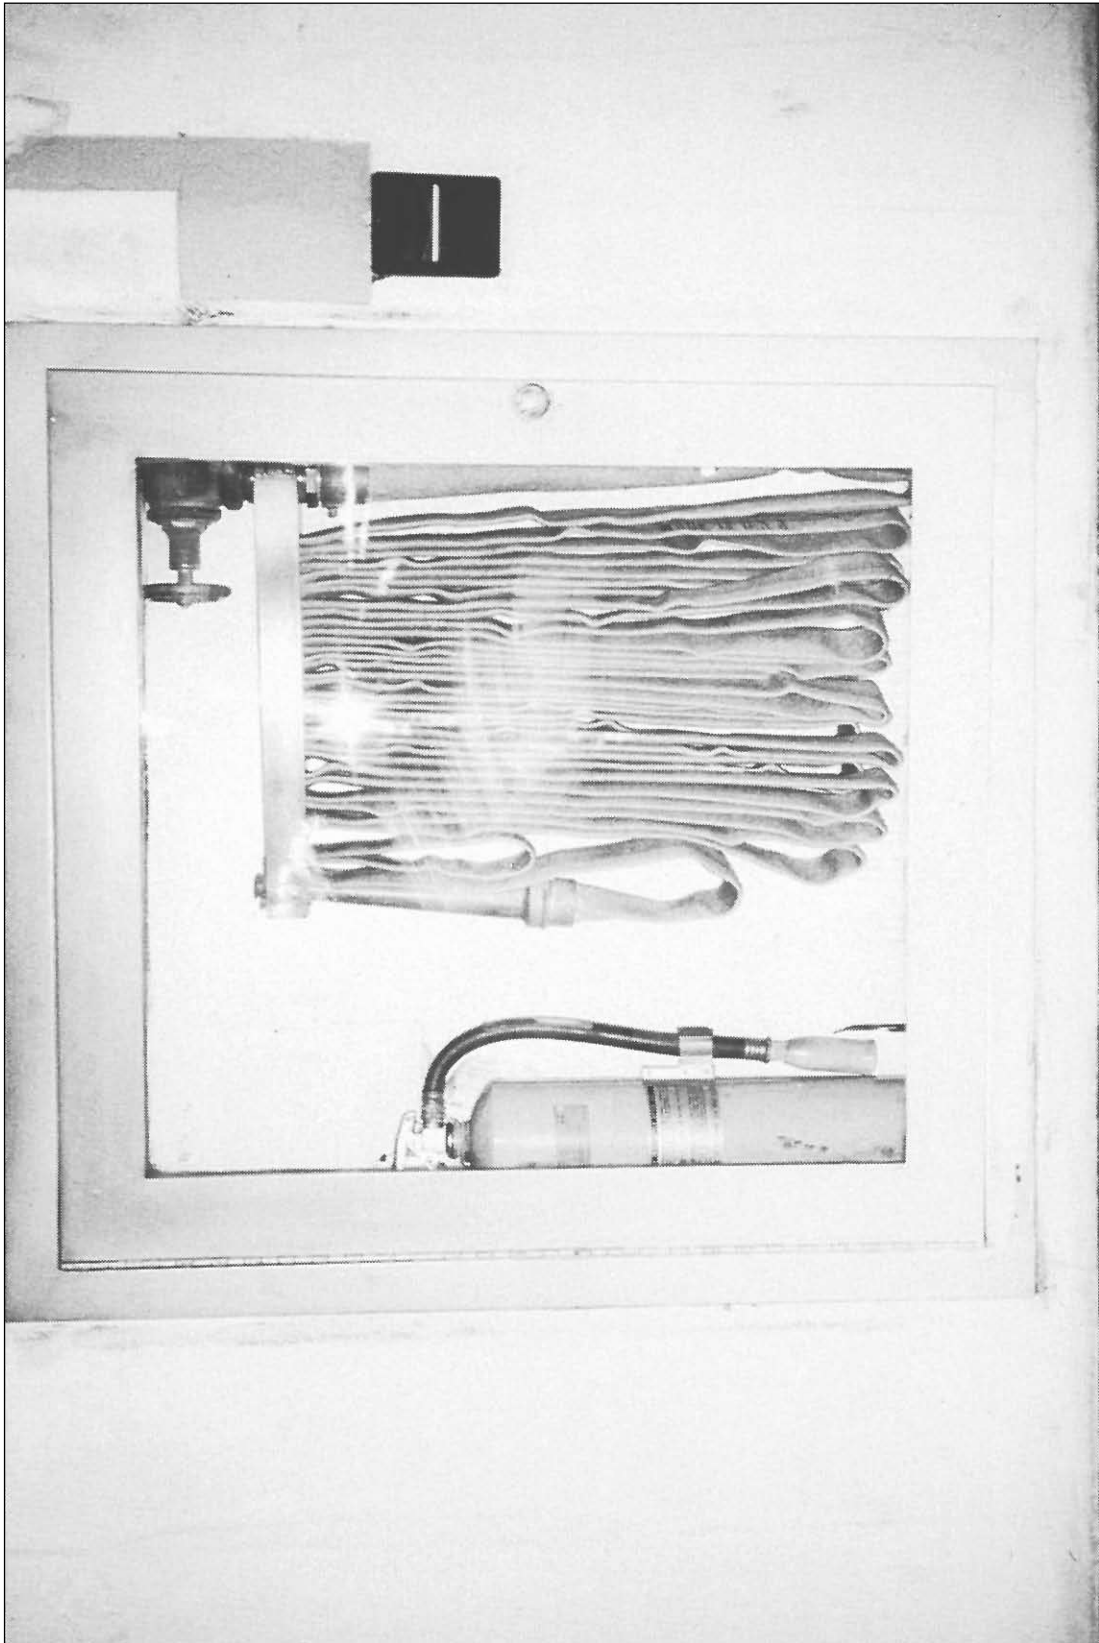
Personnel from Engine 6 carried a highrise pack to the second floor by way of the east stairwell. Hose was connected to the standpipe system and firefighters, who began to make their way to the second floor through the exit stairwell, found the floor completely charged with heavy, black smoke. They observed fire at ceiling level in the area of the smoke barrier doors located midway down the hall. After opening their handline, water was lost for a few moments, probably due to an air pocket within the standpipe system.

8. Typical 1 - 1/2-inch hose outlet, located at each stairwell entrance on each floor.

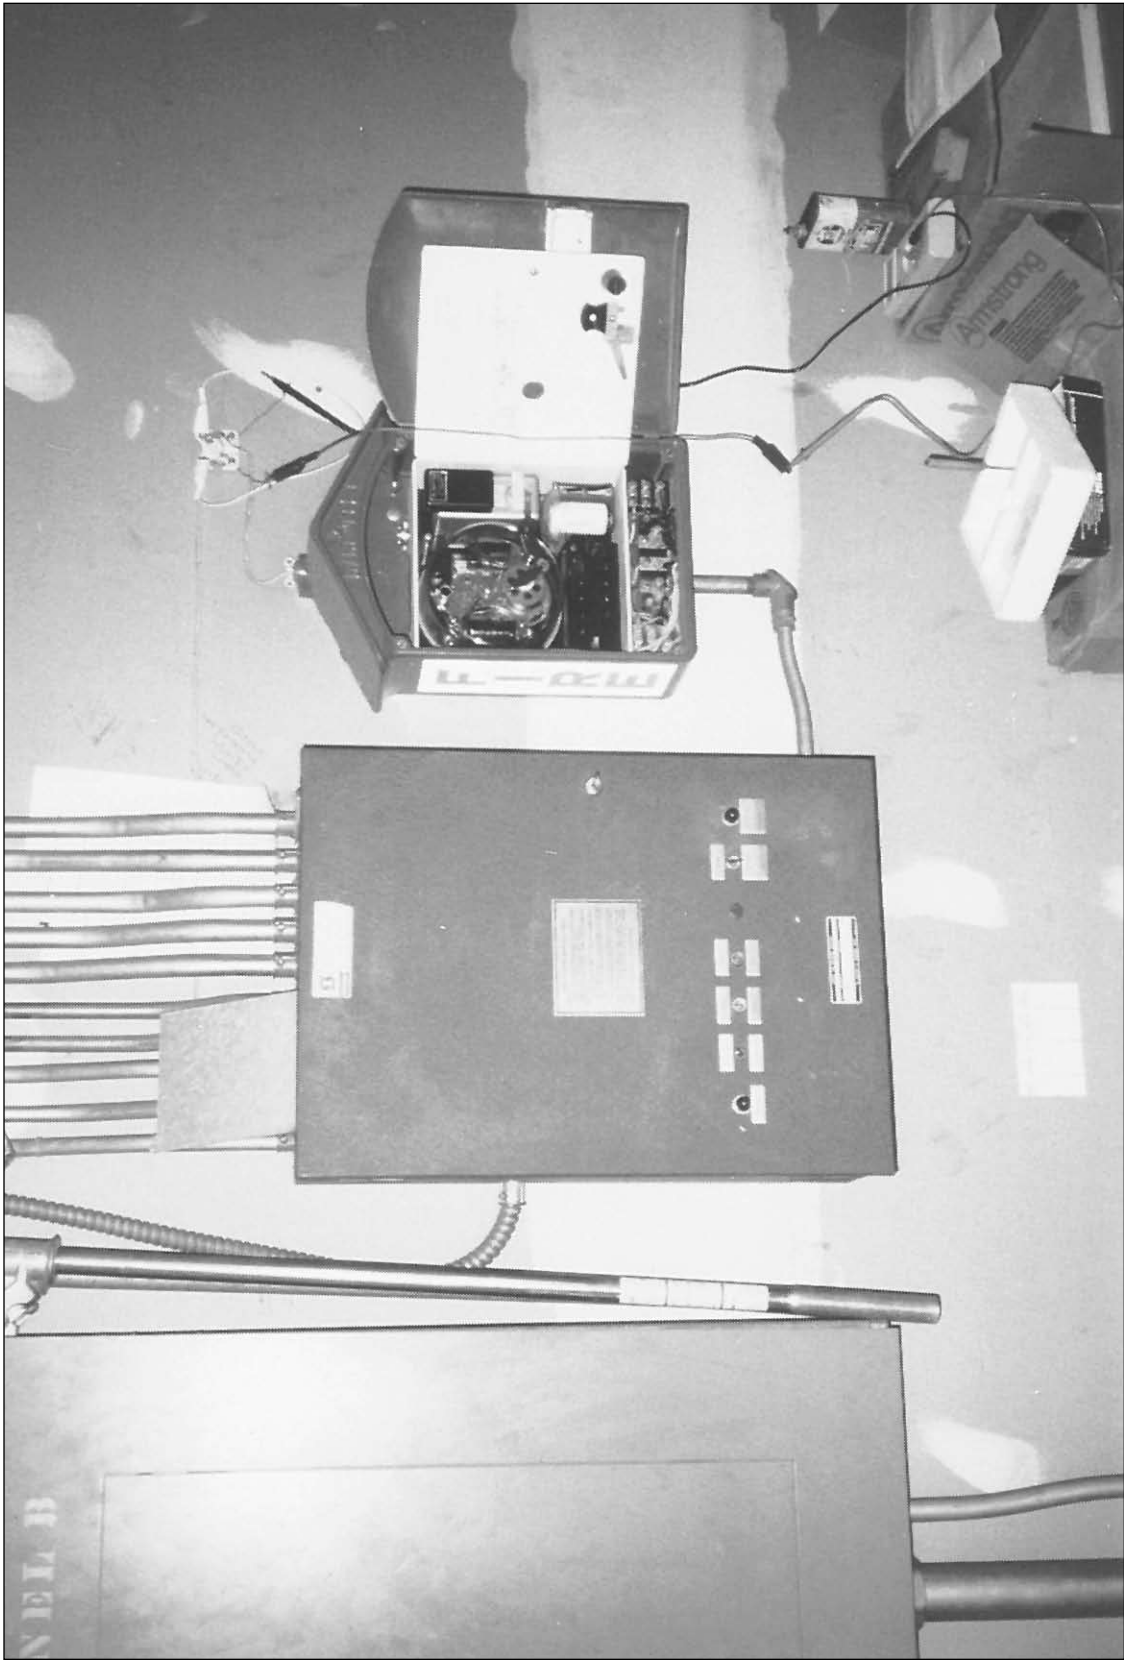
Smoke barrier doors, located in the hall and within 20 feet of the room of origin, failed to close, allowing smoke to completely penetrate the second floor. The interior fire alarm system was pulled. Due to a blown fuse in the main fire alarm control panel, that system also failed to operate and no alarm was sounded.

9. Main control panel for fire alarm and smoke detector systems.

2. Frequent testing of fire protection and alarm systems is critical.

The fact that the smoke barrier doors and alarm system failed to operate illustrates the importance of frequent and thorough inspections and testing of fire protection systems.

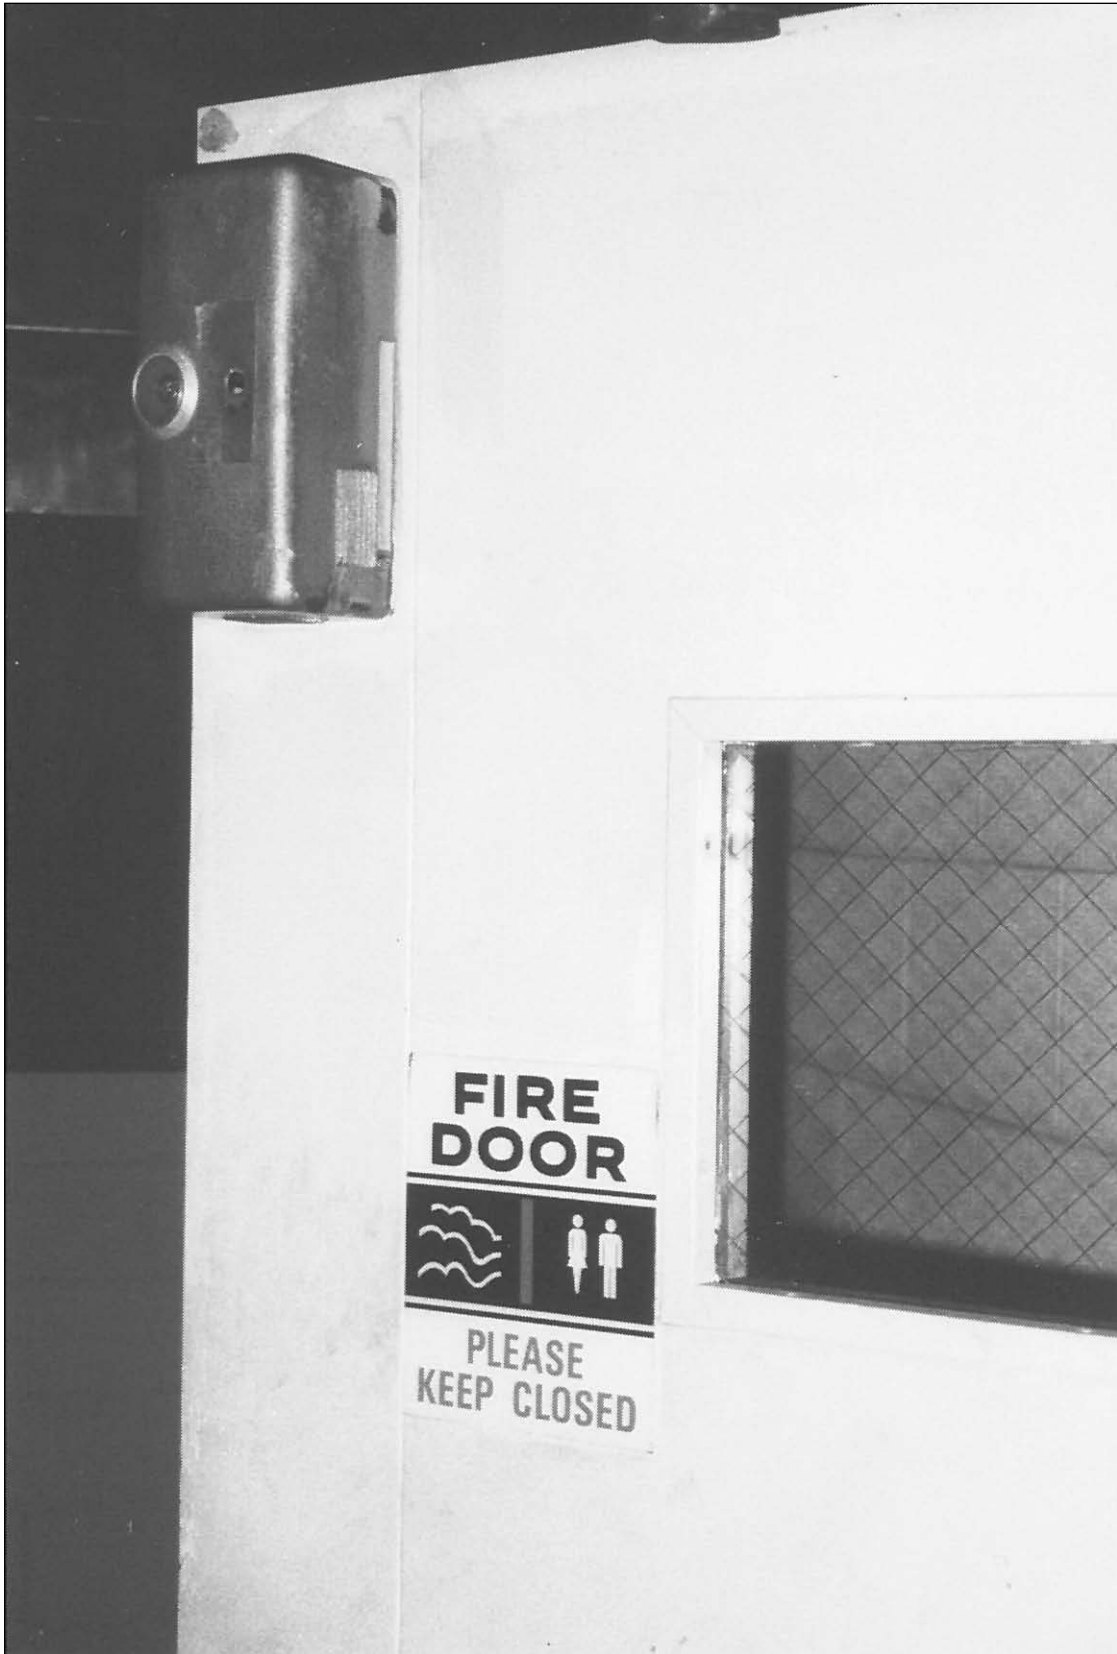
12. Typical door alarm on each stairwell door.

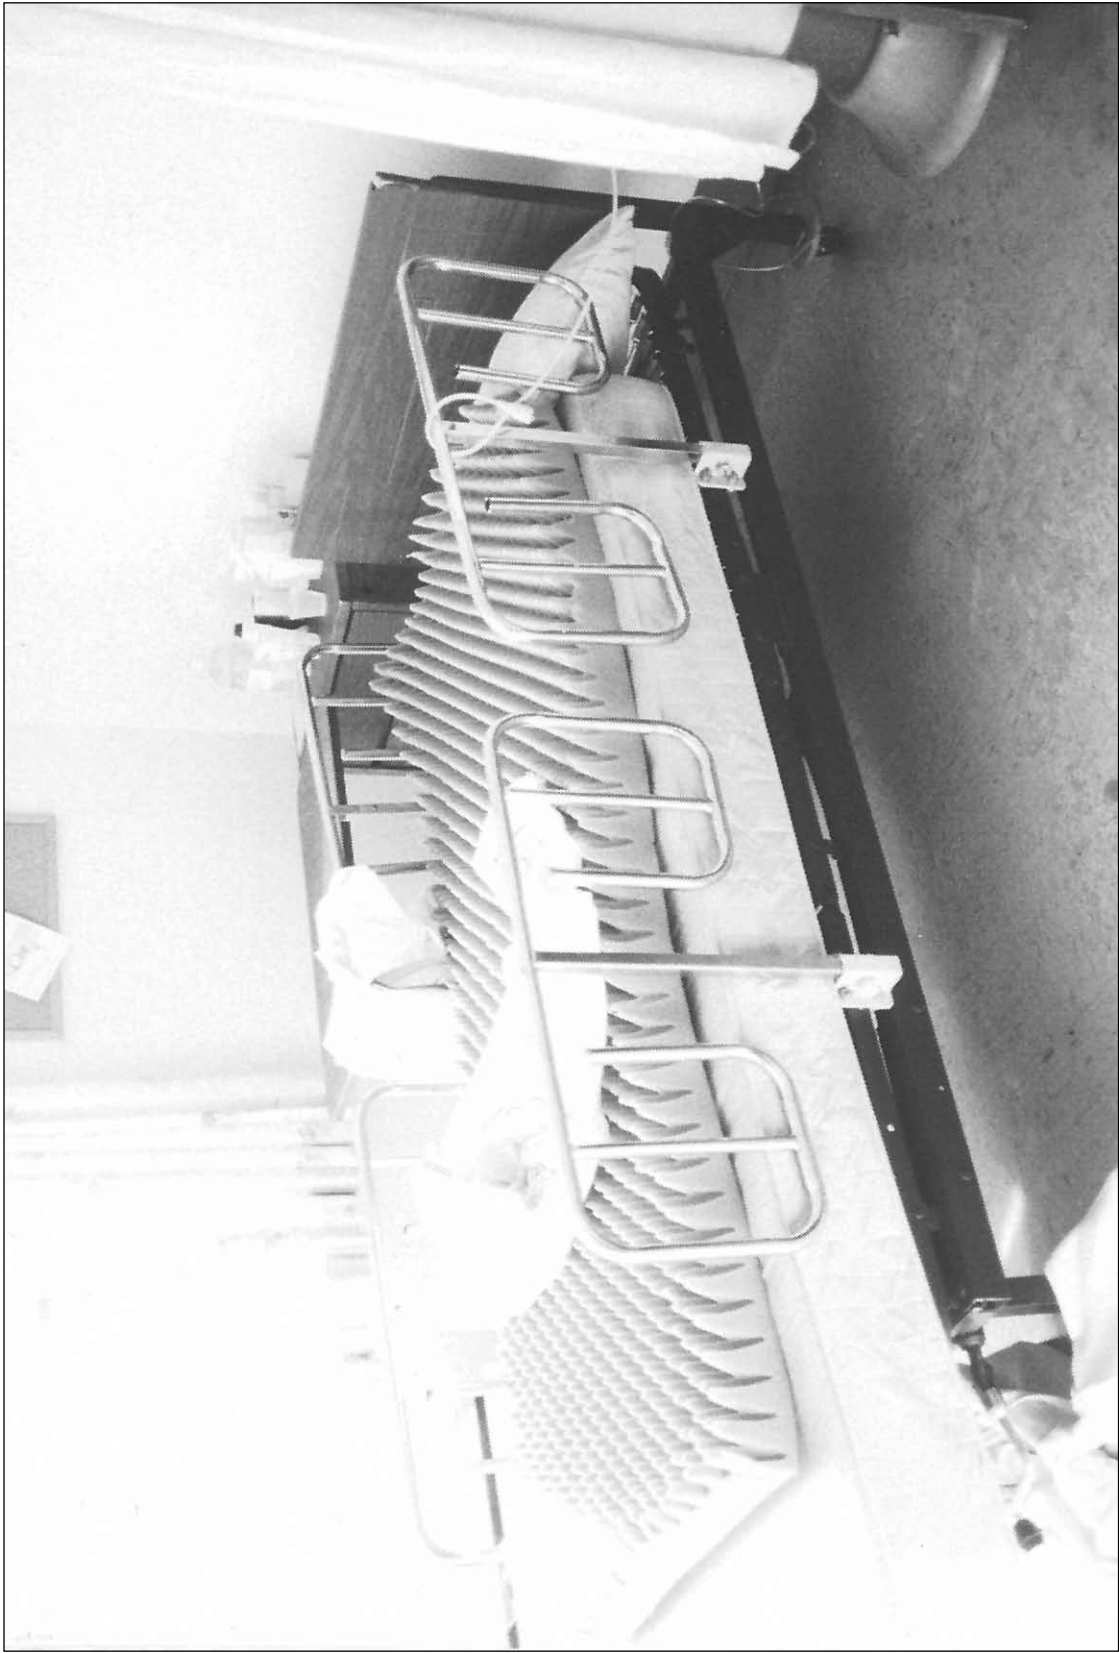
While the polyurethane mattress pads apparently were treated for fire retardancy, they were a major factor in heat and smoke buildup. Equipment and decorations, such as drapes, wall coverings, bed linen, etc., should be of the type that affords the lowest flame spread possible.

14. "Egg crate" polyurethane mattress used throughout home.

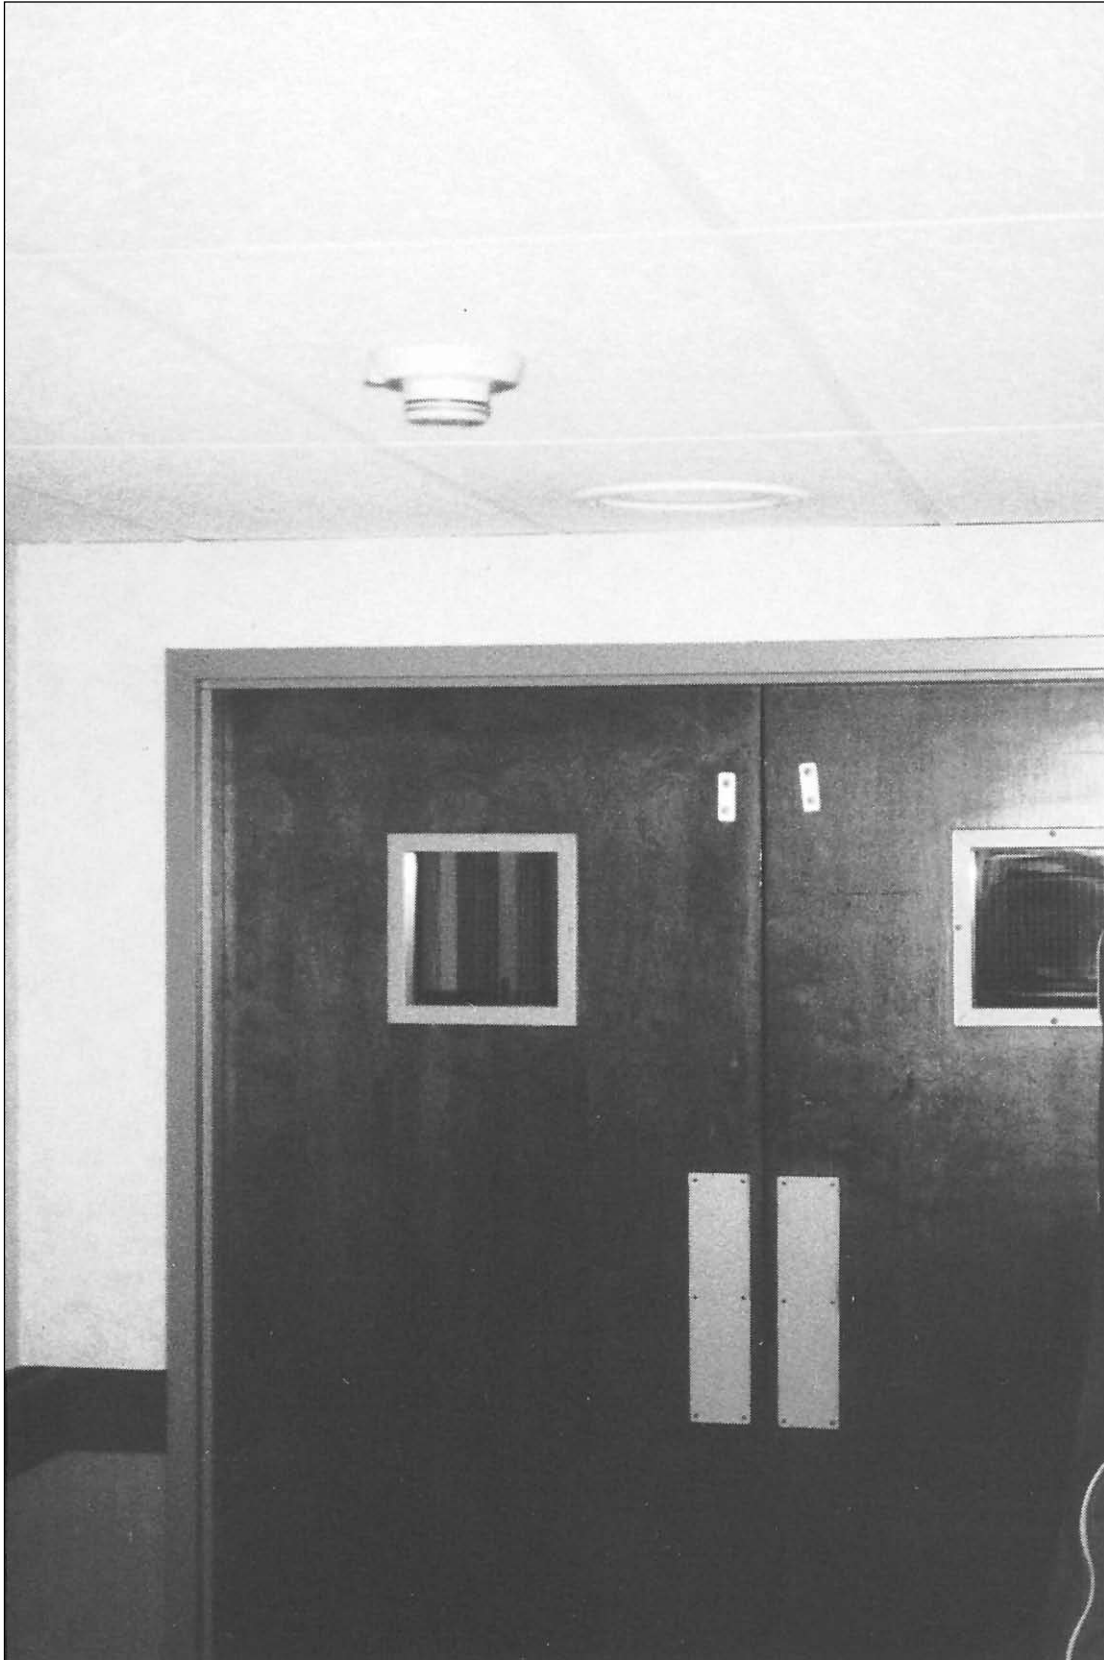
Smoke Barrier Doors	Smoke barrier doors, installed in hallway and equipped with automatic smoke-activated door closures, failed to operate due to blown fuse in fire alarm panel. This allowed rapid spread of heat and smoke throughout second floor.
Code Compliance	Building not subject to current code requirements for fire sprinklers and smoke systems, since it was constructed prior to requirement.
Patient Life Support & Restraint	Many patients restrained to beds with cotton cravats and/or connected to life support systems, making removal by firefighters extremely difficult.
Evacuation	Because of heavy, thick, black smoke and considerable heat, coupled with the fact most occupants were bedridden, rescue and evacuation were difficult and time consuming.
Local Hospital Disaster Plan	Plan was effectively put into operation, thereby providing adequate medical support and transport for the large number of injured.

17. Smoke detector and smoke barrier located on second, third, and fourth floors.

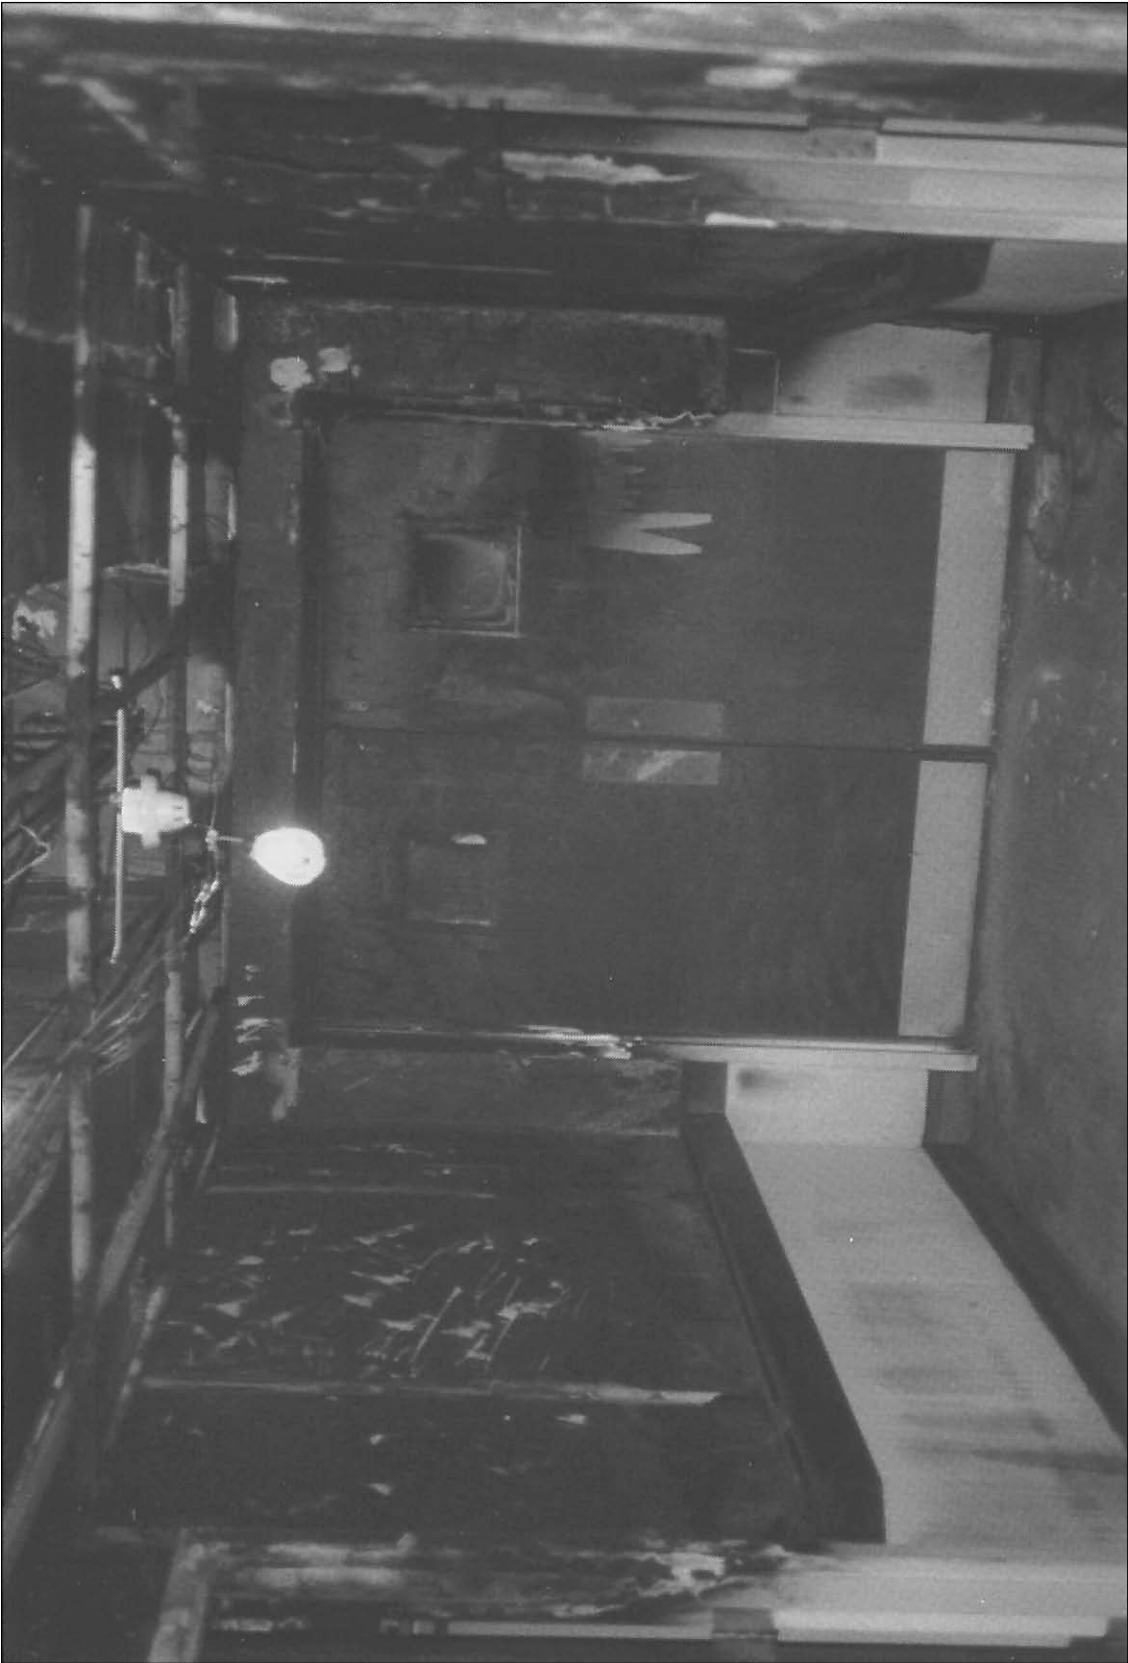
18. Fire damage to smoke barrier doors and to ceiling from room of origin on right.

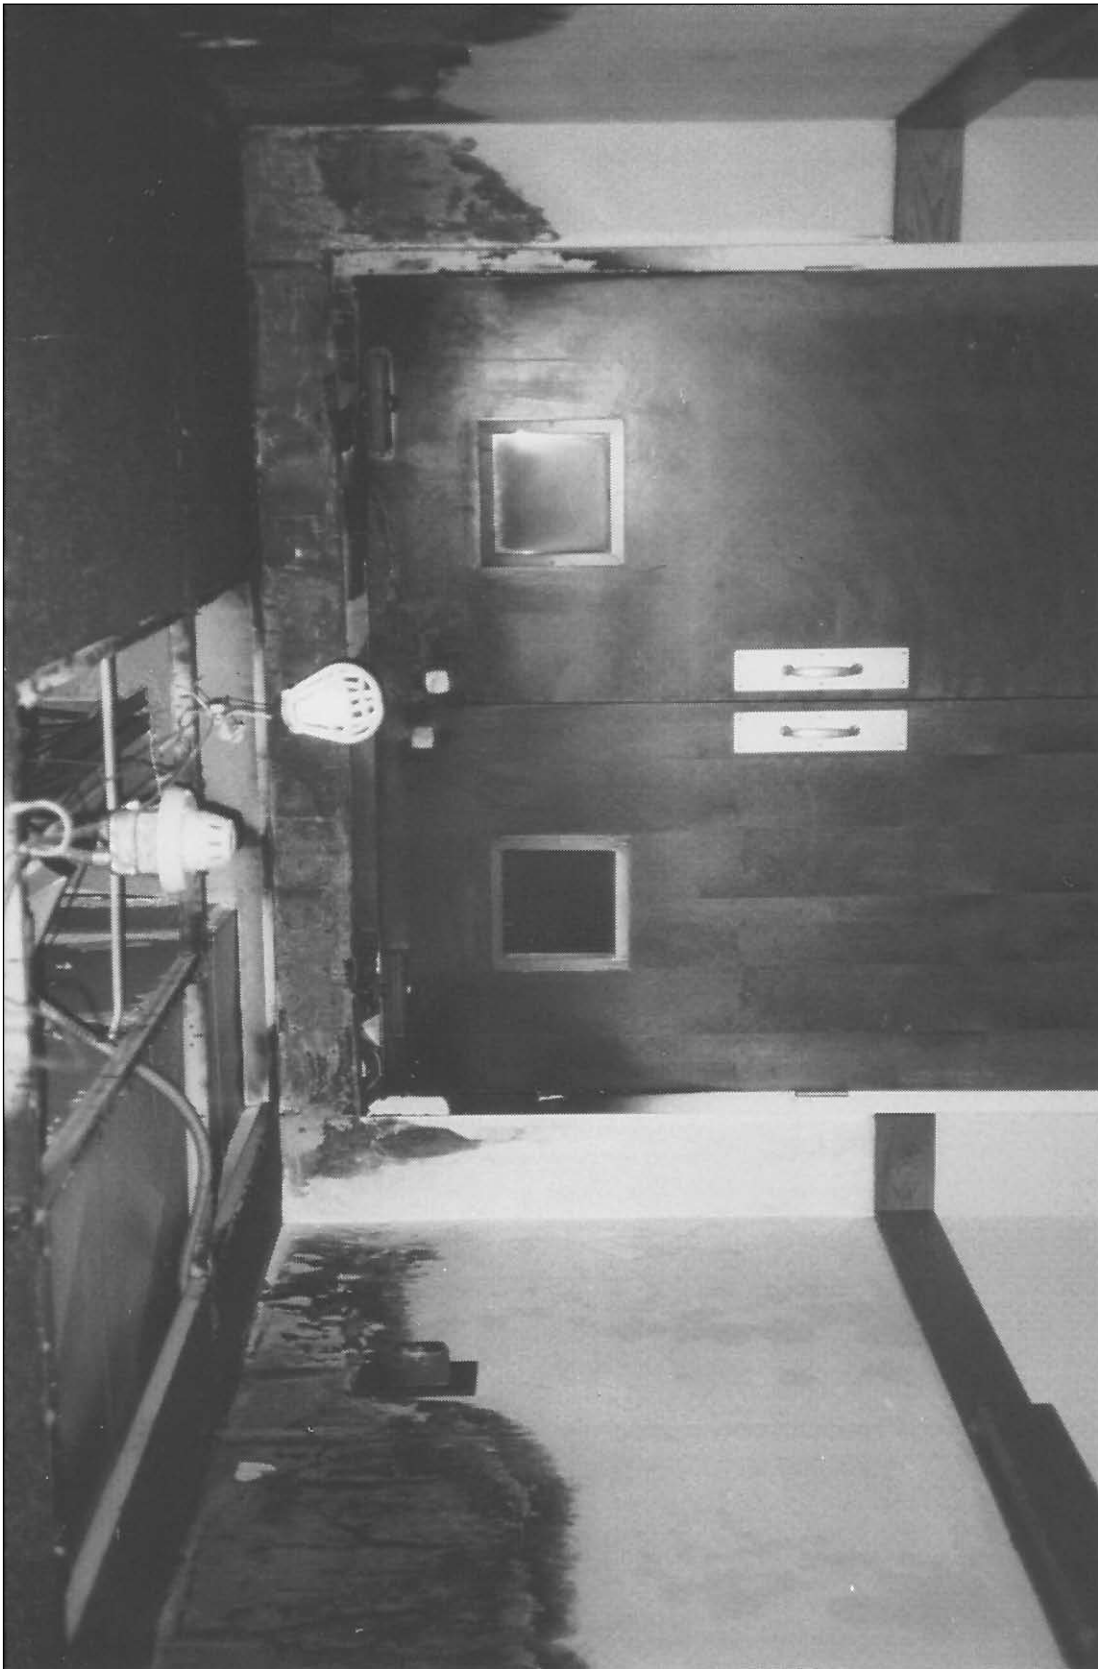
Dollar loss is estimated at \$100,000. Fire completely gutted the room of origin and caused moderate fire damage to ceiling and walls on portions of the second floor. There was heavy smoke damage throughout the second floor, with moderate smoke damage to the third and fourth floors. There was no apparent structural damage.

19. Fire and heat damage to ceiling and walls on opposite side of smoke barrier doors.
