SUBJECT: First Five-Year Review Report  
Piper Aircraft Superfund Site  
Vero Beach, Indian River County, Florida

**First Five-Year Review Report for  
PIPER AIRCRAFT NPL SITE  
The New Piper Aircraft, Inc.  
Vero Beach, Indian River County, Florida**

**December 2003**

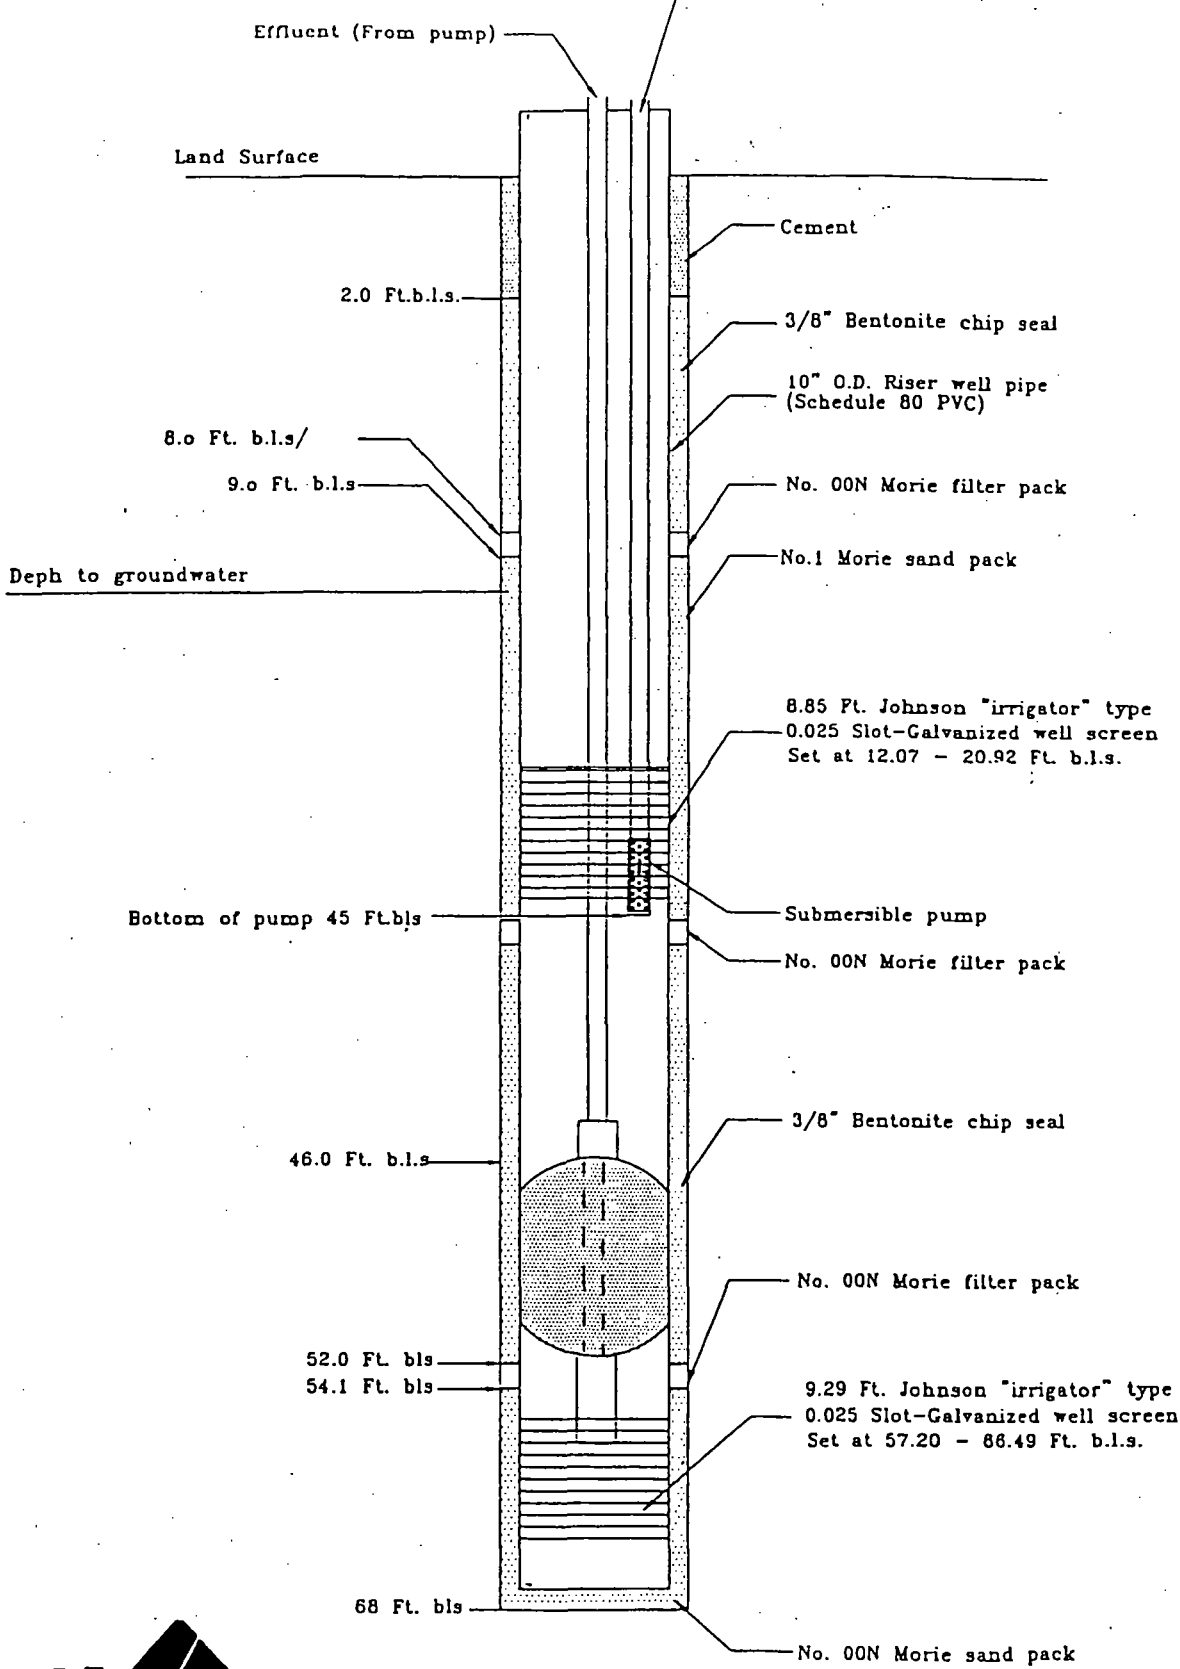
FIGURE 11

Re-development during the construction testing period in May 1998, did not increase the specific capacity of well *UBV-1* significantly. Numerous electrical problems plagued the UVB-1 system during the first year of operation because of unnecessary electrical circuit and design complexities. Frequent troubleshooting and simplifying the electrical cabinet has increased the reliability of equipment and maintained more consistent running conditions.

RECIRCULATING WELL  
 CONSTRUCTION DETAIL  
 UVB-1

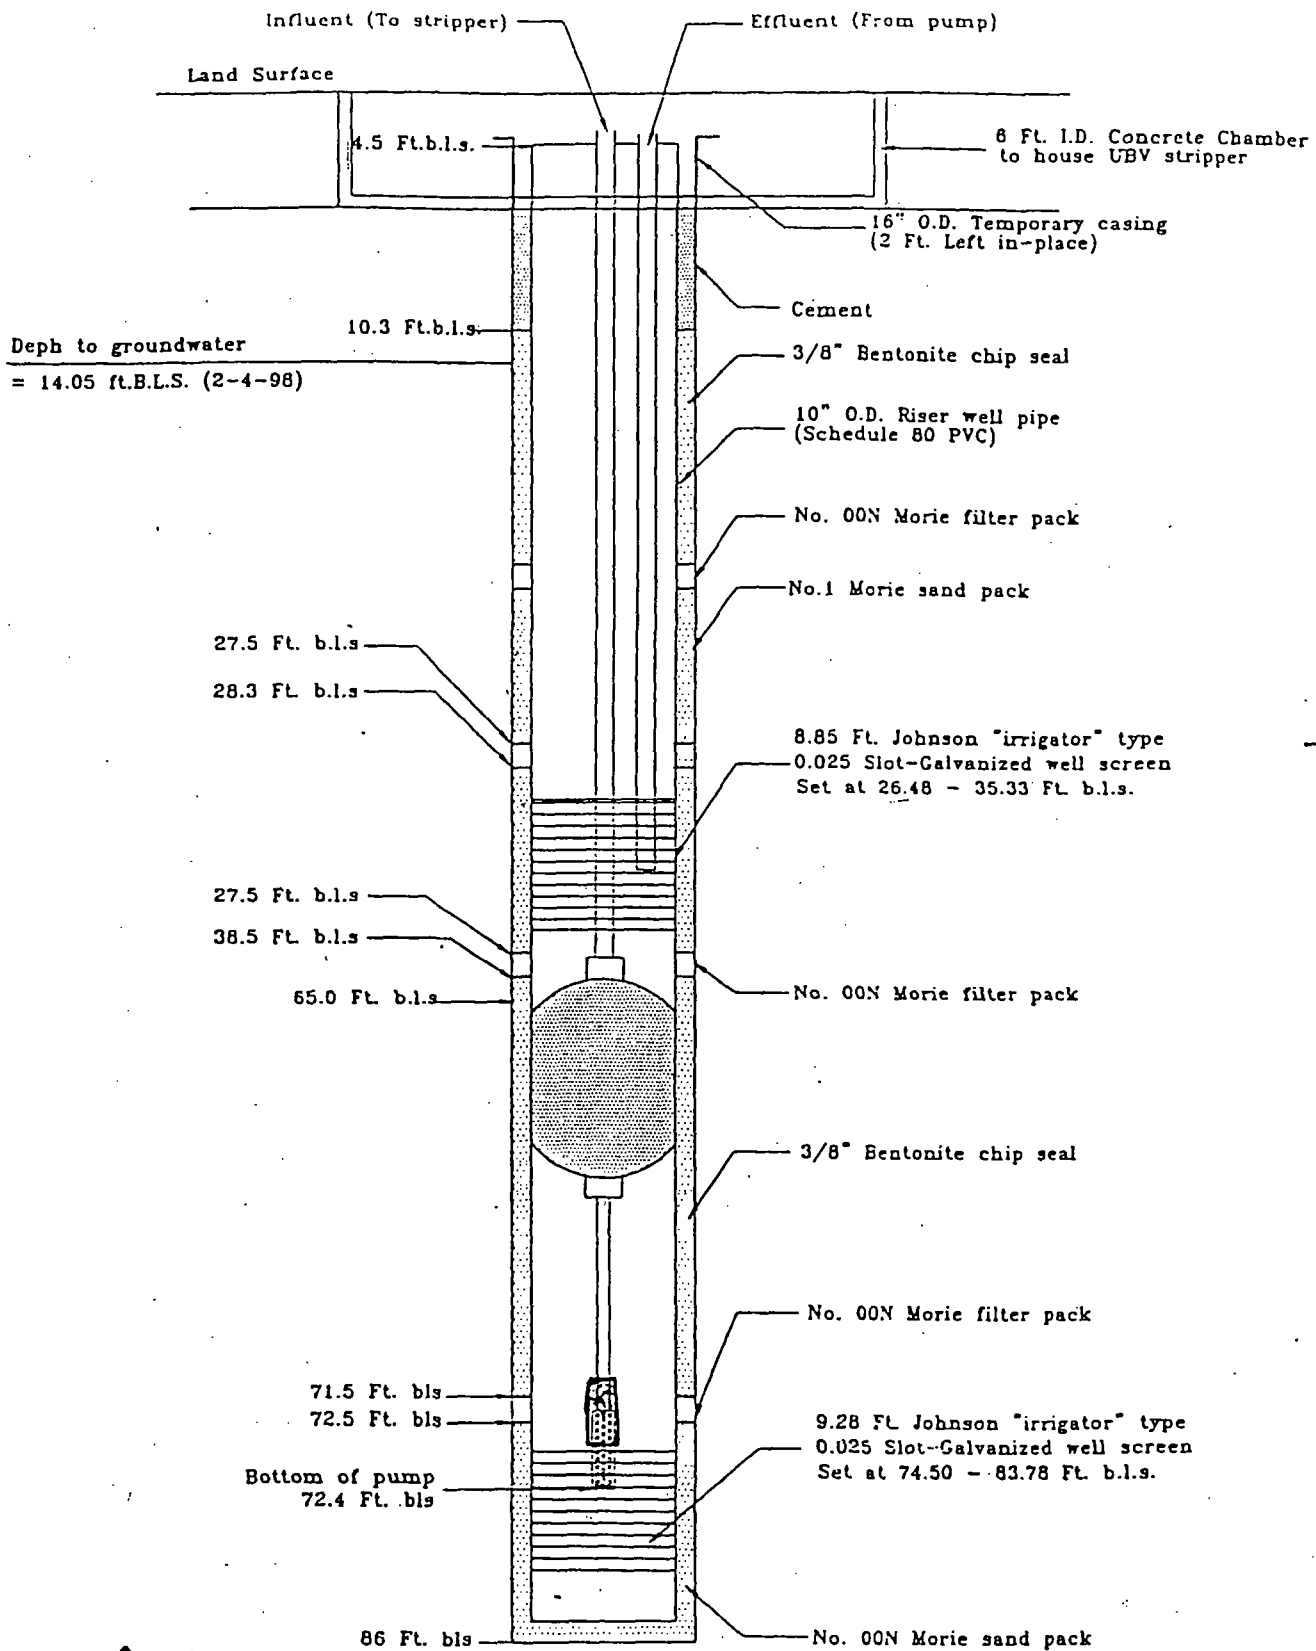
FIGURE 12

In well system UVB-2, the above problems became compounded by failure of the casing well seal (Bentonite), and resultant upward sloping of effluent causing earth sapping under the well vault causing vault subsidence and effluent turbid with bentonite flowing at land surface. It is interpreted that a faulty gravel pack job left the upper part of the upper screen section (see Figure 12), exposed to bentonite seal material. When aquifer materials became resistant to the flow of effluent, the effluent took the path of least resistance funneling up around the

casing sealant followed by progressive subsidence of the well vault. This condition caused the casing to bend, placing stress on pumping equipment in the well.

RECIRCULATING WELL  
CONSTRUCTION DETAIL  
( UVB-2

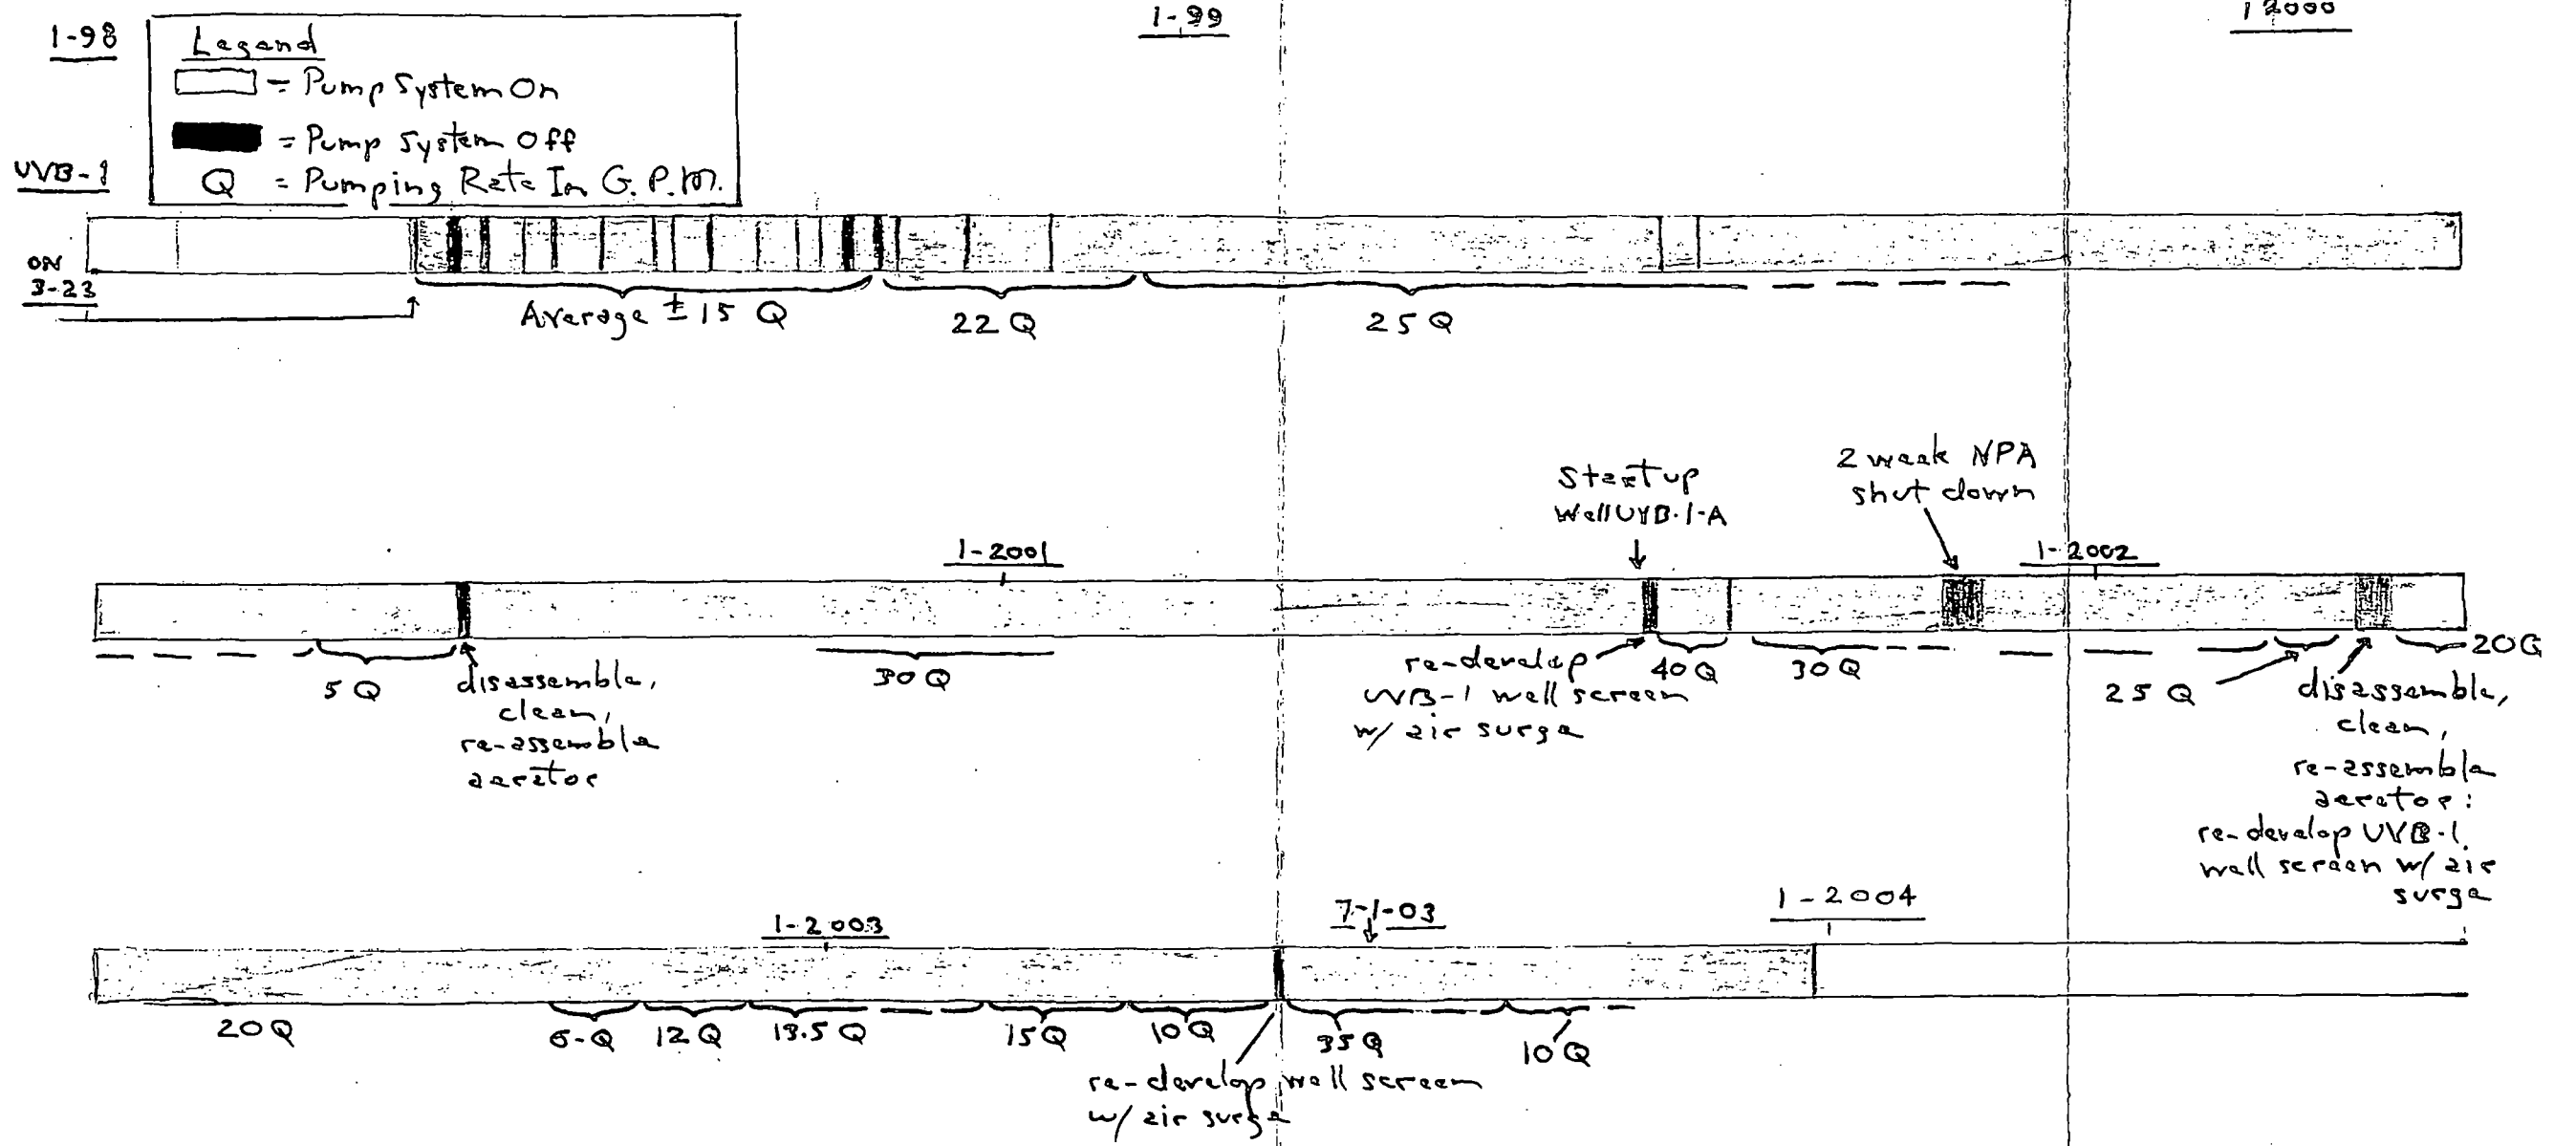
FIGURE 18

Figures 18 & 19 present an operational history of the two UVB wells highlighting significant reasons for system shutdowns including dates of periods to remove red mud from screen sections. The conditions leading to each well development and aerator cleaning were characterized by gradual loss of effluent flow which the receptor wells could accept without overflowing at land surface.

WELL UVB-1  
 FIVE YEAR OPERATIONAL HISTORY
