**NATIONAL TRANSPORTATION SAFETY BOARD
OFFICE OF AVIATION SAFETY
Arlington, Texas 76011**

Summary of Component Examination

DFW08FA062

Aircraft A: N911VA, Eurocopter France AS350B2 S/N 2588

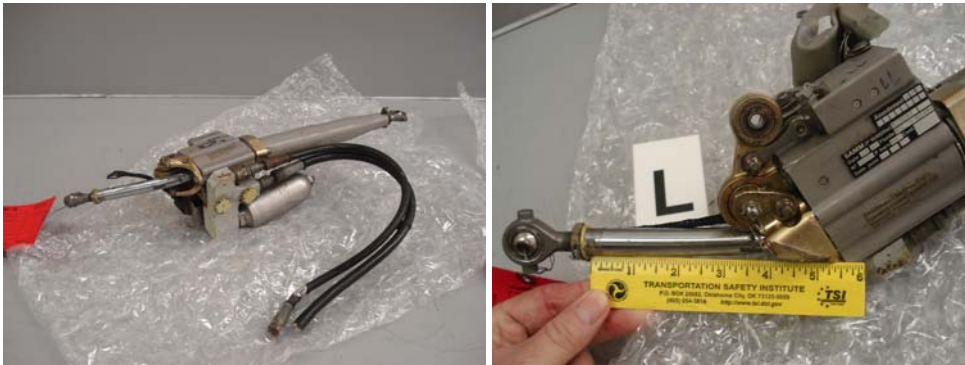
Left lateral main rotor hydraulic servo, Samm/Goodrich P/N 5083, S/N 363:

- Lower rod end bearing to piston rod attachment hardware was in place.
- Piston rod was extended approximately four inches from the lower lock nut to the piston rod gasket.
- Electrovalve was still connected.
- The tapered end remained attached to the servo body assembly.
- One tapered end to servo body assembly attachment bolt was displaced, but remained attached by lock wire connected to the adjacent bolt.
- The accumulator was attached to the servo body assembly.

- After initial photos the servo was disassembled.
- The piston head with seal was intact.
- The upper and lower bearings moved freely up and down the piston rod to the bend.
- No binding was observed on the lever assembly.
- The slide valve of the distribution assembly was free to move.
- Spring action on the bypass valve was noted.
- No vertical scoring was observed within the tapered end liner.

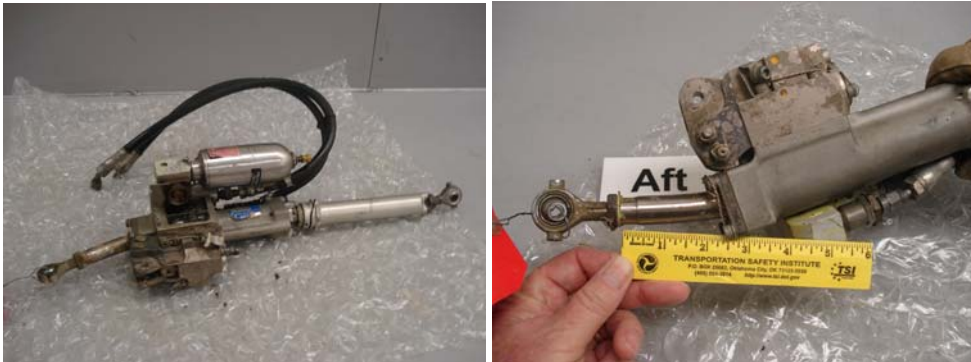
Fore/aft main rotor hydraulic servo, Dunlop P/N AC67246, S/N EAV015:

- Lower rod end bearing to piston rod attachment hardware was in place.
- Piston rod was extended approximately two and a half inches from the lower lock nut to the piston rod gasket.
- Electrovalve had separated.
- Extension piece was cracked and separated from the servo body assembly, with its attachment bolts still connected to servo body assembly.
- The accumulator was attached to the servo body assembly and was dented.

- The extension piece was found separated from the servo body assembly, which allowed contaminants to enter servo (see above notes from external exam).

- Corrosion, sand, and contaminants were noted throughout the servo assembly.
- After initial photos the servo was disassembled.
- The piston head with sealing ring was found intact; wiping ring exhibited compression damage, likely due to impact.

- The upper and lower bearings moved freely up and down the corroded piston rod to the bent areas.
- The inner and outer seals of both bearings were found intact.

- No binding was observed on the lever assembly.
- The slide valve of the distribution assembly was free to move.
- Corrosion and sand were observed within the extension piece and spool assembly of the servo valve assembly.

- Spring action on the plunger lock was noted.
- The inner surface of the servo body assembly exhibited corrosion and pitting.
- No vertical scoring was observed within the extension piece or servo body assembly.

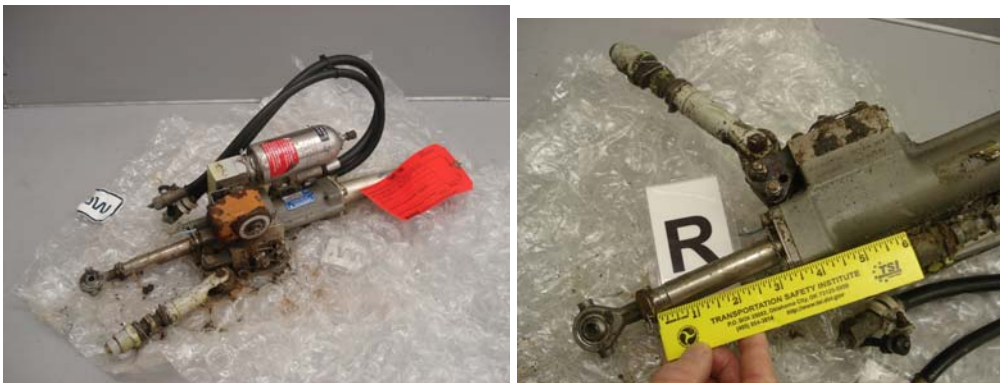
Right lateral main rotor hydraulic servo, Dunlop P/N AC67244, S/N CB215:

- Lower rod end bearing to piston rod attachment hardware was in place.
- Piston rod was extended approximately three and three-eighths inches from the lower lock nut to the piston rod gasket.
- Electrovalve was still connected.
- Extension piece remained attached to servo body assembly with external vertical scoring.
- The upper portion of the control input rod was present and attached to the lever assembly.
- The accumulator was attached to the servo body assembly.

- After initial photos the servo was disassembled.
- The piston head with sealing ring was found intact; wiping ring was in place and exhibited compression impact damage.
- The upper and lower bearings moved freely up and down the piston rod to the bent areas of the piston rod.
- The seals of both inner bearings and outer sealing ring of upper bearing were found intact.
- Damage was observed to the outer sealing ring of the lower bearing.
- No binding was observed on the lever assembly.
- The slide valve of the distribution assembly was free to move.
- Spring action on the bypass valve was noted.
- Corrosion and sand were observed within the extension piece and spool assembly of the servo valve assembly.
- No vertical scoring was observed within the extension piece or inner servo body assembly.
