**Lockheed**
Missiles & Space Company, Inc
Huntsville Research & Engineering Center

RESULTS OF TESTS OF THE SRB
AFT SKIRT HEAT SHIELD
CURTAIN IN THE MSFC HOT
GAS FACILITY

February 1982

Contract NAS8-32982

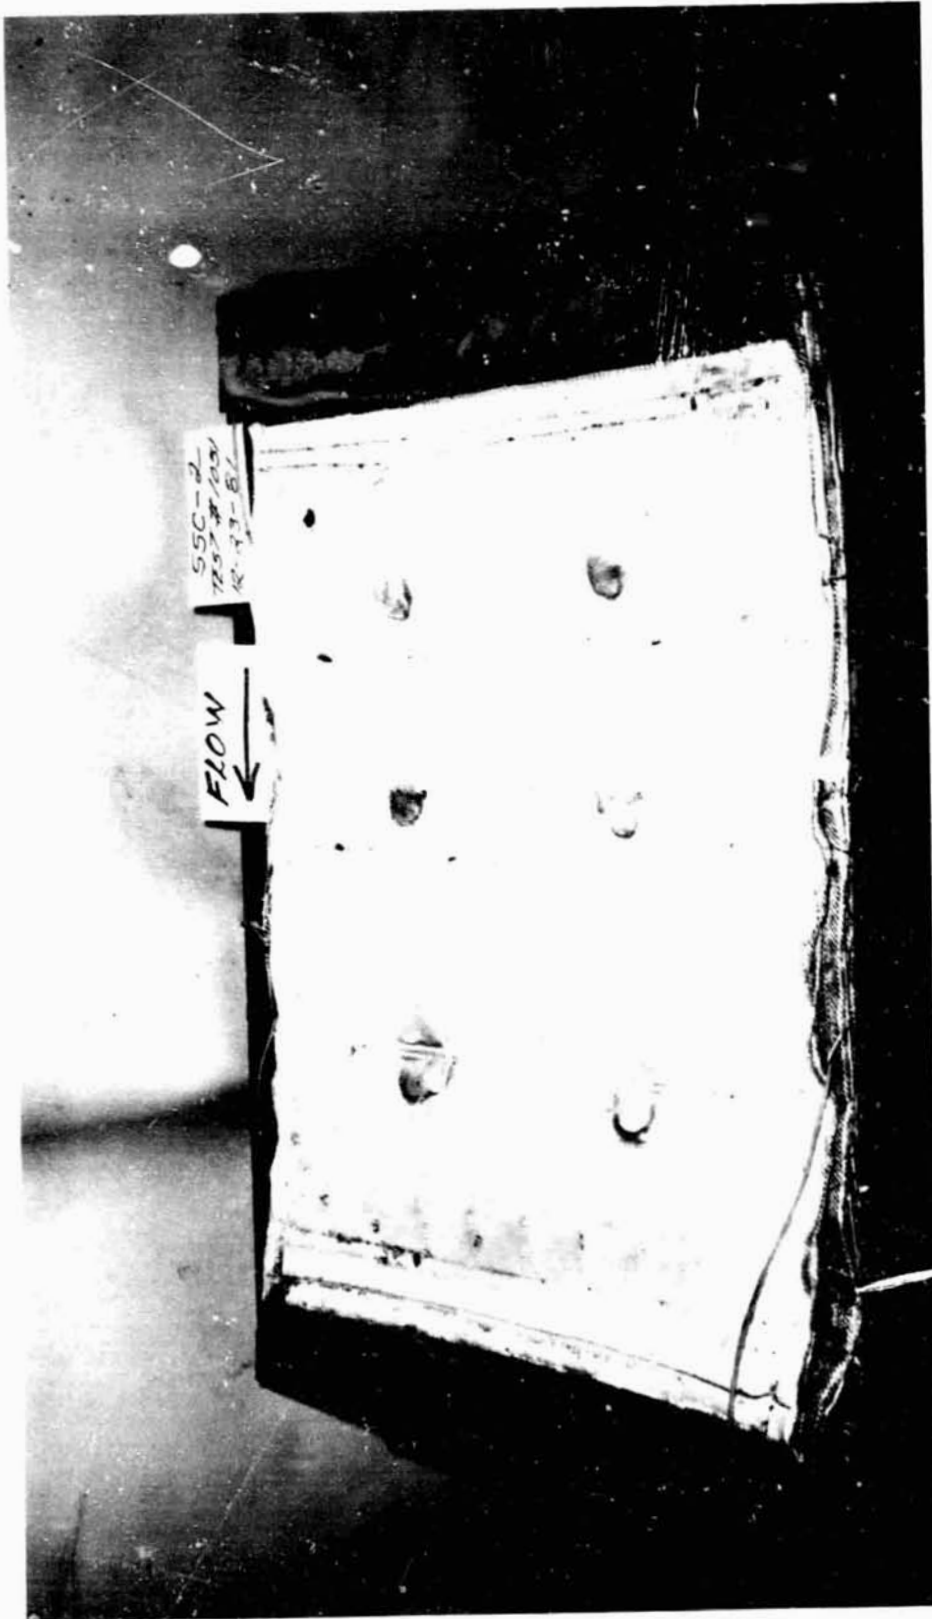
Fig. 5 - Pretest Photo of Curtain Specimen - SSC-2

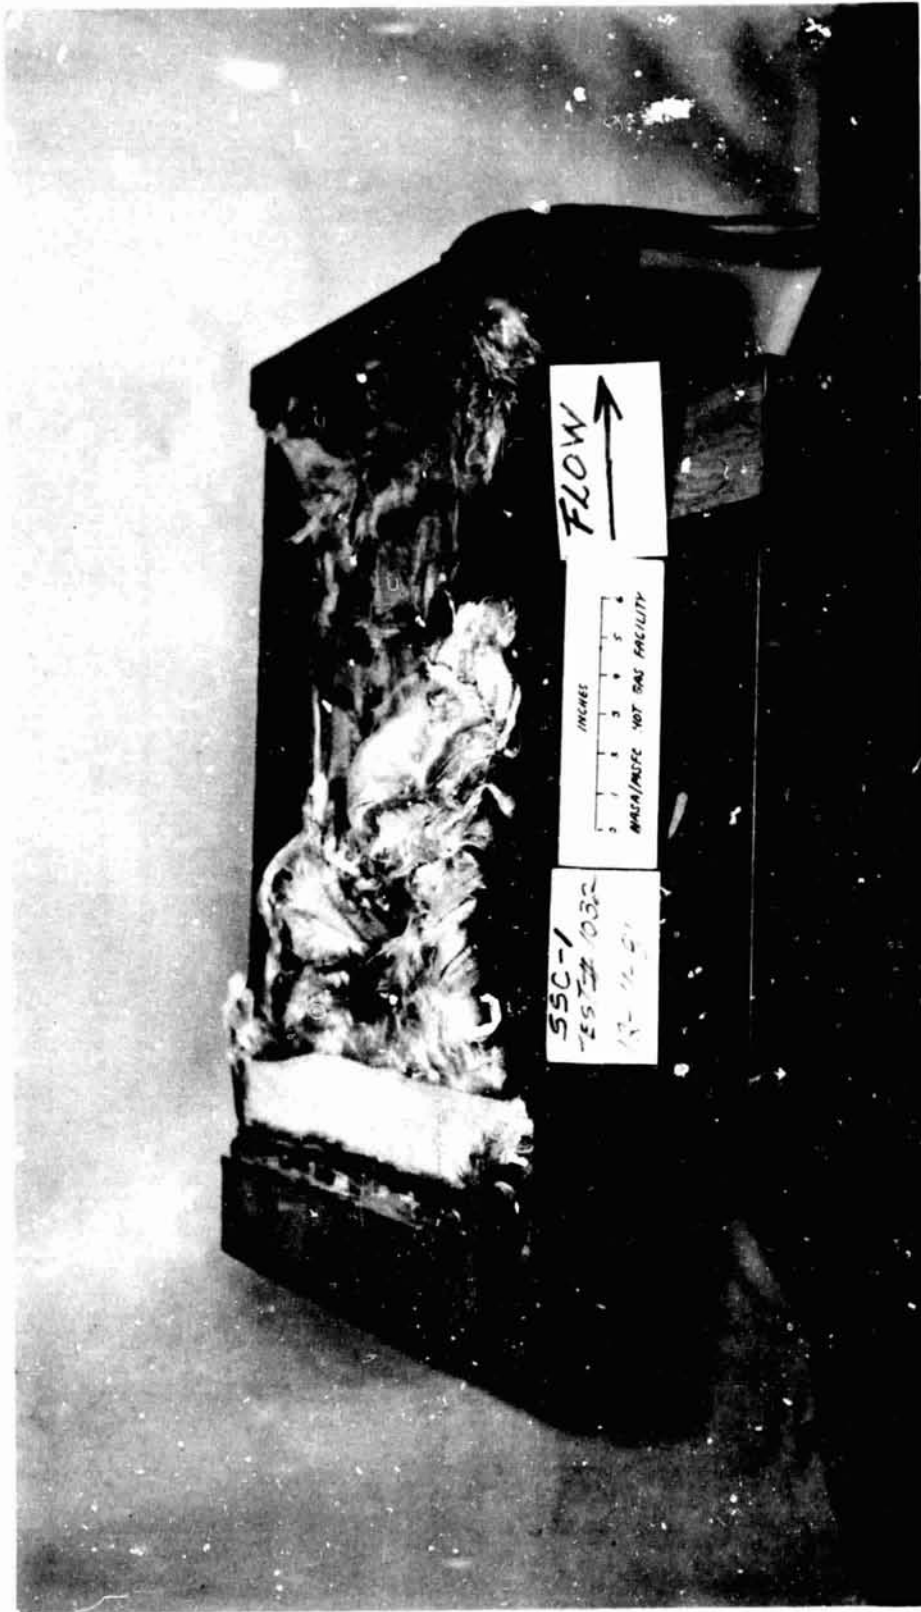
Accelerometer data are shown in Figs. 24 through 29. These g-levels ranged up to approximately 300 g, showing that very severe motion of the curtain occurred. Post-test inspection of the curtain showed that all layers of the blanket burned through. A review of the test movies showed that the curtain outer layers shredded early in the test, indicating severe flutter and flapping of the curtain resulting in the complete shredding by this action. A post-test photograph of the curtain is shown in Figure 30.

Fig. 30 - Post Test photo of Curtain SSC-1

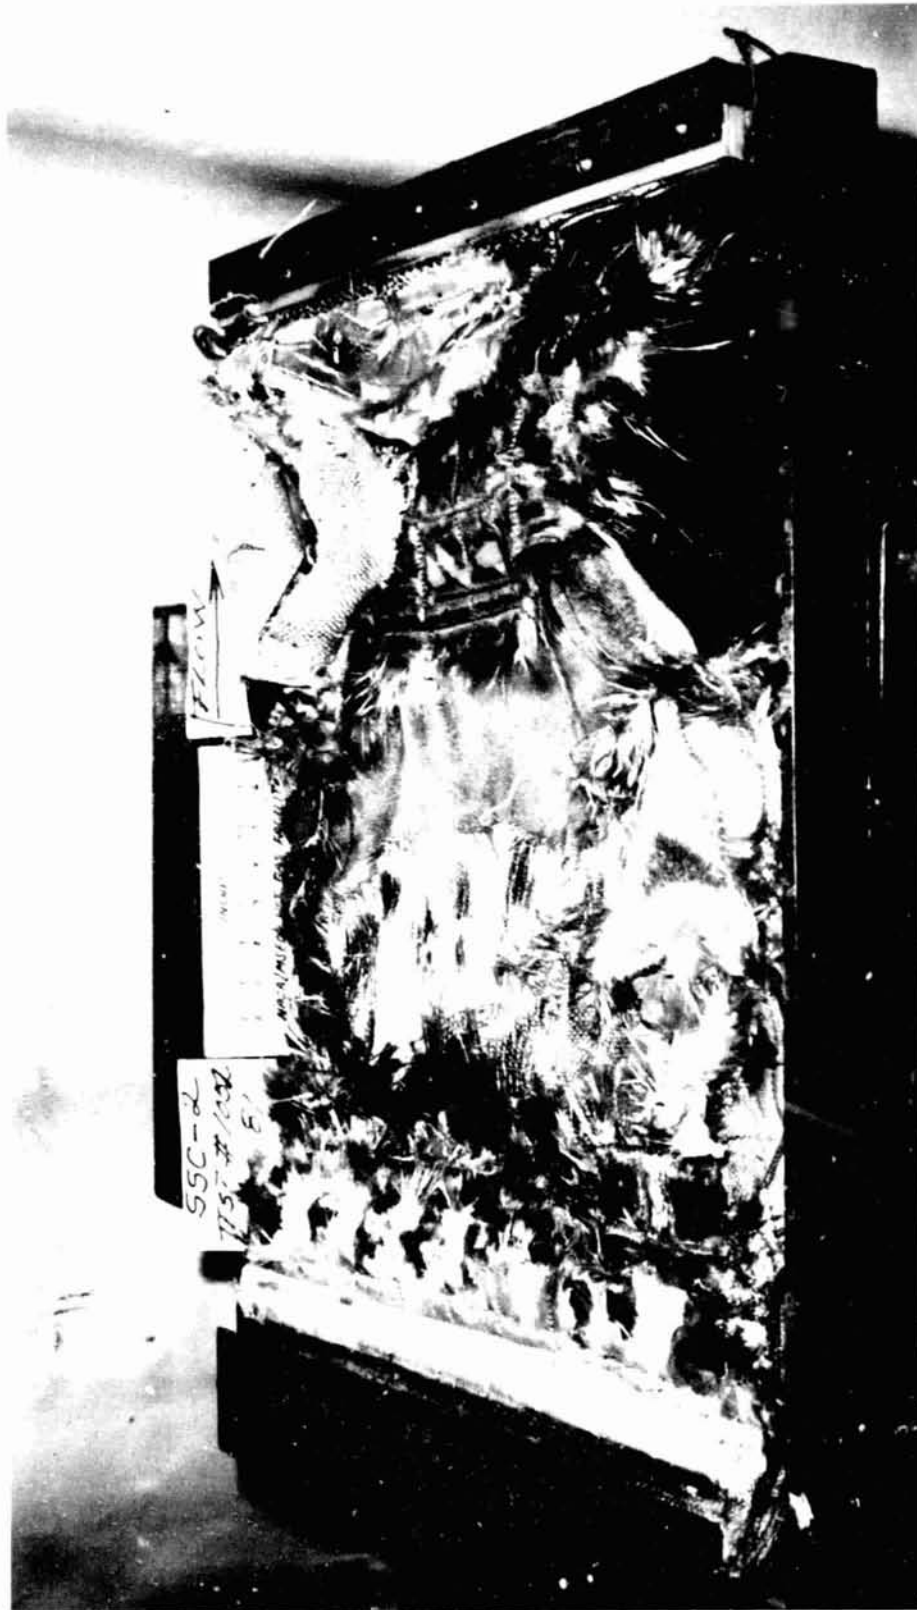
Post-test examination of this curtain showed that SSC-2 was in better condition than SSC-1. However, all layers burned through except the very last one. This better end condition was probably due to the difference in the total test time - when cold flow time is included. Also, this was probably due to part of the cold flow test on SSC-1 being performed after the hot flow test in the HGF. A post-test photograph of SSC-2 is shown in Fig. 54. From this photograph it is obvious that SSC-2 was in better condition after the test than was SSC-1.

Fig. 54 - Post Test Photo of Curtain SSC-2
