EVALUATION OF HEAD AND FACE INJURY POTENTIAL
OF CURRENT AIRLINE SEATS DURING
CRASH DECELERATIONS

June 1966

Office of Aviation Medicine
FEDERAL AVIATION AGENCY

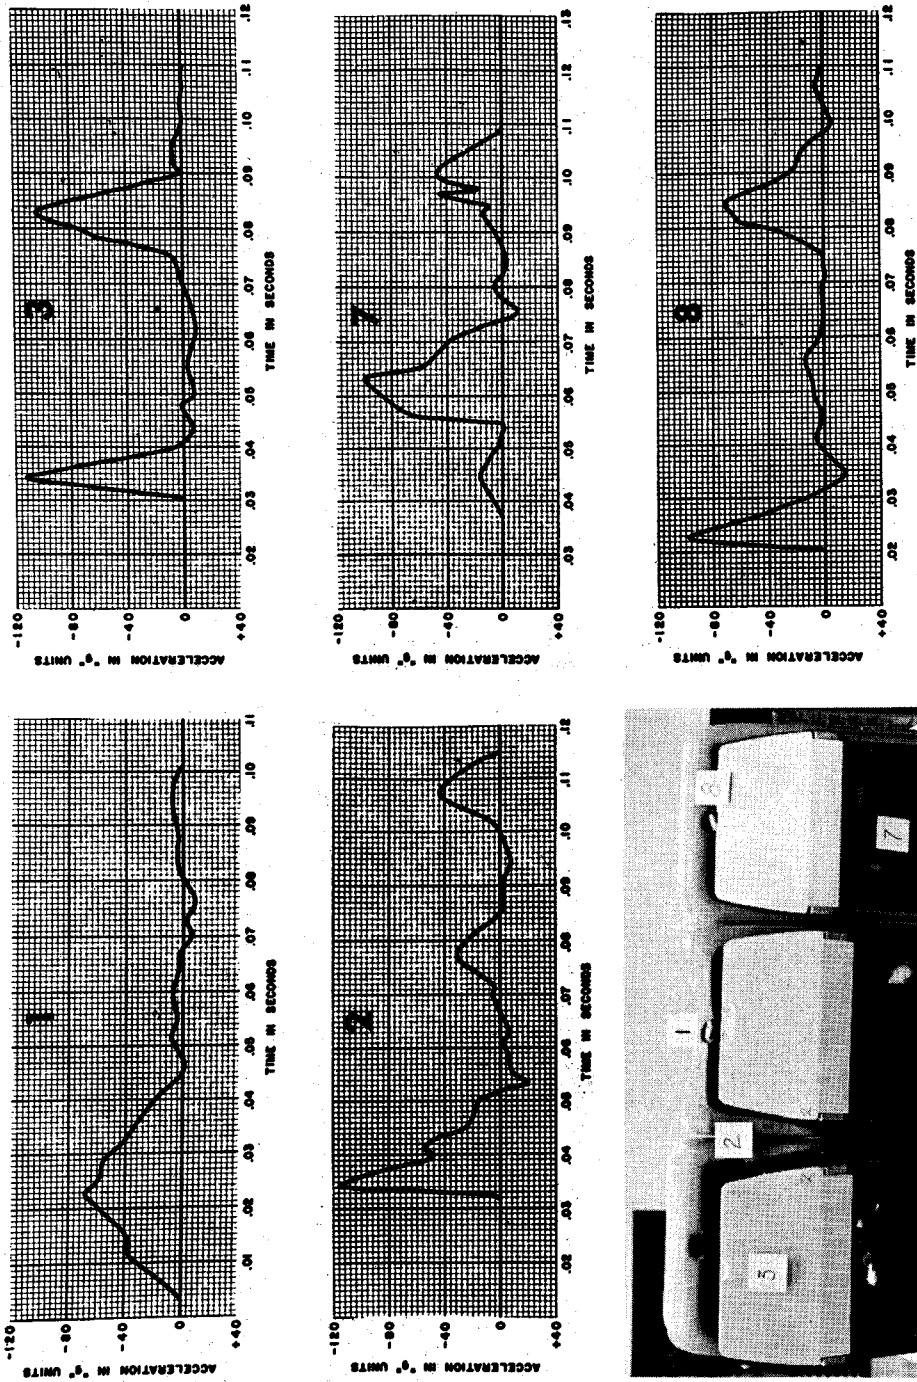
FIGURE A1. Seat A.

Five impacts of the dummy head were made against Seat A at the points shown in Figure A1

(Figures A1 through A10 are in the Appendix.) by numbers 1, 2, 3, 7, and 8. Corresponding "g" time-force curves are presented. Impact #1 (on the top of the middle seat) produced a sizeable deformation in the soft metal structure. The metal deformed readily and *contoured* to the head, distributing the force over a large area of the skull. The peak force was about 70g with a slow rise time (20 milliseconds). The deceleration extended over 40 milliseconds. Referring to Figure 1, we would expect this impact to produce no bony injury if struck by the forehead or teeth-maxilla areas, but it would be of sufficient force to fracture a single zygomatic (cheek bone), nose, or mandible (jaw bone). In all five instances, however, the passenger would be rendered unconscious.²

Impact #2 was between the left and middle seats with the seats in the upright position. Most of the force (120g peak) was used in forcing the seat backs to break forward. There was little deformation of the seat structure, causing the impact loads to be concentrated on a small area of the head. This would have produced fatal fractures. It is of interest that a steady pull of only 10 to 12 pounds is needed to force one of these seat backs forward.

Impact #3 against the center of the serving tray in the left seat back (with the seat upright) produced two peaks of over 100g: one when the seat back was forced forward and the other when the head subsequently struck the lower cross member of the seat back. There was no deformation of the serving tray. Estimates of injury potential presented in Table 1 are based on a previous report² and the area of contact of structure with the head. For injury estimates for the following figures, refer to Table 1.

Some seat-design engineers feel that under actual crash conditions the "break-away" type of seat back will fold forward from its own momentum out of the way of the head. If this is true, the head possibly will strike the lower portion of the seat back or a tubular cross member. Impact #7 simulates this condition. The right seat back was impacted in the forward position. In the graph for #7, the first small peak of about 15g was produced in bending the thin metal at the bottom of the seat before the head made contact with the heavy tubular cross member concealed beneath it. At that time a very lethal, long-duration (20 milliseconds) force of over 100g was applied to the head.

Impact #8 was against the top of the right seat back (seat upright) at the top edge of the serving tray. Note similarity of curves 3 and 8.

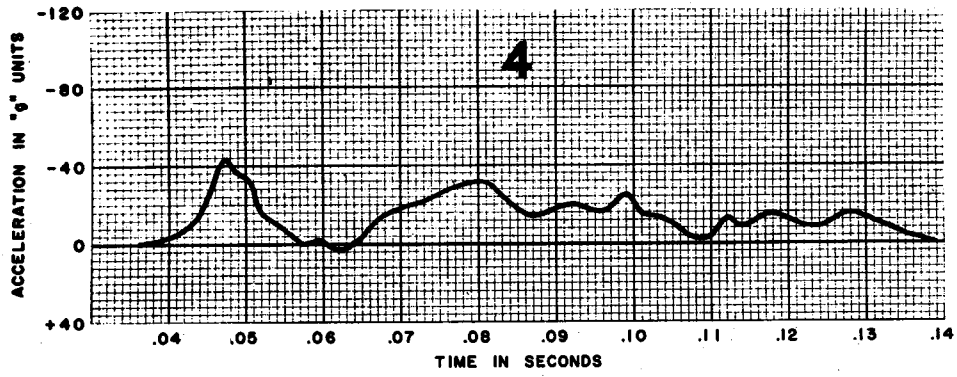
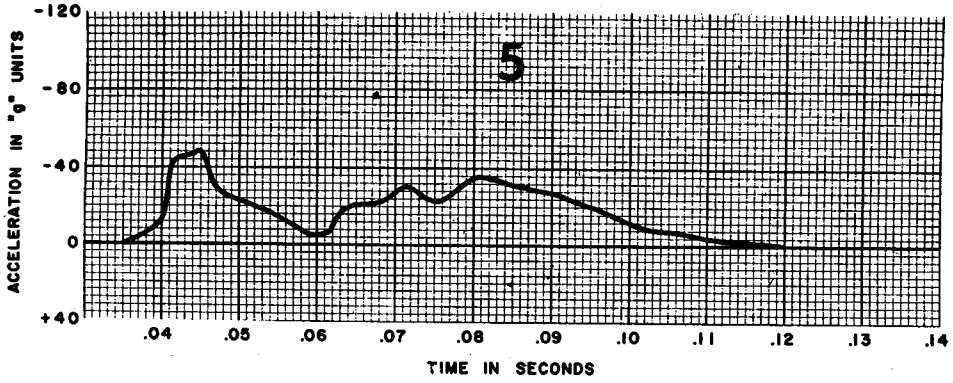
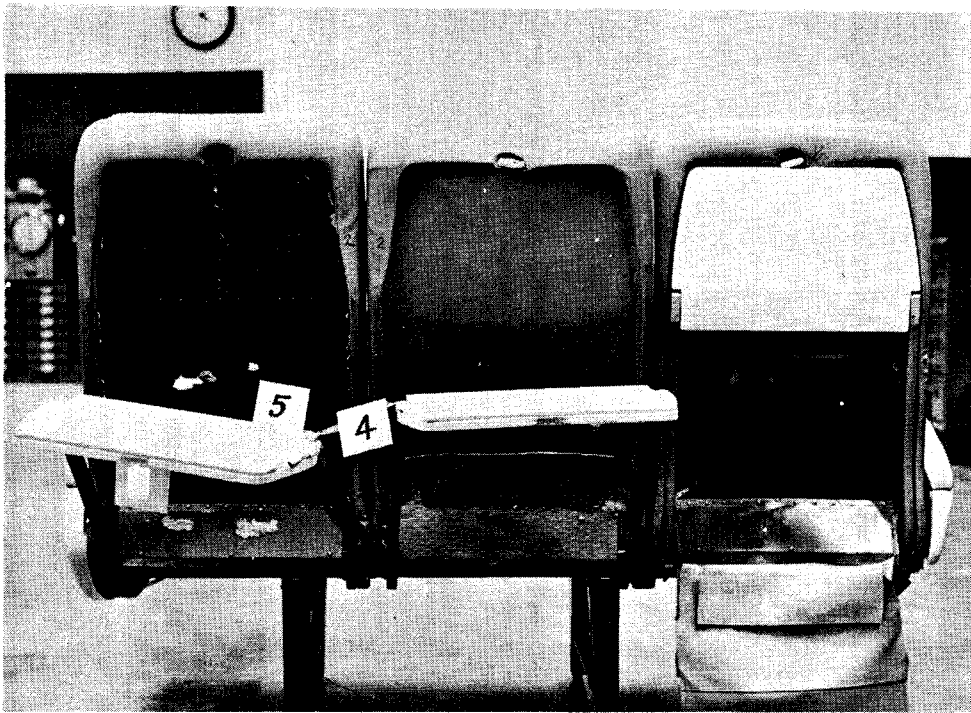
FIGURE A2. Seat A.

Since the arms supporting the folding serving trays have broken off in some airline crashes and caused serious injury, two impacts were made on the unfolded trays of Seat A (Figure A2). Impact #4 was centered in an area between the left and center trays, whereas impact #5 was against the right edge of the left seat tray. The tray support arms in both cases bent several inches but did not fracture. The impacts produced long duration forces of about 40g or less.

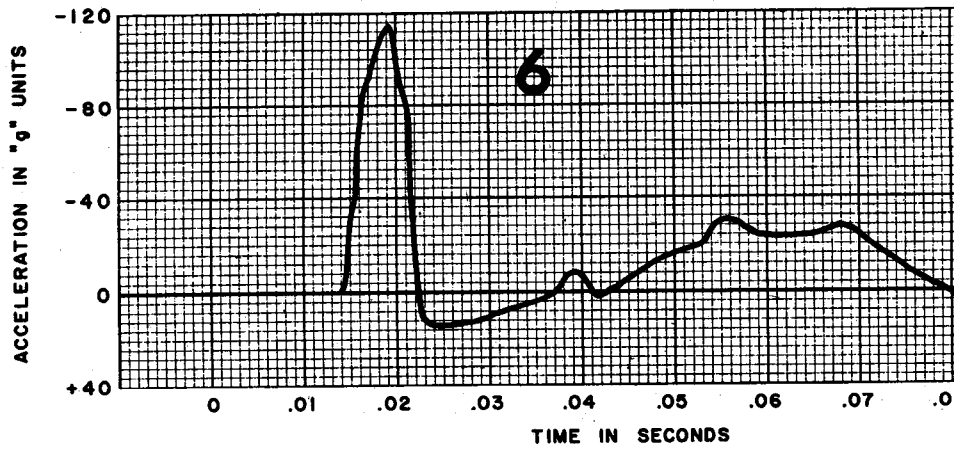
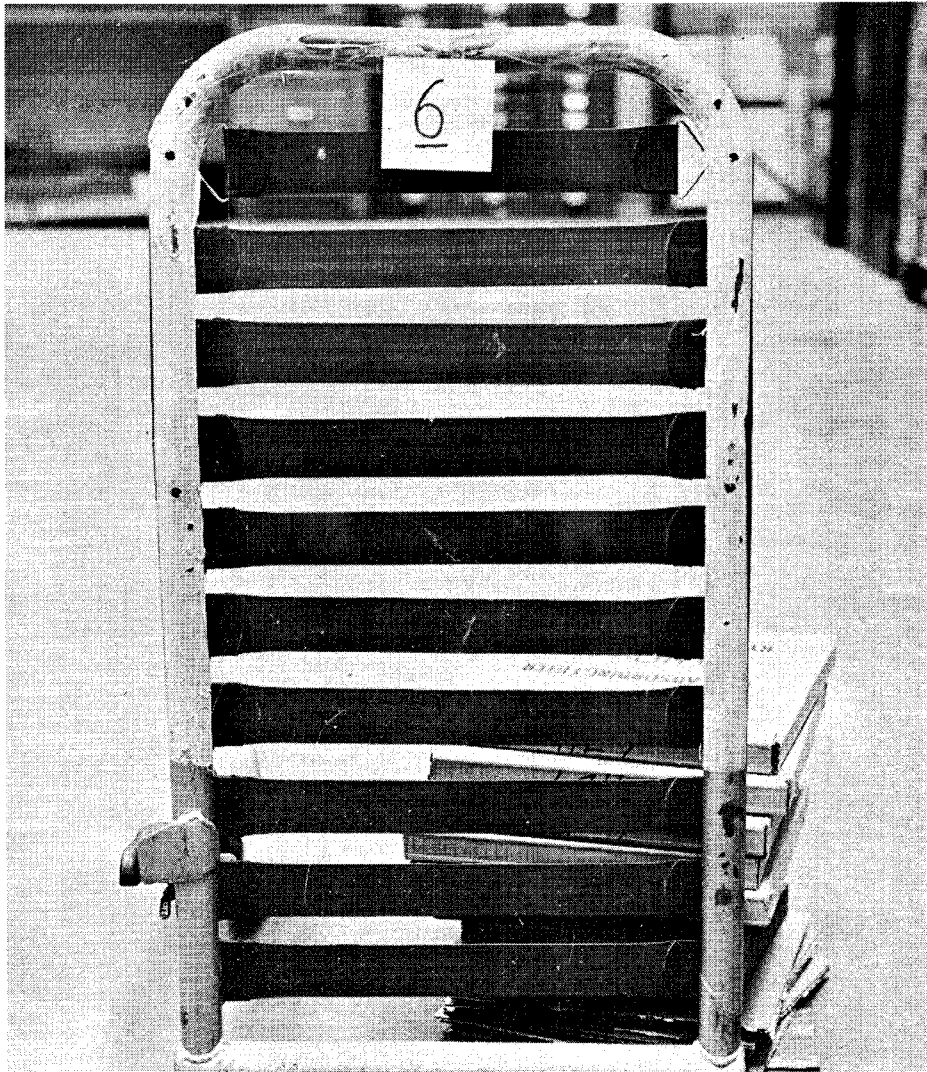
FIGURE A3. Seat B.

In Figure A3, the dent left by the head impact against the top tubular structure (Seat B) is barely visible in the photograph. The sharp

rising 120g peak force applied to an area of not more than 1 sq in. of the head would undoubtedly have caused fatal injuries.

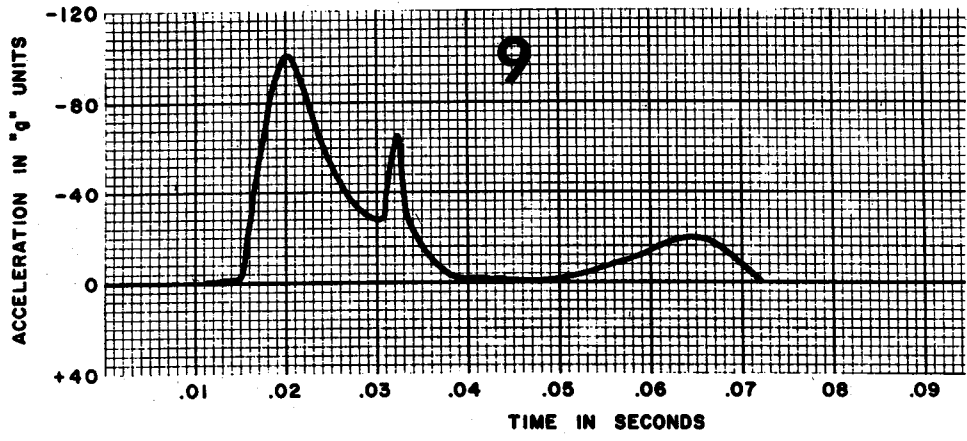
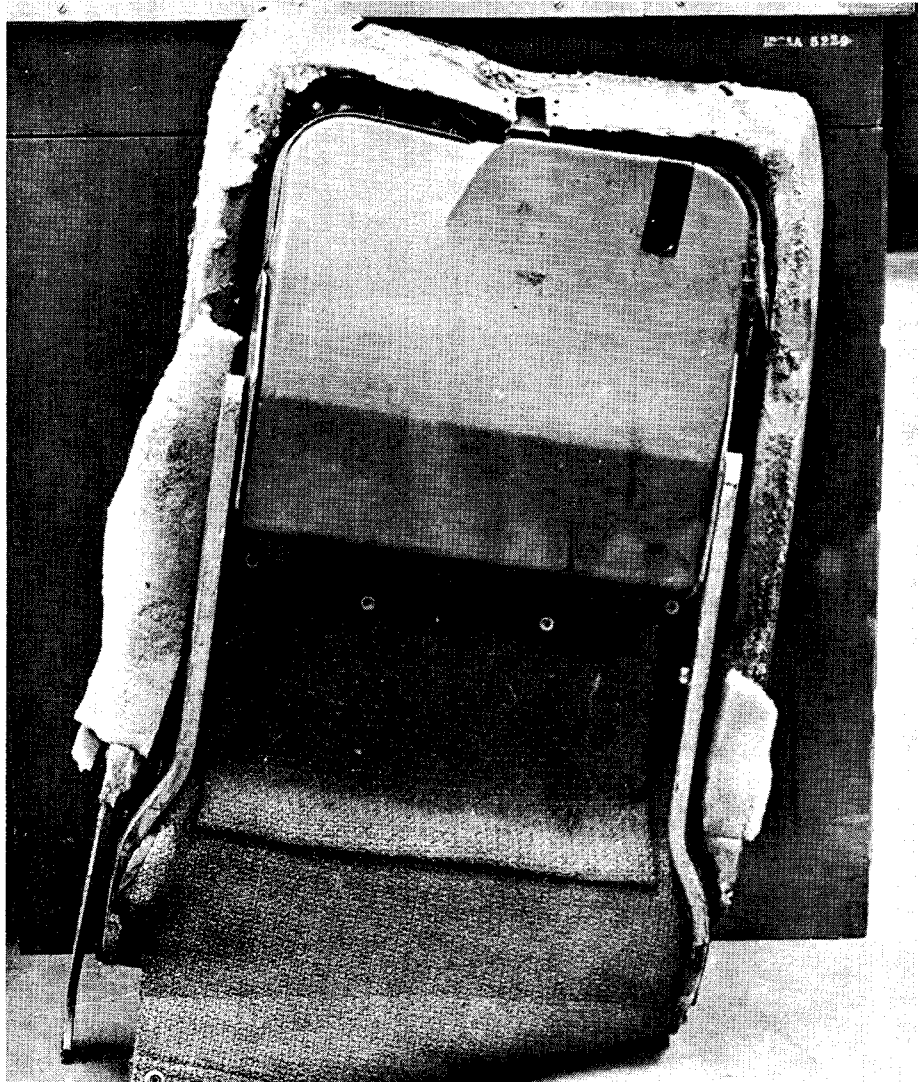
FIGURE A4. Seat C.

Impact #9 against the top edge of Seat C produced a somewhat larger dent (Figure A4). The g-force curve looks almost as severe as the one in Figure A3; however, there is one important difference. Since the metal did deform and contour to the curvatures of the head, the pressure in pounds per square inch on the head would be much less than in the previous figure and the danger of injuries reduced accordingly.

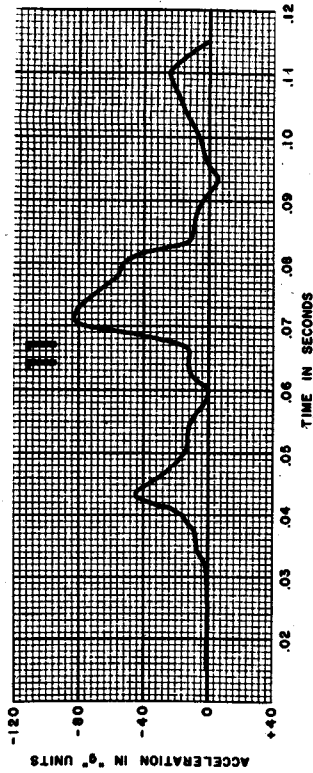
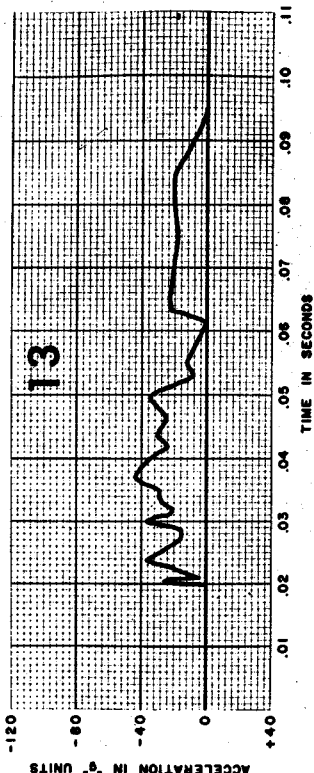
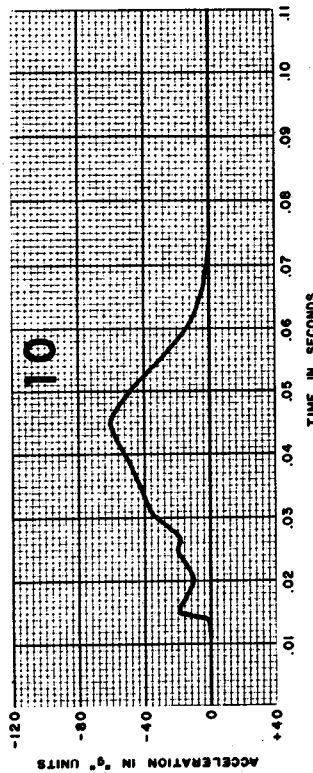
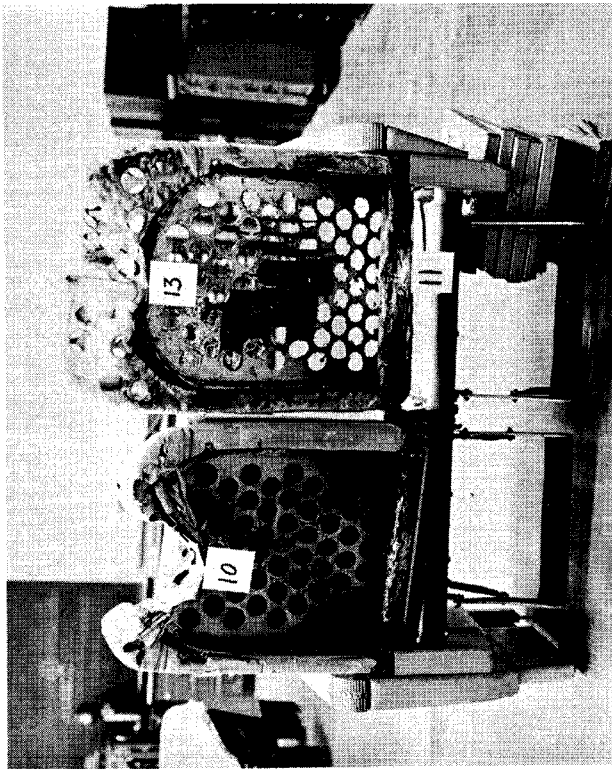
FIGURE A5. Seat D.

Three impacts against Seat D in Figure A5 show that it is a fairly safe seat for head impact. The top edge of the left seat back (test #10) deformed 11 inches and contoured perfectly to the head. Note that initial bending of the structure started at 20g and that the force is spread out with a slow rise time and a peak of not over 60g. Test #13 against the top rear surface of the right seat back shows a more desirable pattern. The head did not experience over 40g; however, test #11 against the tubular cross member at the bottom of the right seat back produced peak forces in excess of 80g. Throughout this report this type of tubular structure is shown to be very dangerous and undoubtedly causes a large number of head and leg fractures. This area of the seat requires additional safety-design consideration.

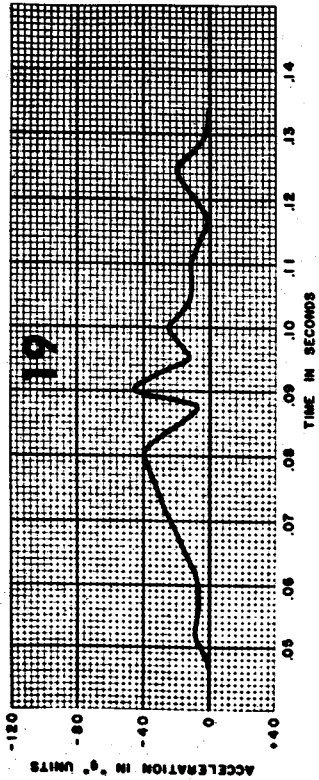
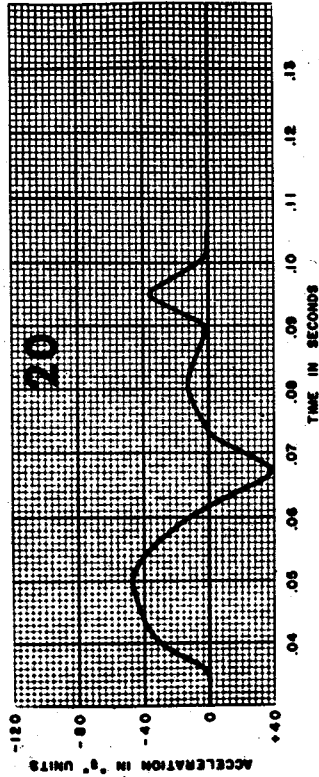
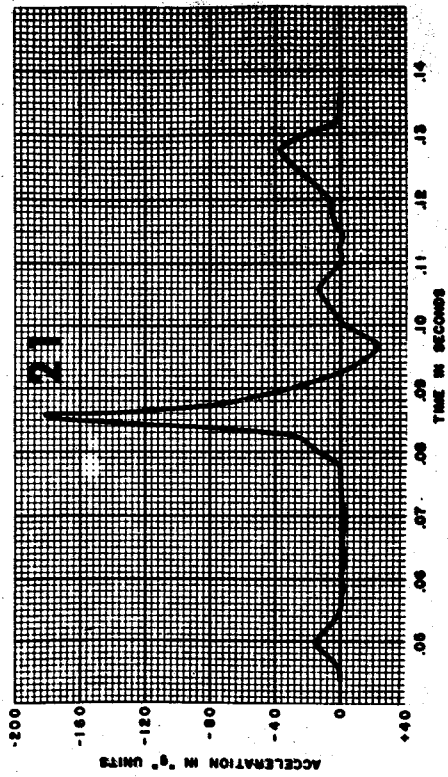
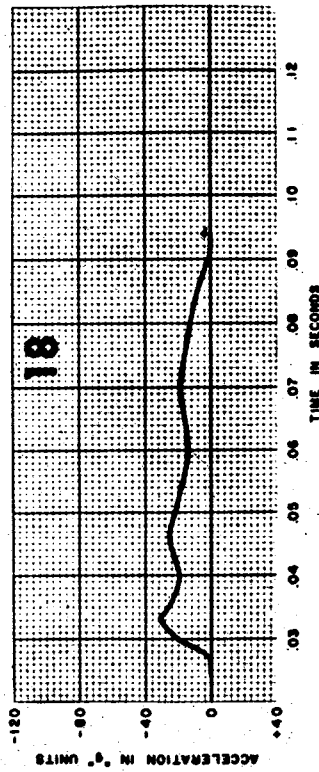
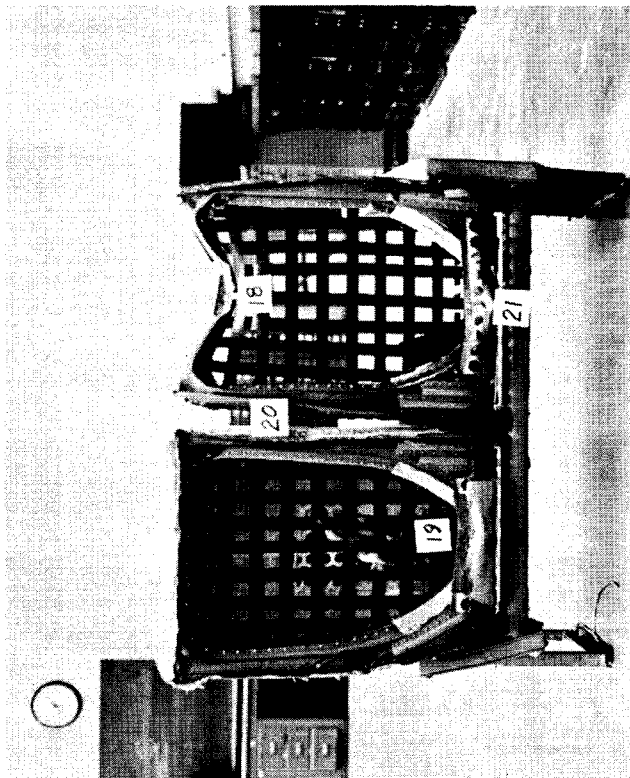
FIGURE A6. Seat E.

Seat E in Figure A6 (mostly fabricated of sheet aluminum) is shown by the force curves to have very good deforming characteristics with the exception of the lower tubular cross member, which produced fatal impact forces of 180g.

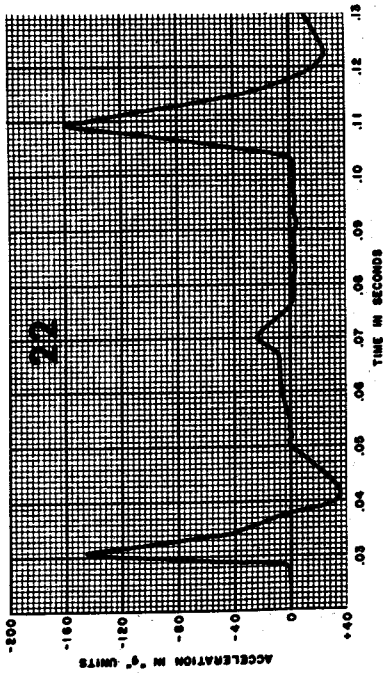
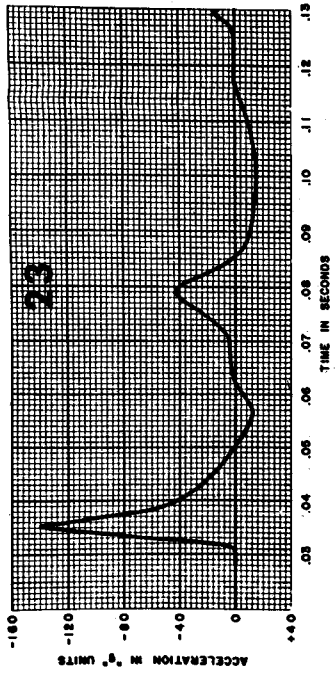
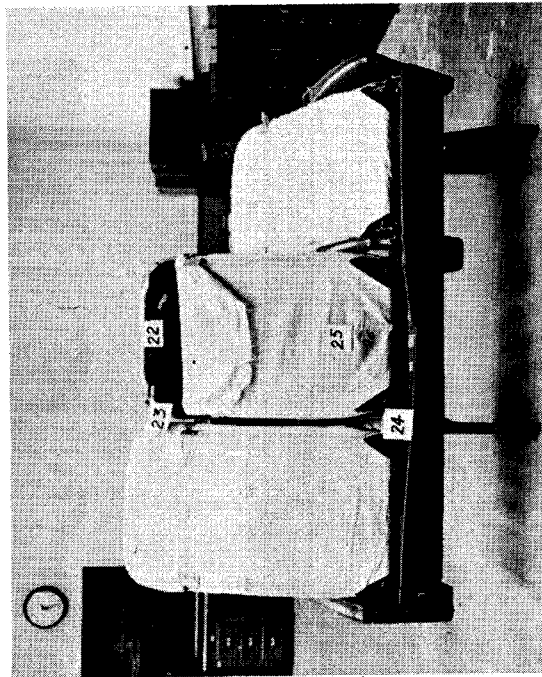
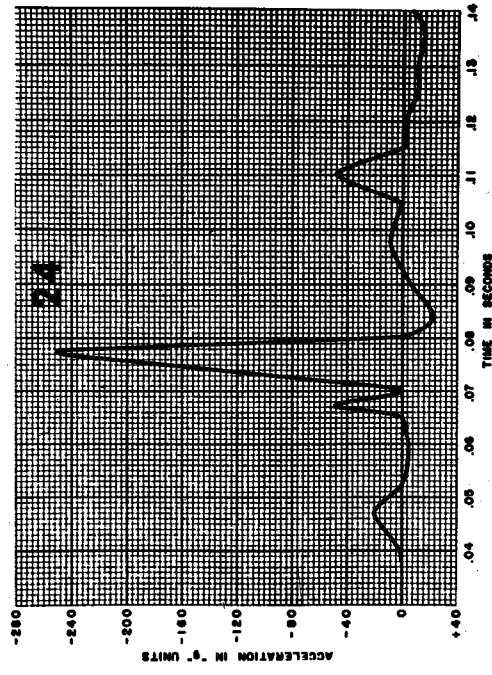
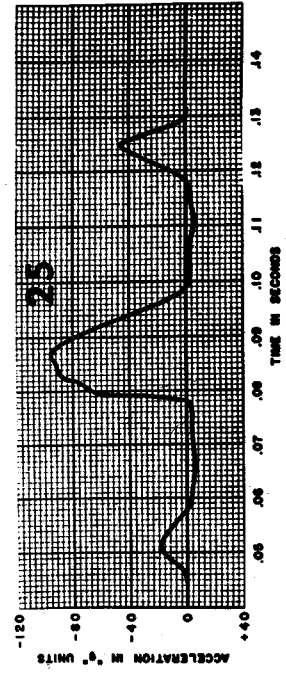
FIGURE A7. Seat F.

Seat F (Figure A7) is constructed of aluminum tubes and produced high forces during all impacts. The most dangerous part of the seat, however, is the aft end of the rigid seat arm protruding rearward between the seat backs. Test #24 against one of these arms produced a peak force of 250g.

e. The lethal characteristics of seat arms should be eliminated.

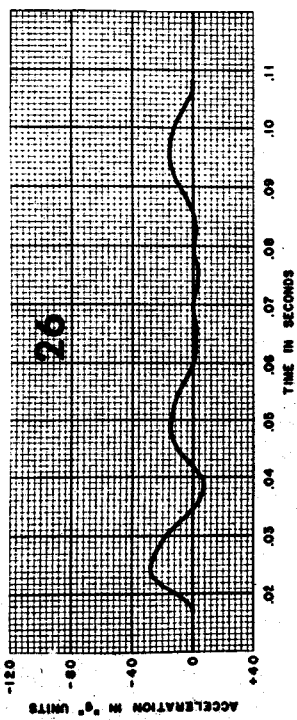
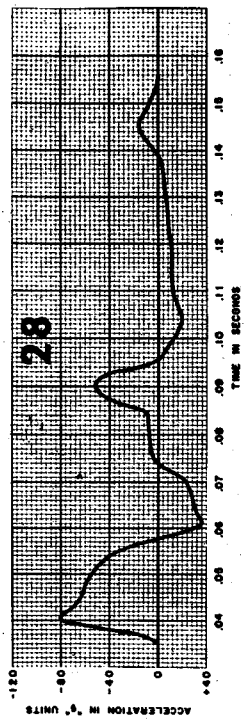
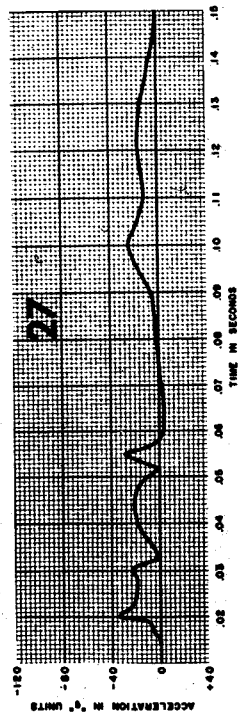
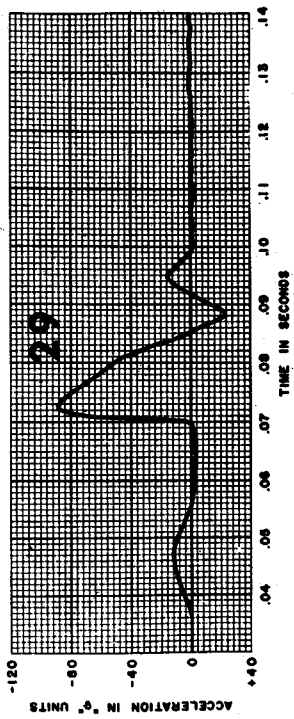
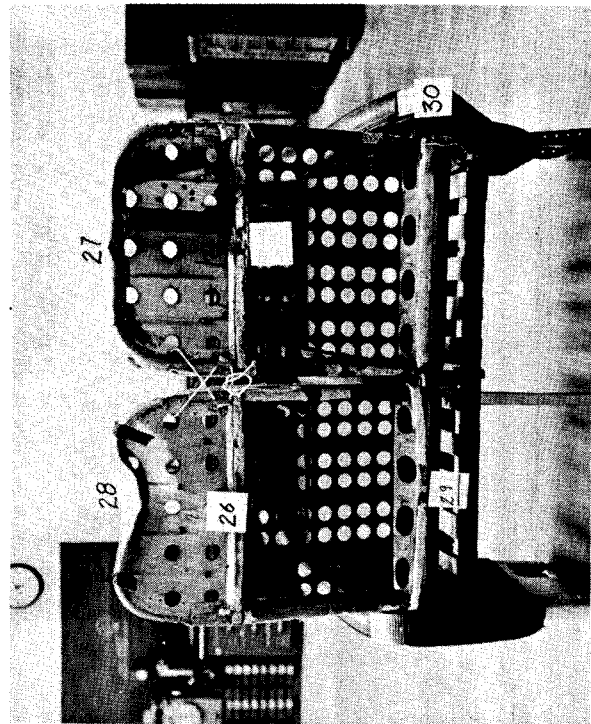
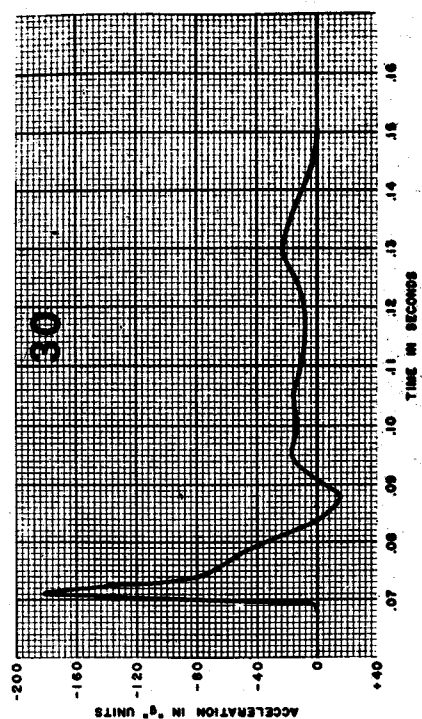
FIGURE A8. Seat G.

Seat G (Figure A8), similar in construction to that shown in Figure A4, produced low g-forces on the upper structure but again pointed out the danger of the rigid arm (test #30—180g).

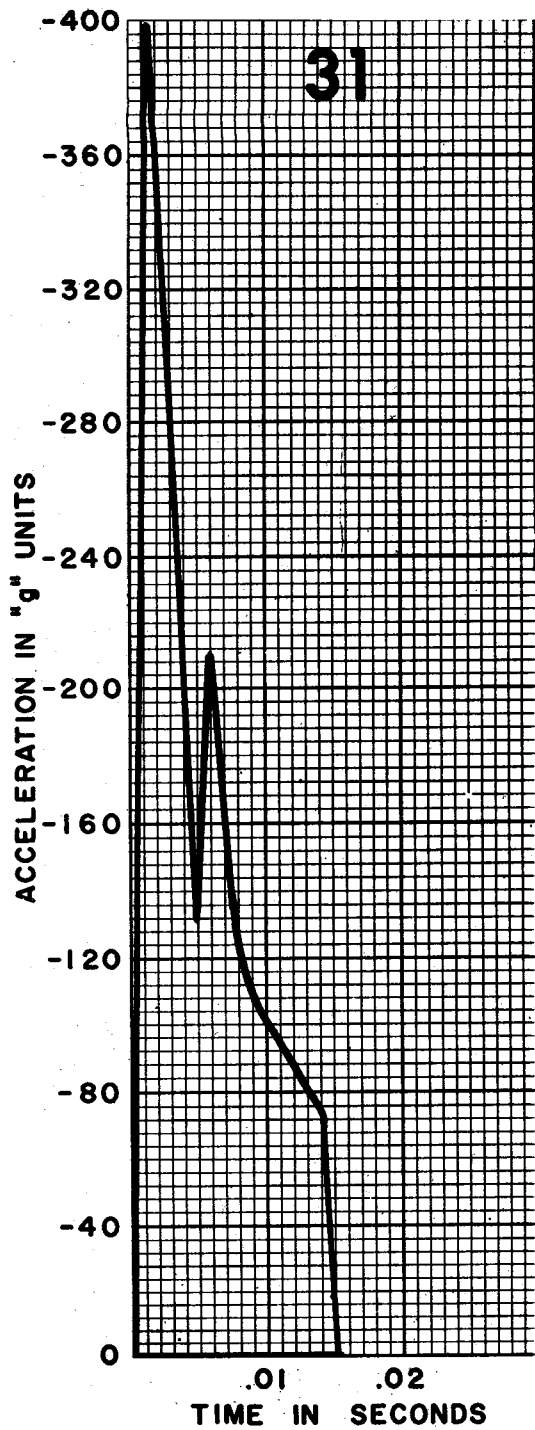
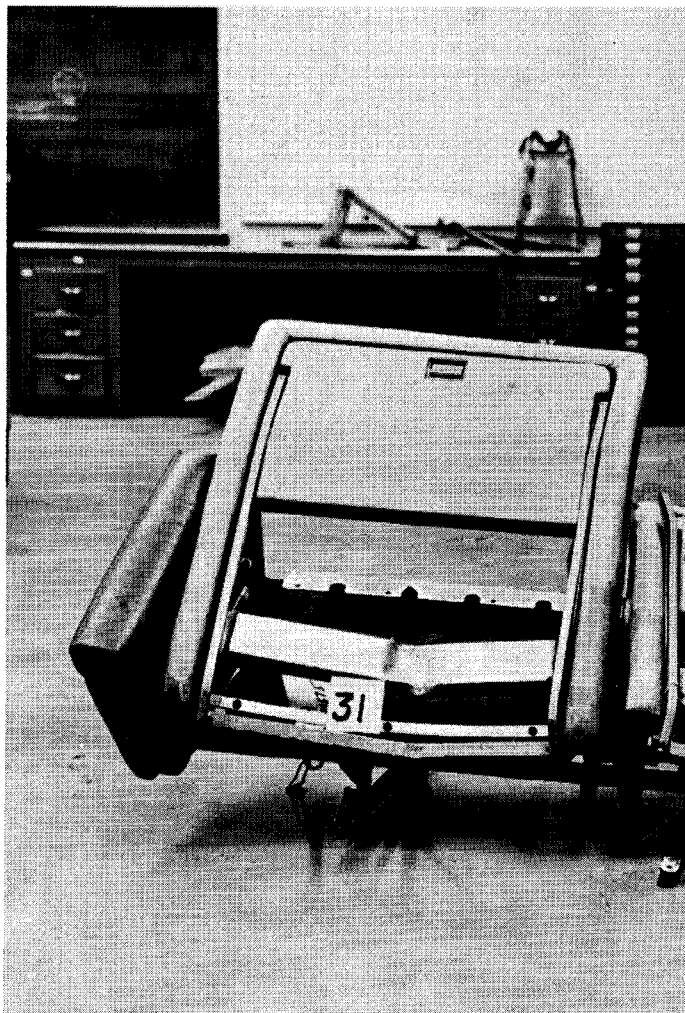
FIGURE A9. Seat H.

Seat H has two heavy, square-edged, tubular structures in the lower portion of the seat back. Tests #31 (Figure A9) and #32 (Figure A10) show unusually high g-forces when these rigid structures are impacted. The top of the seat back is also of square tubular construction and

a. Tubular construction should only be used in areas where it cannot cause injury.

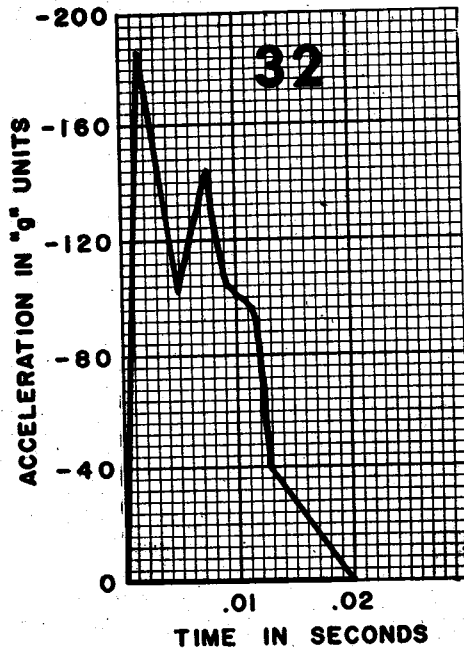
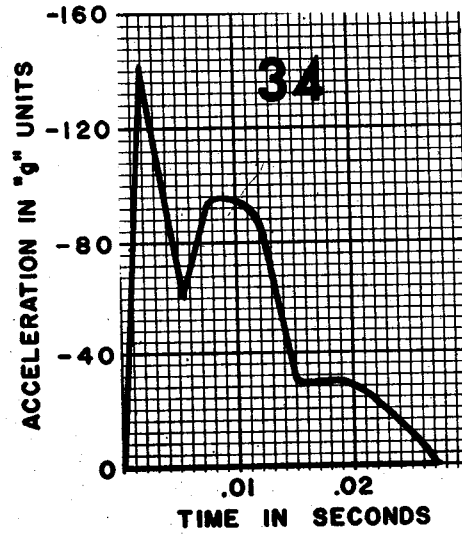
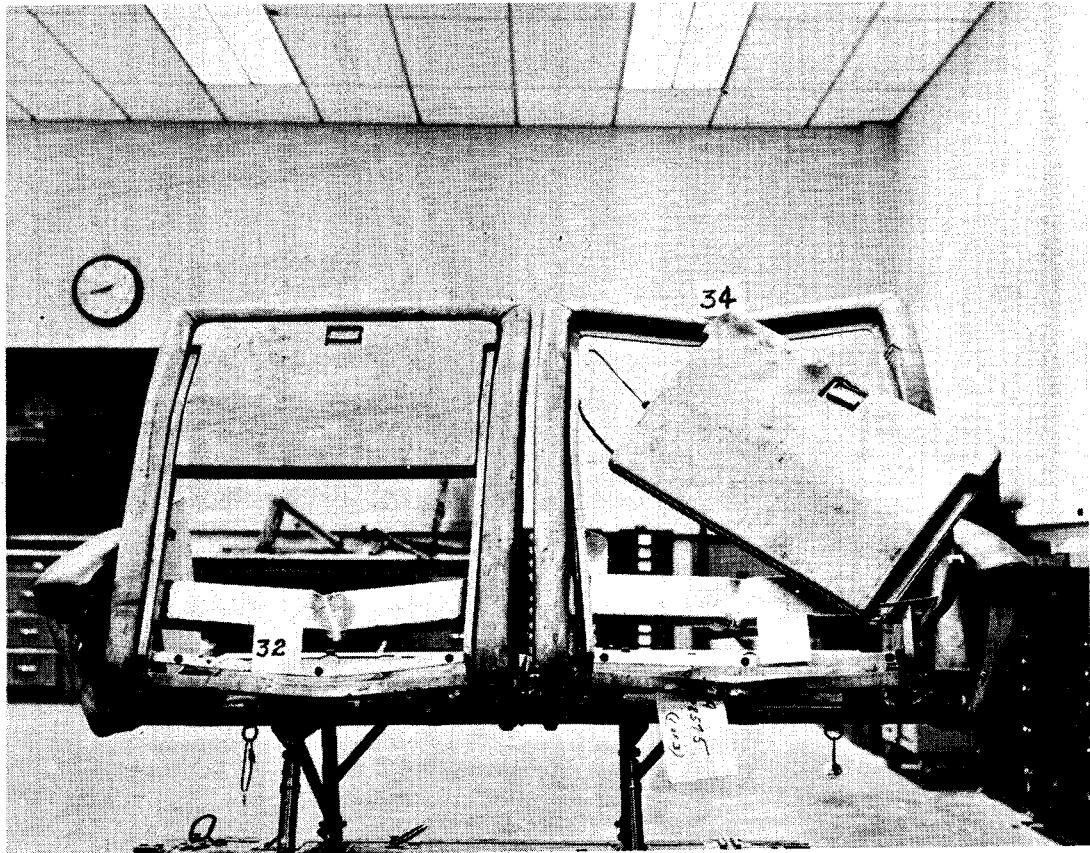
FIGURE A10. Seat H.

produced 140g when impacted (#34, Figure A10).
