Supplement to Safety Alert for Operators (SAFO) #08013

Recommendations

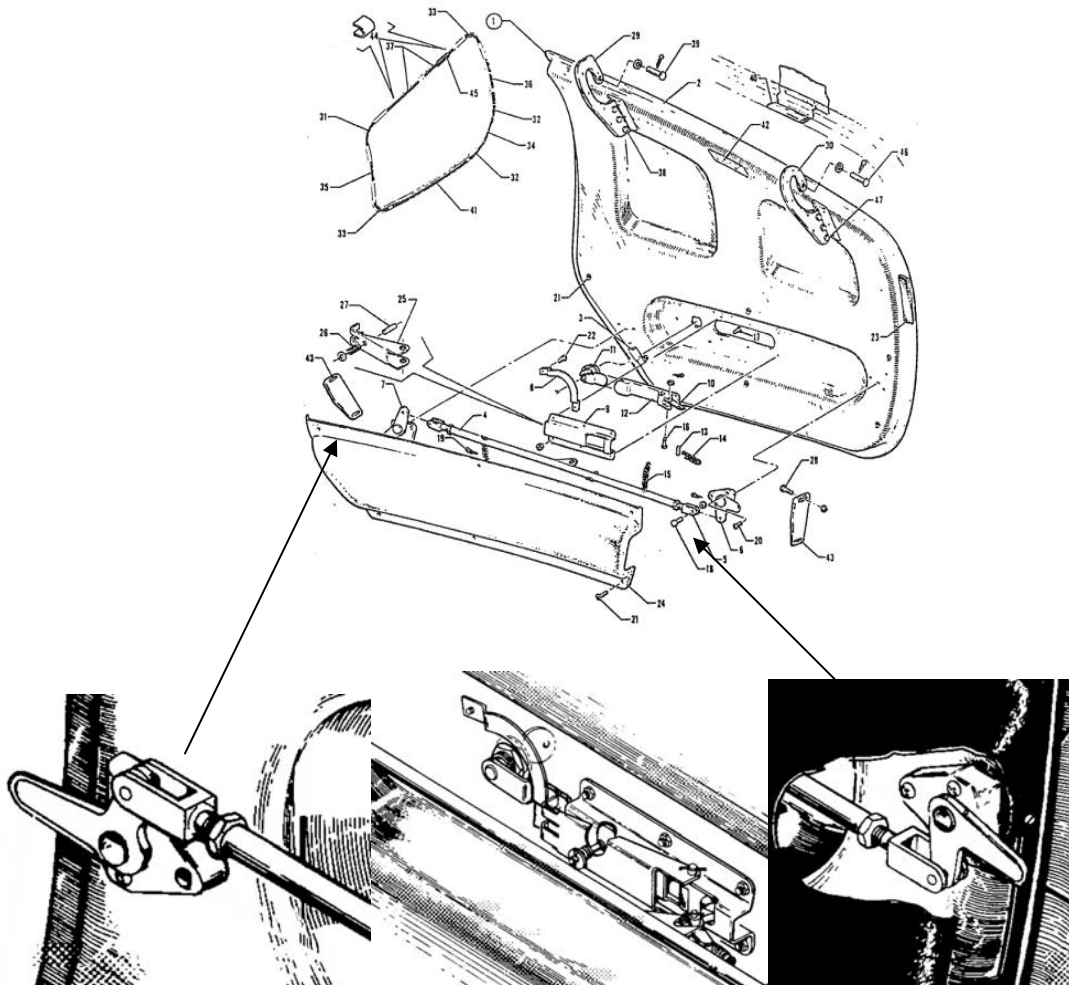
In the closed and locked position, the door is secured from opening at 4 locations; 2 gooseneck hinges at the top, and 2 arm assemblies, one at each end of the door (see drawing below). Each arm assembly (installed in the door) has a locking tab that makes contact pressure against the edge of a corresponding fuselage-mounted baggage door plate.

To open the door, a key is inserted into the lock assembly, and turned clockwise. This action rotates a cam plate in the lock assembly clear of the slot in the baggage door handle. The baggage door handle is now free to move. The operator first pushes on the forward part of the handle, which pivots the aft end of the handle outward. The operator then pulls outward on the aft end of the baggage door handle, which is now free to pivot about the handle center. This lever action causes the forward portion of the baggage door handle to rotate inward and aft, and consequently, also causes the baggage door latch tube assembly to move and release the locking tabs.

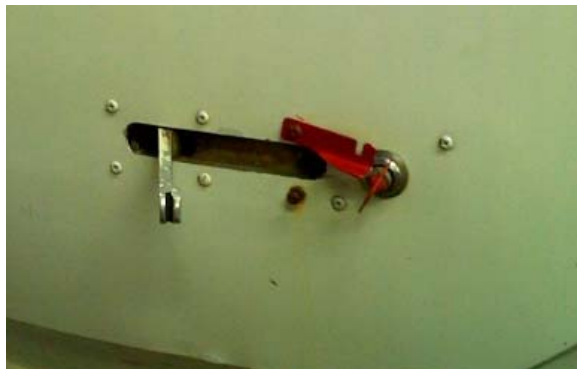
A. Yes, Anchorage Aircraft Certification Office (ACO) reports that other Alaskan operators have adapted the latch modification pictured below.

3. Operators need to remove any "permanent key" installations. This defeats the safety feature of having a removable key. The key can only be removed when the lock is either totally open or completely engaged. With a "permanent Key" installed, the lock is free to rotate.

4. Make sure latch and lock mechanisms conform to original type design and are in a condition for safe operation.
