MARINE ACCIDENT REPORT

GROUNDING OF THE PANAMANIAN PASSENGER SHIP
ROYAL MAJESTY ON ROSE AND CROWN SHOAL
NEAR NANTUCKET, MASSACHUSETTS
JUNE 10, 1995

**Adopted: April 2, 1997
Notation 6598A**

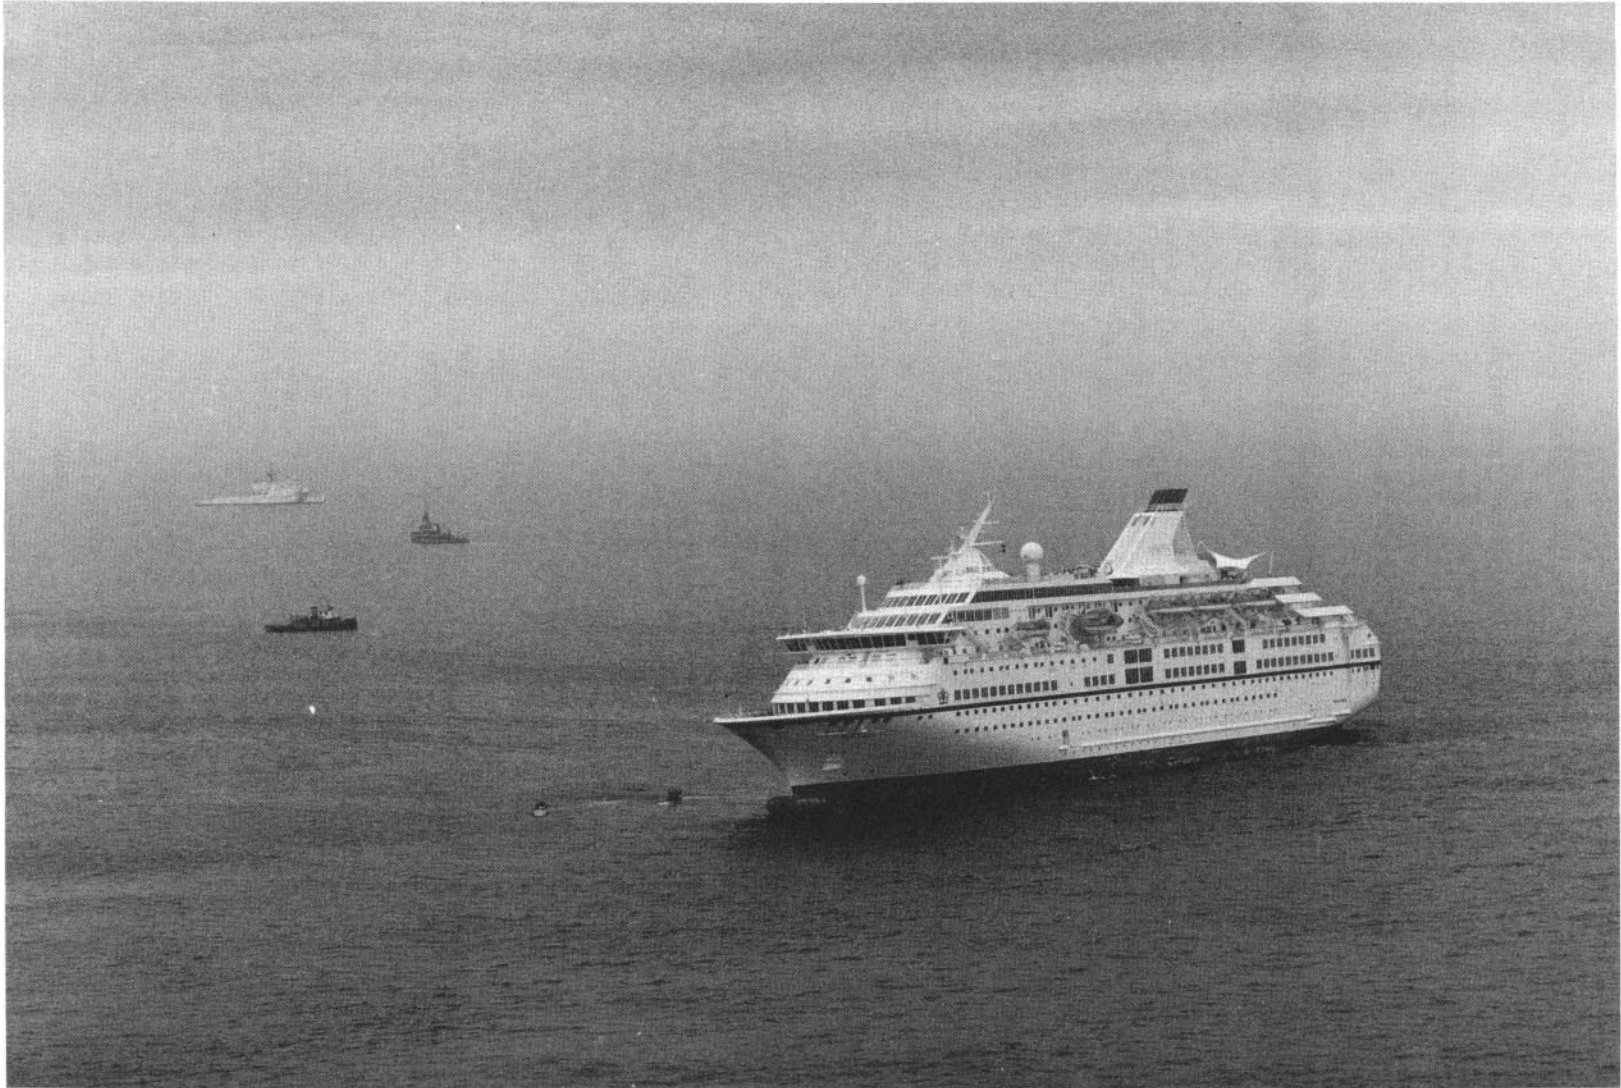
Figure 6—Royal Majesty aground.

On June 16, the *Royal Majesty* left Boston for the Sparrows Point Shipyard in Baltimore, Maryland, where it was drydocked and repaired. The grounding of the *Royal Majesty* had damaged its outer hull extensively. According to the field survey conducted by Lloyds Register on June 19, a portion of the vessel's outer shell plating, which was about 51 feet wide and 41 feet long, needed to be cropped and renewed. The report also indicated that the bottom fuel oil

tanks and the internal steel structure between the vessel's internal tank tops and hull plating had been substantially damaged. No oil spilled as a result of the accident.

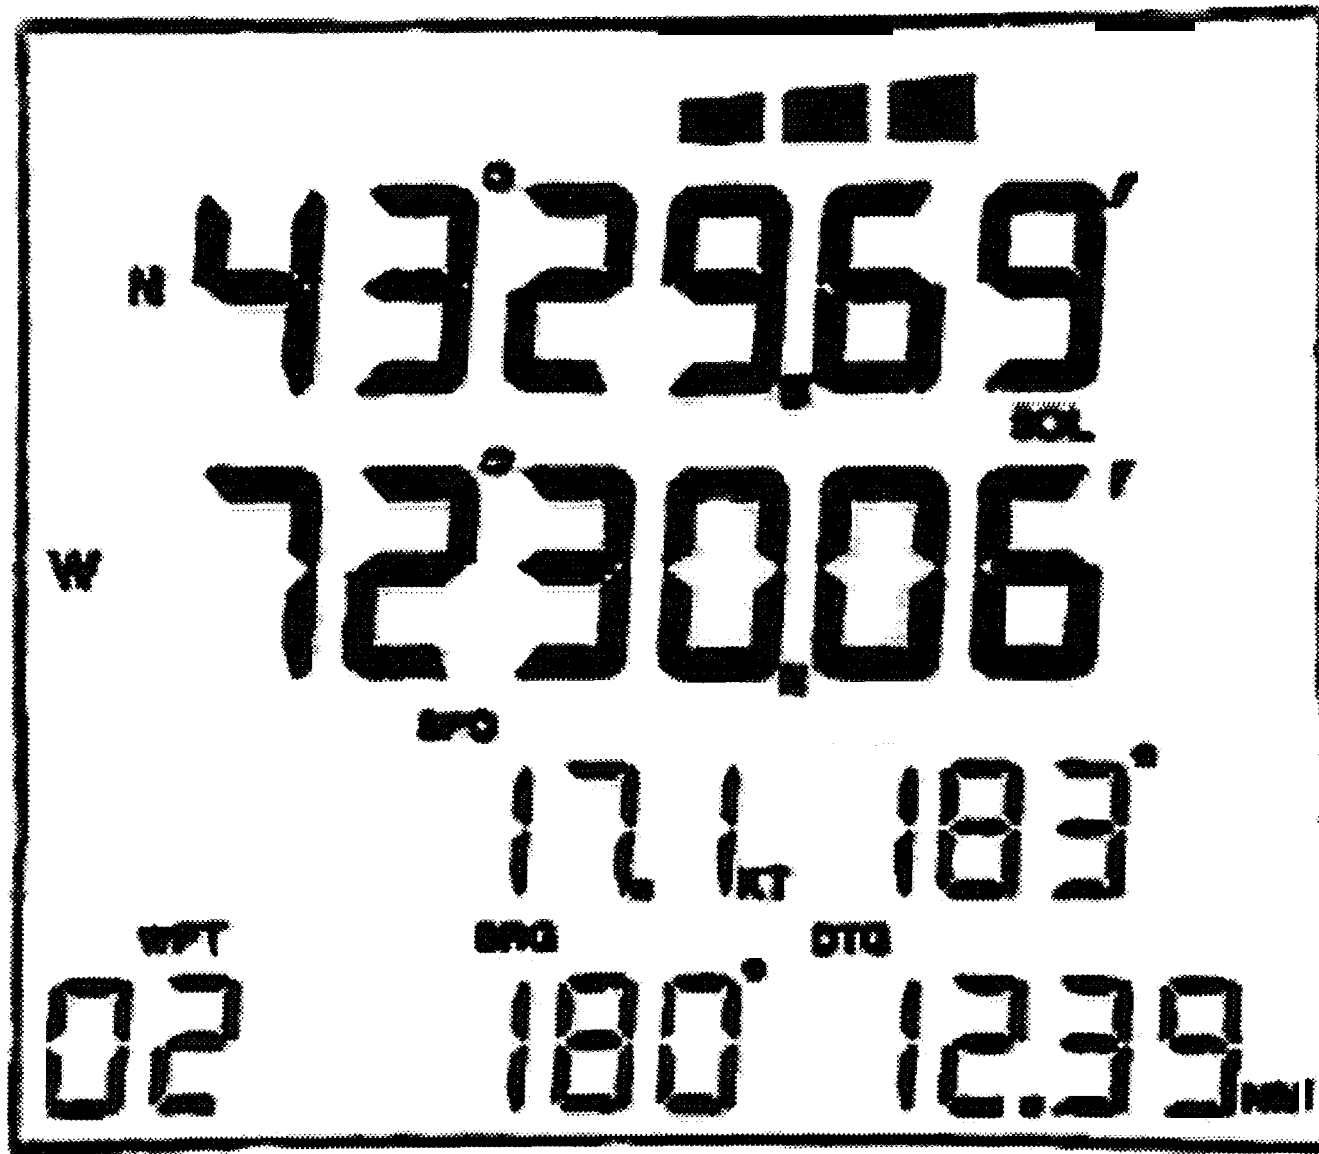
Figure 8—GPS display showing SOL and DR.

All the watch officers testified that they did not see *SOL* and *DR* displayed on the GPS unit during their watches before the grounding. Their testimony indicated that they understood the meaning of these symbols and had seen them on previous occasions.

When the GPS unit defaulted to its DR mode, it displayed both *SOL* and *DR*, indicating that the GPS solution was no longer valid and that the unit had switched to a DR mode. Although the watch officers testified they used the GPS data for plotting, each officer also testified that he did not see *SOL* displayed on the GPS unit. Ineffective monitoring of sophisticated automated equipment is not new. The Safety Board has investigated several aviation accidents in which pilots failed to monitor flight instruments during automated flight.⁴⁸ Likewise, empirical research on the monitoring of auto-

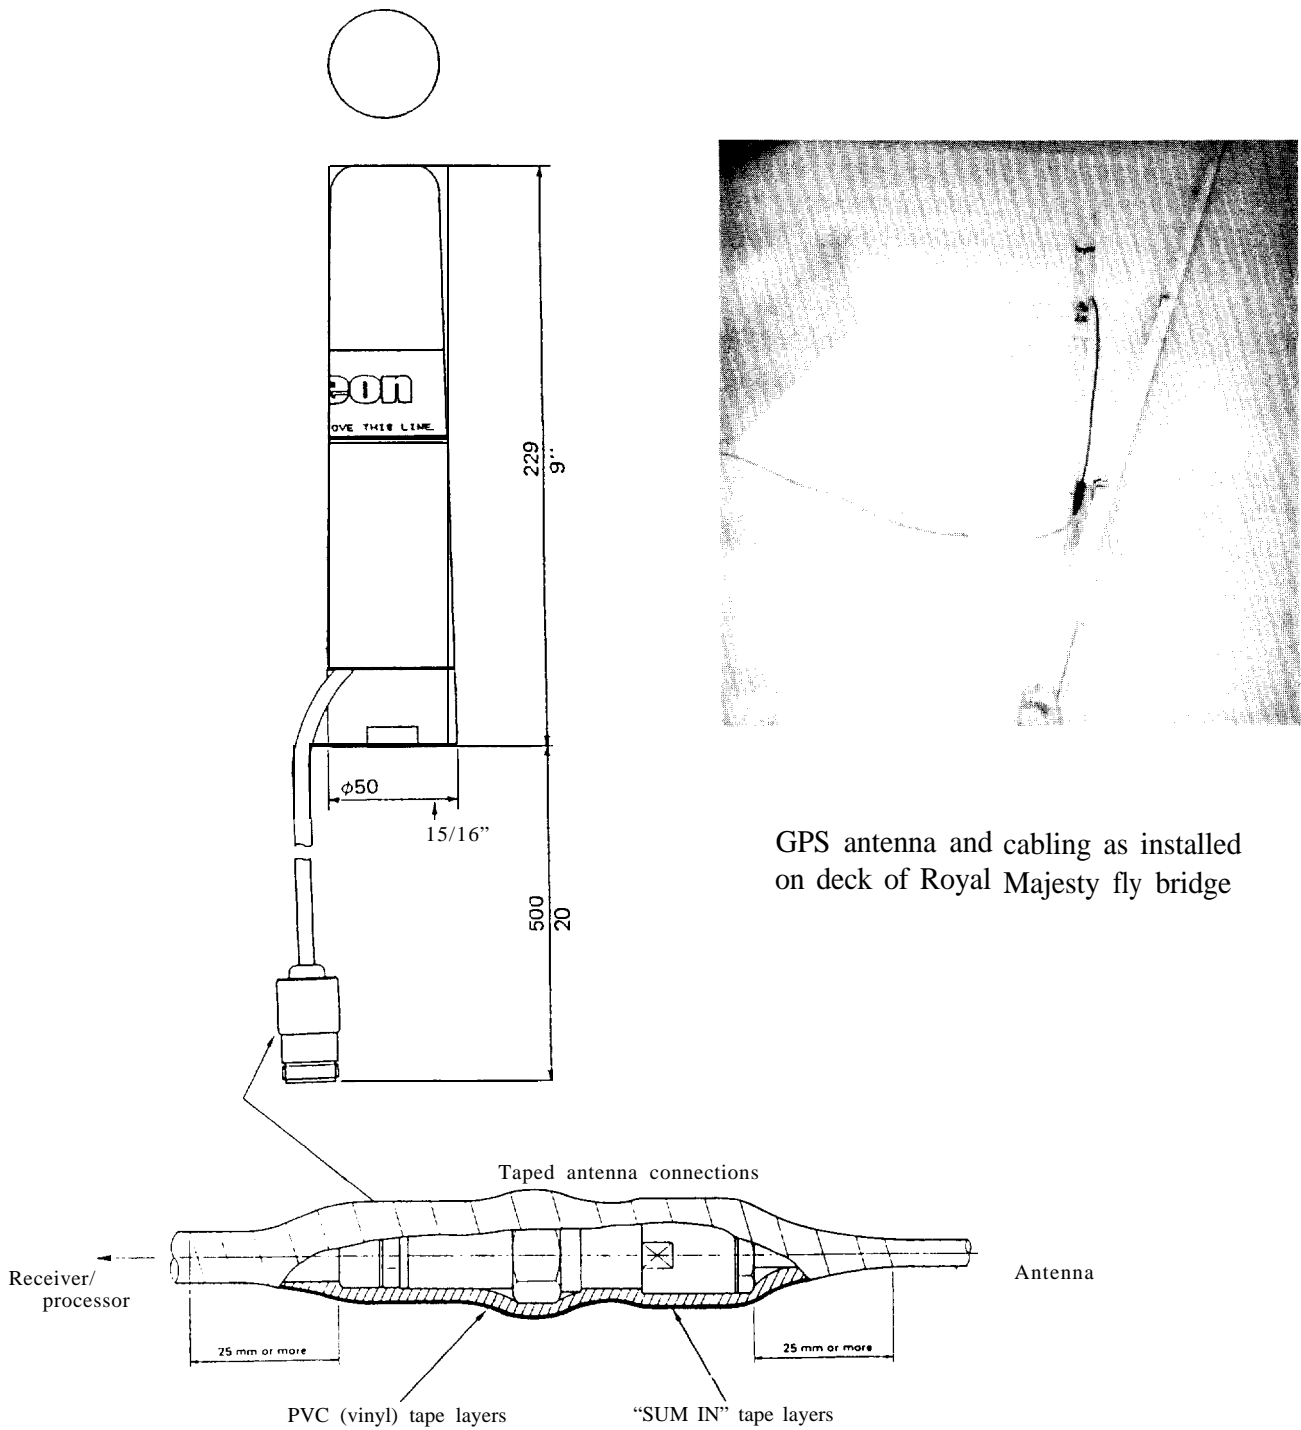
Figure 9—GPS antenna assembly (photograph shows antenna and cabling as installed on deck of fly bridge).

After the accident, representatives from Majesty Cruise Line and the Coast Guard examined the *Royal Majesty*’s GPS antenna and receiver. They found that the GPS antenna cable had separated from the factory connection at the antenna. The antenna cable, which was factory-assembled, showed no sign of physical damage, other than having been separated from the connection. The Safety Board examination also revealed that the cable was openly routed on the roof of the bridge and that it had been painted with a brush or roller at least twice when the bridge was being painted (see figure 9). Traffic on the roof of the bridge was limited to Majesty Cruise Line employees. However, the GPS cable was not secured to the roof or protected from someone tripping over it, kicking it, or otherwise damaging it and the nearby antenna connector.

GPS antenna and cabling as installed on deck of Royal Majesty fly bridge

The investigation determined that the GPS antenna, which was originally installed on the radar mast, had been moved in February 1995, several months before the grounding, as part of an effort to eliminate chopping. An examination of the GPS antenna cable indicated that it was routed in such a way that it could be kicked or tripped over, which could induce separating stress at the antenna cable connection, and that it had been painted on at least two occasions. However, precisely when the painting was done was not known. In short, it could not be determined whether the GPS antenna failed as a result of crewmembers' inadvertently damaging it while they were doing routine maintenance, as a result of crewmembers' tripping over the cable, or as a result of other unknown factors. Nevertheless, the Safety Board concludes that openly routing the GPS antenna cable in an area where someone occasionally walked increased the risk of damage to the cable and related connectors. The Safety Board believes, therefore, that to decrease the risk of damage, Majesty Cruise Line should eliminate the practice of openly routing navigation equipment cable to decrease the risk of damage and that the ICCL should encourage its members to do the same.
