Chapter 8

The Grounding of the *Royal Majesty*

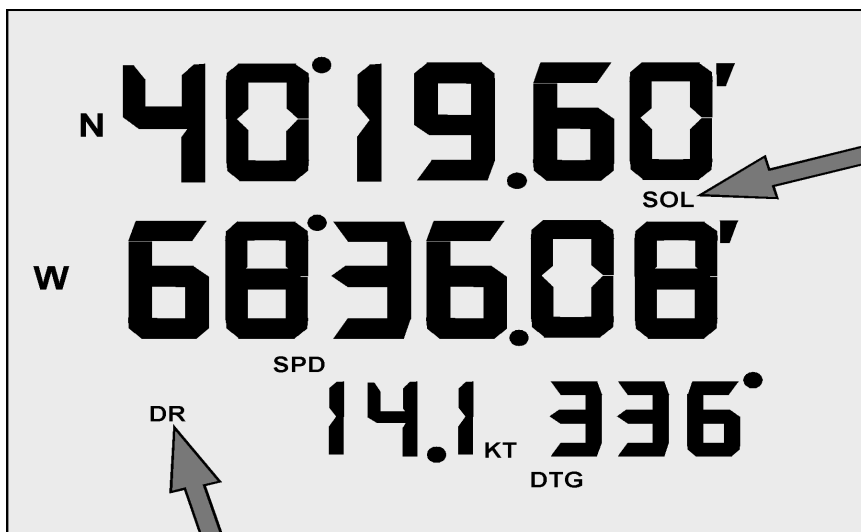
Figure 8.5 (b). GPS display indications at 8 P.M. on the night of the grounding. The arrows show the DR (dead reckoning) and SOL (solution) indications.

The fact that three officers and the captain did not notice the small **DR** and **SOL** symbols on the GPS display may suggest a breakdown in bridge-keeping practices and poor interface design on behalf of the GPS manufacturer. The symbols were very small (about 1/8 of an inch), inconspicuous, and somewhat misleading (**SOL**). Furthermore, the GPS alarm was not connected to the general alarm system in the bridge, so that when the cable broke and the alarm sounded, only someone who was standing by the unit would hear the one-second beep, which was barely audible to begin with for such a critical failure. Finally, as mentioned earlier, the interface between the GPS unit and the autopilot and radar map was incorrect.

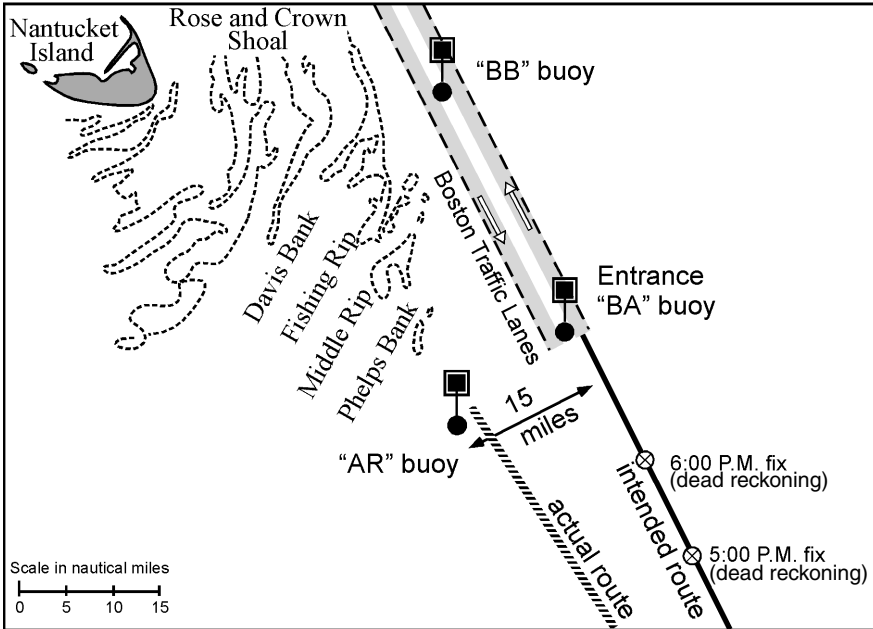
Figure 8.6 (a). Actual and intended route of the *Royal Majesty*.

At 6 P.M., the radar map showed the vessel sailing on track and heading accurately toward the right side of the traffic lanes. Yet in reality, the *Royal Majesty* was 14.5 miles west of the lanes, close to shore, and heading toward the dangerous Nantucket Shoals (figure 8.6[a]). The radar map deceived the crew—and the reason for this is important for us to understand because it exposes the kind of problems that plague automatic control systems, especially of the navigational kind. You see, the source of ship position for the radar map display was none other than the crippled GPS unit; whatever the GPS said, the radar map displayed. And since the GPS position did not reflect the ongoing and increasing position deviation, it provided information as if the ship was following its pre-programmed route. That's what the radar map displayed—which was, of course, a false description.

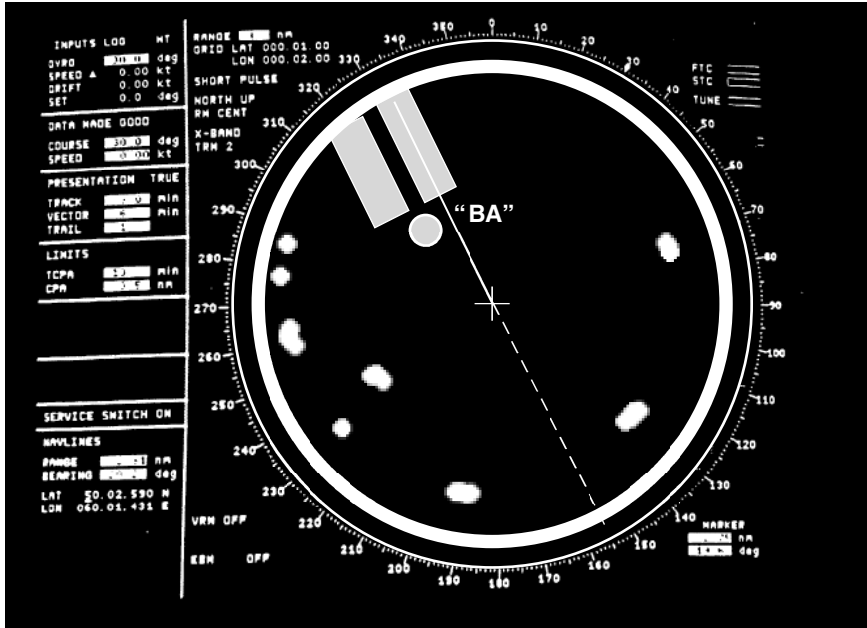
Figure 8.6 (b). The radar map, showing the radar screen and rendering of the traffic lanes and entrance buoy (BA).

more than 15 miles away from the entrance buoy to the Boston traffic lanes, which was too small to be detected. And since the radar's range was set to 24 miles, they did not see land on the radar. As a consequence, the map shift was not detected.

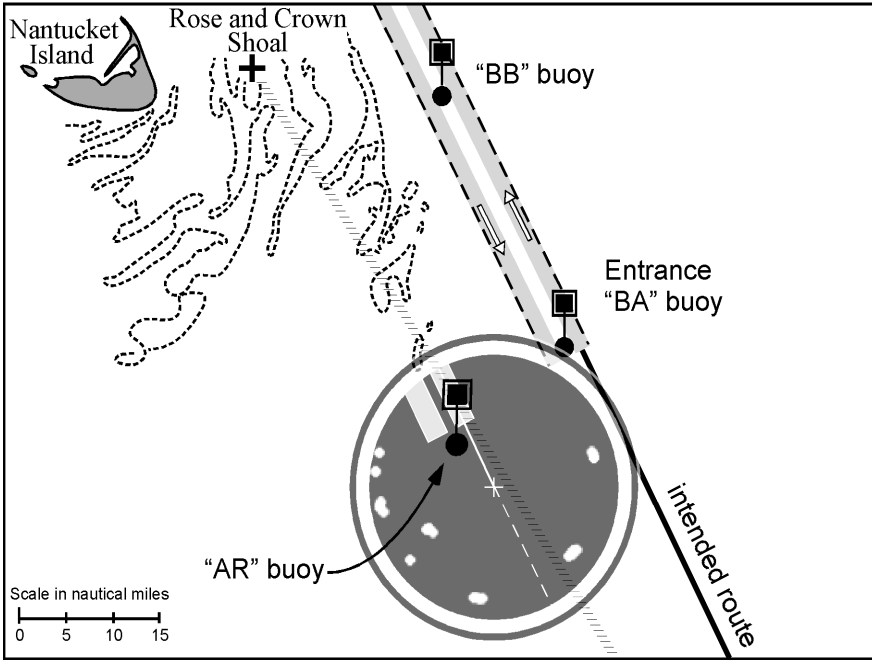
Figure 8.6 (c). Superimposition of the radar map and buoy rendering on top of an actual nautical map. Showing how the actual location of the “AR” buoy matched the expected location of the “BA” (entrance) buoy.

One of them, the Asia Rip buoy, flashing yellow light at a 2.5-second interval, was guarding the southeast tip of the shoal area. Anchored by a long and heavy chain to the wreck of an unfortunate vessel, the Asia Rip buoy was 15 miles to the west of the entrance buoy. And 15 miles is an important number here, because by a rare and unfortunate twist of fate, at that time the *Royal Majesty* was exactly 15 miles off her intended route! And therefore, on the radar map, it was actually the radar return from the Asia Rip buoy that coincided with the rendering of the entrance (BA) buoy (see figure 8.6[c]).

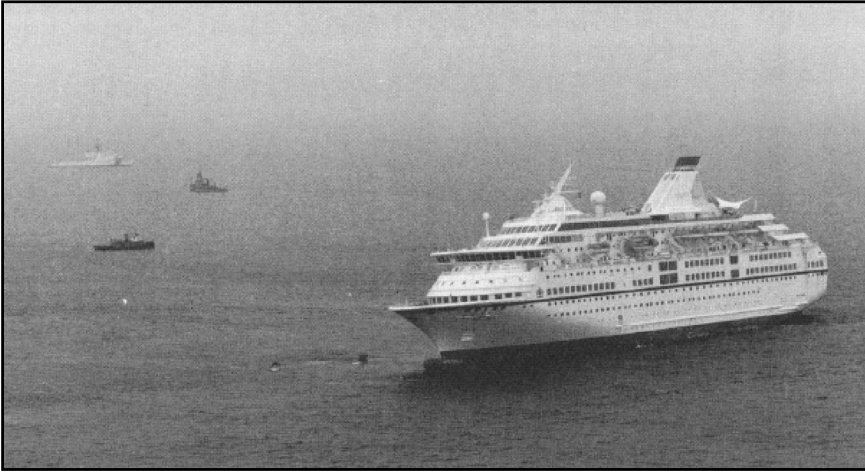
Figure 8.7. The *Royal Majesty*, grounded on Rose and Crown Shoal and surrounded by two tugs and a Coast Guard cutter (source: National Transportation Safety Board).

shoal, resting on her right side, showing her dark red bottom, like a matronly aunt caught with her pants down (figure 8.7).
