Subject: Recall 08V-305 Headlamp Bulb Replacement - Low Beam Bulbs

Service Communication: 2008-004 USA

Affected Model: 2007-2008 Norge 1200

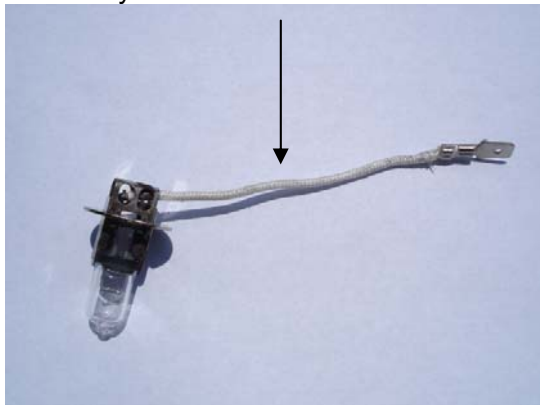
Part Identification: The low beam headlamp bulbs that are subject to this recall do not have a protective sheath over the white wire.

Old style bulb without sheath

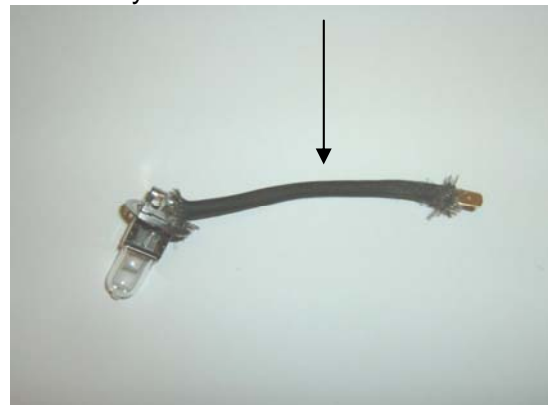
New style bulb #981082 with sheath

Parts Ordering Information: Please order Qty. 2 headlamp bulbs (part # 981082) from the BM ordering system.
