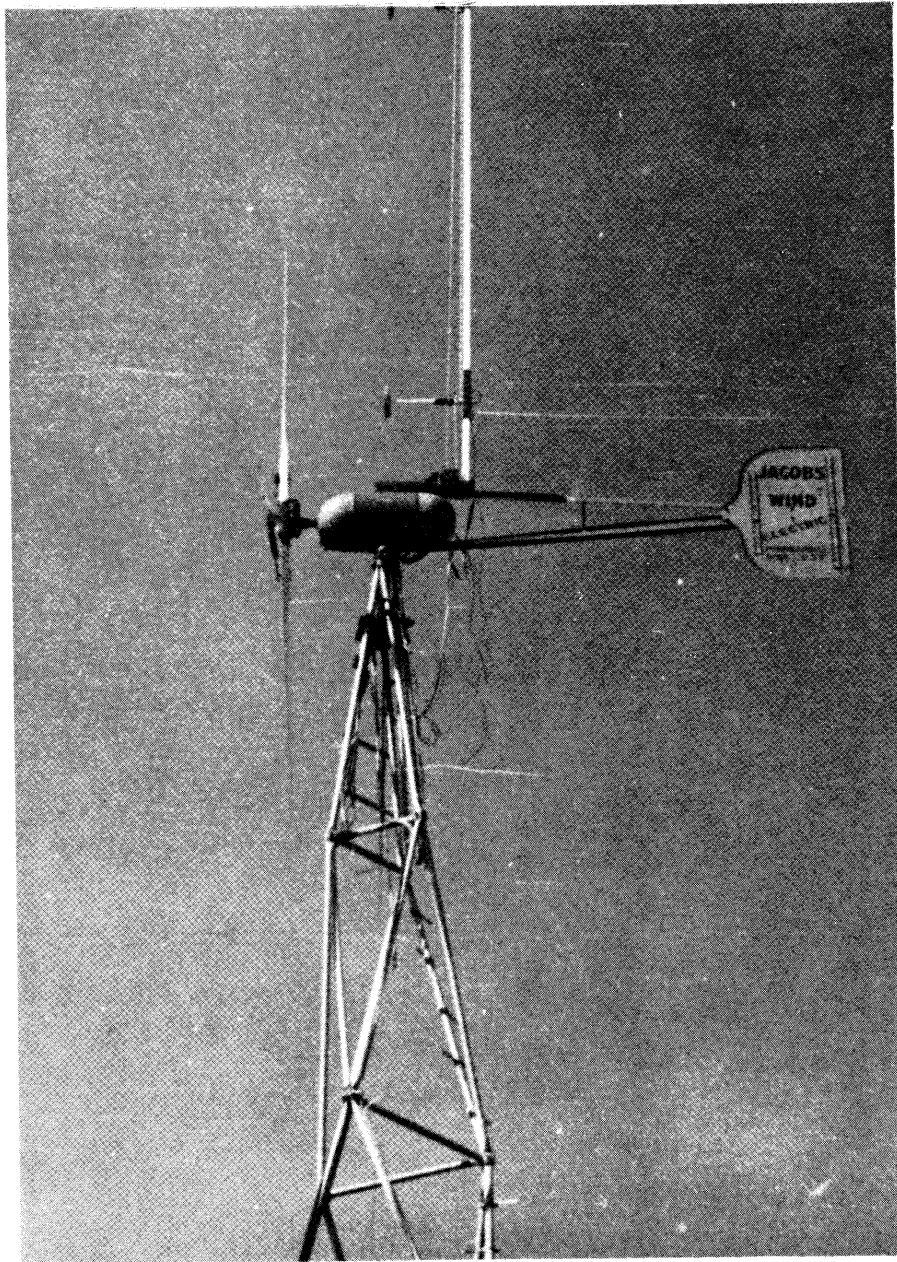
FIGURE 1

Instrumented Jacobs with a Single
Anemometer Boom

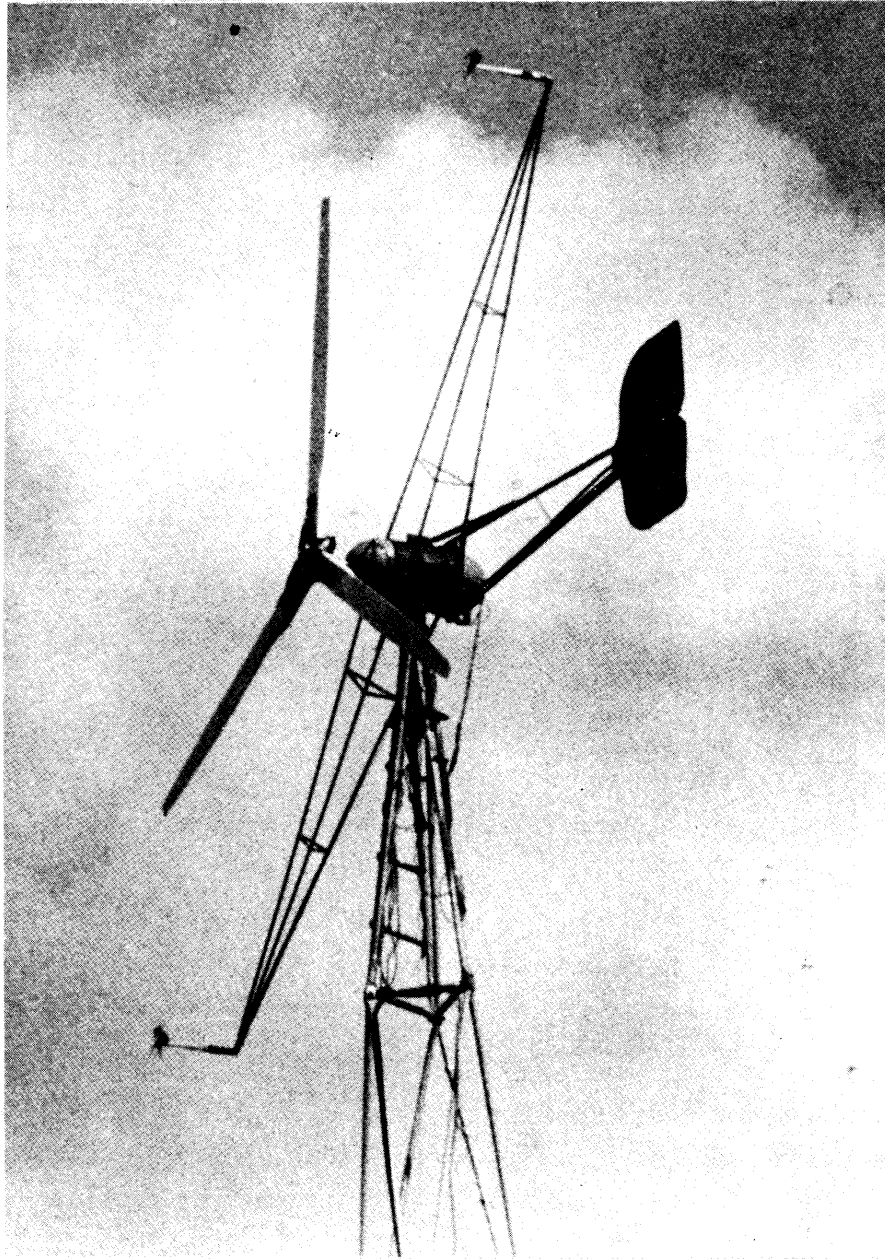
FIGURE 2

Instrumented Jacobs with a Twin
Anemometer Boom
