**A STUDY OF THE PERFORMANCE OF
PETROLEUM STORAGE TANKS DURING
EARTHQUAKES, 1933-1995**

Thomas W. Cooper
T.W. Cooper, Inc.

June, 1997

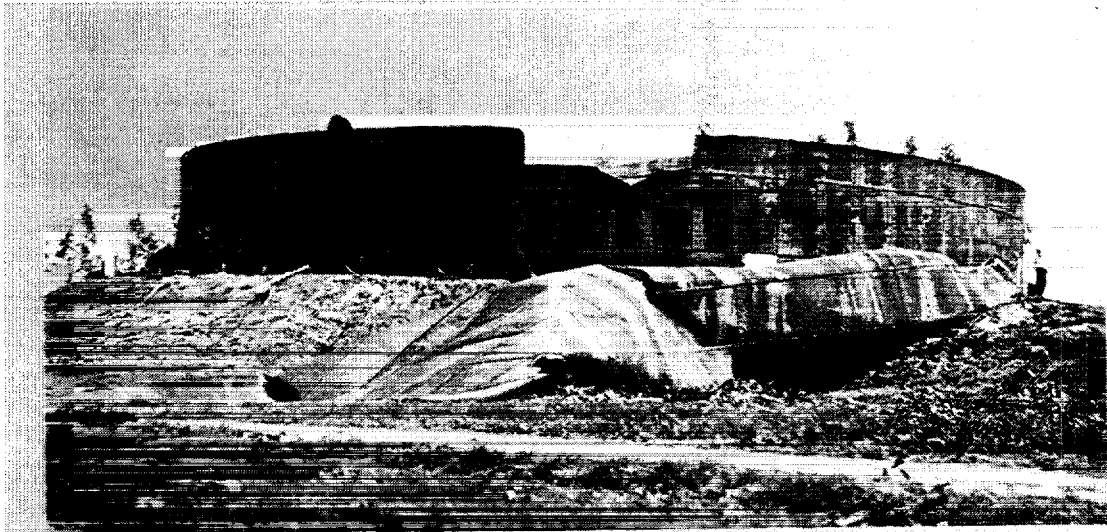
Tank "C" was a tank 45.4 m (150 ft) in diameter and 19 m (63 ft) high which had a 14.5 m (48 ft) water depth at the time of the earthquake. This tank had eleven shell courses and the failure was at the top of the fourth shell course. Portions of the tank shell were up to 60 m (200 ft) from the tank after the failure. This tank was 45 km from the epicenter and was probably within 1-2 km of the fault; see Figure 2.2 [10].

Figure 7-8. The top of this steel tank was thrown about 200 feet due to sloshing liquids. Western Avenue tank of the Los Angeles Water Department after the 1933 Long Beach, California, earthquake.

Figure 2.2 CLADWP Western Avenue Tank. The top of this steel tank was thrown about 200 feet due to sloshing liquids [L. Lund/Steinbrugge Collection at UCB EERC/Richmond].

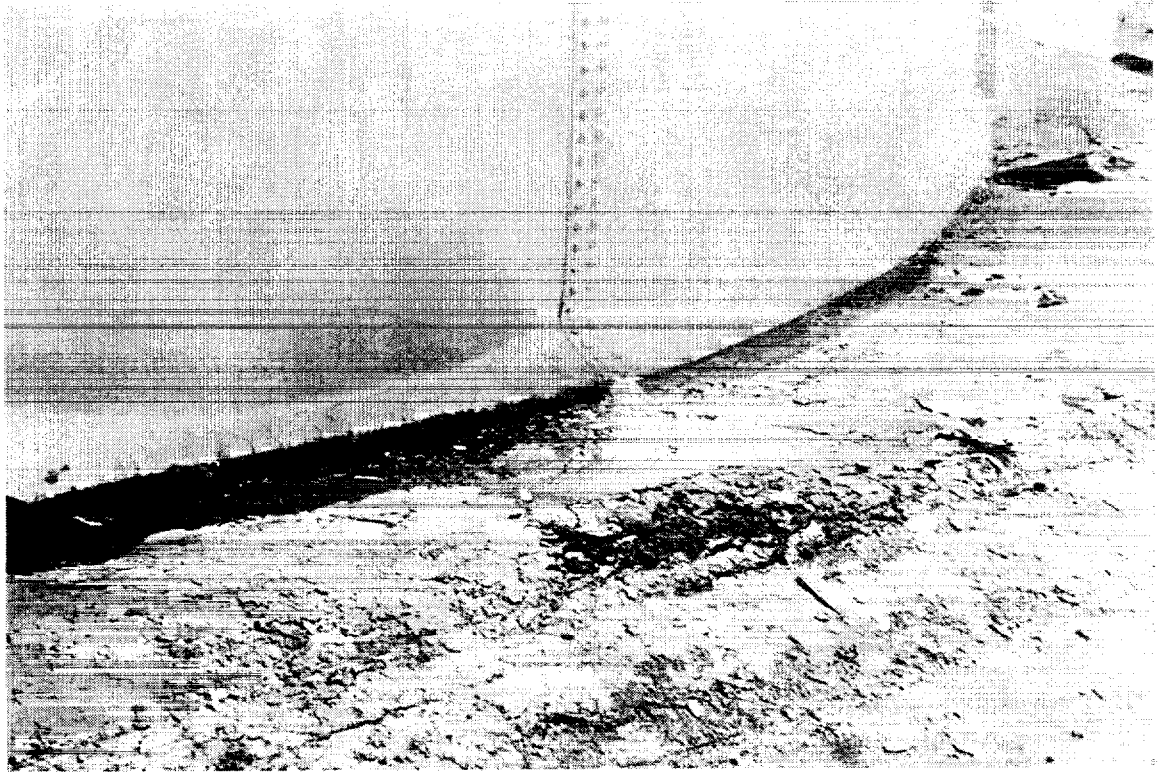
Virtually all of the tanks listed in Table 3.1 were riveted tanks, with thick shells to allow for acceptable tensile stresses at the riveted splice between the shell plates. Considering the proximity of the facilities to the epicenter and severity of the earthquake, one would expect more tank damage, especially considering the extensive damage to older buildings from this earthquake. Continental Station, not listed in Table 3.1, sustained no damage. Damage to the tanks at the A.M. Kelly Station was reported not significantly different from that at the General Petroleum Stations listed in Table 3.1. Figure 3.2 shows the elephant foot buckling on a bolted tank at the General Petroleum Emidio Station.

Figure 3.2 Bolted Tank at General Petroleum Emidio Station [Steinbrugge Collection at UCB EERC Richmond]

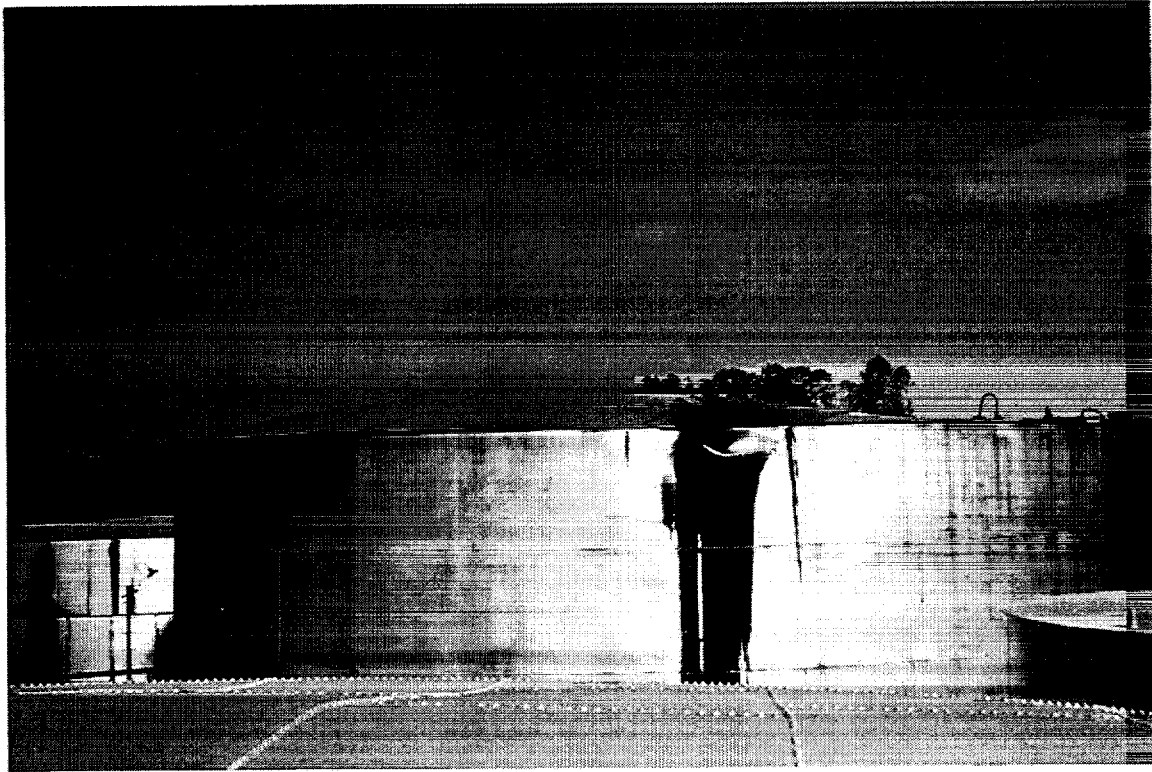
Figure 3.3 Roof/shell buckling and tearing at Weed Patch [Steinbrugge Collection at UCB EERC Richmond]

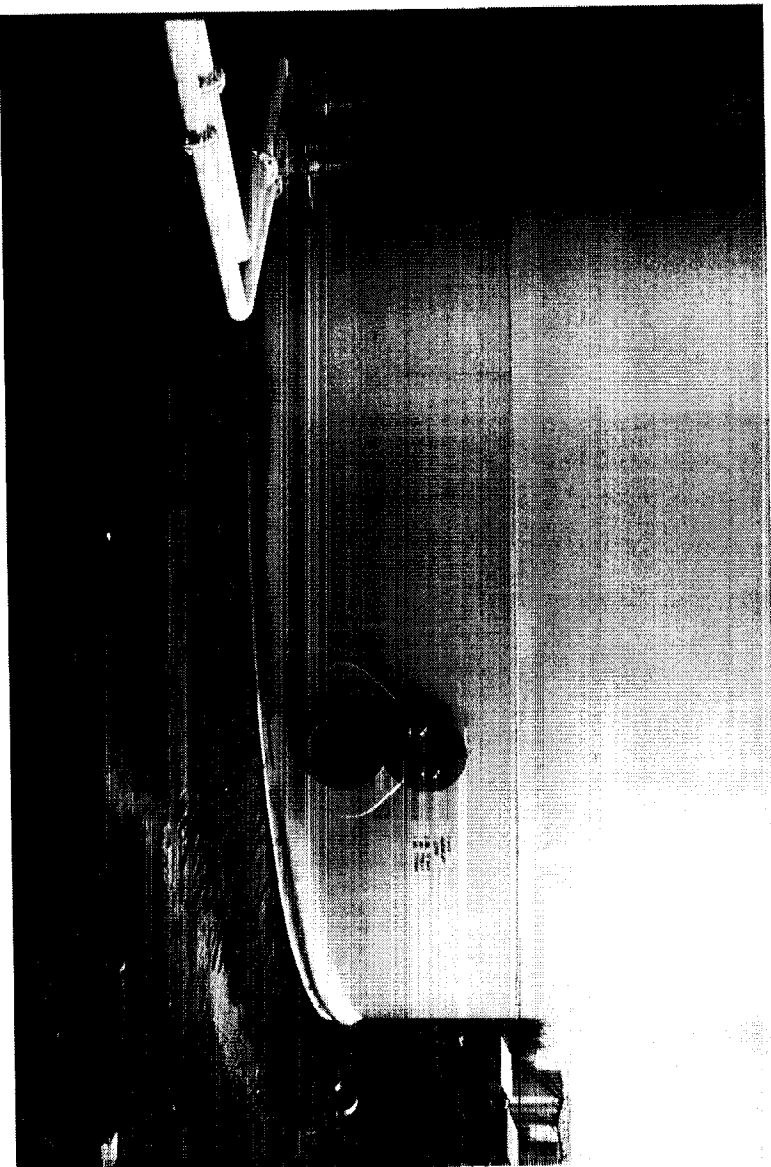
Figure 4.2 Elephant foot buckling and shell/floor failure [Courtesy G. Housner].

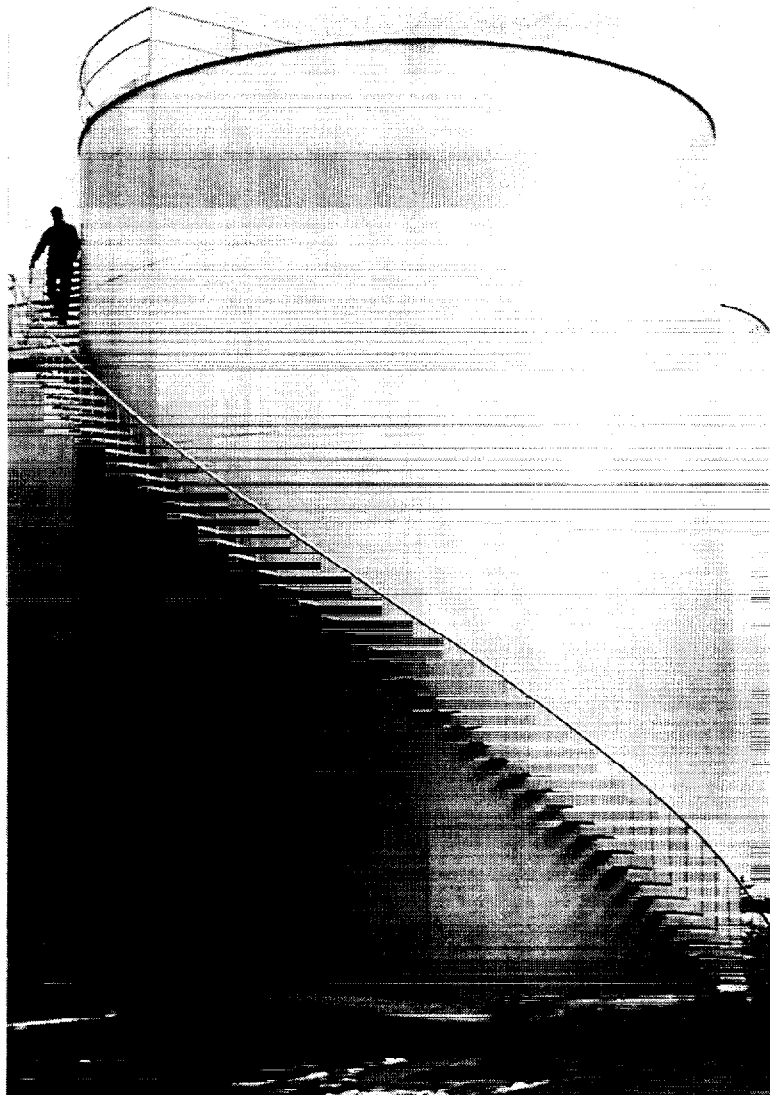
Figure 4.3 Port area, Anchorage [Steinbrugge Collection at UCB EERC Richmond]

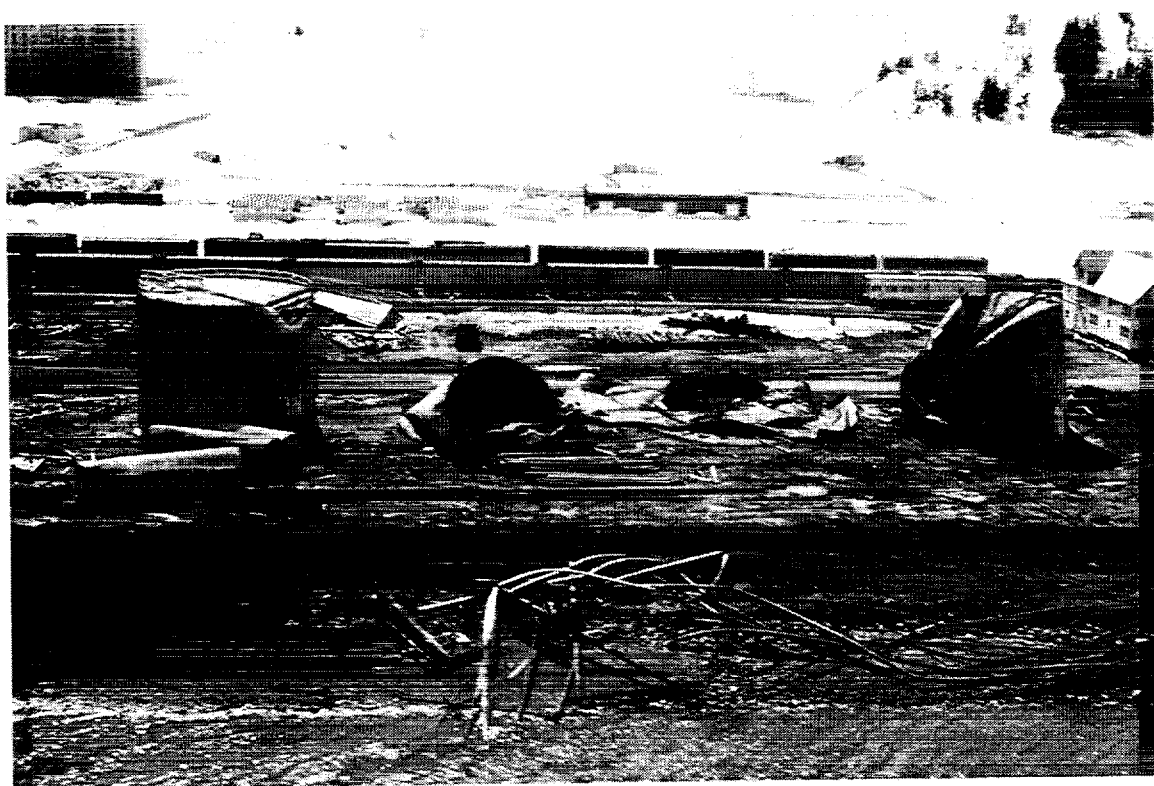
Figure 4.4 Whittier tanks near waterfront (Courtesy W. Daniels)

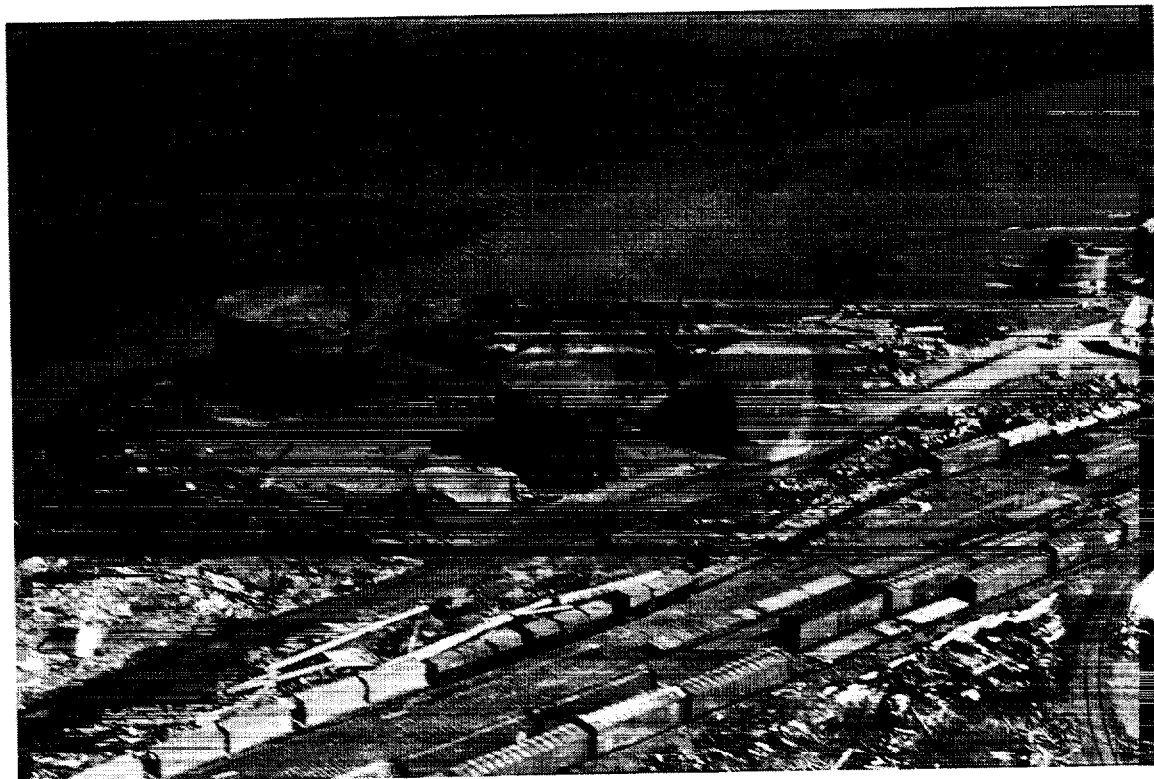
Figure 4.5 Whittier tanks, fire and tsunami damage (Courtesy W. Daniels)

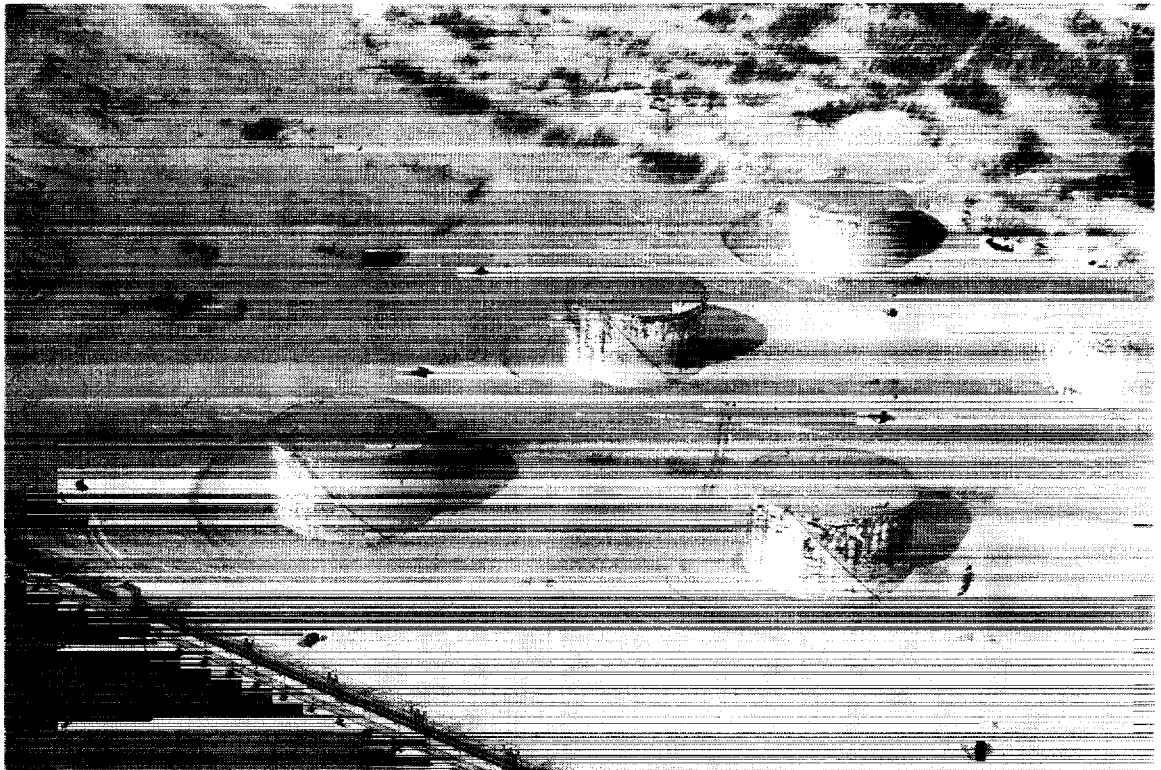
Figure 4.6 Tanks at Whittier which sit well back from the shore [Steinbrugge Collection at UCB EERC Richmond]

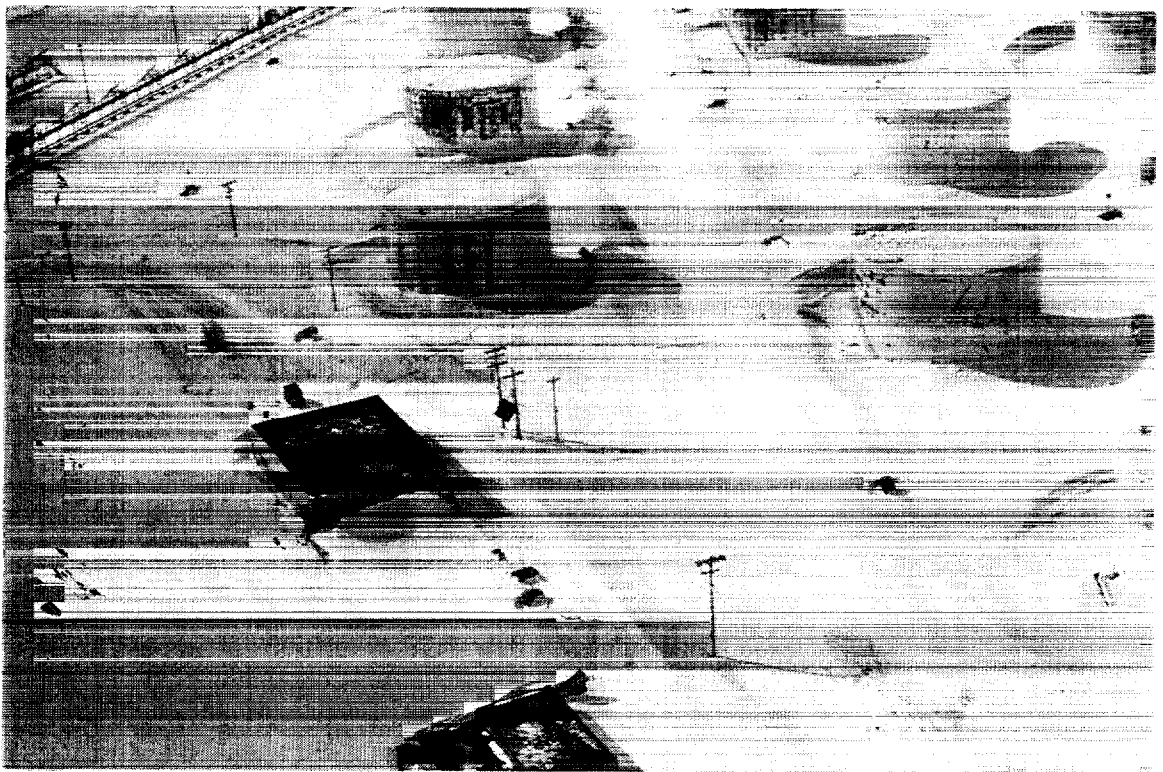
Figure 4.7 Whittier tanks which survived both the earthquake and tsunami with minimal damage [Steinbrugge Collection at UCB EERC Richmond]

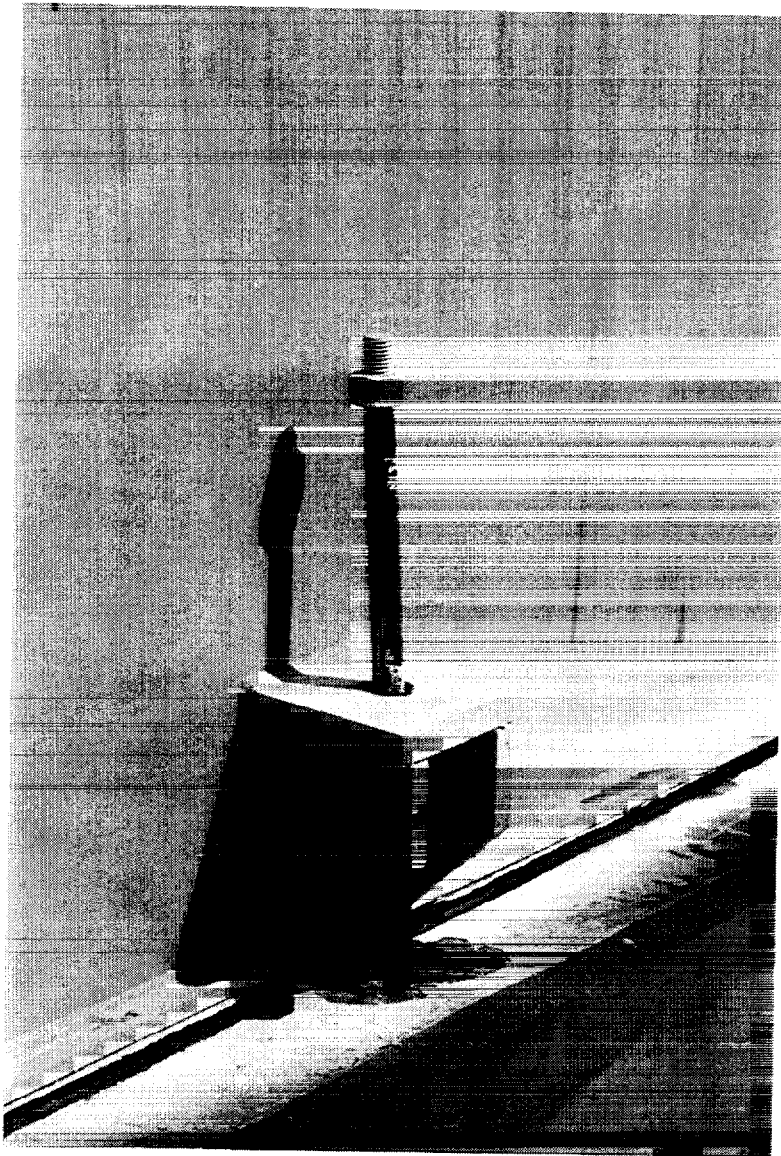
Figure 5.3 Jensen tank, pulled or stretched 1 inch anchor bolt [Steinbrugge Collection at UCB EERC Richmond]

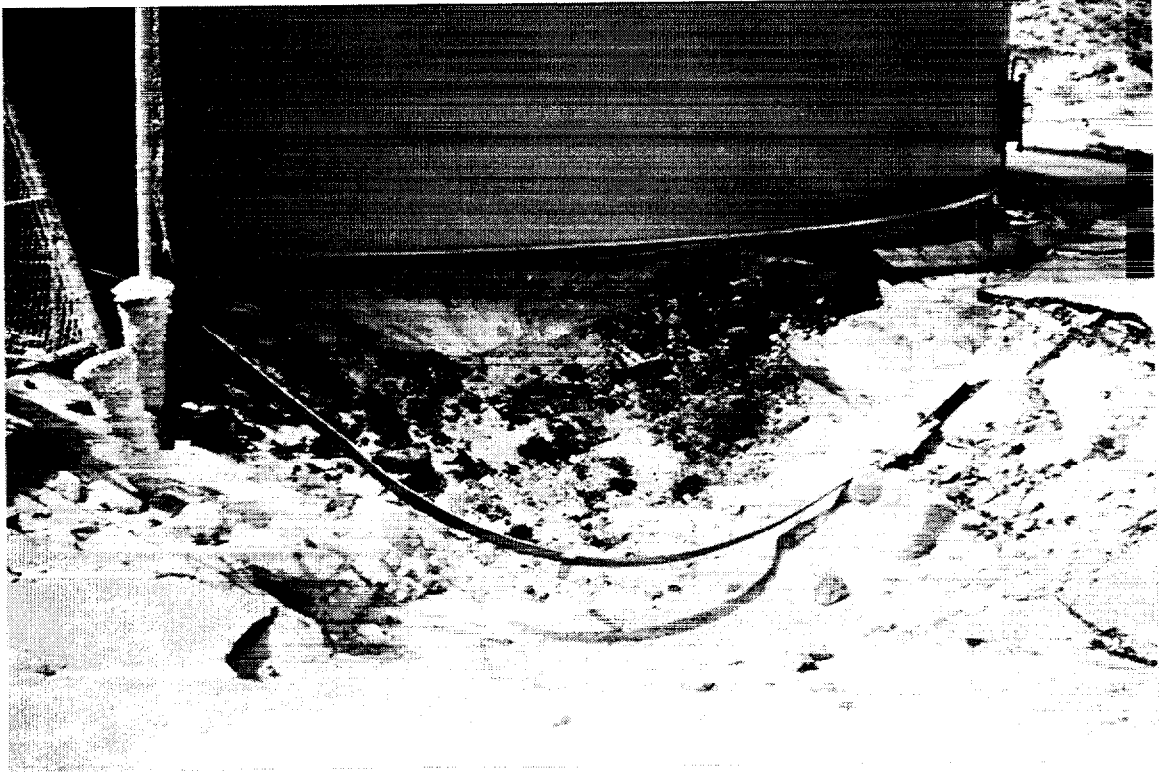
Figure 5.4 Olive View Hospital Tank which had a shell/floor failure [Steinbrugge Collection at UCB EERC Richmond]

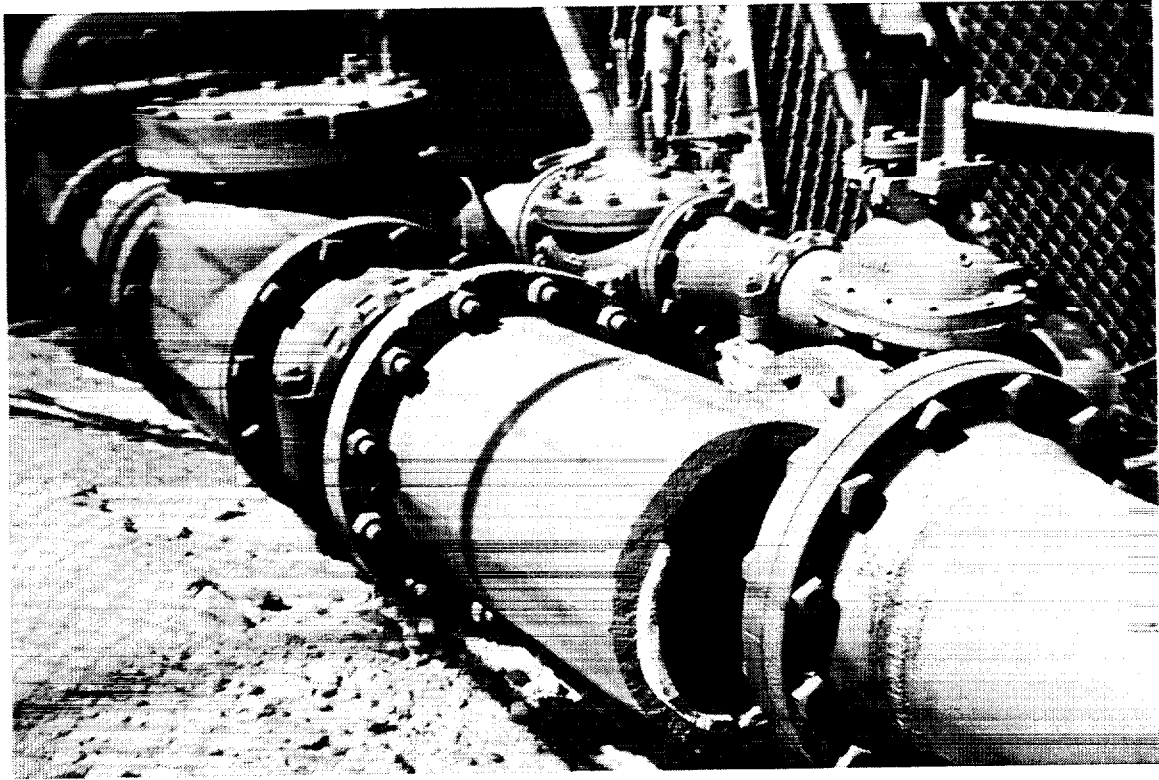
Figure 5.5 Olive View Hospital Tank Piping [Steinbrugge Collection at UCB EERC Richmond]

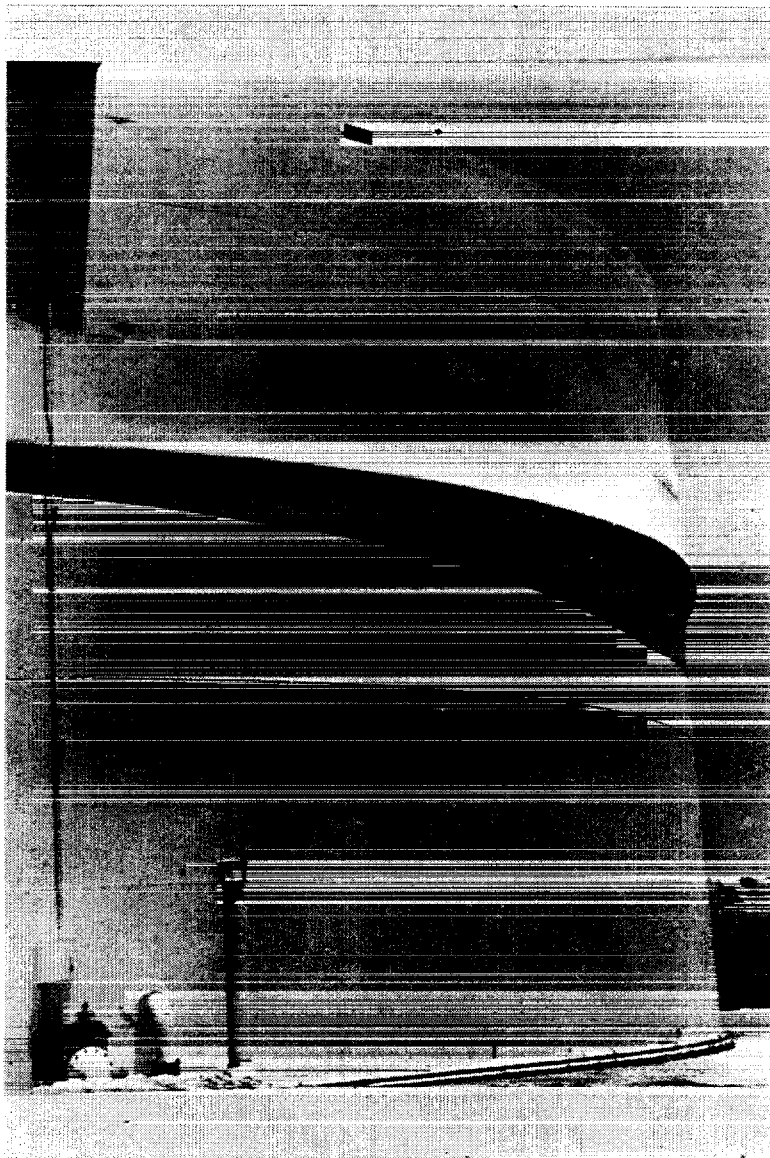
Figure 5.6 Sesnon Tank of CLADWP [Courtesy of G. Housner].

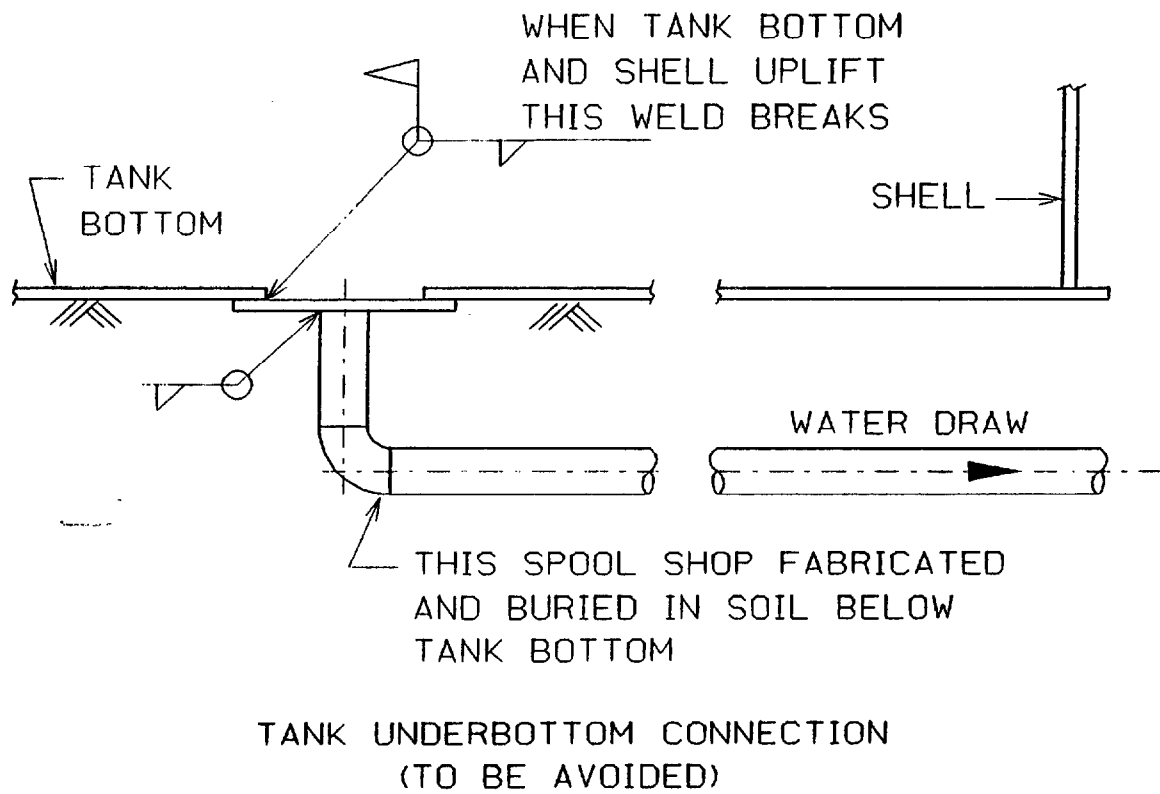
Figure 7.2 Waterdraw piping on Tank 7, Mainline pumping station. Field weld failed, allowing contents to leak.

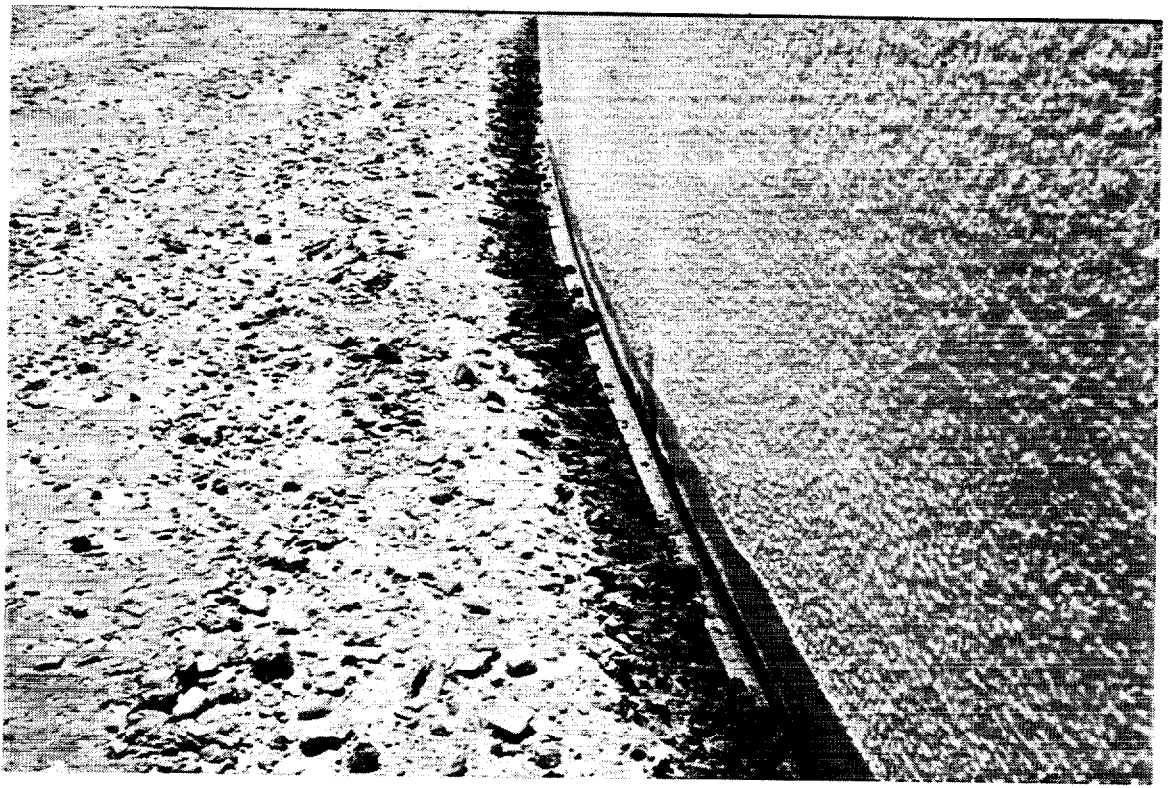
Figure 7.3 Tank 7, 61 m (200 ft) diameter by 14.8 m (48 ft) high with oil pounded into adjacent soil about 10 cm (4 in) in a NE-SW direction. Other tanks with only 3.05 m (10 ft) of oil did not do this.

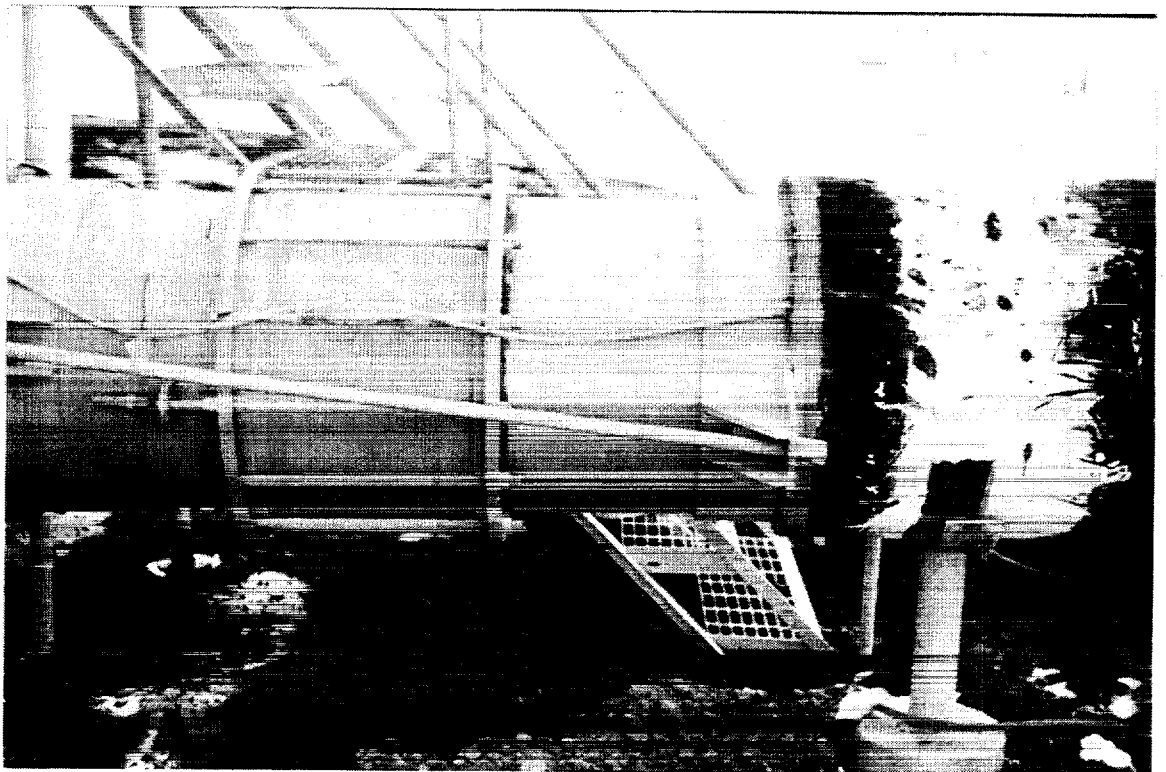
Figure 7.4 Inlet/outlet line on Tank 7, support was battered on both sides of pipe.

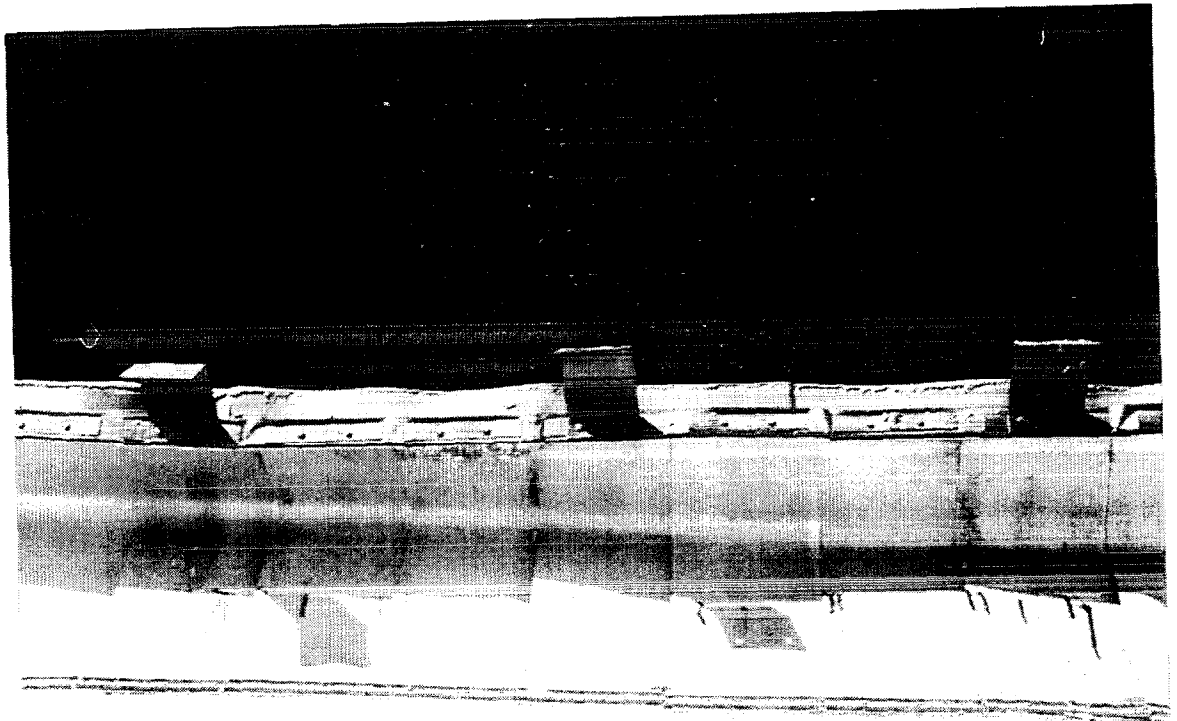
Figure 7.5 Bent secondary seal on Tank 8, this bending was maximum in NE-SW directions.

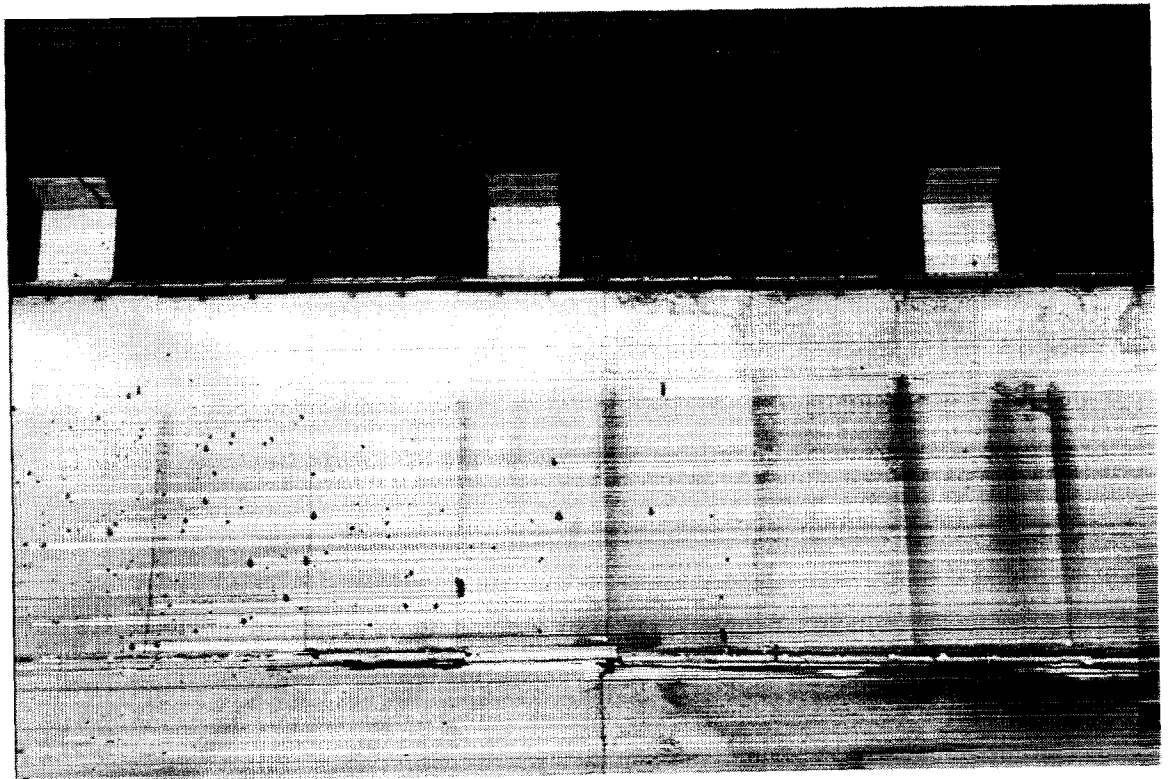
Figure 7.6 Normal unbent seal on Tank 8, seals did not bend in NW-SE direction. This was typical for all tanks at this site.

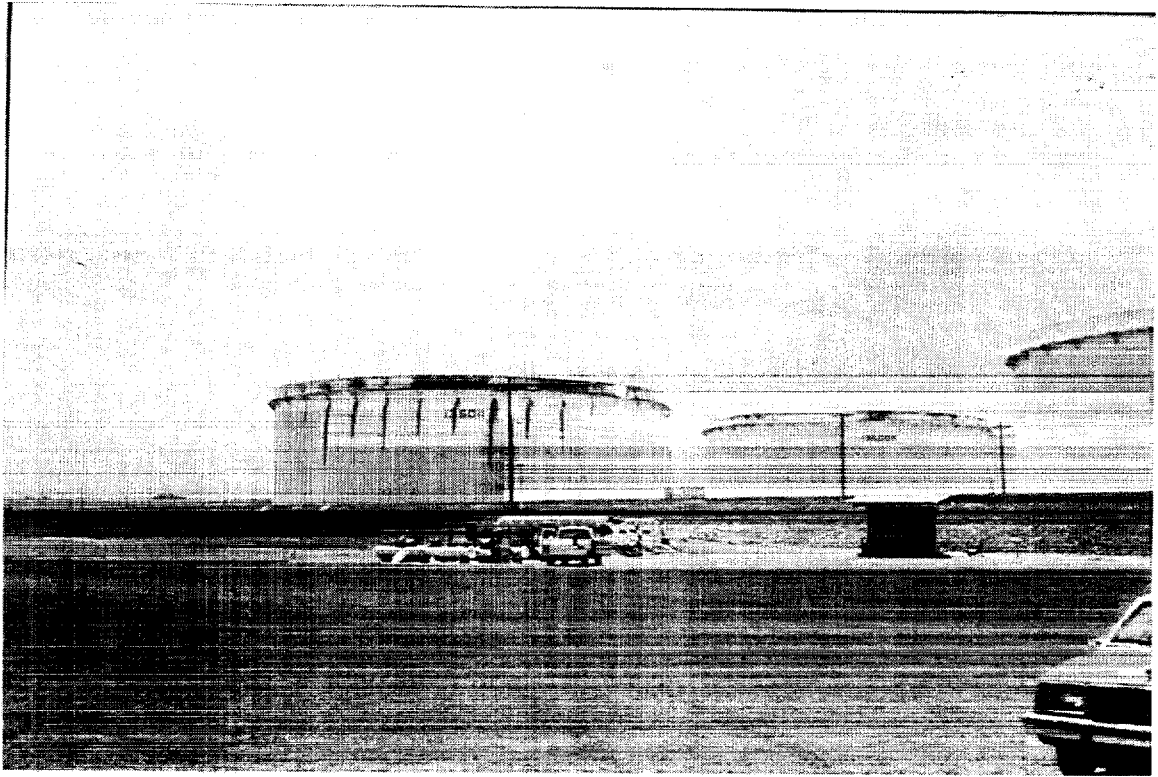
Figure 7.7 These tanks were at Site B and were full.

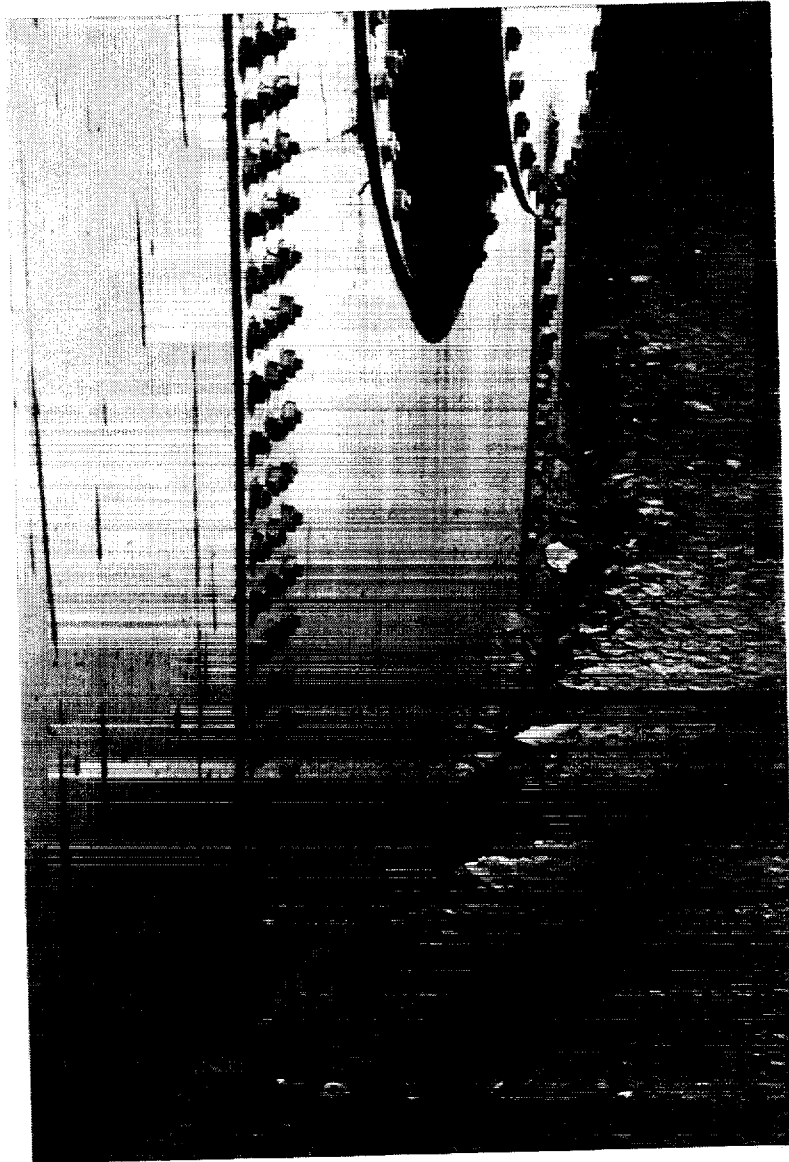
Figure 7.9 Bolted tank which pounded into the ground [Steinbrugge Collection at UCB EERC Richmond].

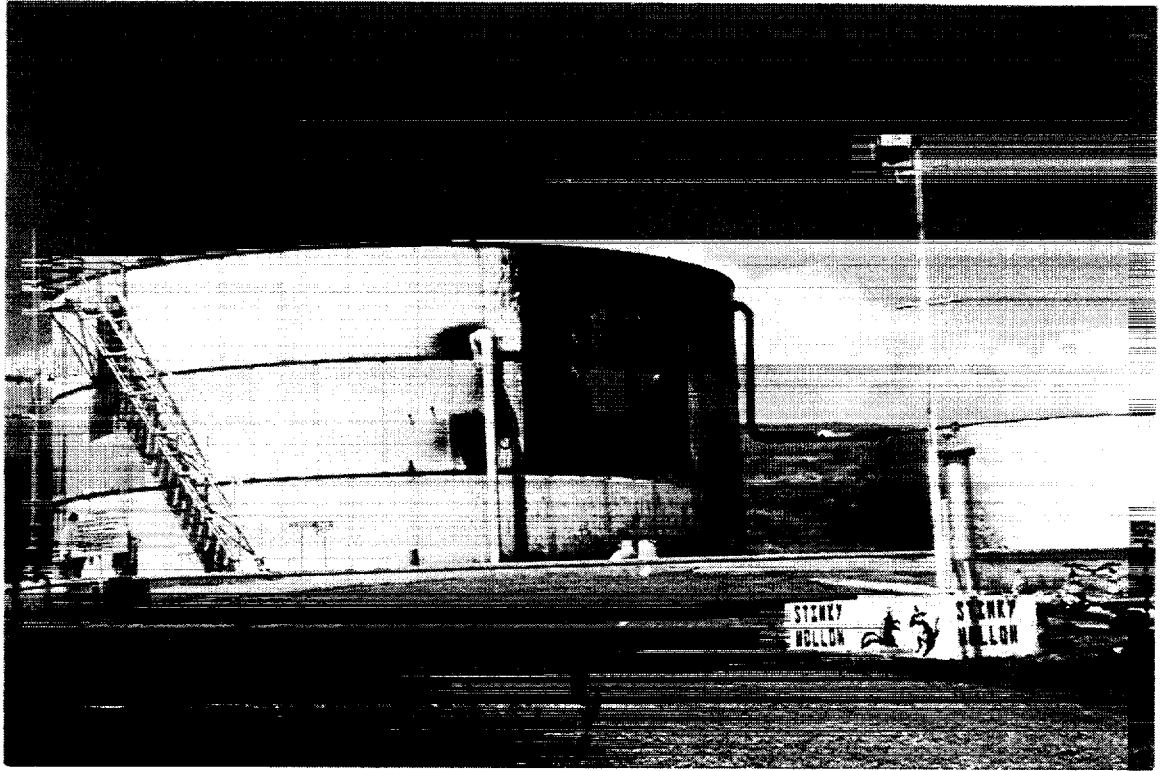
Figure 7.10 Roof spillage on this bolted tank [Steinbrugge Collection at UCB EERC Richmond].

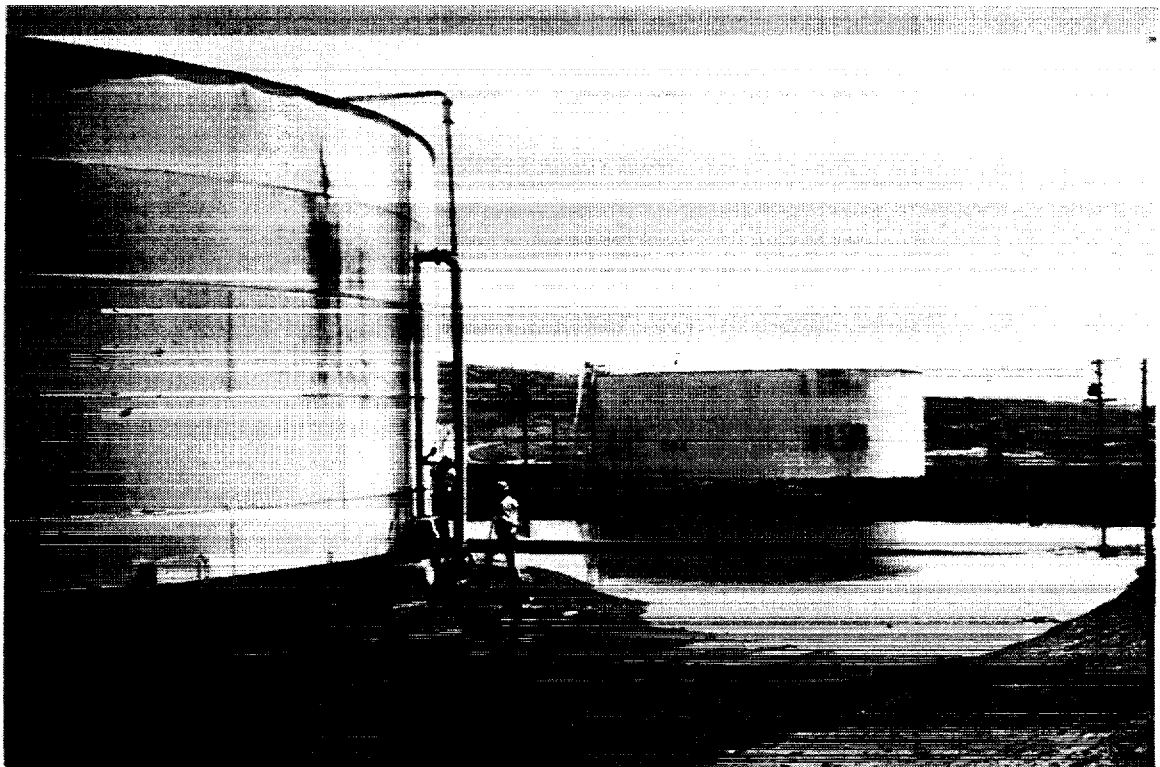
Figure 7.11 Broken valves/fittings caused this spillage [Steinbrugge Collection at UCB EERC Richmond].

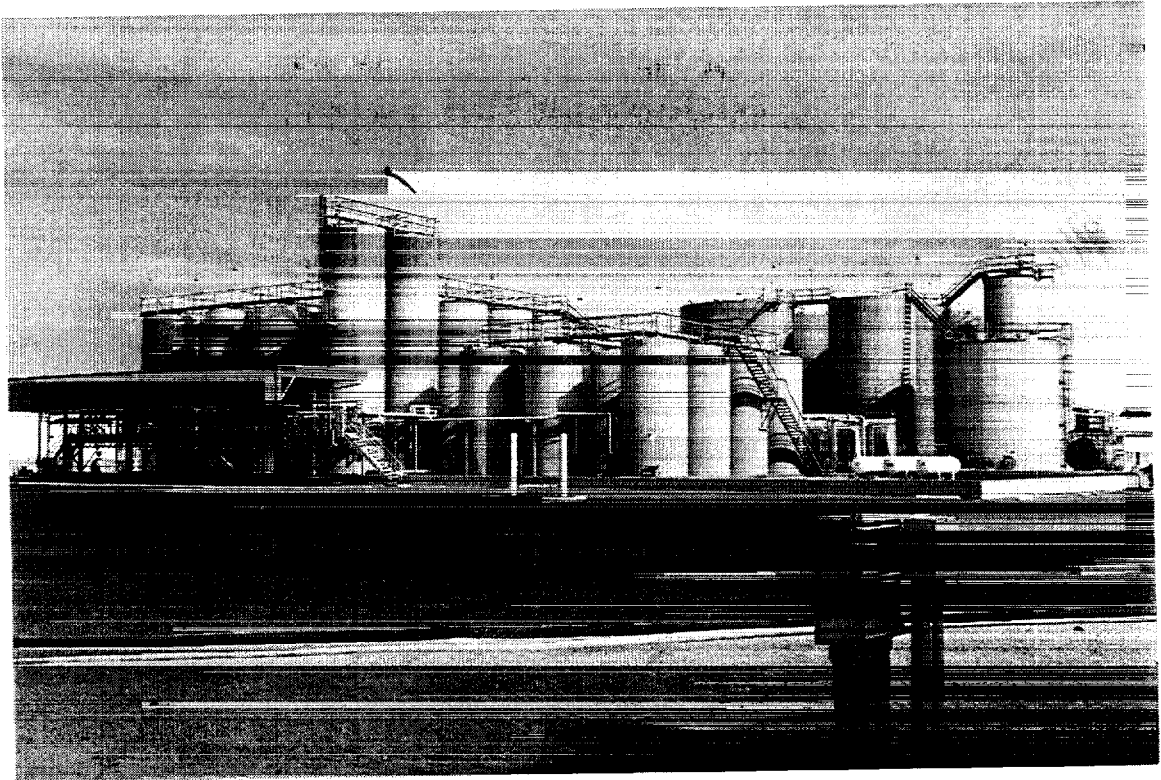
Figure 8.2 Tank block at a lube oil plant where severe damage occurred to larger tanks. Only one 9.2 m (30 ft) diameter by 12.3 m (40 ft) high nearly full tank had elephant foot in this tank block. The 3.7 m (12 ft) diameter by 14.8 m (48 ft) high tank - with the wind sock - had anchor bolt action shown in Figure 8.3. All tanks on pile and concrete mat foundation.

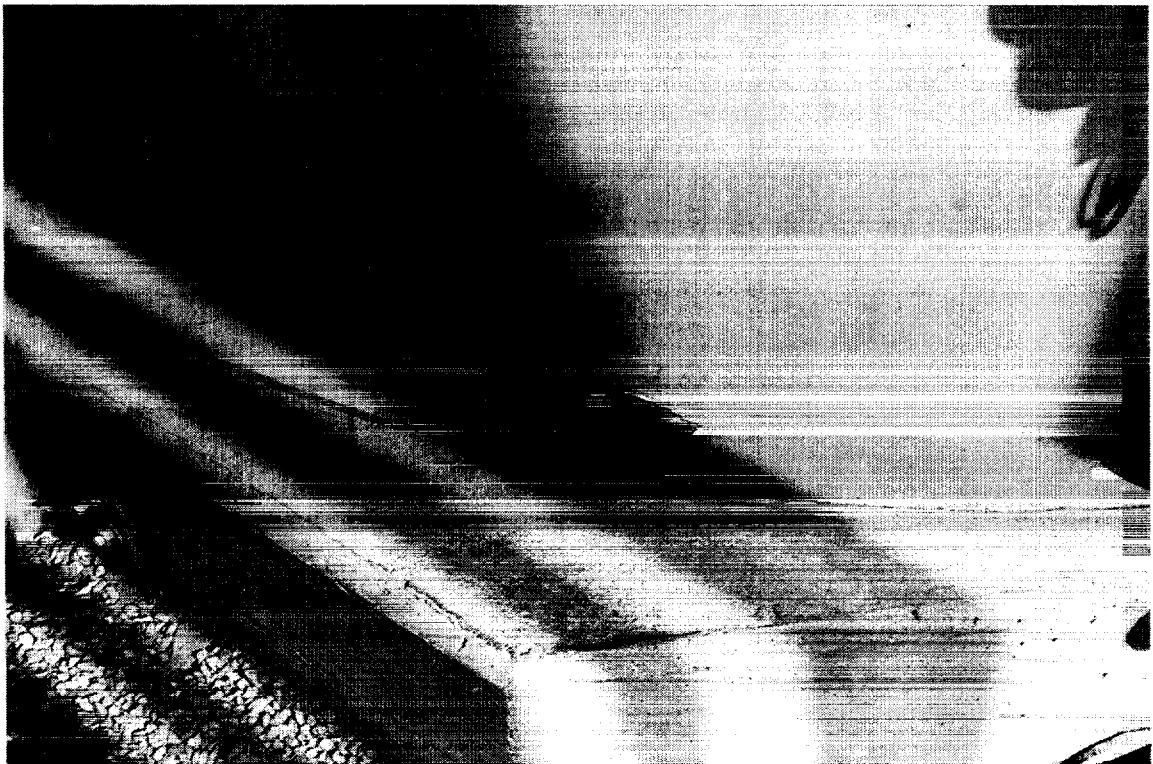
Figure 8.3 3.7 m (12 ft) diameter by 14.8 m (48 ft) high tank with 8ea. 31.7 mm (1¼in) anchor bolts and a ½in bottom plate. Tank was less than half-full.

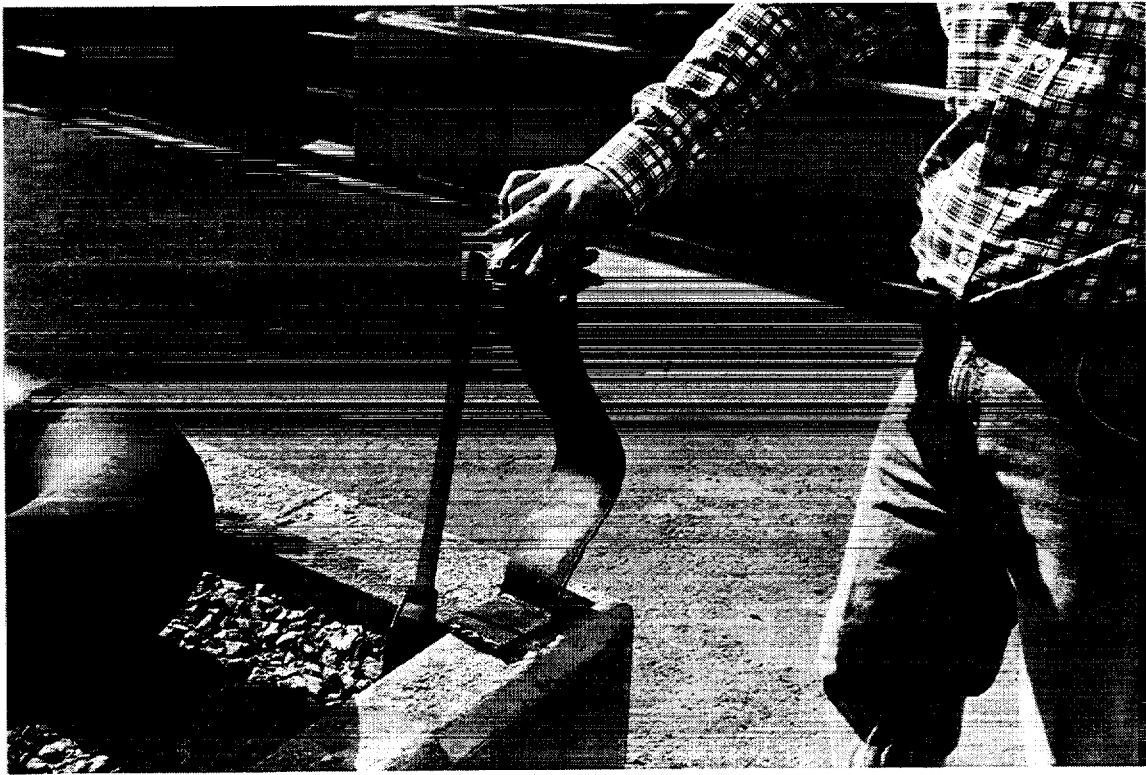
Figure 8.4 View of cut-out of elephant foot shell of 9.2 m (30 ft) diameter by 12.3 m (40 ft) high tank which was nearly full at time of earthquake.
