**A STUDY OF THE PERFORMANCE OF
PETROLEUM STORAGE TANKS DURING
EARTHQUAKES, 1933-1995**

Thomas W. Cooper
T.W. Cooper, Inc.

June, 1997

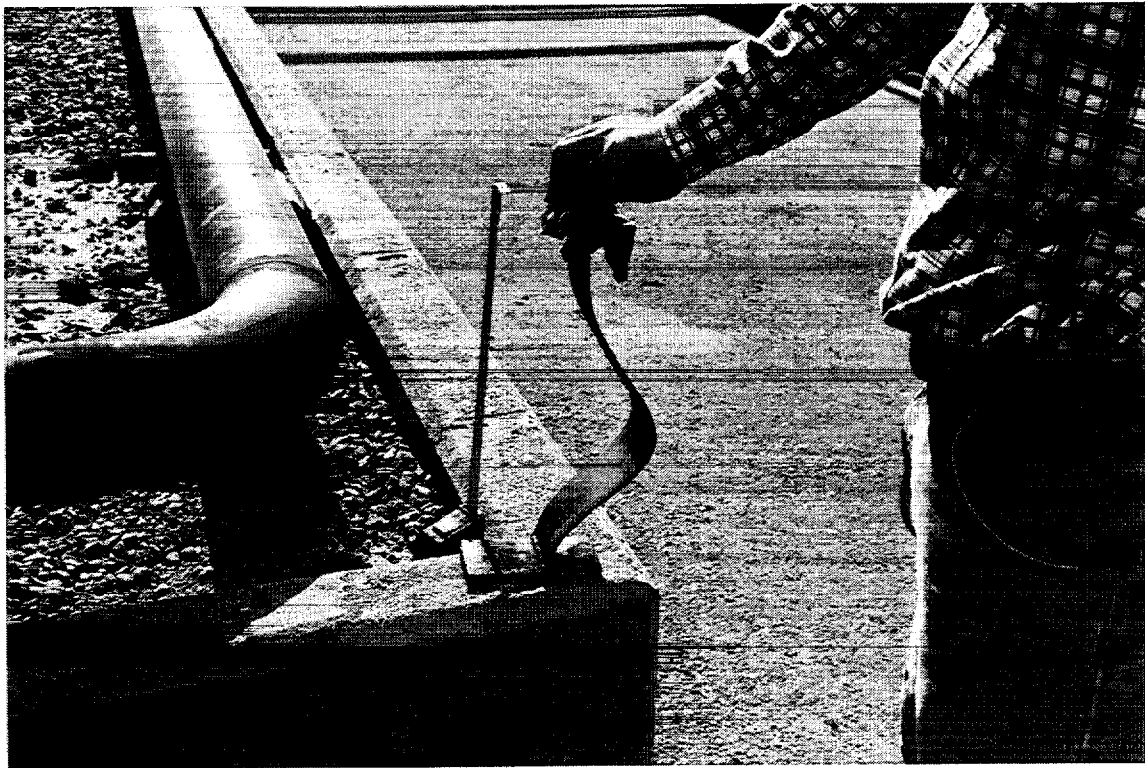
Figure 8.5 Additional view, same tank as Figure 8.4.

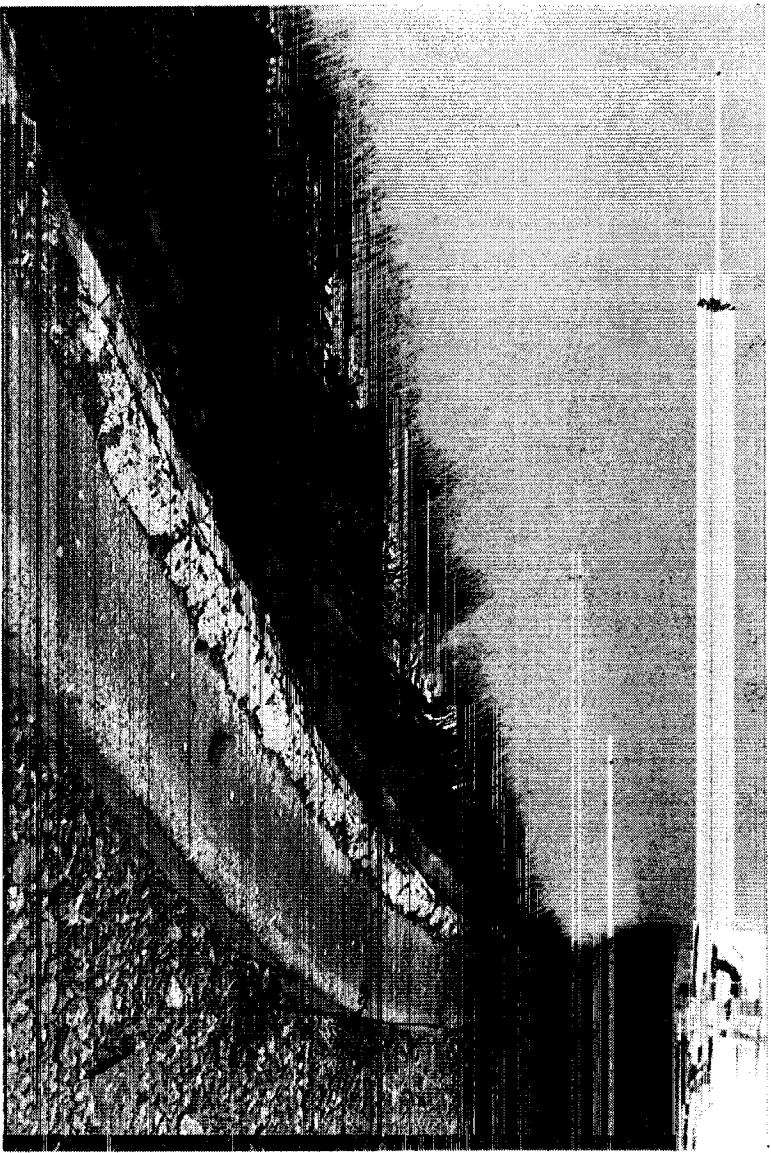
Figure 8.6 Elephant foot on 12.2 m (40 ft) diameter by 9.7 m (32 ft) high tank. Note absence of vertical crack lines in paint at weld.

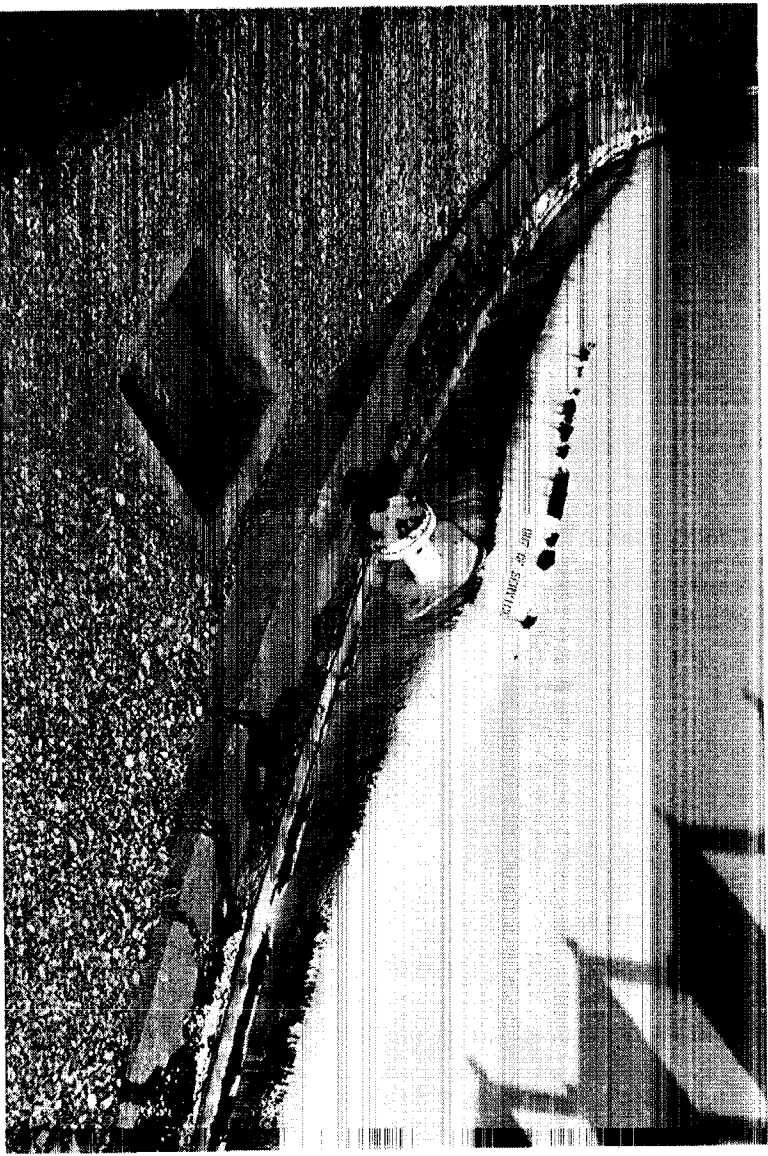
Figure 8.7 Same tank as Figure 8.6, elephant foot maneuver around reinforcing plate at nozzle.

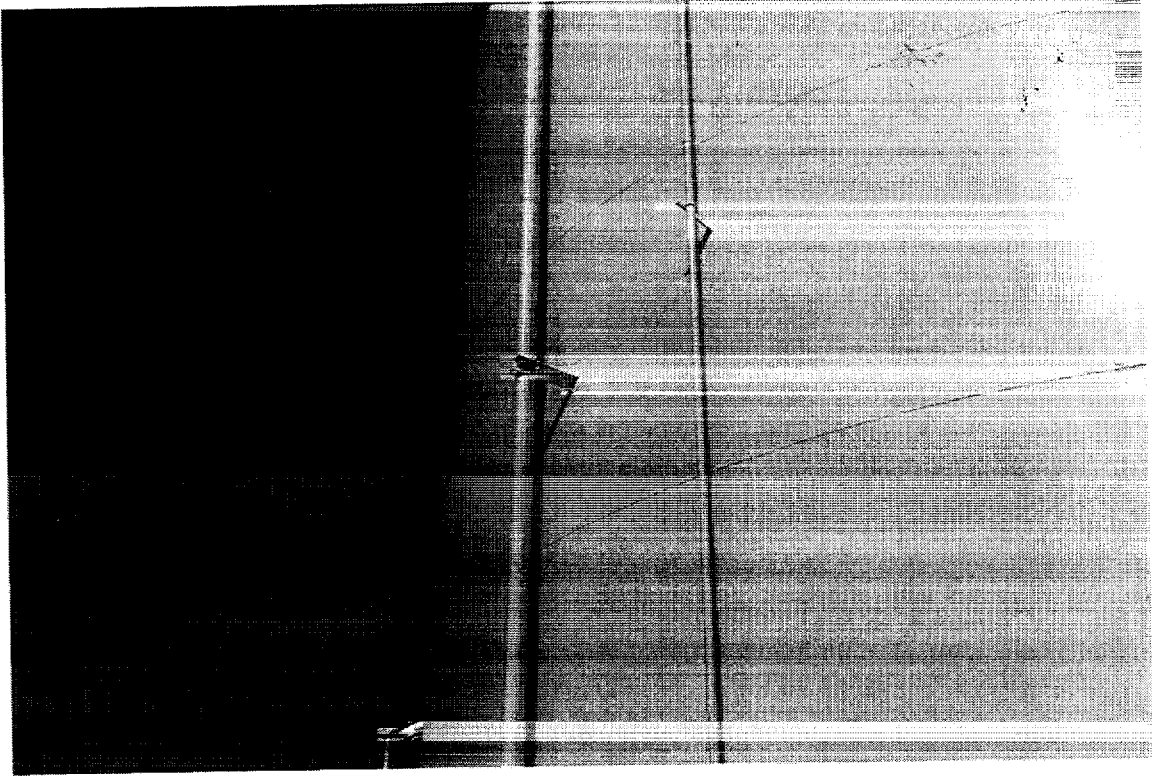
Figure 8.8 Bracket on pipe pulled out making a hole in the tank shell, through which product drained.

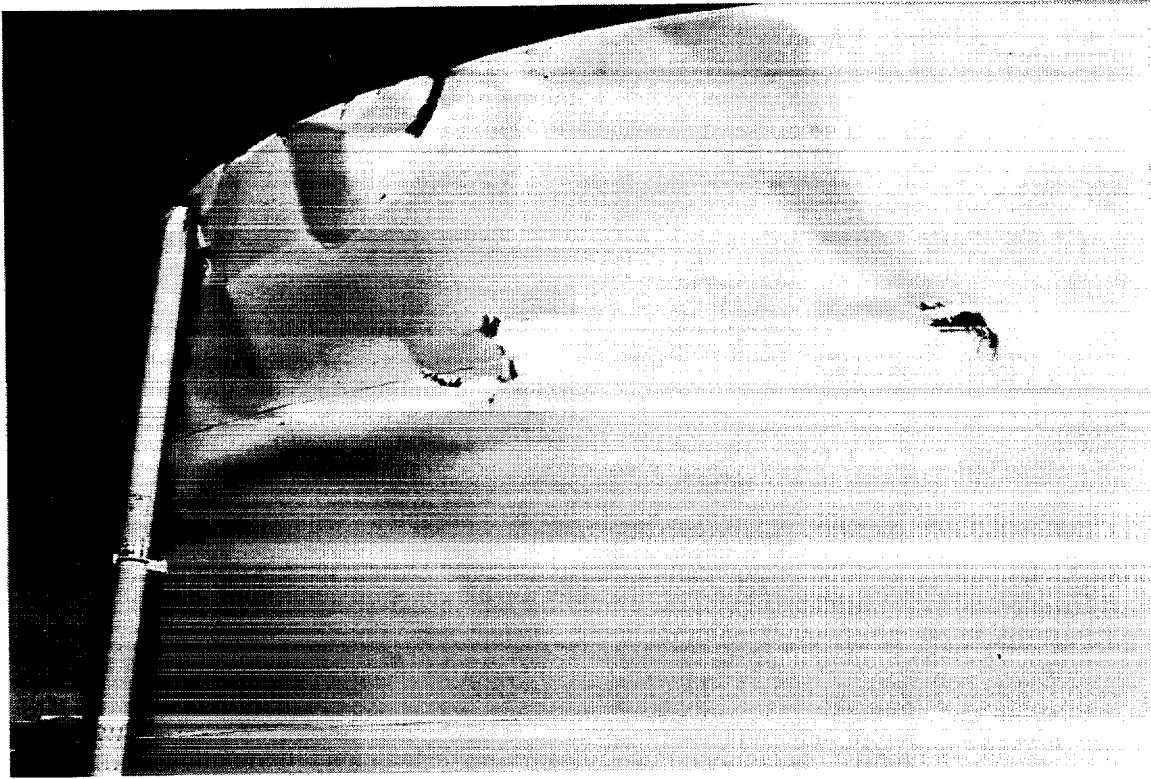
Figure 9.4 South side of Tank A. Pipe clamp slide was 0.6 m (22 in).

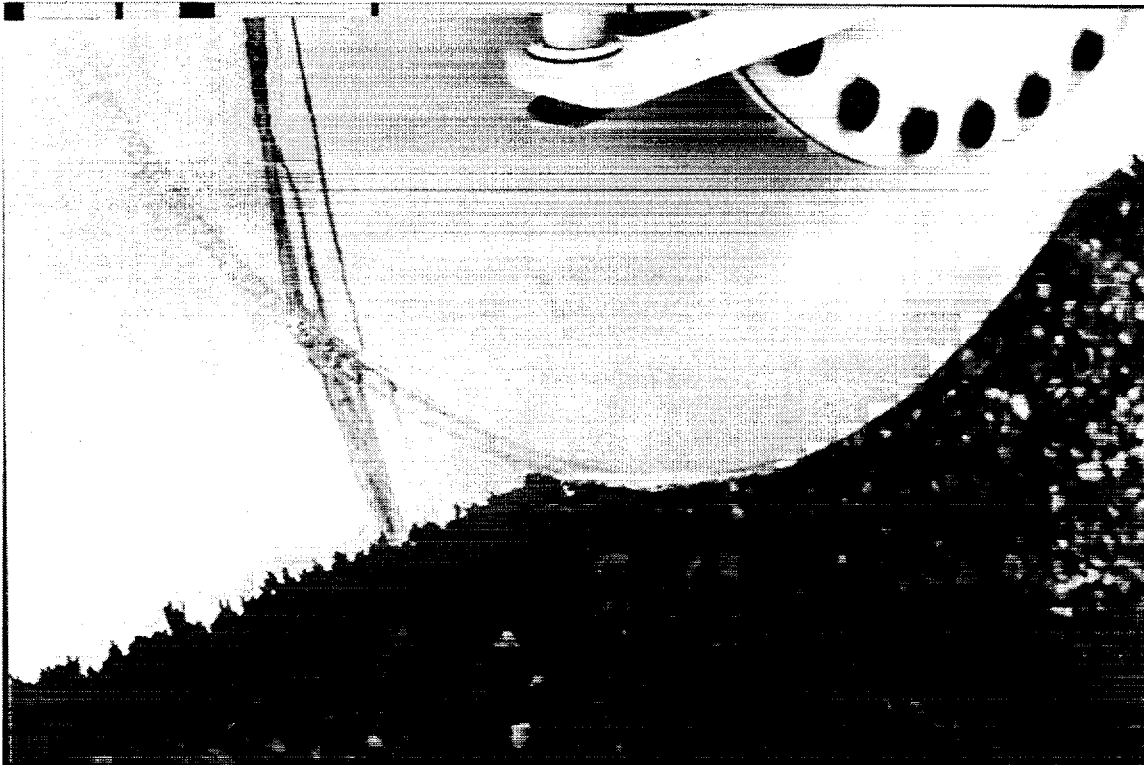
Figure 9.5 Tank A, tear on shell at the bottom of reinforcing plate.

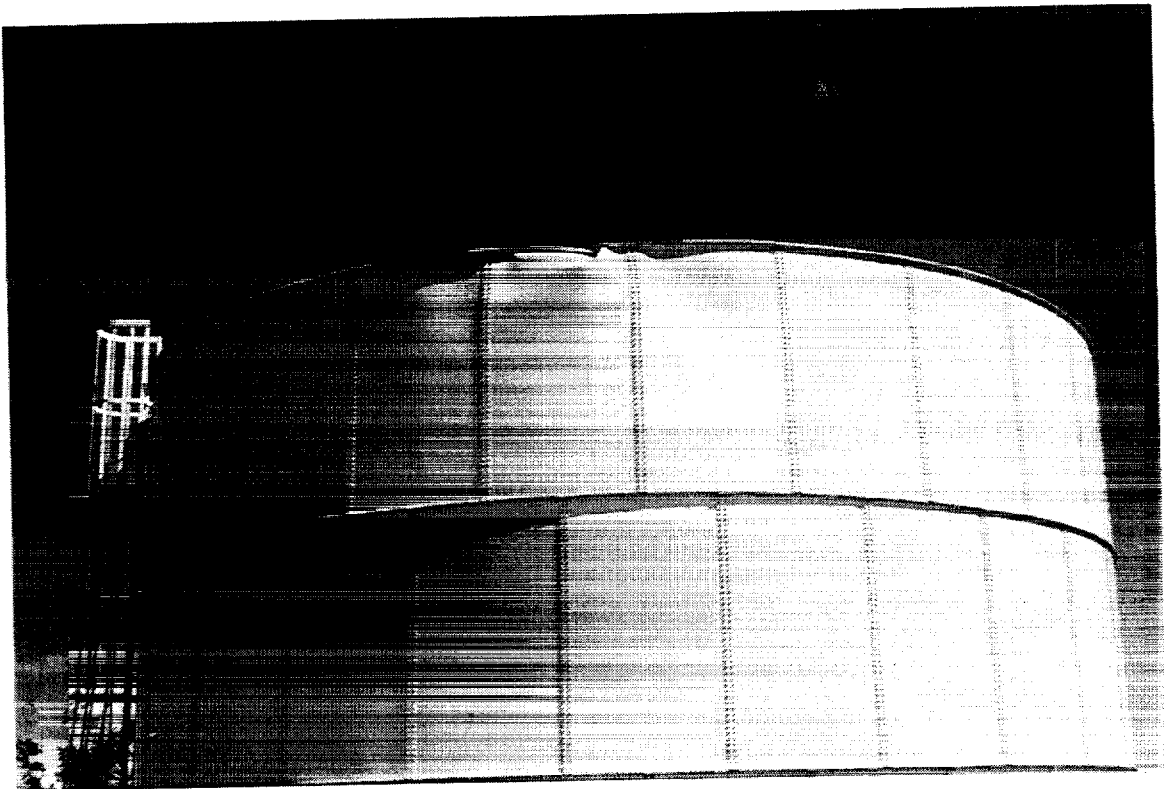
Figure 9.6 Roof/shell buckling on CSA-70.

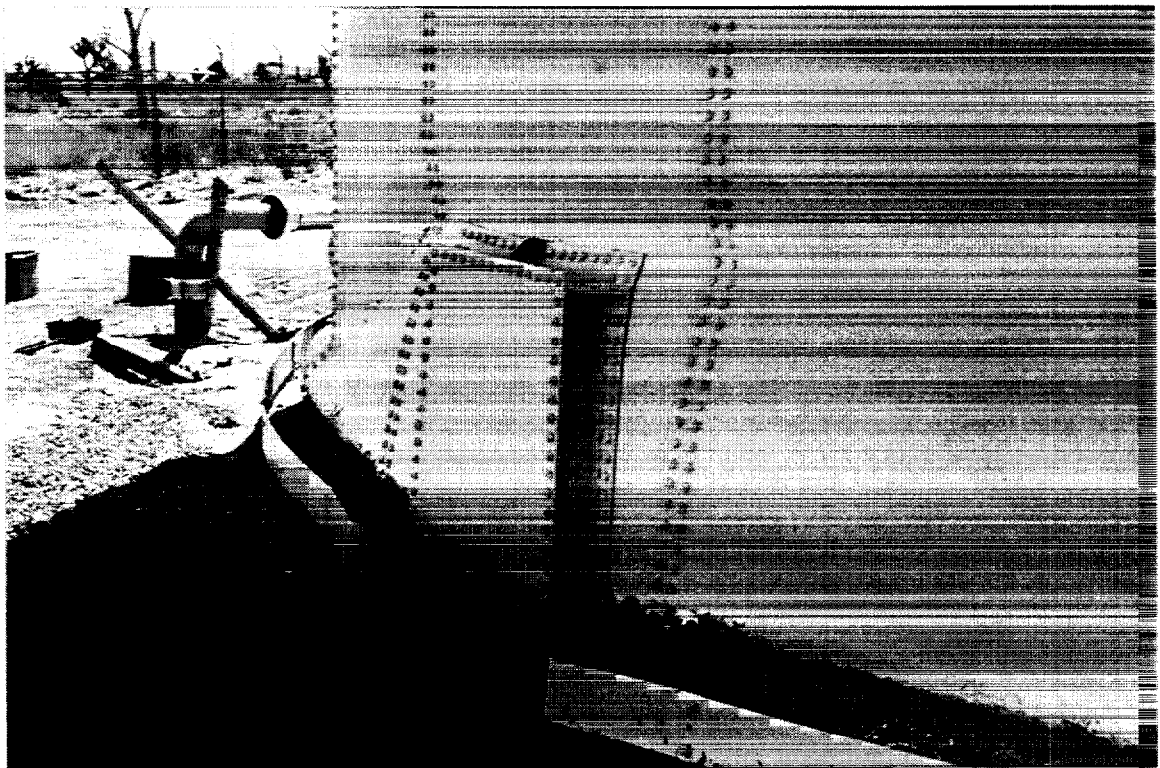
Figure 9.7 CSA-70 clean-out door, tank on rock foundation.

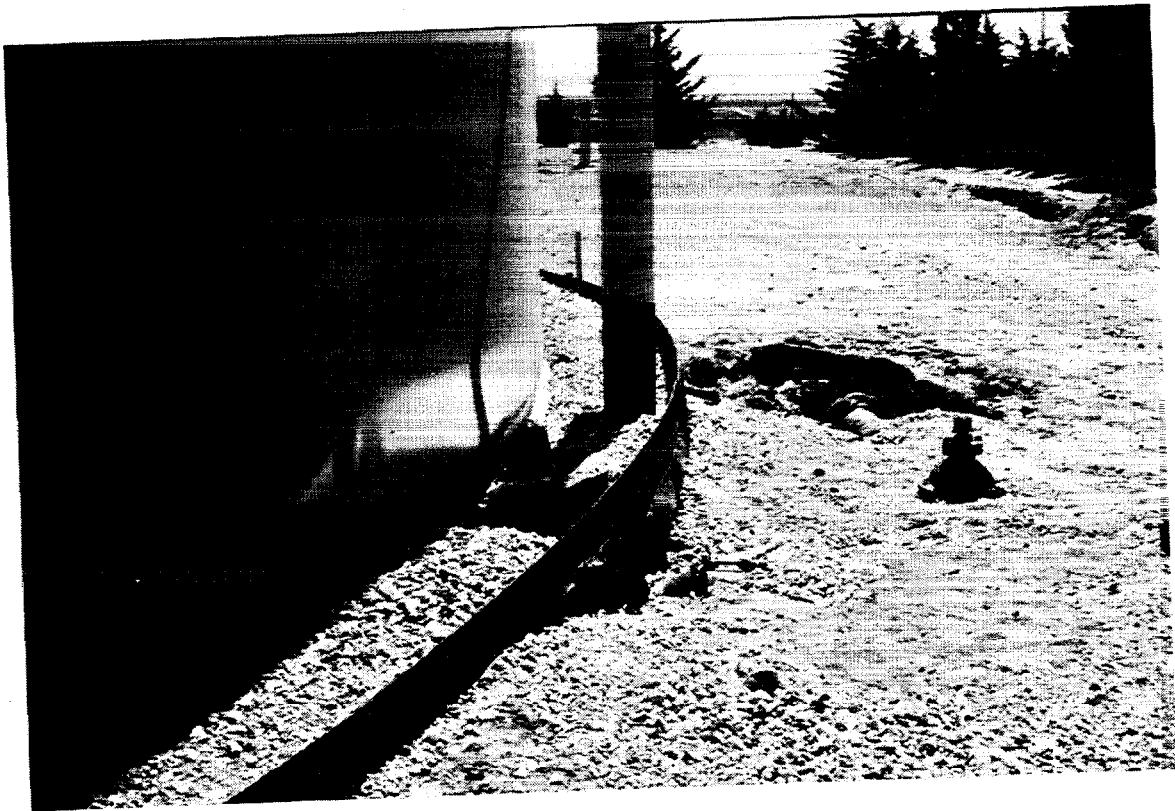
Figure 9.8 Tank A, riser pulled piping and rock retainer ring out of the ground.

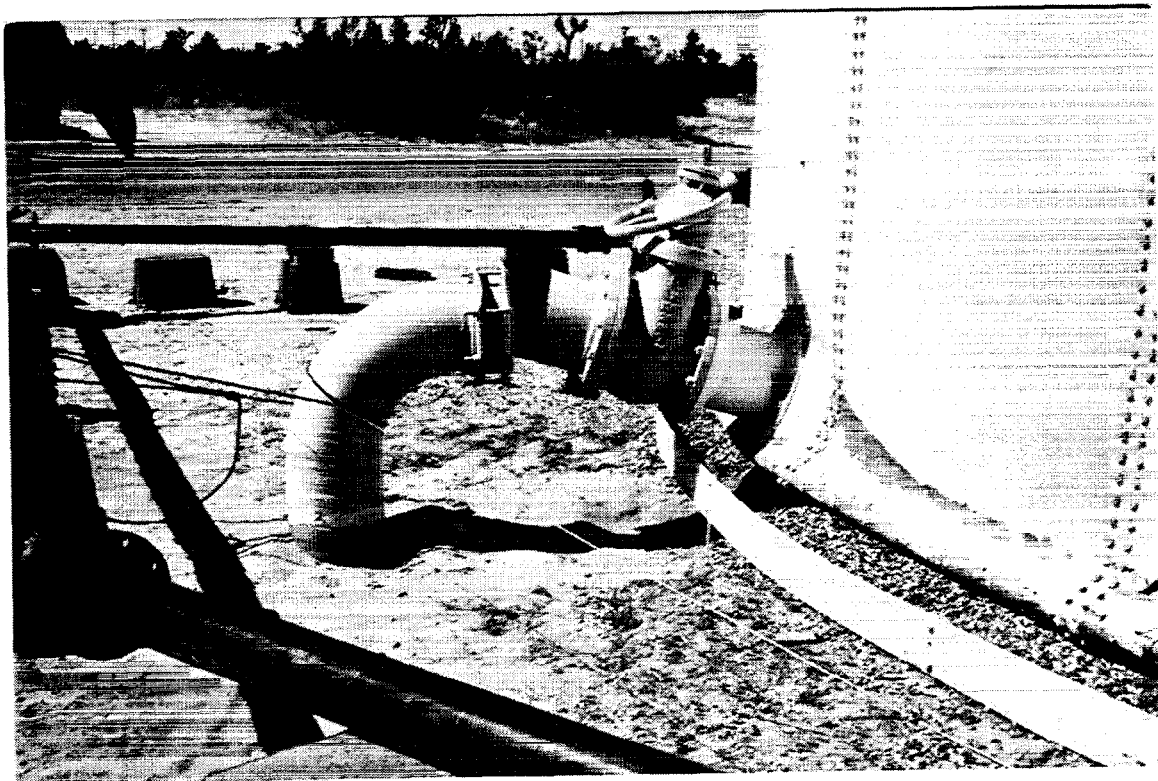
Figure 9.9 Piping at CSA-70.

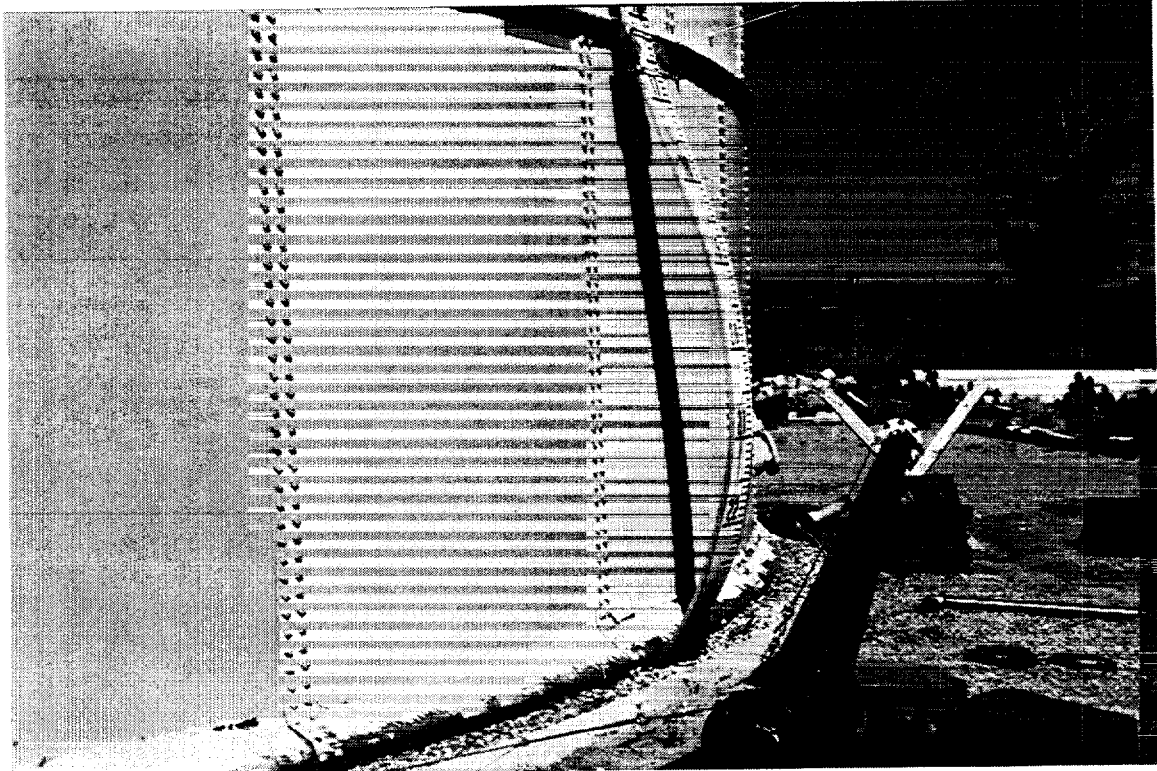
Figure 9.10 CSA-70 tank, elephant foot was fairly uniform around tank.

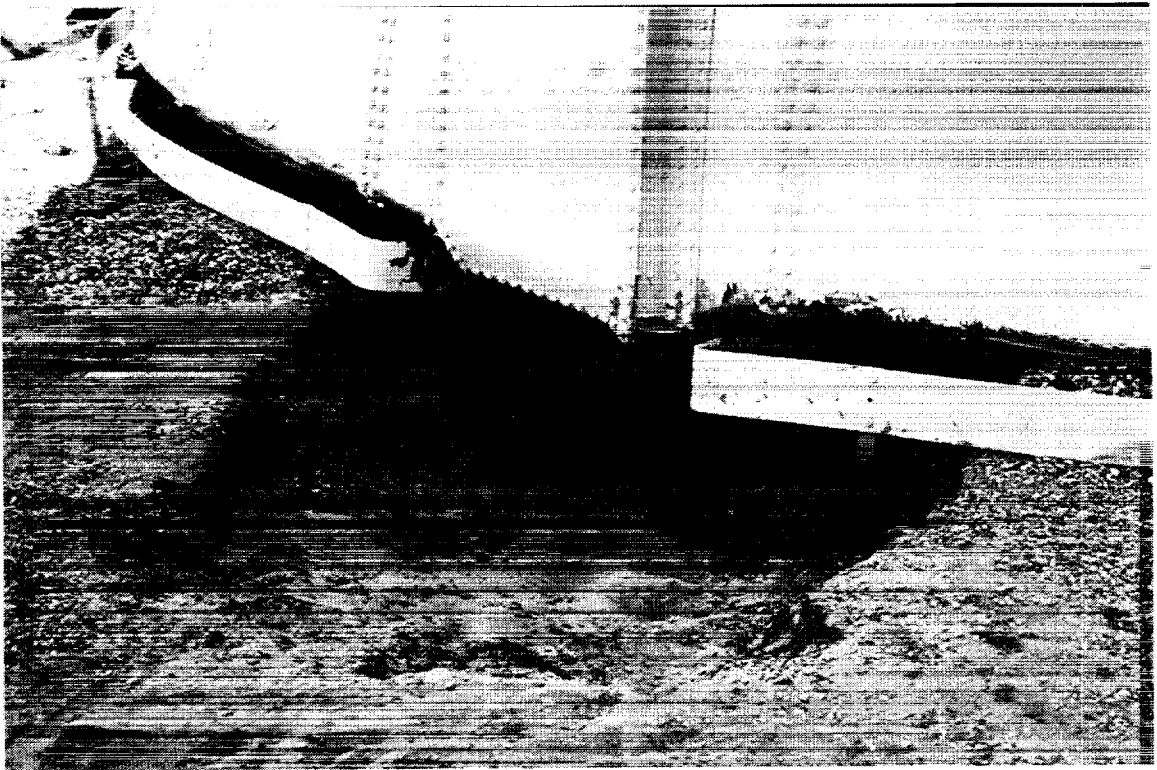
Figure 9.11 CSA-70 tank, damage of clean-out door, and washout of soil.

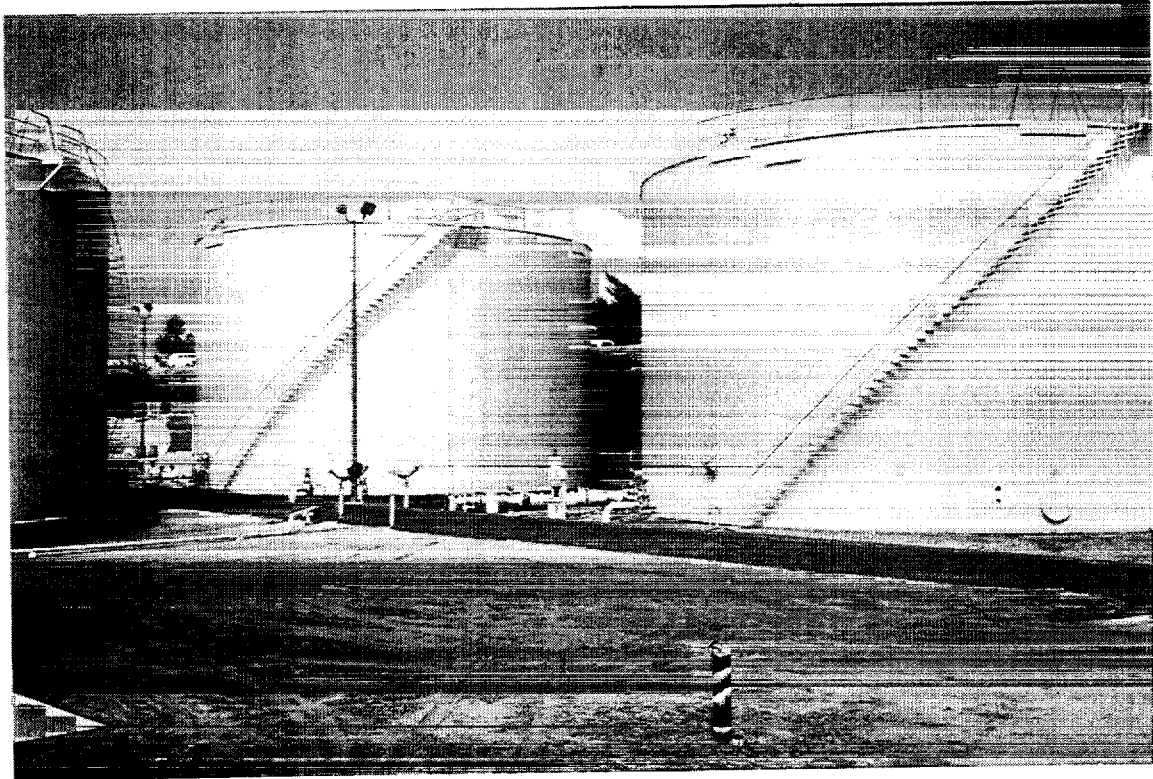
Figure 10.3 Sepulveda Products Terminal, internal pan tanks had no damage but product did slosh on the top of the pans.

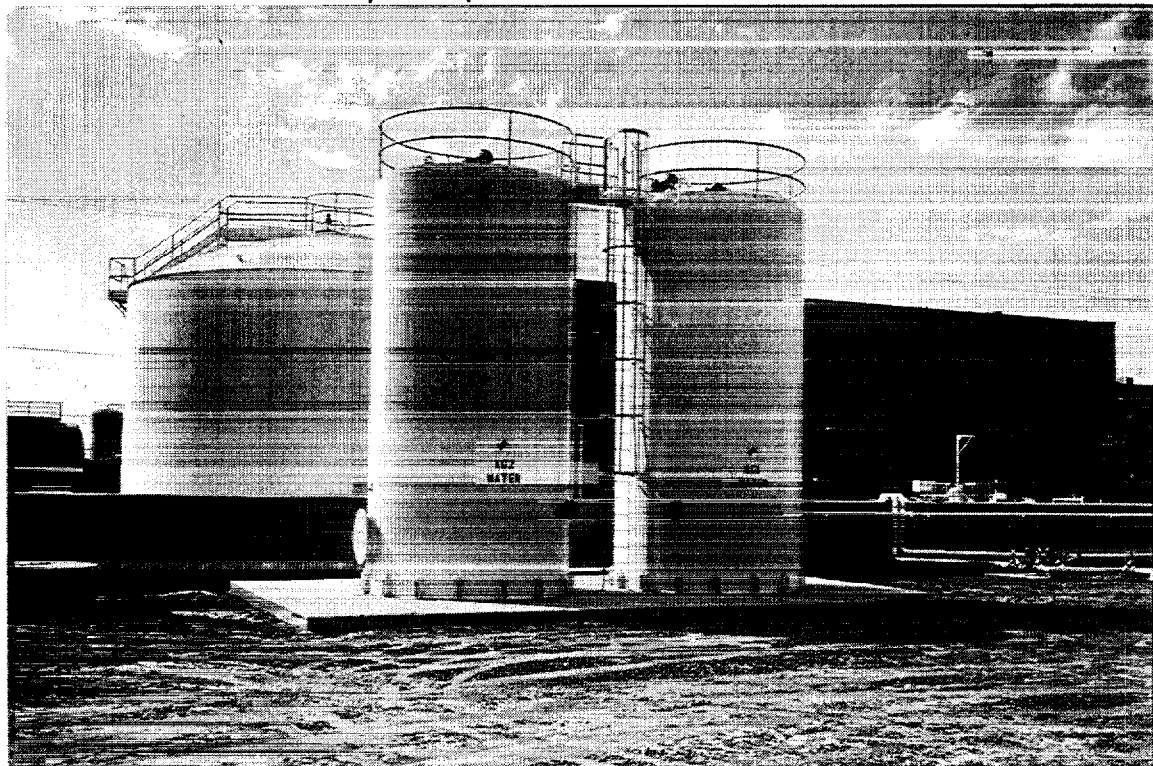
Figure 10.4 Wastewater tanks at Sepulveda Terminal, AG2 (on left) was full at time of earthquake, AG1 was empty. No damage to AG2.

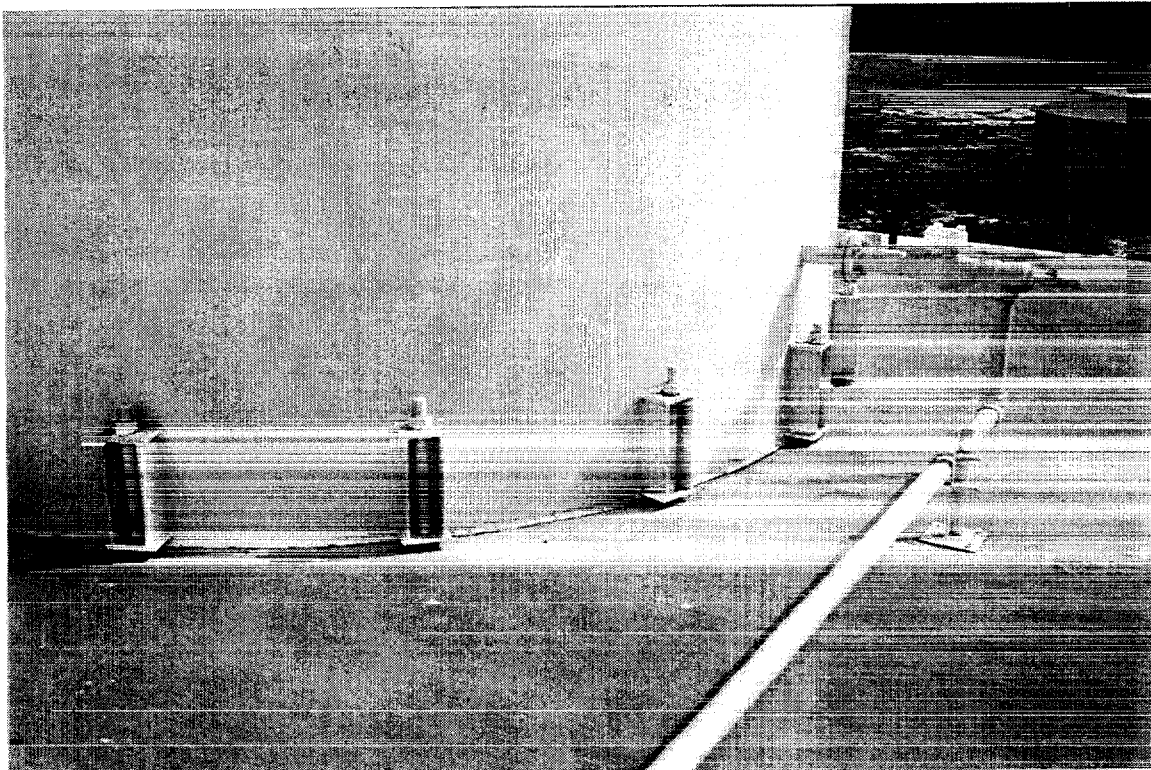
Figure 10.5 Anchor bolts and chairs on Tank AG2.

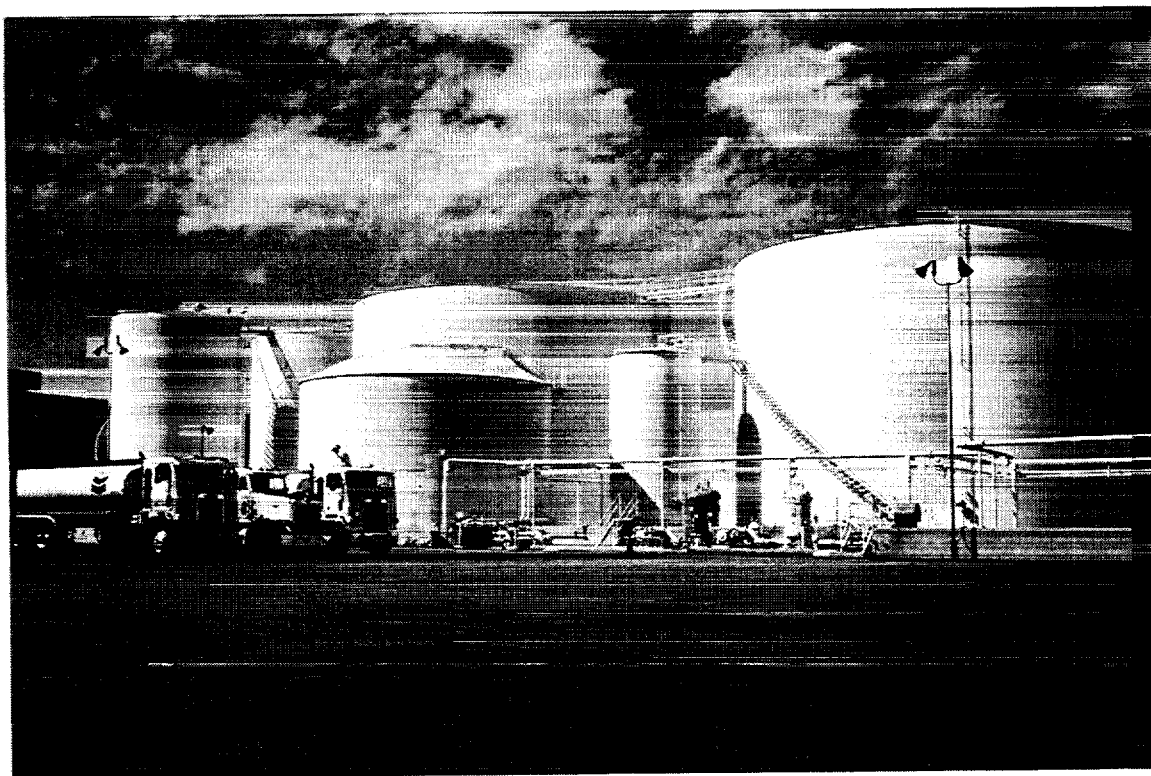
Figure 10.6 Van Nuys Terminal, no significant damage at this location.

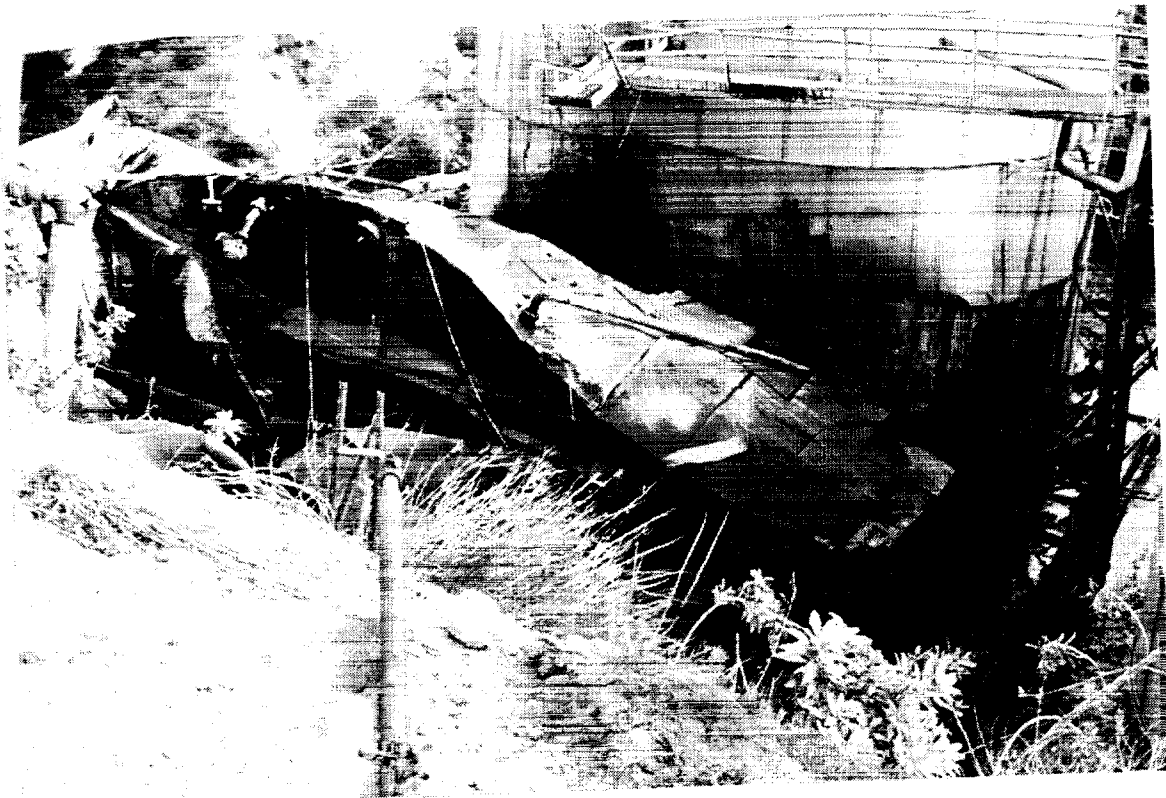
Figure 10.7 Aliso Canyon bolted oil production tank, which collapsed [Courtesy of L.Lund].

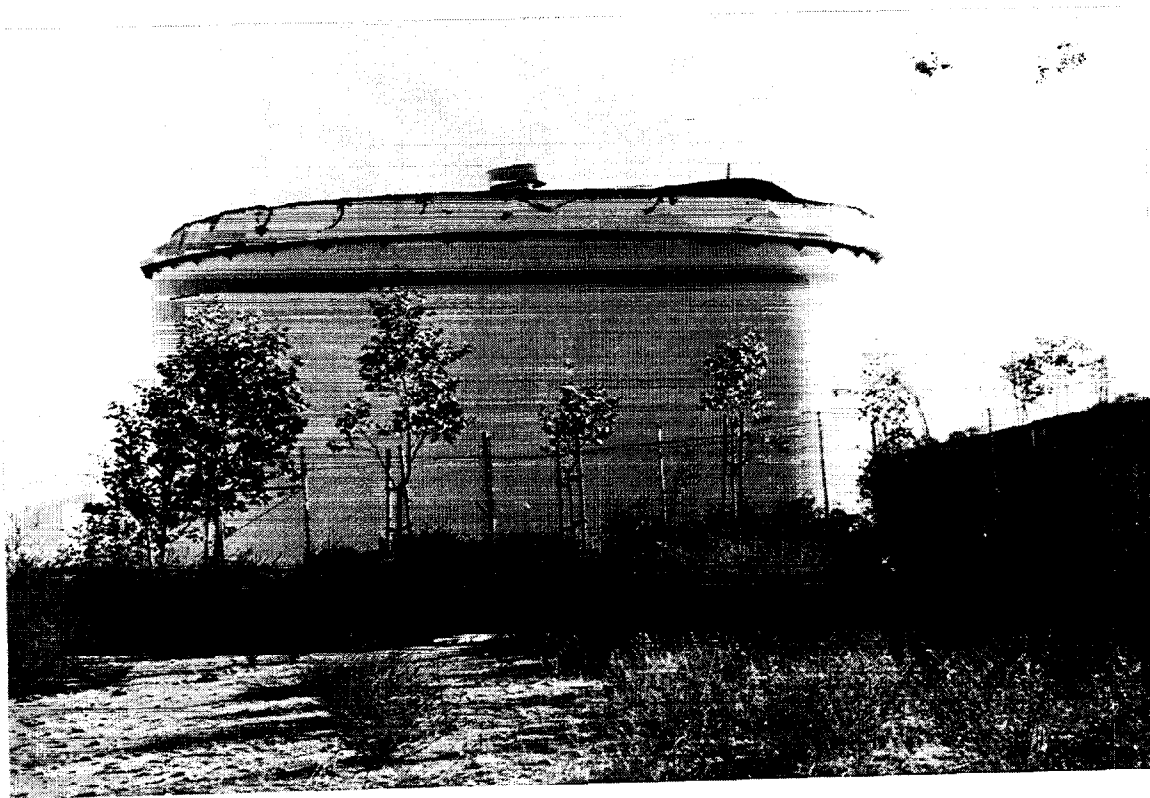
Figure 10.8 Larwin tank, 18.3 m (60 ft) in diameter by 12.2 (40 ft) high showing roof damage [Courtesy of L. Todd].

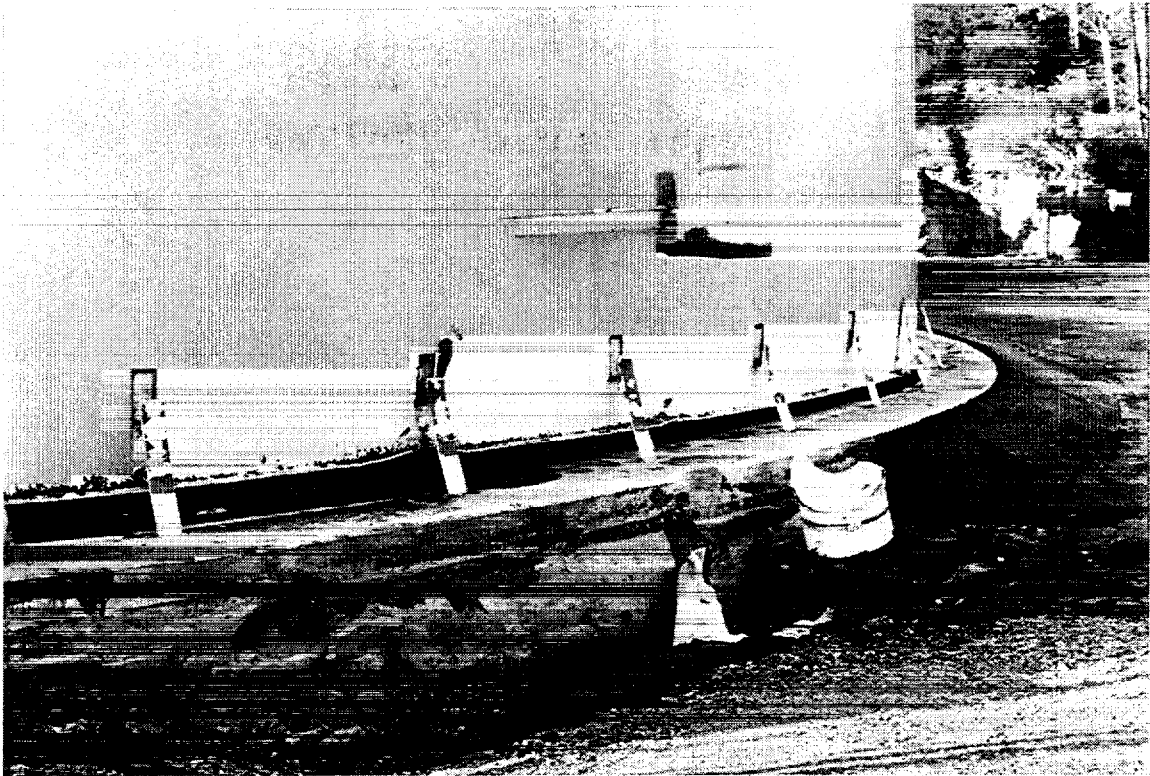
Figure 10.9 Larwin Tank, shows permanent bottom distortion and uplift and stripping of anchor straps [Courtesy of L. Todd].

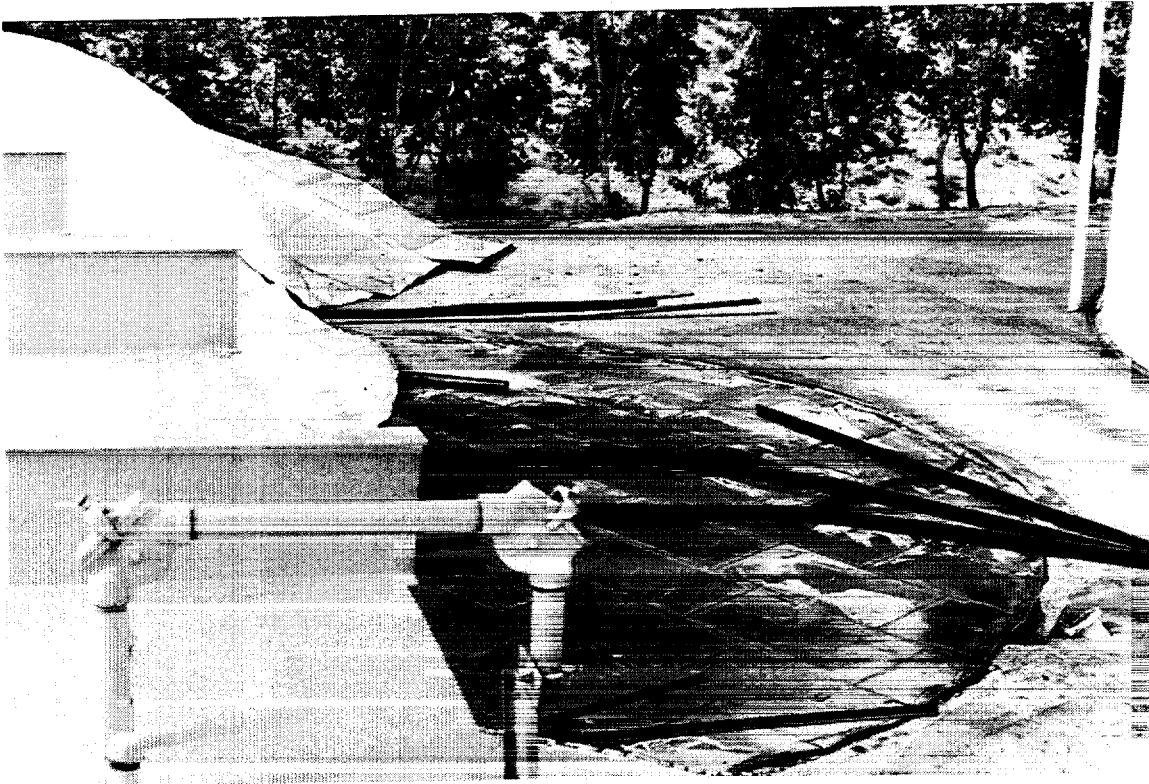
Figure 10.11 MMII, showing bottom and shell rip, note exterior rafters on MMIII [Courtesy of L. Todd].

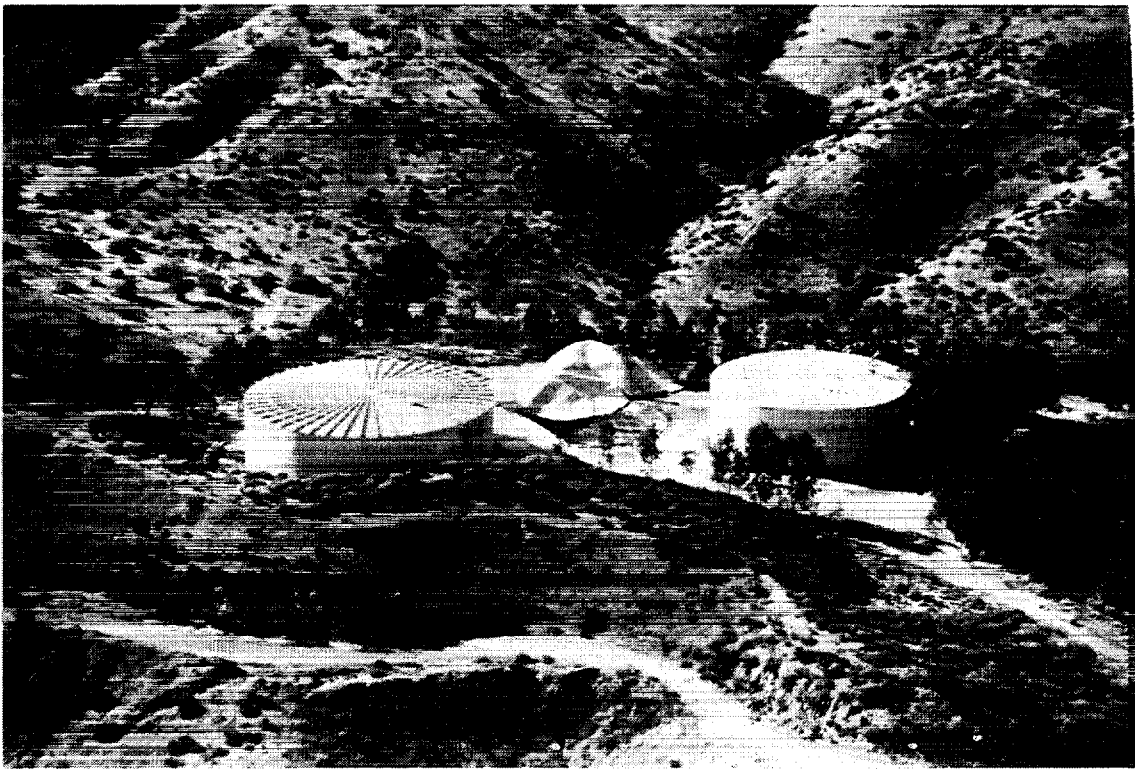
Figure 10.12 Setting for MM (Magic Mountain) tanks [Courtesy of E. Lindvall].

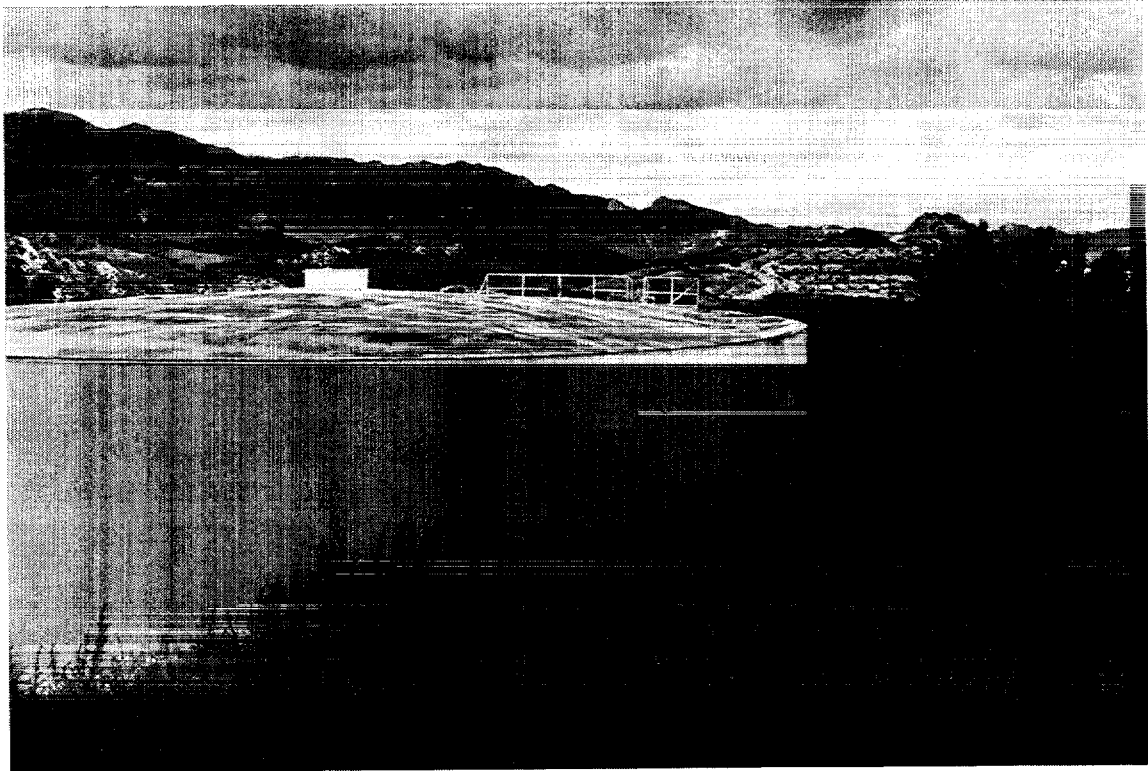
Figure 10.13 Roof, rafter, and shell damage on Tank 7, NCWD. This tank had a 12.7 mm (1/2 in) annular ring (or bottom plate) and did not elephant foot.

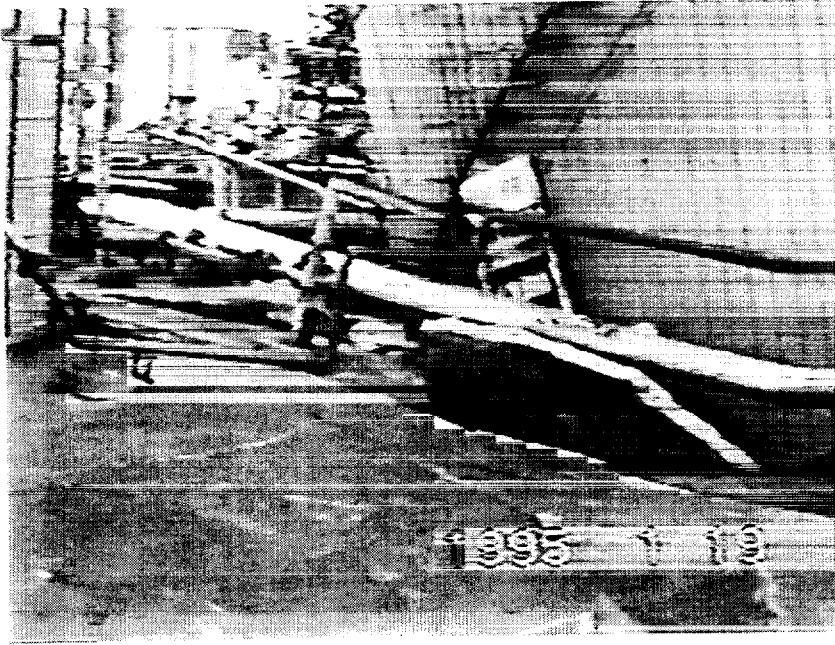
Figure 11.2 Settlement and tilting due to liquefaction (GATX video).

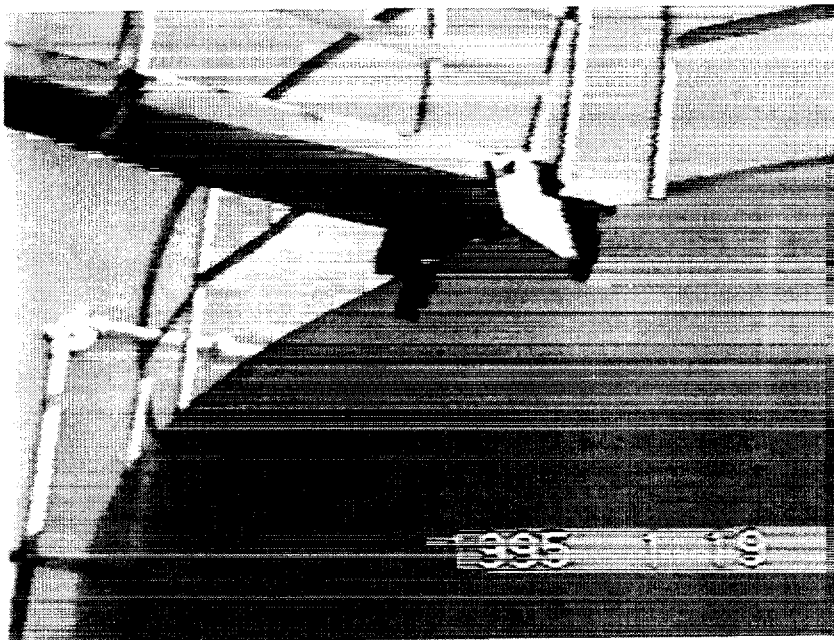
Figure 11.3 Inter-tank walkway joint failure (GATX video).

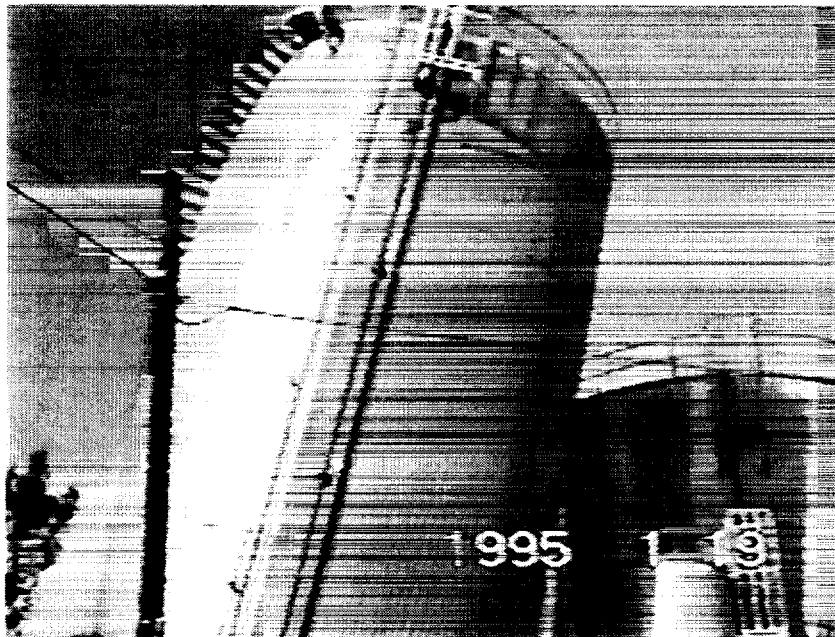
Figure 11.5 Tilted tank (GATX video).

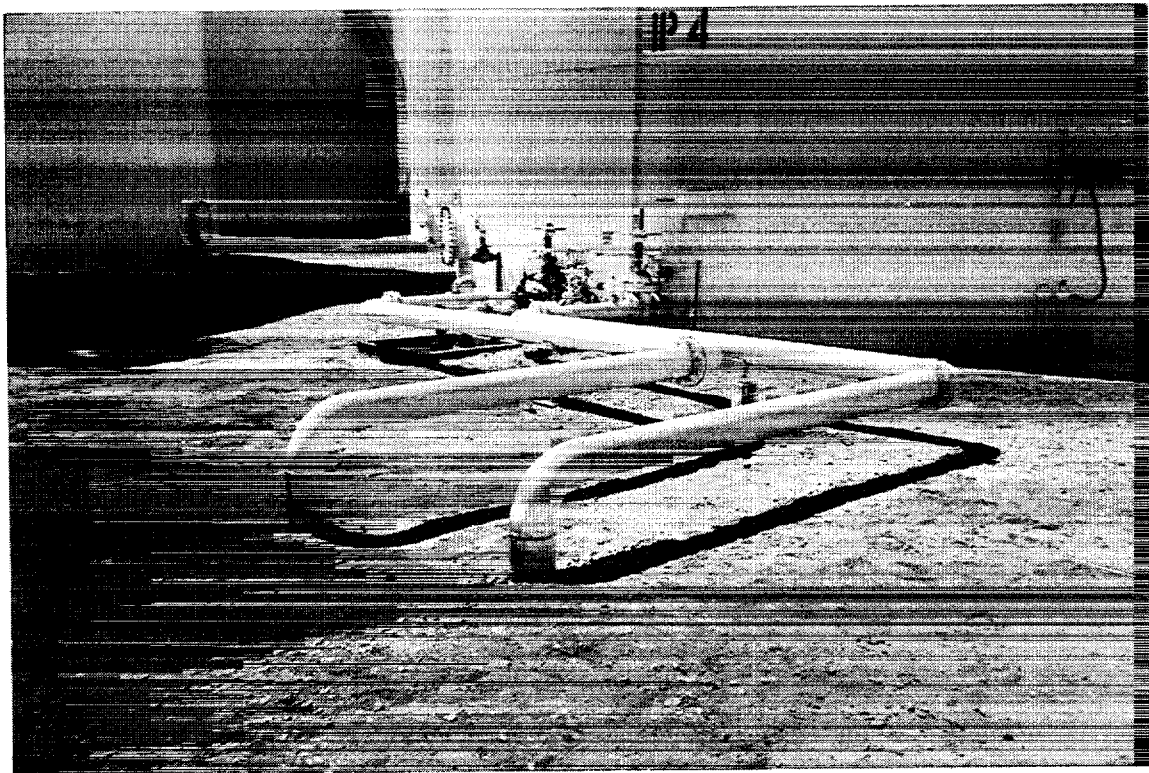
Figure 13-1 Inlet-Outlet piping which provides flexibility, note that the flanges in the horizontal runs are lap-joint stub end flanges. (Courtesy of J. Englehardt, SFPPL).

12. Inlet-outlet piping should be made more flexible, and consideration should be given to making inlet-outlet piping from steel (including steel valves).
13. Additional studies should be made on tanks with d/H ratios of less than two to determine if elephant foot buckling can be eliminated, either by increasing shell thickness (Sesnon) or anchorage.
