REPORT OF INVESTIGATION

Underground Nonmetal Mine
(Trona)

Fatal Powered Haulage Accident
September 19, 2007

FMC @ Westvaco
FMC Corporation
Green River, Sweetwater County, Wyoming
Mine I.D. No. 48-00152

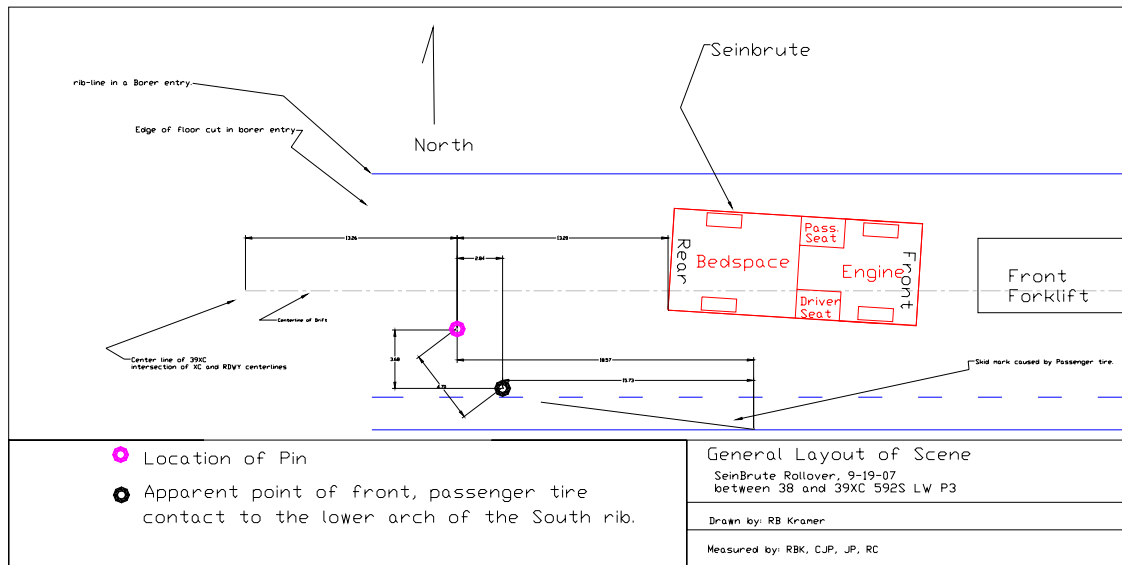
Figure 1

The accident occurred in the middle entry of the 592 longwall panel number 3 between crosscuts 38 and 39. The entry was driven using a borer mining machine and was about 16 feet wide and 10 feet high. The roof and floor were cut flat with the radial cutter heads but the borer created convex curved ribs on both sides of the entry.

The right front tire of the service truck contacted the right rib of the entry. The same tire created a mark on the roof approximately 15 feet from initial contact with the rib. The angle of climb on the rib measured 11%. There was no indication that the truck slid forward once it landed upside down indicating a slower speed/weight ratio. As the vehicle rolled, it rotated counter clockwise with the passenger side coming to rest across the entry to the left (north) rib.

SCHEMATIC OF ACCIDENT SCENE

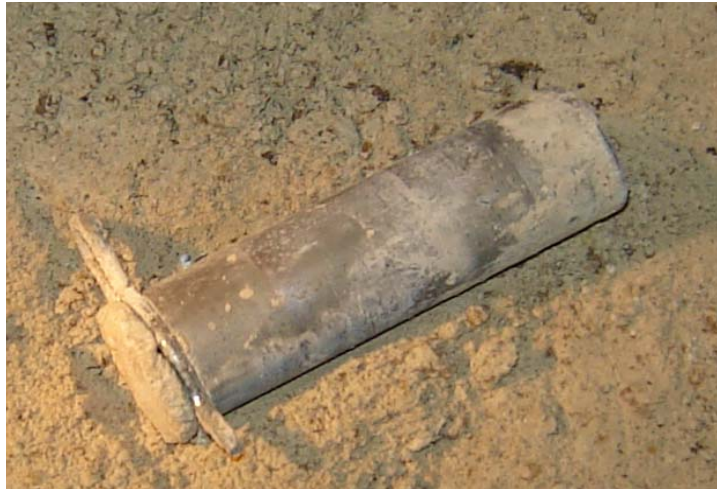
Figure 2 (Appendix B) shows a photo of the steering cylinder clevis pin that came out of the steering cylinder clevis at the time of the accident. One end of this pin still had the hairpin fastener (clip) in place. The nominal diameter of the pin was 1-inch and the length was approximately 3- $\frac{3}{8}$ inches. This pin had a groove at each end that was approximately $\frac{1}{8}$ inch wide and approximately $\frac{1}{8}$ inch deep. A hole with a diameter of approximately $\frac{3}{16}$ inch was drilled through the pin at the location of each groove.

The outside diameter of the steering cylinder clevis pin that fell out at the time of the accident was compared with the inside diameter of the clevis pin hole on the rod end of the steering cylinder. The wear on these parts allowed the cylinder clevis pin to move while the vehicle traveled. This movement allowed the clevis pin to slide out when the hairpin fastener installed on one end of the pin came off.

CLEVIS PIN THAT CAME OUT OF STEERING CYLINDER, ONE HAIRPIN STILL ATTACHED

Corrective Action: Procedures should be implemented to utilize a different type of fastener to secure the steering cylinder clevis pin.

The mine operator replaced the steering pins with a 1 inch diameter grade 5 bolt trimmed to 5 inches in length. A $\frac{3}{16}$ inch diameter hole was drilled through the threaded end to accept a cotter pin. A castle nut, washer, and cotter pin were used to secure the bolt to the steering connections.

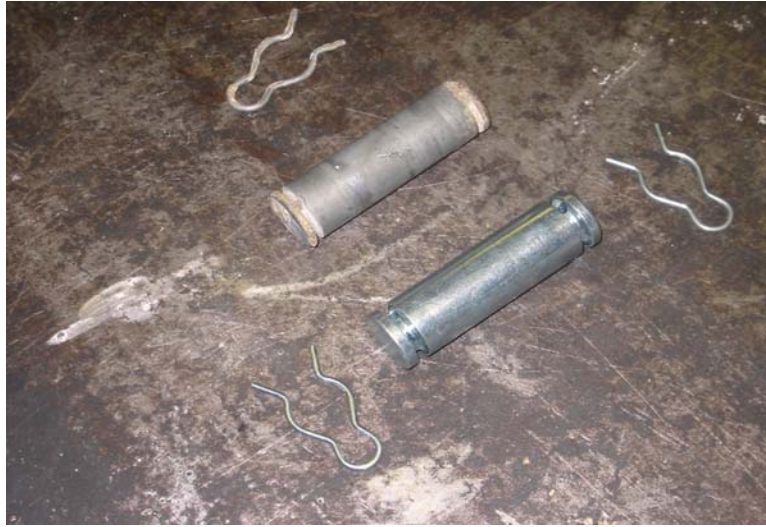
A hairpin fastener was placed in the groove on each end of the clevis pin to secure it in the clevis. This pin (top pin) is depicted in Figure 3 (Appendix B).

A pin similar to the pin that came out of the steering cylinder clevis at the time of the accident and two new hairpin clips are shown in the bottom of the photo in Figure 3 (Appendix B).

TOP: PIN AND HAIRPIN CLIP THAT CAME OUT OF THE STEERING CYLINDER CLEVIS ON THE MACHINE INVOLVED IN THE ACCIDENT
BOTTOM: NEW CLEVIS PIN WITH NEW HAIRPIN CLIPS

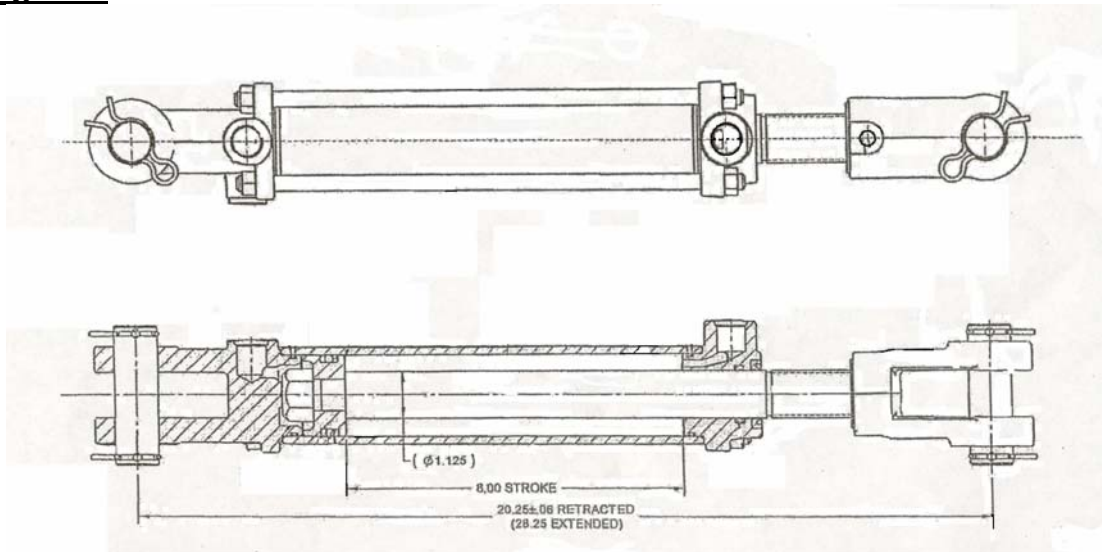
Figure 4 (Appendix B) depicts the cylinder on the machine at the time of the accident. This drawing shows hairpin clips holding the clevis pins in place.

STEERING CYLINDER WITH HAIRPIN CLIPS HOLDING CLEVIS PINS IN PLACE
