Subject: Motorcoach Safety Research
Motorcoach Sled Test Program. Date: AUG 14 2008

REPORT NUMBER: 220-MGA-2007-002R

**FMVSS 220 BASED RESEARCH TEST
OF MOTOR COACH ROOF STRENGTH**

**1992 MCI MC-12 MOTOR COACH
NHTSA NO.: CN0800**

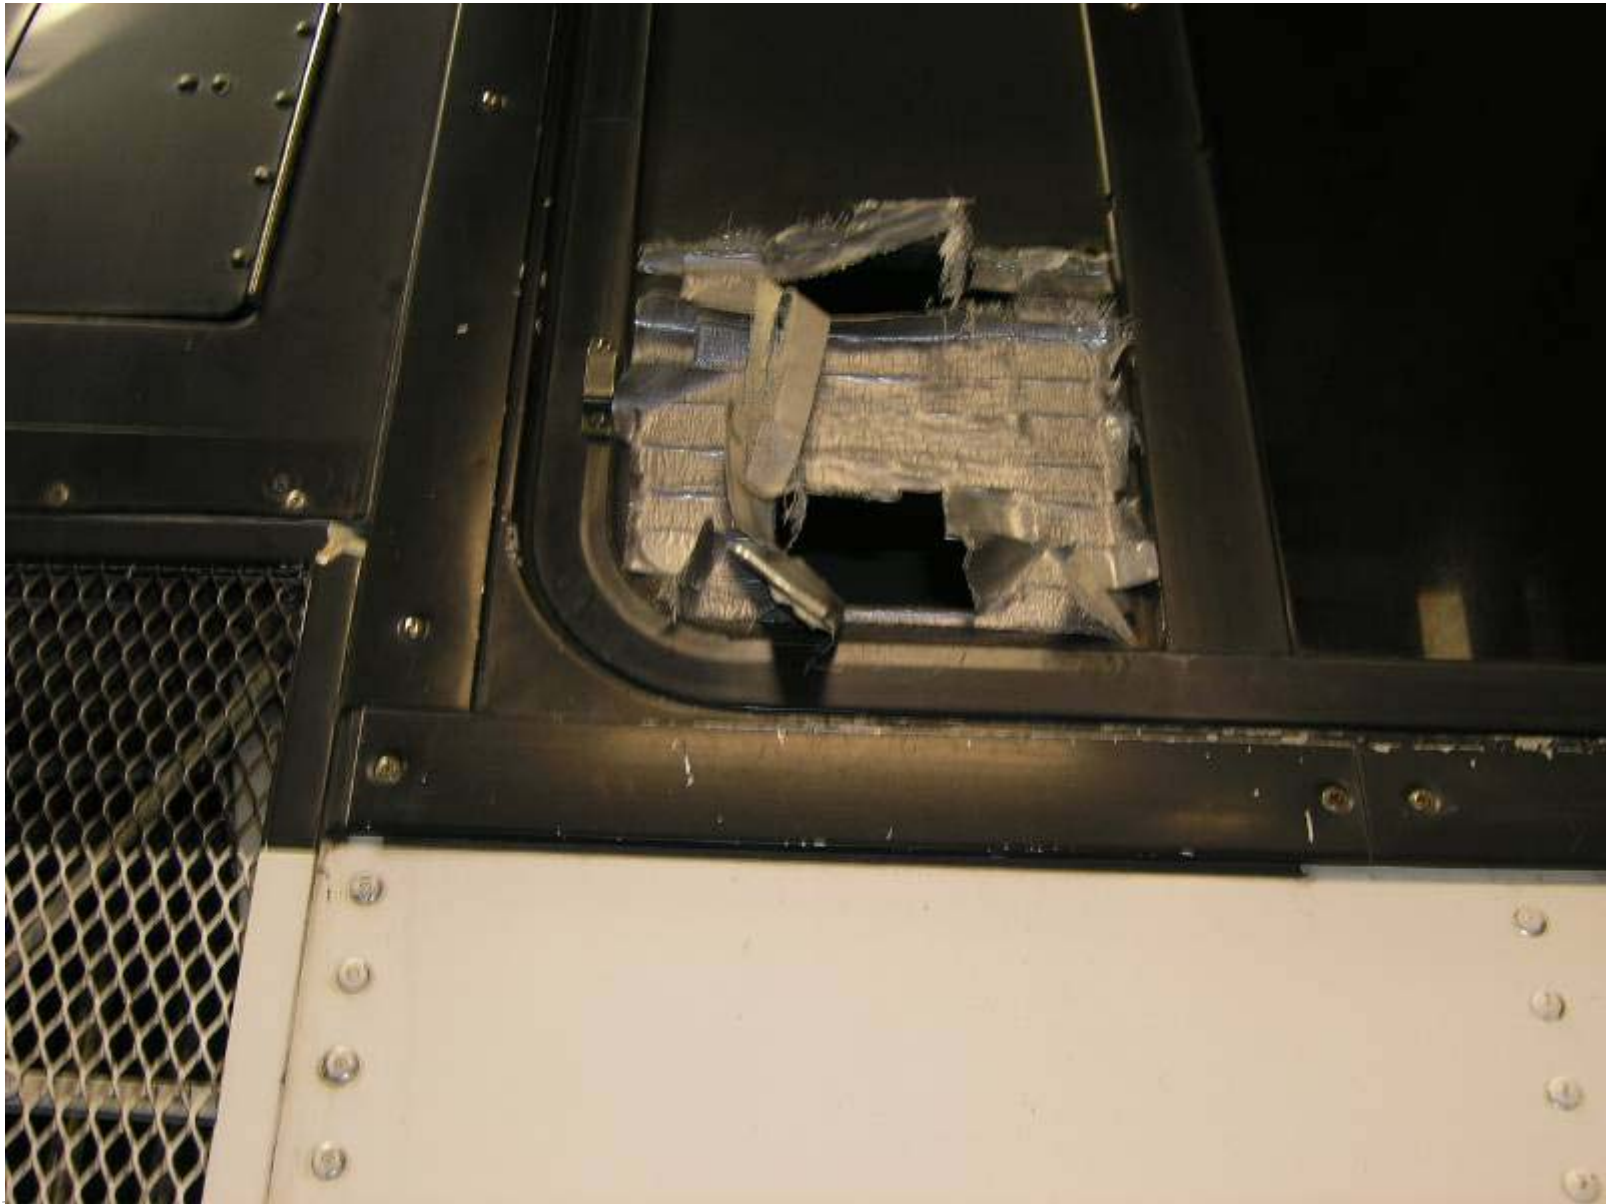
Pre-Test Close up View of Right Side Window 7 Damage

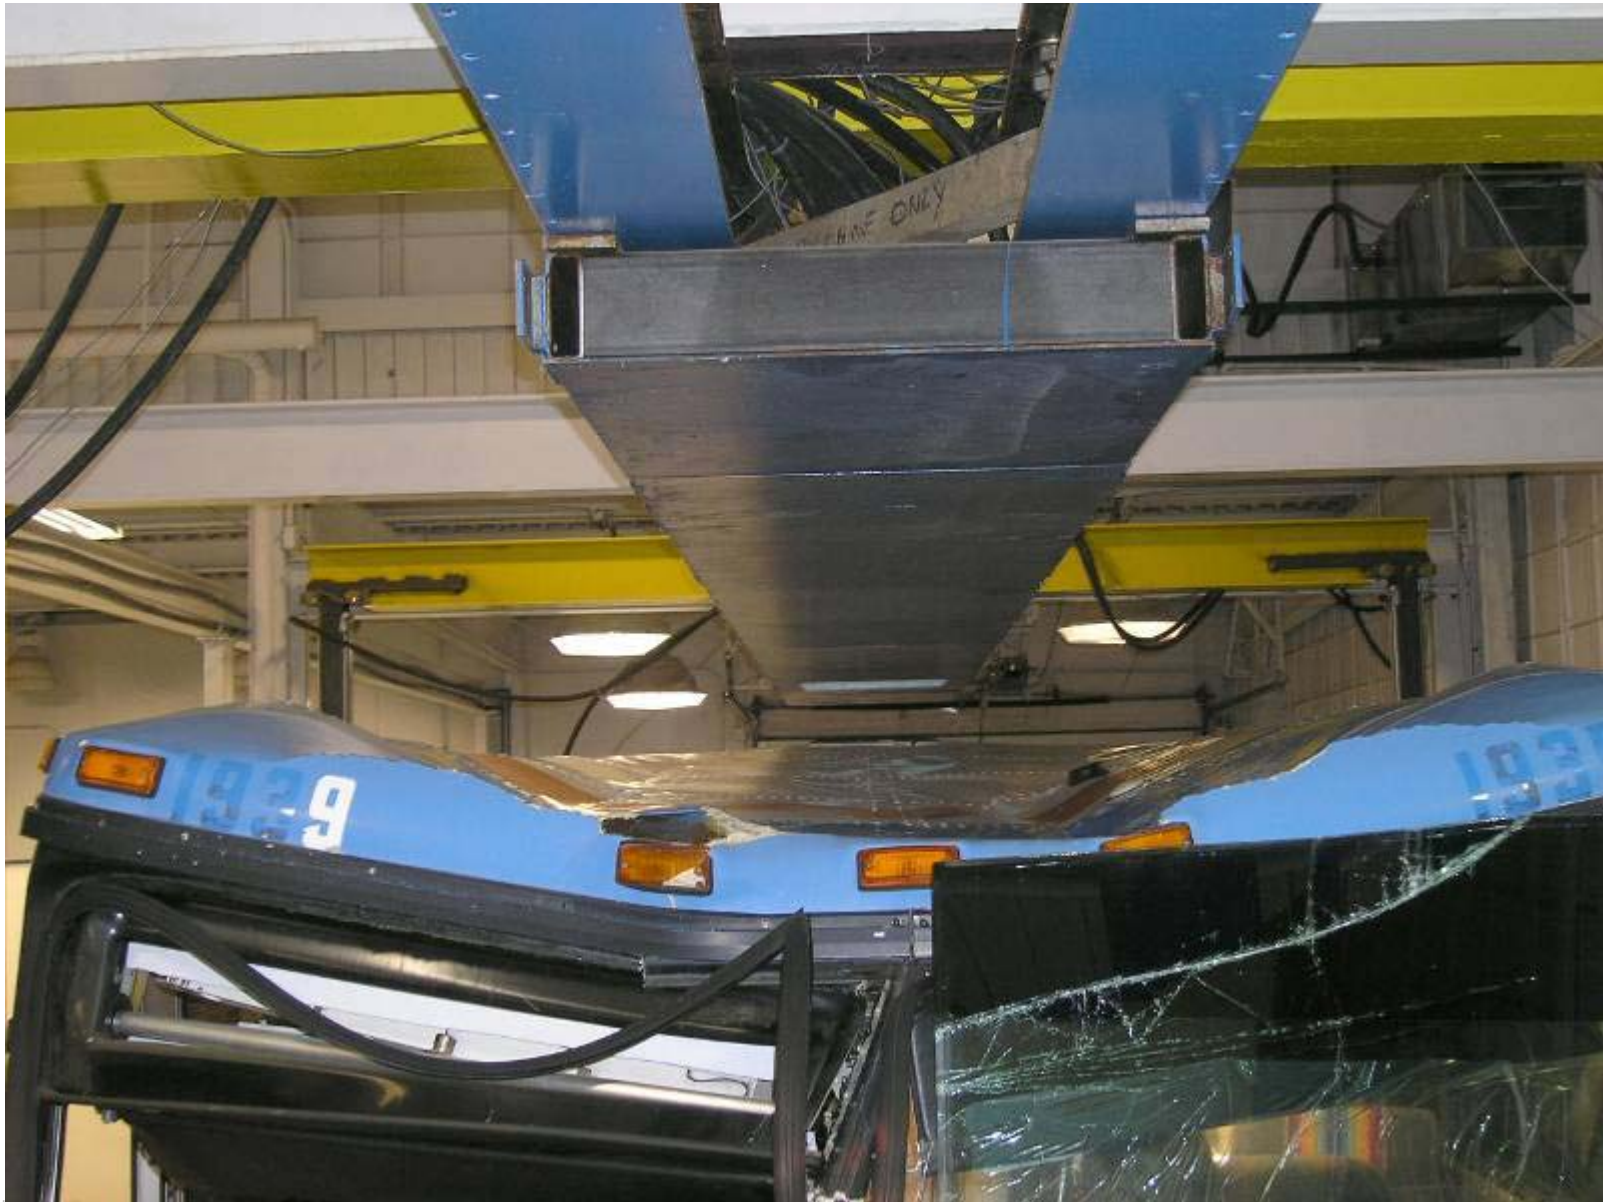
Post-Test Front View of Bus Roof Close Up (Exterior)

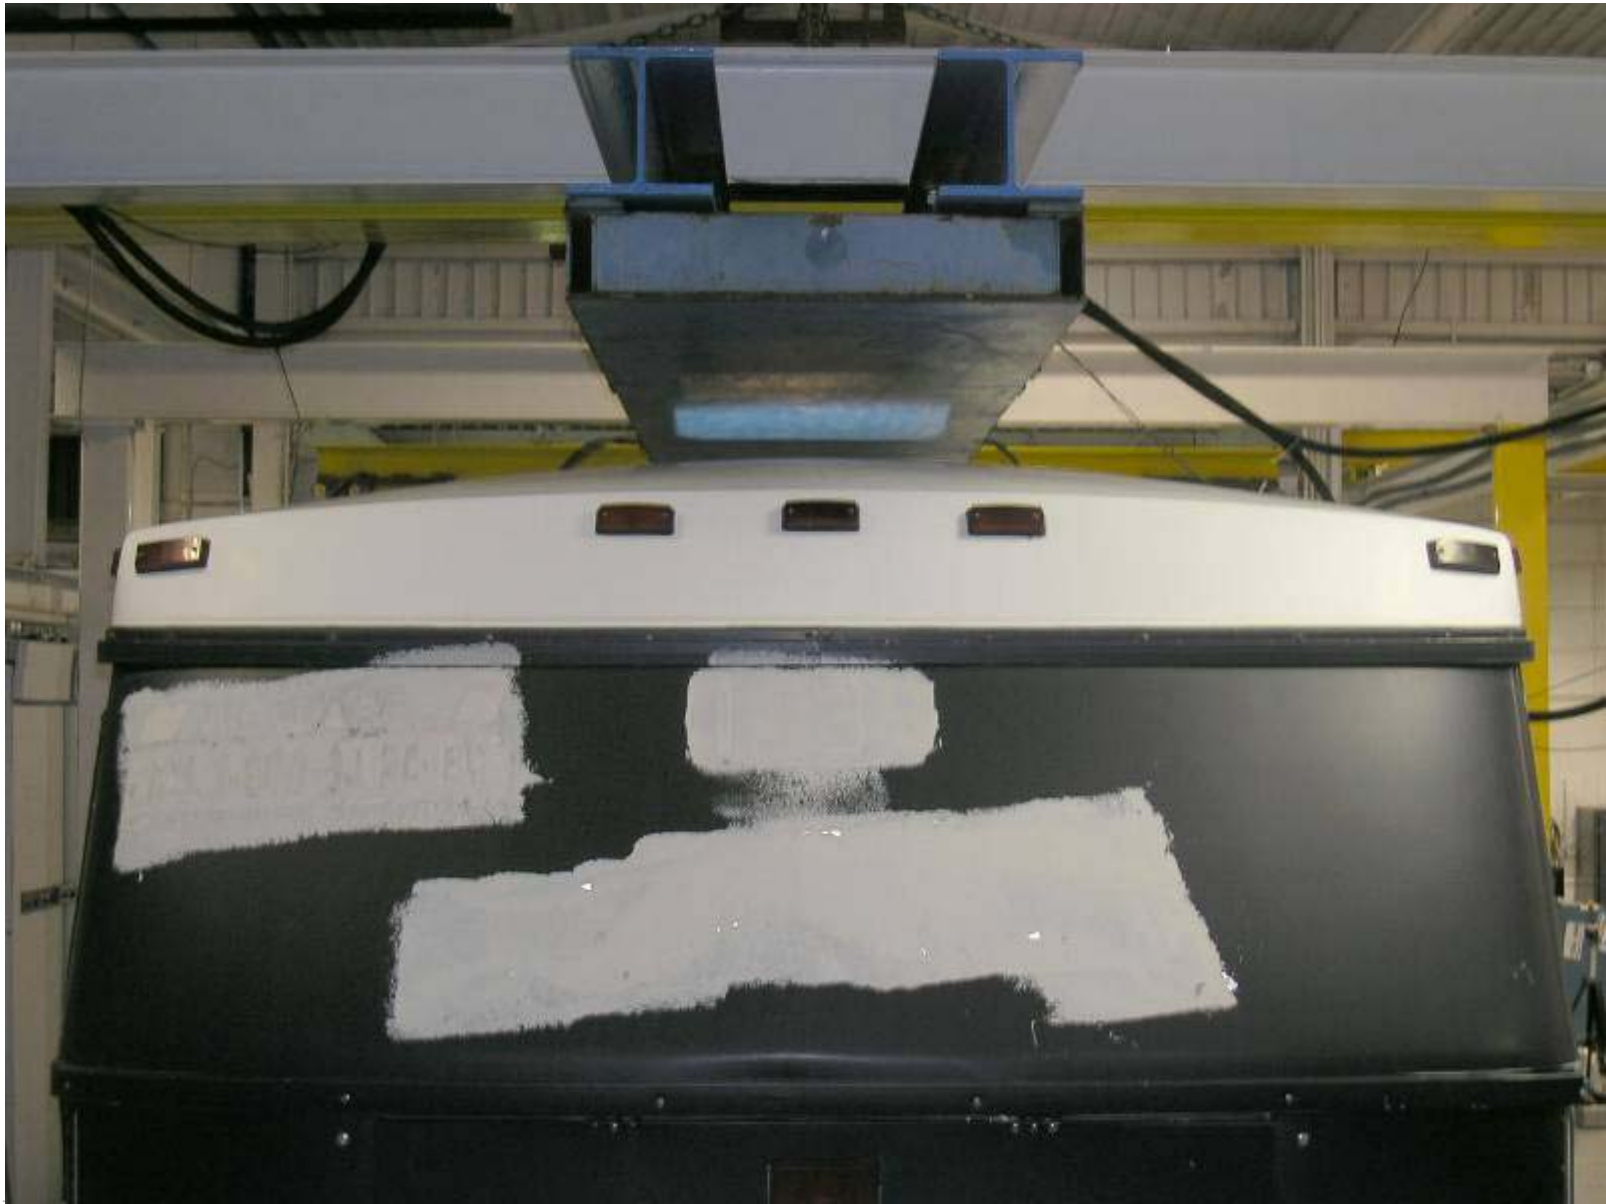
Post-Test Rear View of Bus Roof Close Up (Exterior)

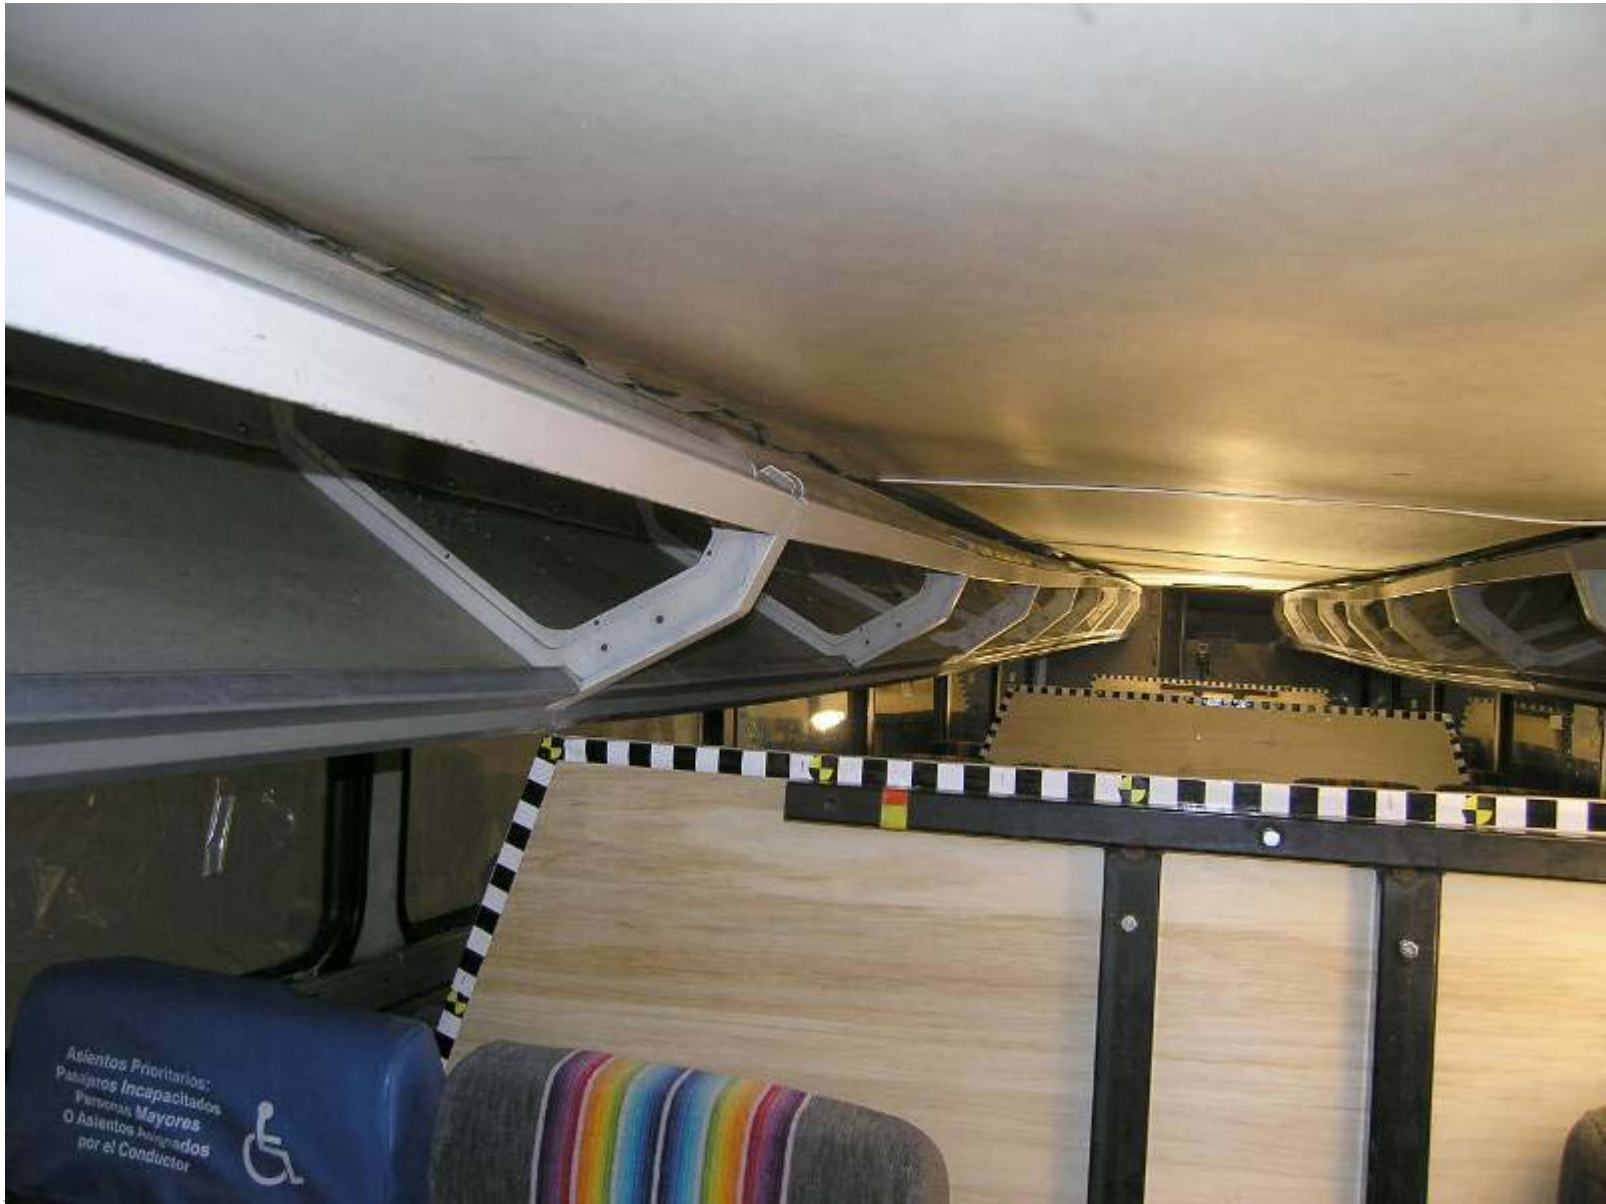
Post-Test Rear View of Bus Roof (Interior)

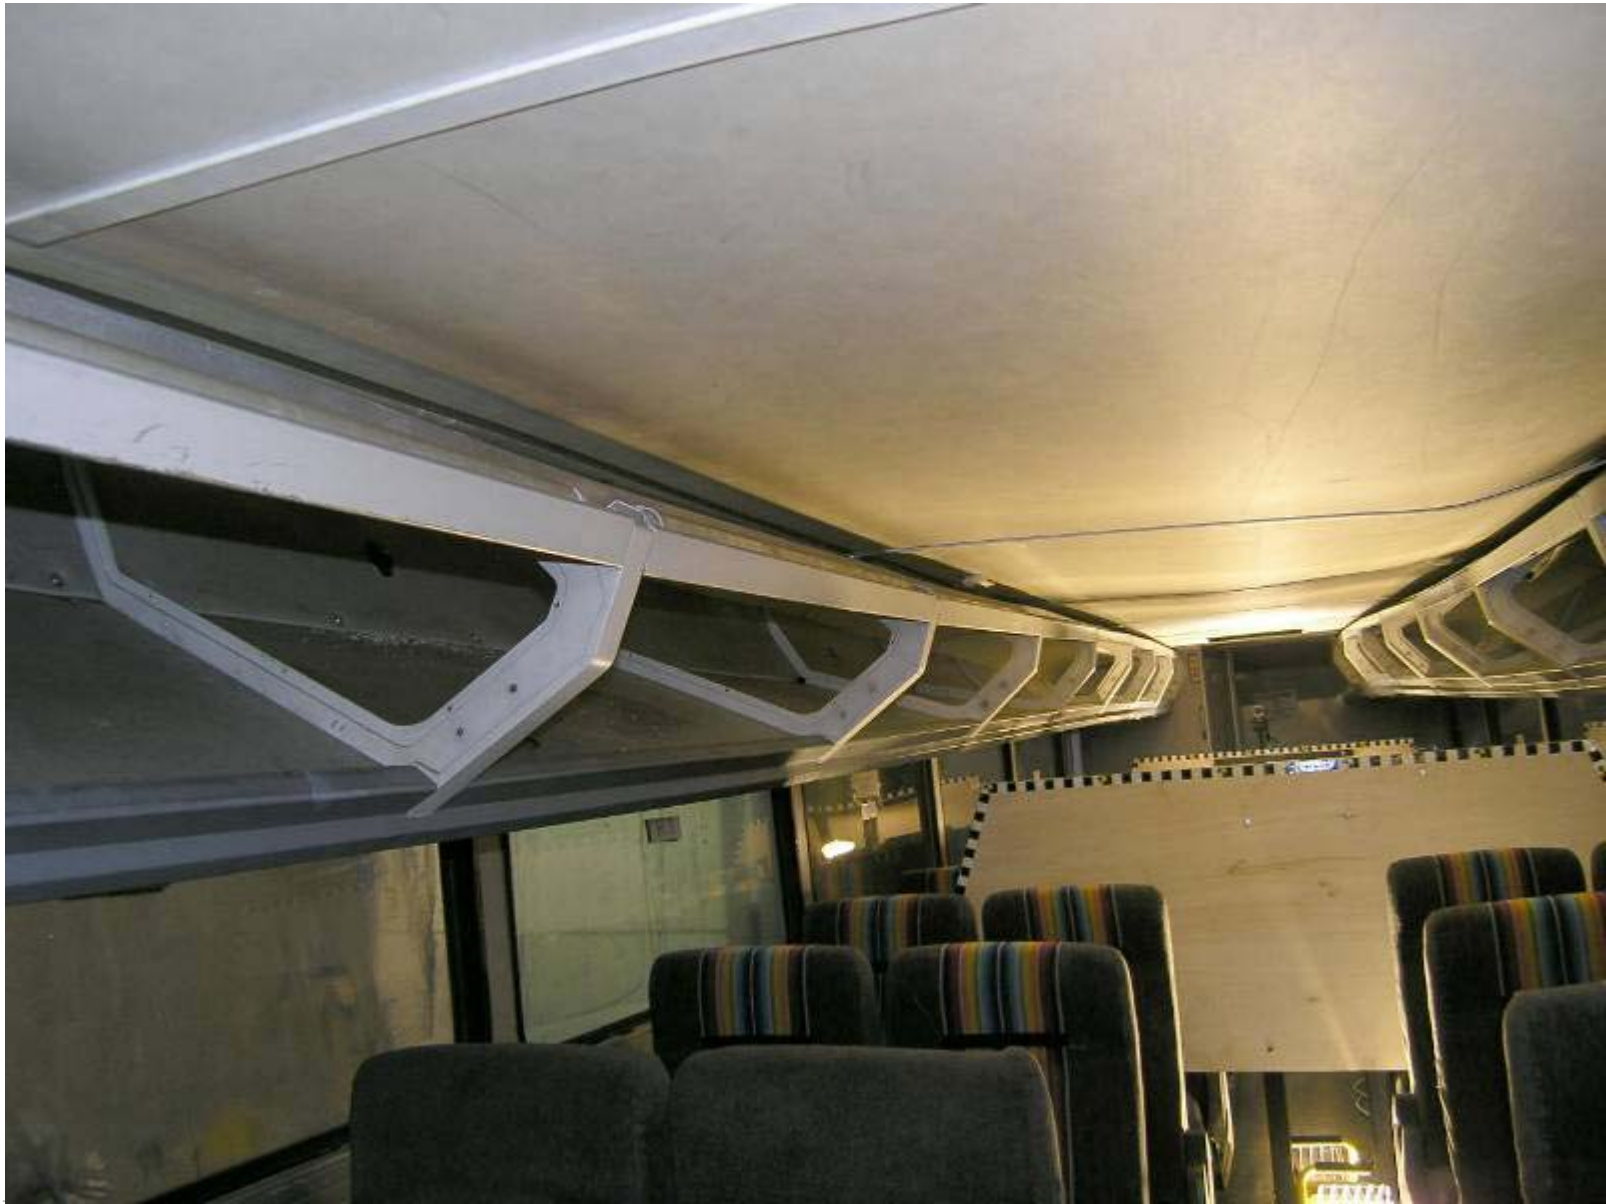
Post-Test Front View of Bus Roof (Interior)

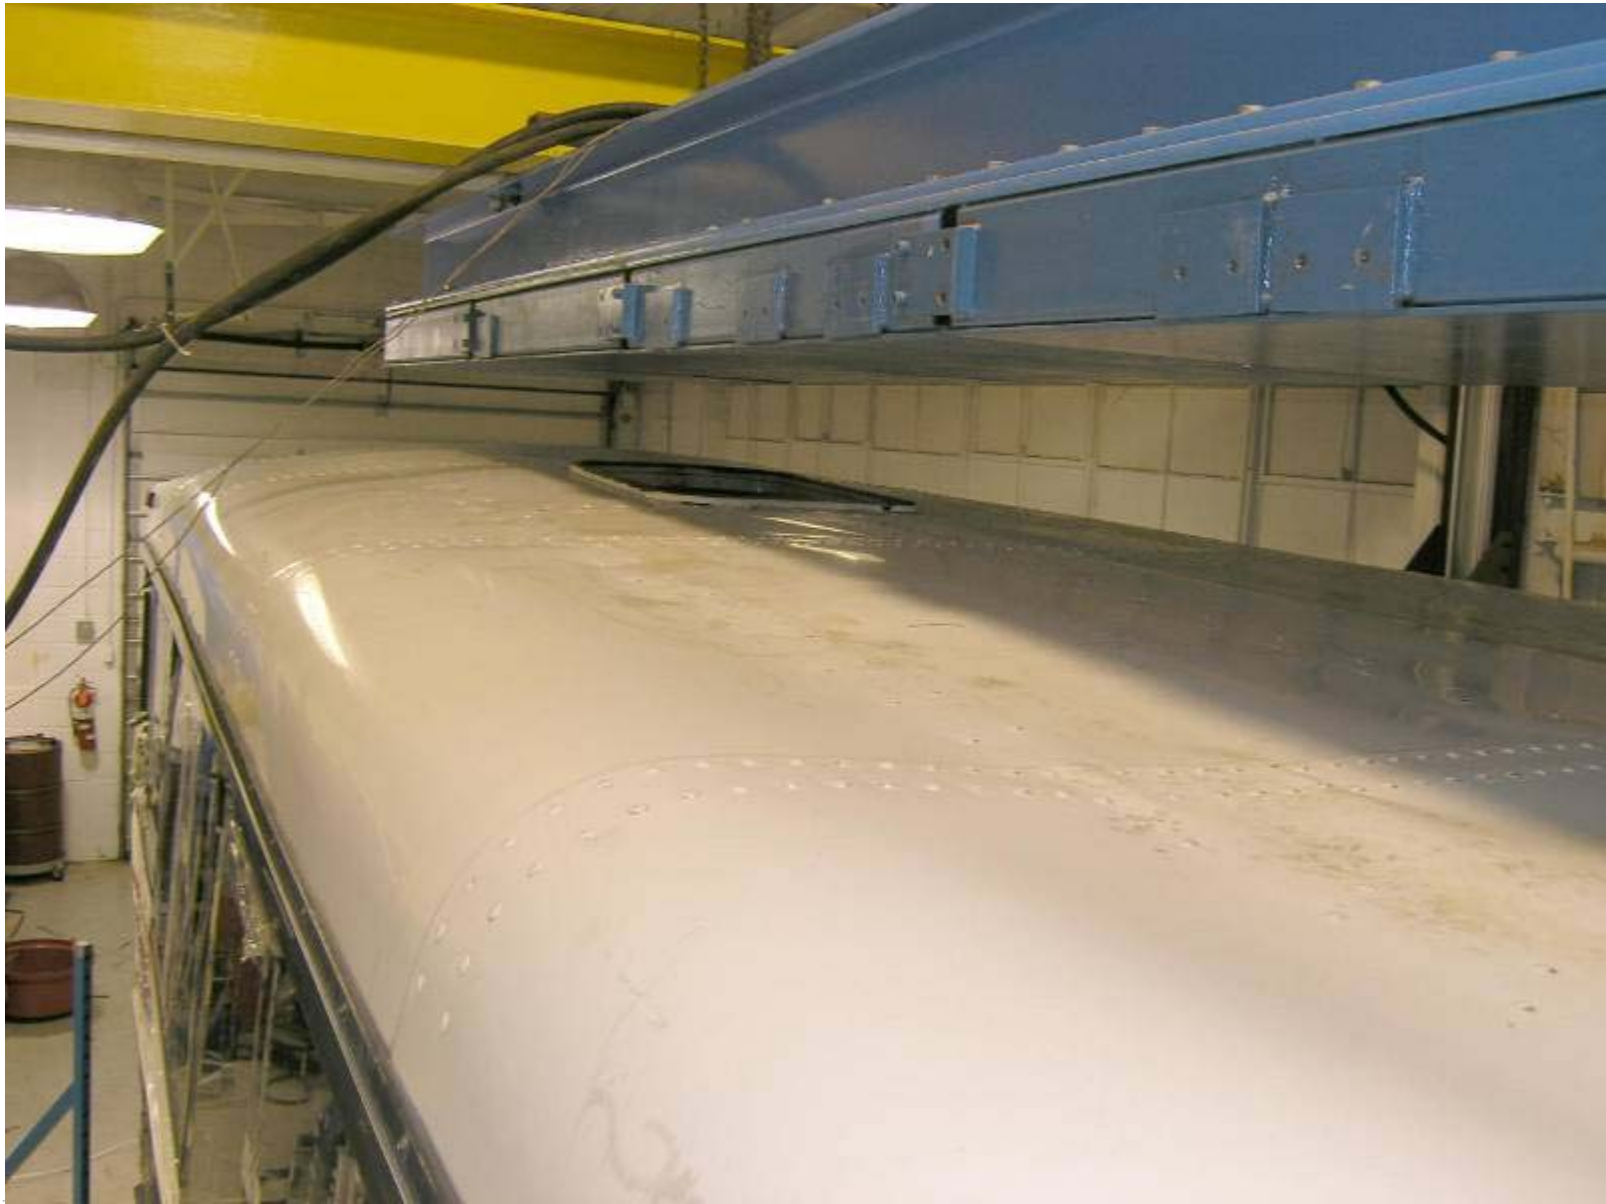
Post-Test Roof Exterior View 1

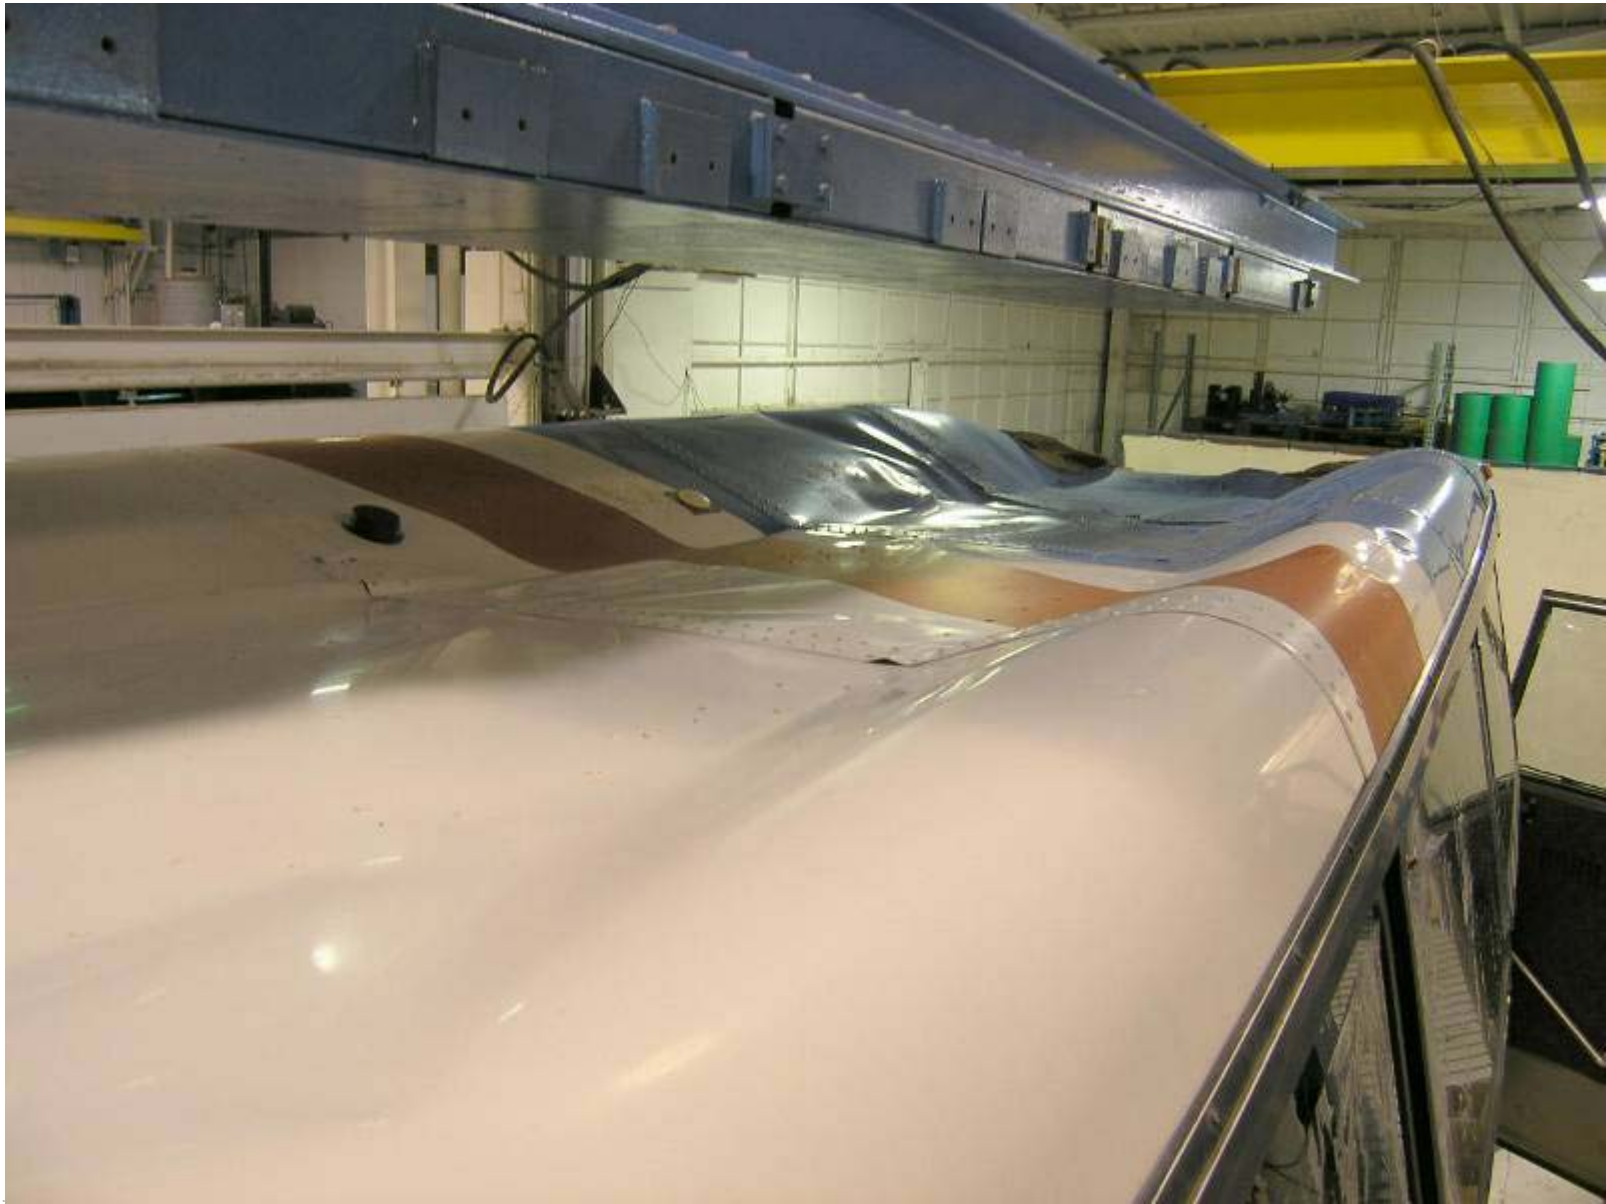
Post-Test Roof Exterior View 2

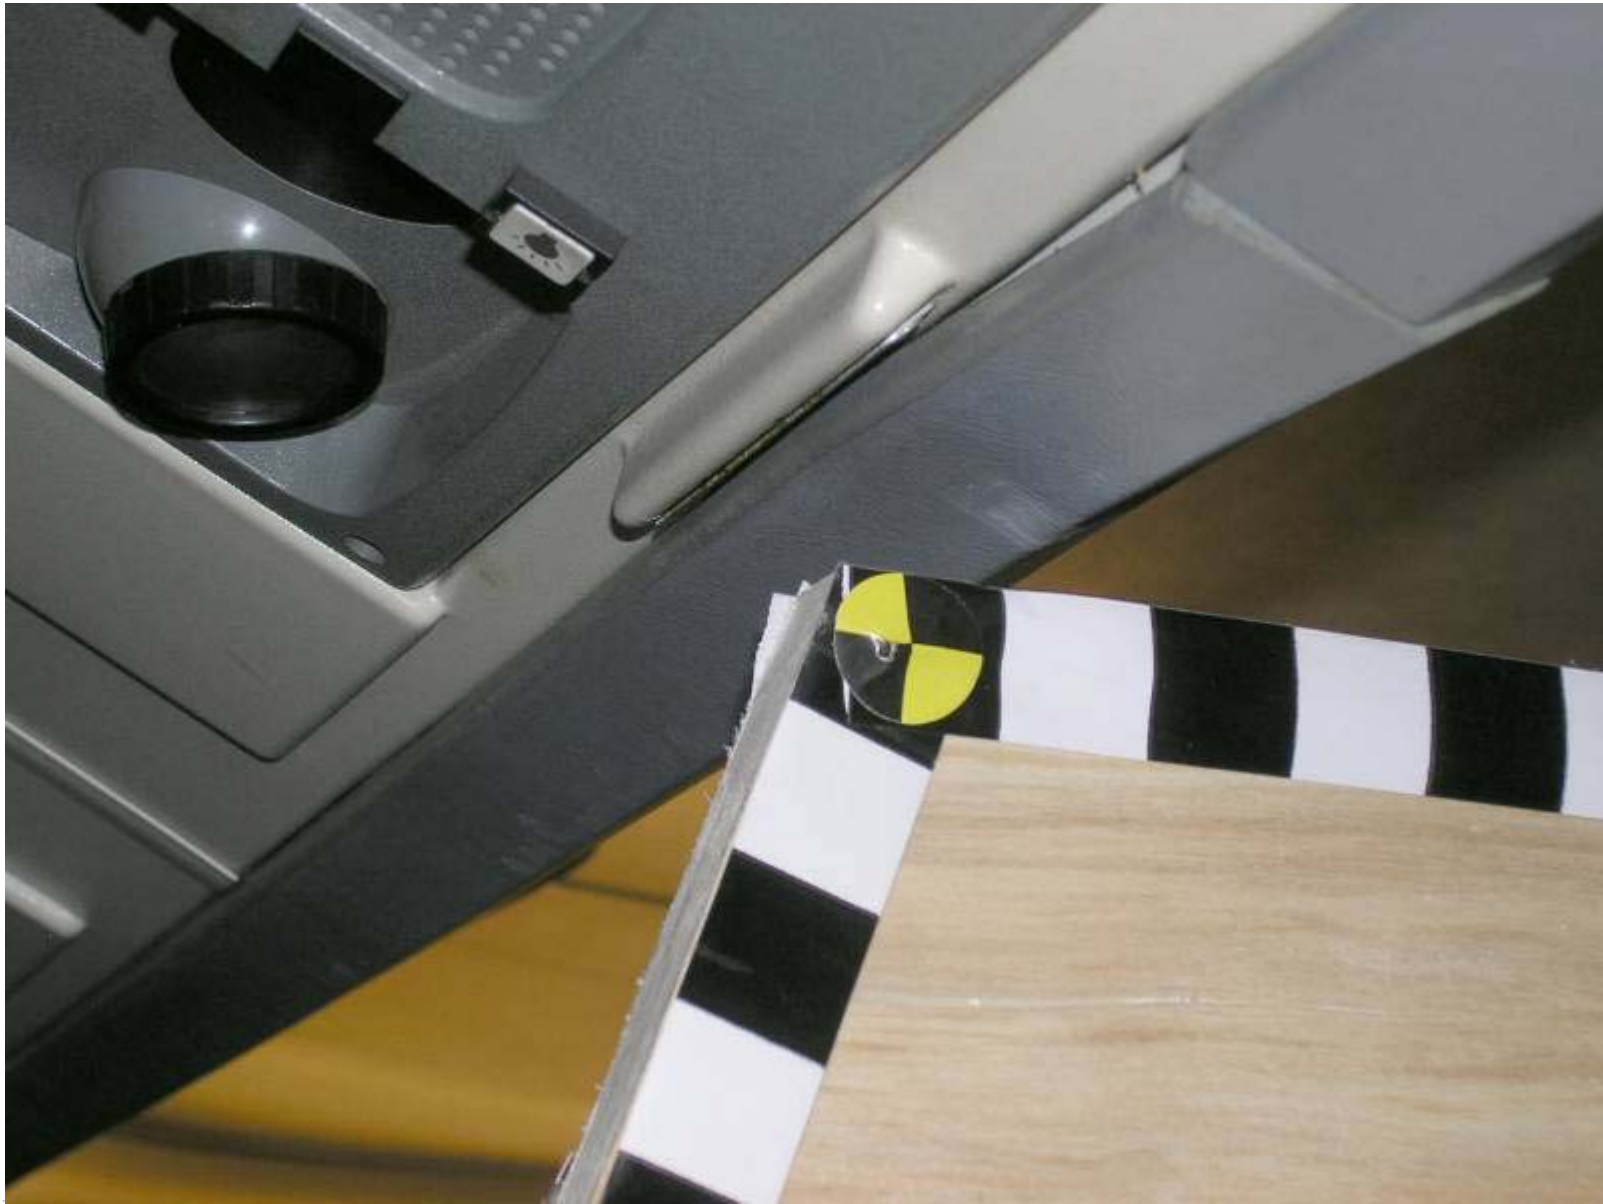
⁽²⁾ The left and right luggage racks contacted the foremost residual space template (T₁) prior to reaching the calculated maximum roof load.

Post-Test Front Template Clearance View 1

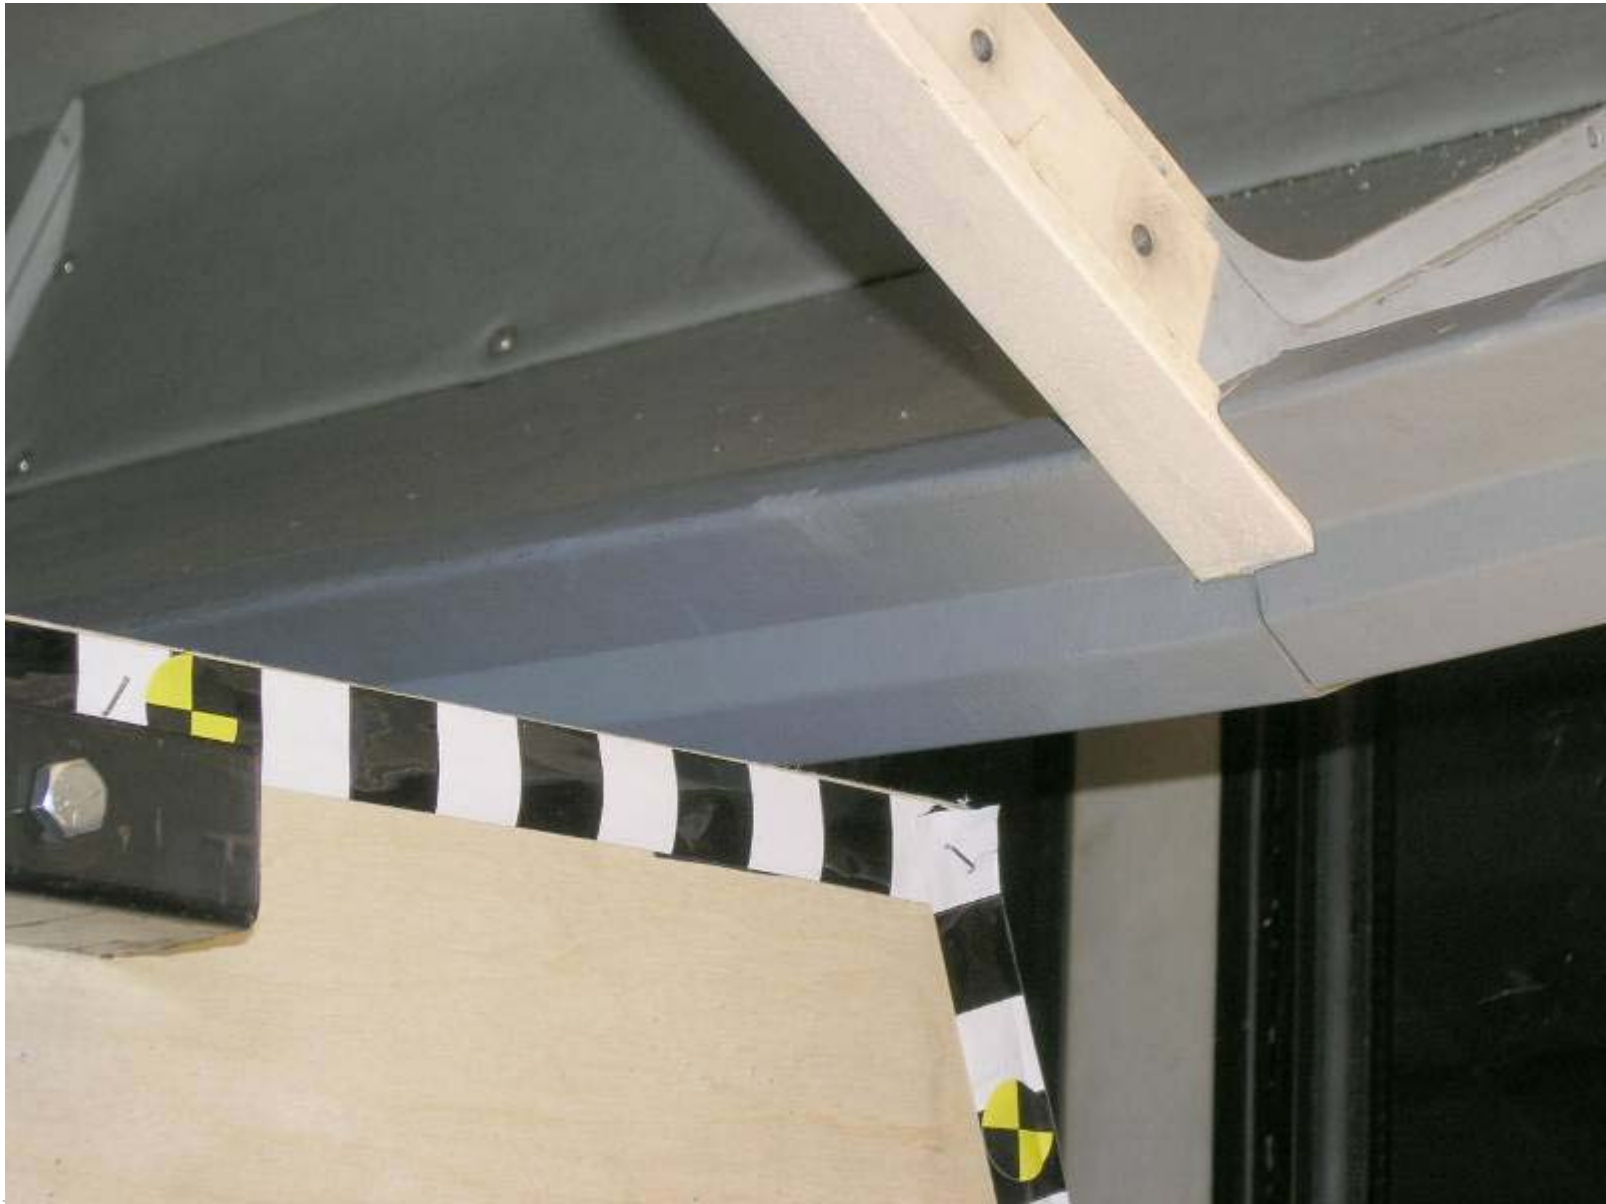
Post-Test Front Template Clearance View 2

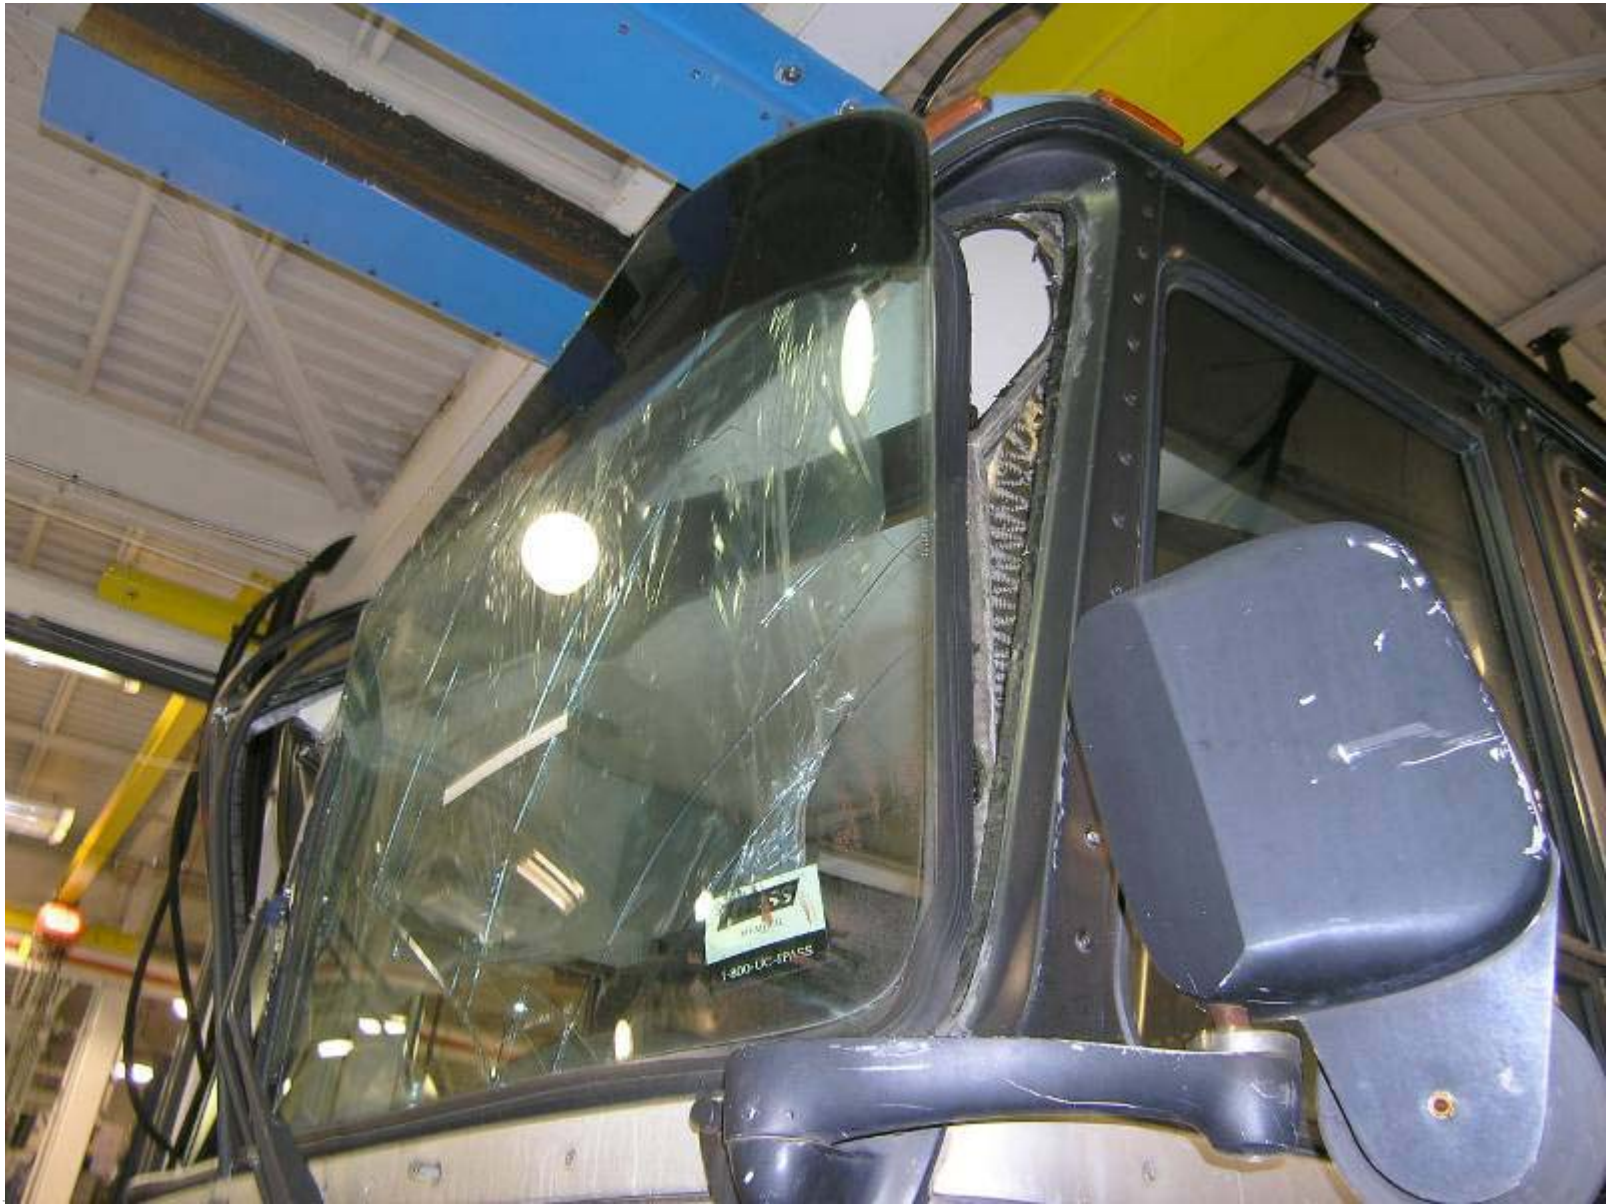
Post-Test Windshield Damage View
