**RESULTS OF INVESTIGATIONS OF
FAILURES OF GEOTHERMAL
DIRECT-USE WELL PUMPS**

**U.S. Department of Energy
Contract No.: DE-FG07-90ID 13049 A007**

**Geo-Heat Center
Oregon Institute of Technology
Klamath Falls, OR**

December 1994

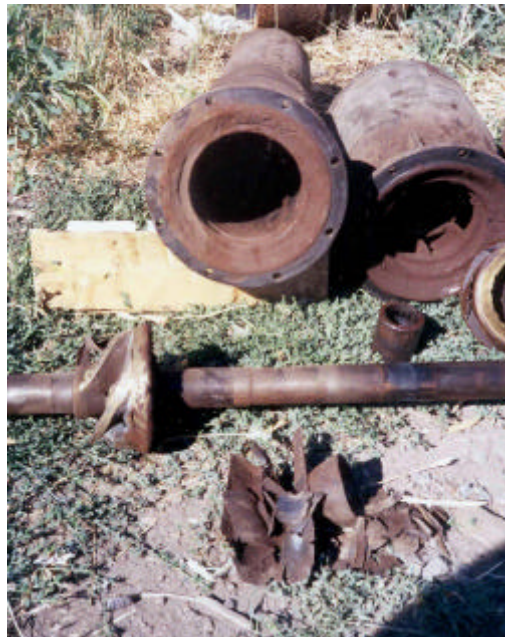
As can be seen from the photographs, failure was initiated in the lower end. The suction case bearing (tail bearing), bearing case and even the supporting ribs are gone. A small amount of one the ribs can be seen in the suction case (Figure 1). Also in Figure 1 are what was remaining of the first stage impeller, pieces of bearings, and the bottom cap of the suction case bearing. Figure 2 shows that the first intermediate- stage bearing support is worn through to the waterways, and the 2nd-stage impeller skirt and part of the shroud are worn away. The 10th- and 11th-stage bearings and impellers (Figure 3) still show wear, but far less than the lower stages.

Figure 1. OIT #5 suction case, 1st bowl and impeller.

This pump had been in the well almost exactly five years and was still operating, but at reduced flow rate. Although the lower end was completely gone and obviously banging around inside what remains of the lower bowls, the pump noise at the surface was normal except for some wear in the variable-speed drive thrust bearing, which could be heard and located using a stethoscope.

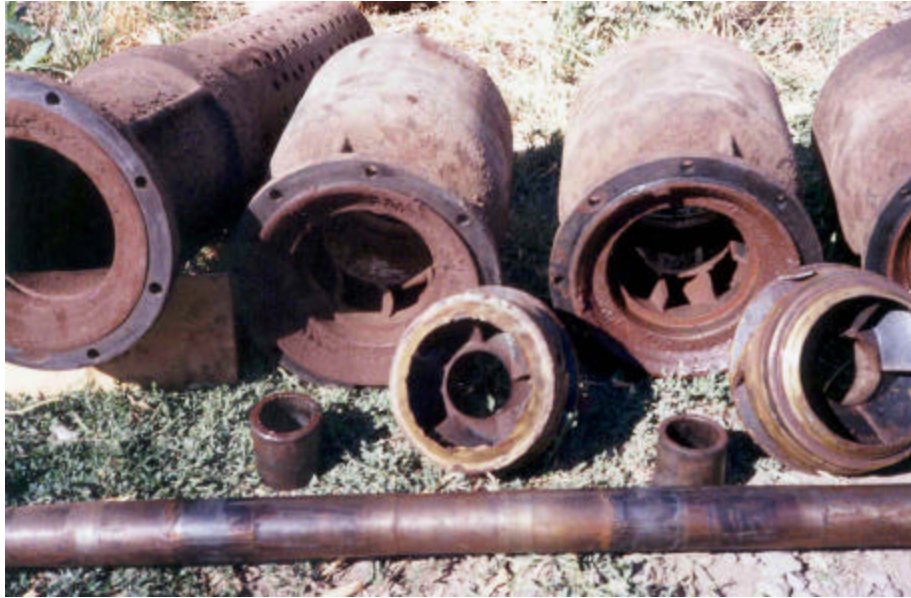
Figure 2. OIT #5 suction case, 1st and 2nd bowls, and 2nd and 3rd impellers.

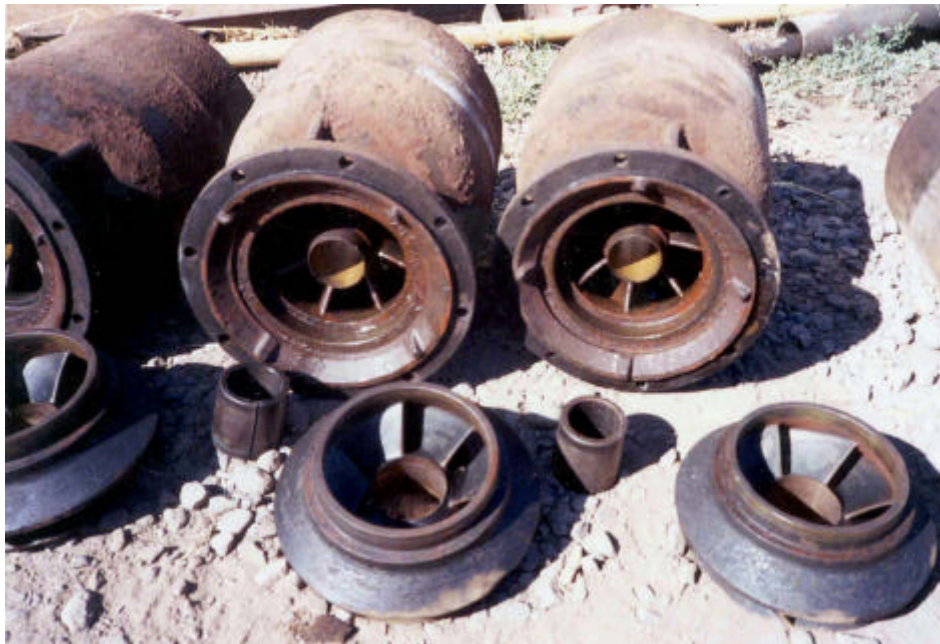
Figure 3. OIT #5 10th and 11th bowls, and impellers

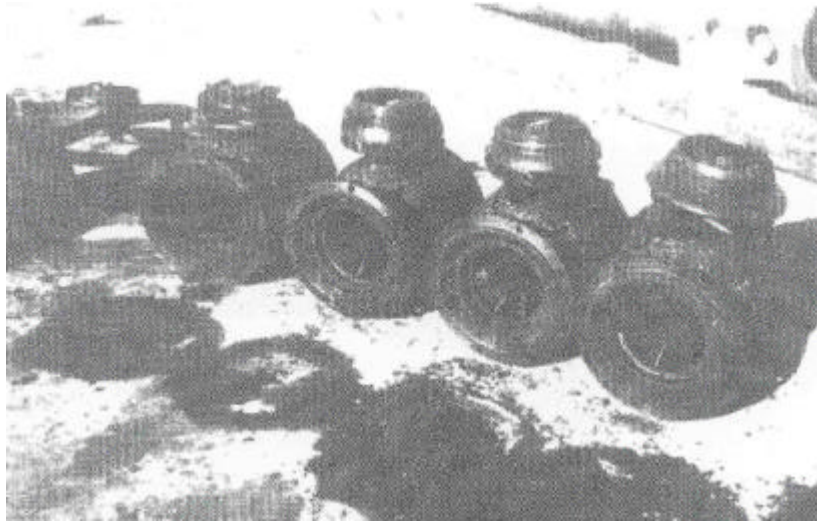
Inspection showed wear had progressed from the bottom stage up. Only bits and pieces of bearing could be found, and had black thin uniform coating which could be scratched with knife but not fingernail. Impeller skirts of most impellers were gone, and there was extensive wear to impeller vanes and shrouds on lower impellers. Bowl bearing wear had varied from nearly eliminating cast iron bearing seats in lower bowls (Figure 4) to portions of bearings remaining in the upper bearings (Figure 5), the shaft was worn and had copper colored areas at bearing locations (Figure 6).

Figure 4. MWMC 1st through 4th bowls and impellers.

The cause of this failure seems obvious. When running under no flow conditions, the power required to maintain the water column at near ground level is dissipated in the pump. Water in the pump soon is flashed to steam providing no lubrication. The bottom bowl, having the least pressure in it (pumping level head), experiences flashing first and flashing progresses up the pump.

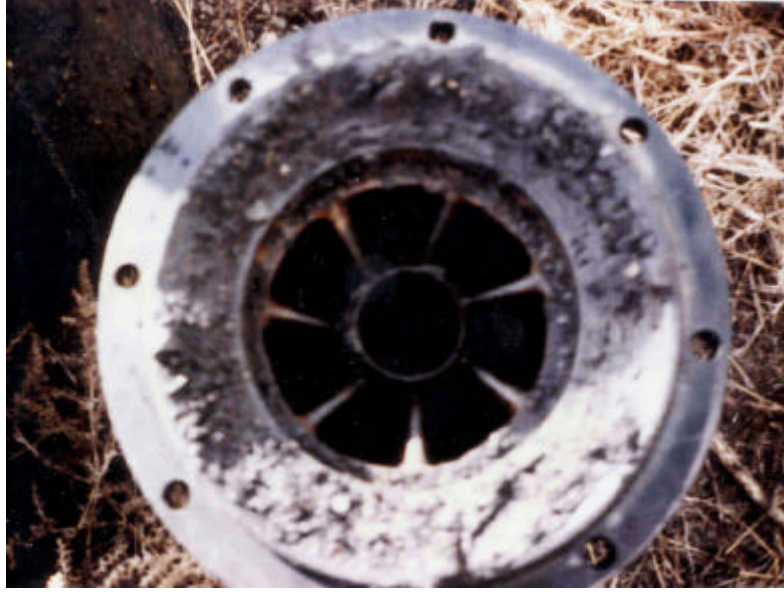
Figure 5. MWMC 13th bowl.

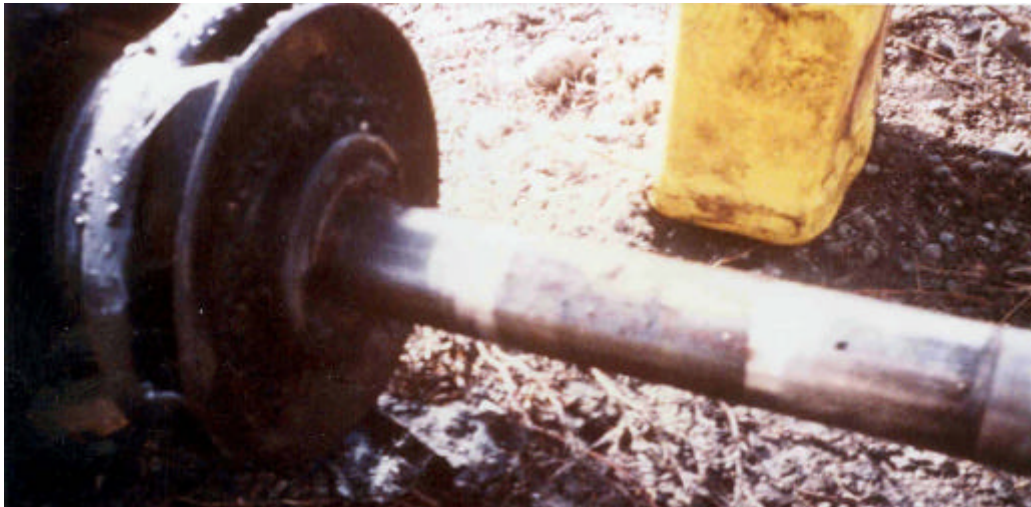
Figure 6. MWMC 1st stage impeller and discolored shaft.

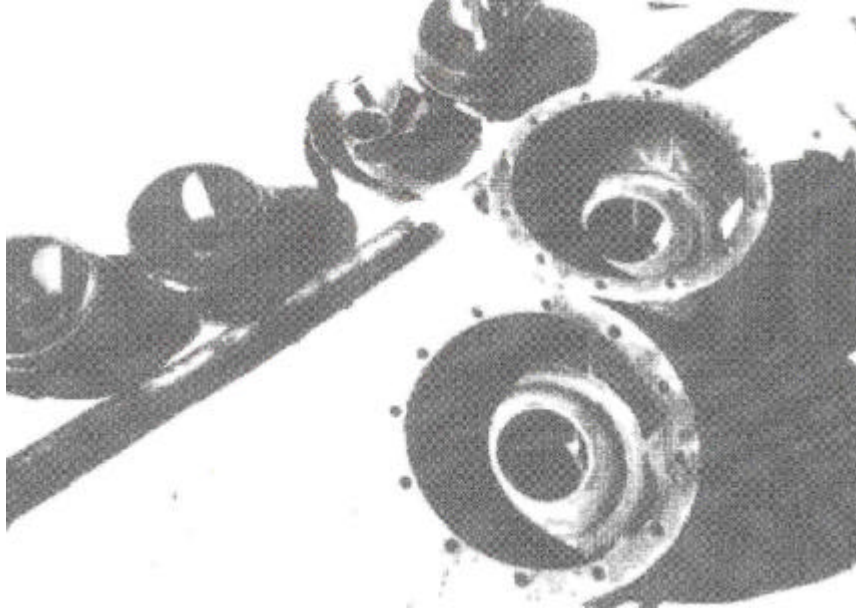
Shaft broken at second impeller thrust ring. Thrust ring gone--probably pumped through. Second impeller and bowl very badly worn resulting from missing thrust ring. Other impellers and bowls badly worn apparently from lack of lateral and poor lateral adjustment. Bowl bearings badly worn.

This pump had a rough life. Lateral was worn and it was impossible to measure its intended length, but probably was about 3/8 inch to 1/2 inch. In order to operate the pump each time it was started it was run several minutes, shut off, the lateral adjusted, run several more minutes, shut off, lateral adjusted and this repeated until it seemed the pump did not severely load the motor. A very poor practice. It resulted in wear at both top and bottom of impellers and matching bowl surfaces. The broken shaft was probably the result of starting when the impellers were bound.

Figure 7. Ross Colahan pump 230 ft, 1-1/2 year operation, shaft broken at impeller thrust ring groove.

The pump is not beyond repair. It is planned to re-machine the bowls to provide more lateral and cleanup bowl/impeller skirt mating area, install impellers with longer and larger diameter skirts to match machining and to install silicon carbide bearings.

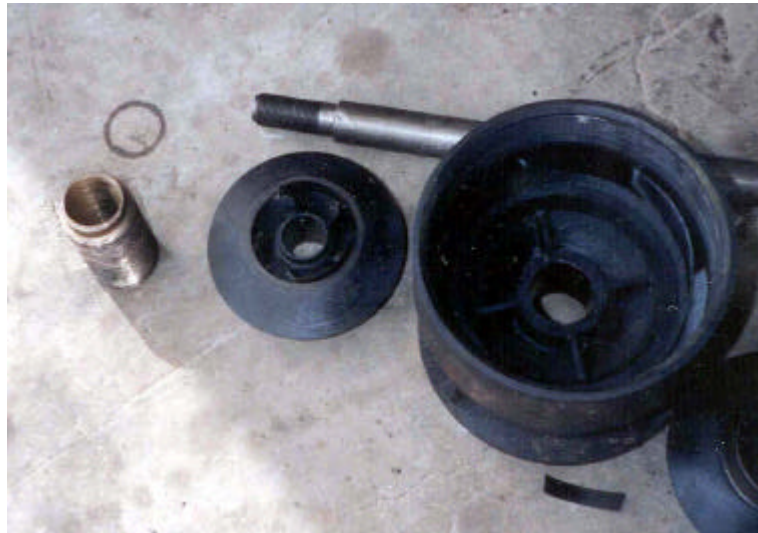
The lower bearing in the oil tube was badly worn--hourglass shaped. There were only bits and pieces of bowl bearings except for the tail bearing which was worn but still intact. Starting at the top, the first impeller skirt was worn completely away; 2nd, 3rd and 4th impeller skirts were worn but still attached; 5th and 6th skirts were completely gone; 7th worn but attached; 8th completely gone; and 9th, 10th and 11th skirts were there. The 11th or bottom impeller and bowl showed the least wear. Lateral had been correct as evidenced by no wear on top of impellers and machining marks visible on bottoms. An identification number was readable on the bottom impeller.

Figure 8. Left to right bottom: oil tube brg., top impeller, top bowl, and 2nd impeller from top.

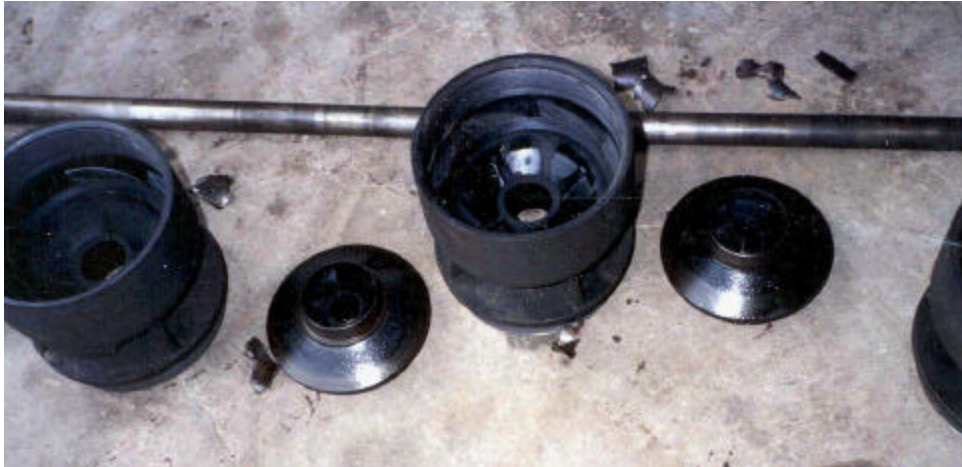
Figure 10. 3rd bowl, 4th impeller, 4th bowl, and 5th impeller.

Impeller and bowl vanes appeared in as cast condition indicating no sand pumping, cavitation or recirculation problems.

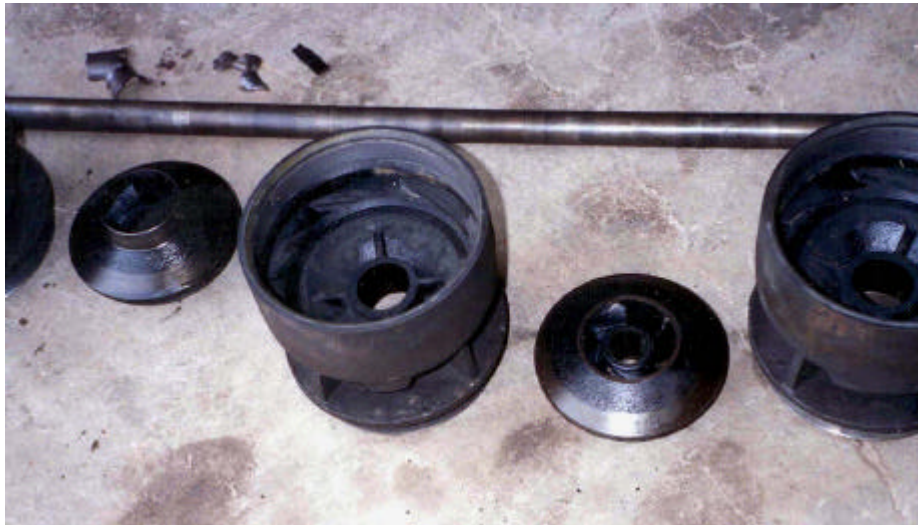
Figure 11. 4th impeller, 4th bowl, 5th impeller, and 5th bowl.

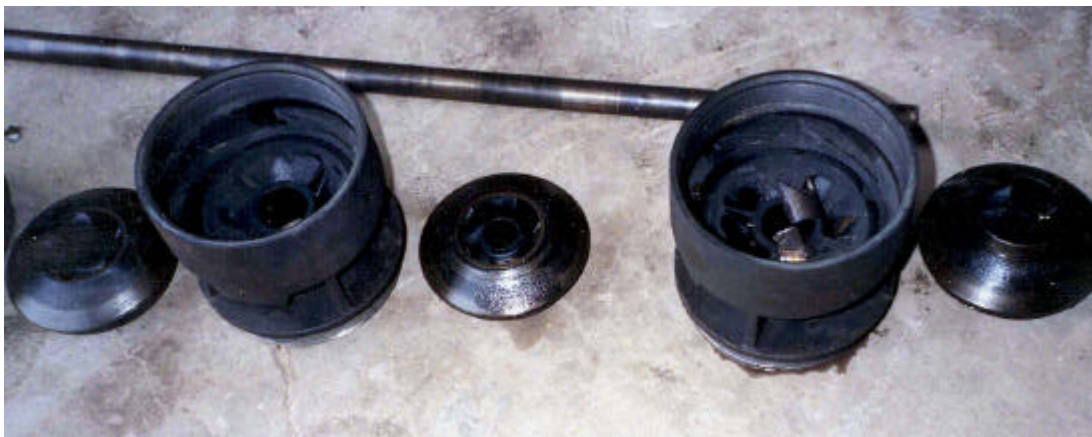
Figure 12. 5th impeller, 5th bowl, 6th impeller, and 6th bowl.

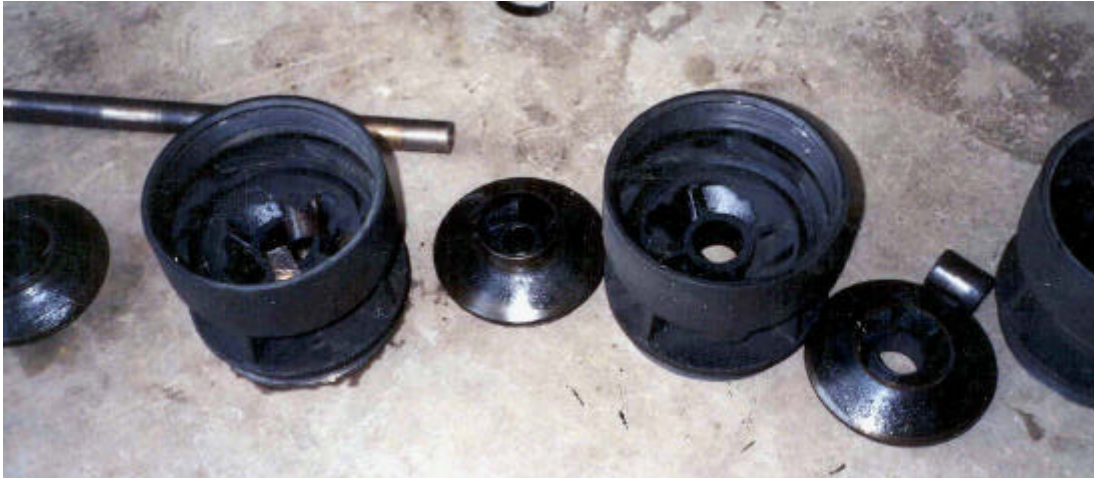
Figure 13. 9th, 10th and 11th impellers and bowls.
