Investigation of  
January 1989 Blowout and Fire  
Well No. 11  
Sulphur Lease OCS-G 9372  
Main Pass Block 299

Gulf of Mexico  
Off the Louisiana Coast

by  
Michael J. Saucier  
Jack Hendricks  
Joseph Y. Chong  
Floyd T. Bryan  
Paul Schneider

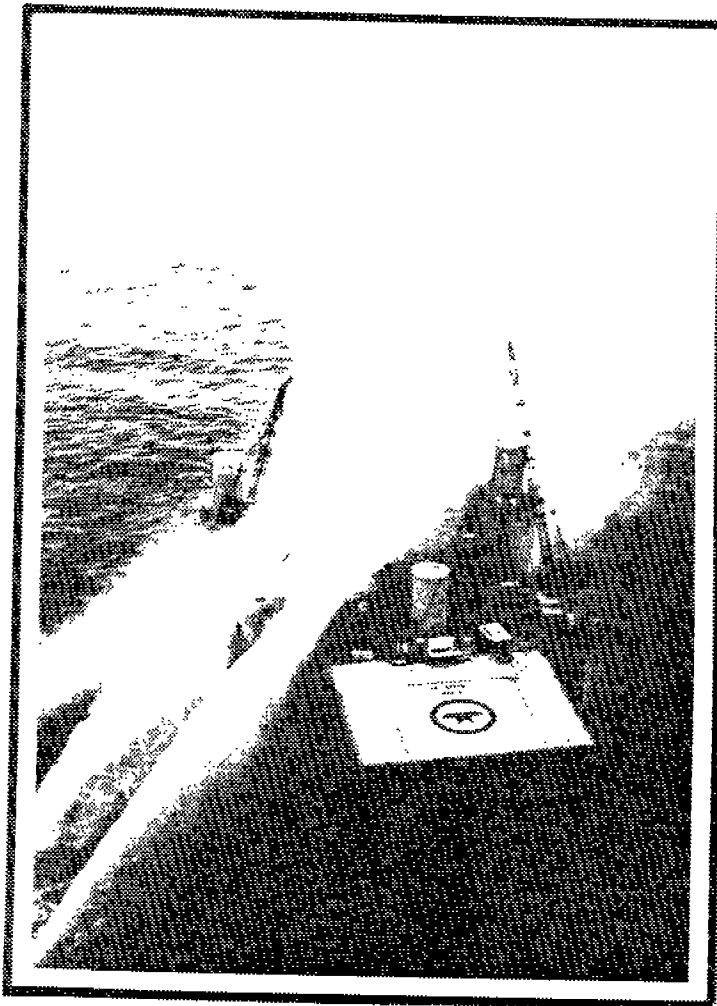
Photographs of Rig and Fire

Personnel from MMS flew over the drilling location on January 9, 1989, the day after the blowout occurred, and photographed the burning rig (see attachment 1). They then proceeded to the nearby drilling rig *Teledyne Movable 18* where personnel from *Teledyne Movable 16* were evacuated when the blowout and fire occurred. The MMS personnel obtained firsthand accounts and other preliminary information about the accident from the personnel who were on *Teledyne Movable 16*.

The blowout and fire resulted in the total loss of the *Teledyne Movable 16*, a multi-million dollar, mat-supported jack-up rig. There were no injuries to personnel, and pollution was minimal.

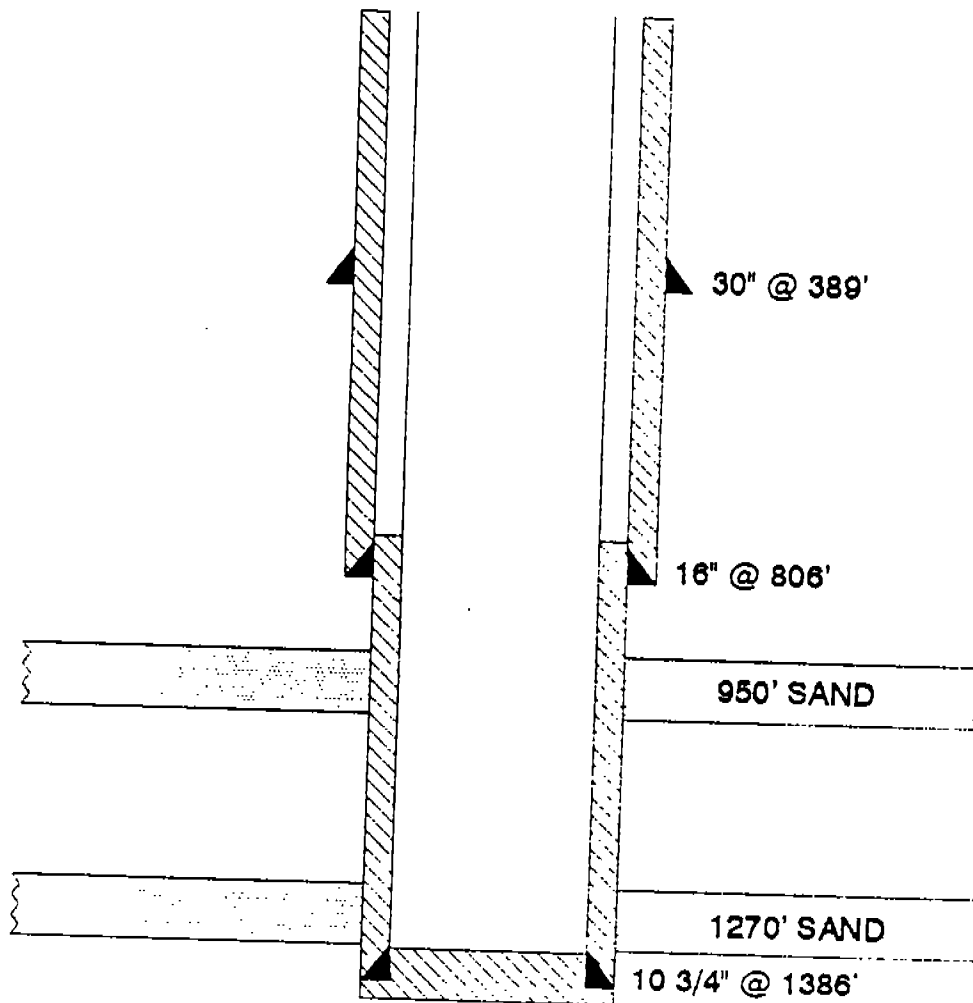
FREEPORT-McMORAN RESOURCES  
OCS-G 9372 WELL NO. 11  
MAIN PASS BLOCK 299

The blowout most likely occurred when gas migrated to the surface from the 950- or 1,270-foot gas zone via the annulus of the 16-inch by 10<sup>3</sup>/<sub>4</sub>-inch casing strings shortly after the 10<sup>3</sup>/<sub>4</sub>-inch casing string was cemented. The blowout was probably caused by the operator's attempt to cement the 10<sup>3</sup>/<sub>4</sub>-inch casing using cement mixed to a density that exceeded the pressure necessary to fracture the formation opposite the 10<sup>3</sup>/<sub>4</sub>-inch casing string.

Fracturing the formation causes fluid (cement and drilling mud) to be lost to the formation, which loss in turn lowers the fluid level and hydrostatic head in the annulus. This lowering creates an under-balanced condition that possibly allowed the upper gas sand to flow into the annulus and migrate to the surface. It is probable that the lower gas sand contributed to the uncontrolled gas flow when the fluid level in the well dropped further.

200 feet, based on a gauged hole of 13½-inches. There was no factor of safety included or added to the calculation to account for hole enlargement due to washout. The well was ultimately drilled to 1,386 feet, 264 feet less than expected. A caliper log run just prior to the cementing operation indicated the average hole size was 15½ inches. A recalculation by the operator of the required cement volume based on the existing conditions would have shown that more cement would be required. Instead of increasing the cement volume and decreasing the weight of the cement to account for the actual conditions, the operator used 375 sacks of cement as originally proposed in the APD. Further, the volume of cement was decreased by mixing with less water to yield 16.2 ppg and 1.09 cu ft/sack.

- (1). Ensure the annulus is staying full of fluid and no flow is observed prior to nipping down the blowout preventer equipment.
- (2). Ensure the correct volume and weight of cement are being used.

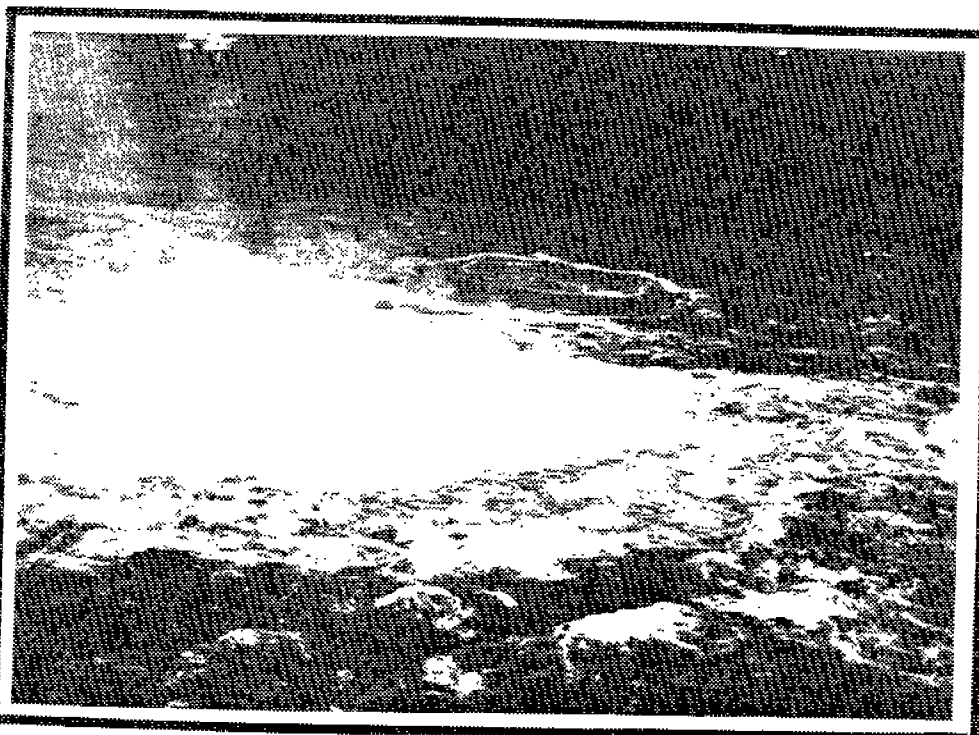
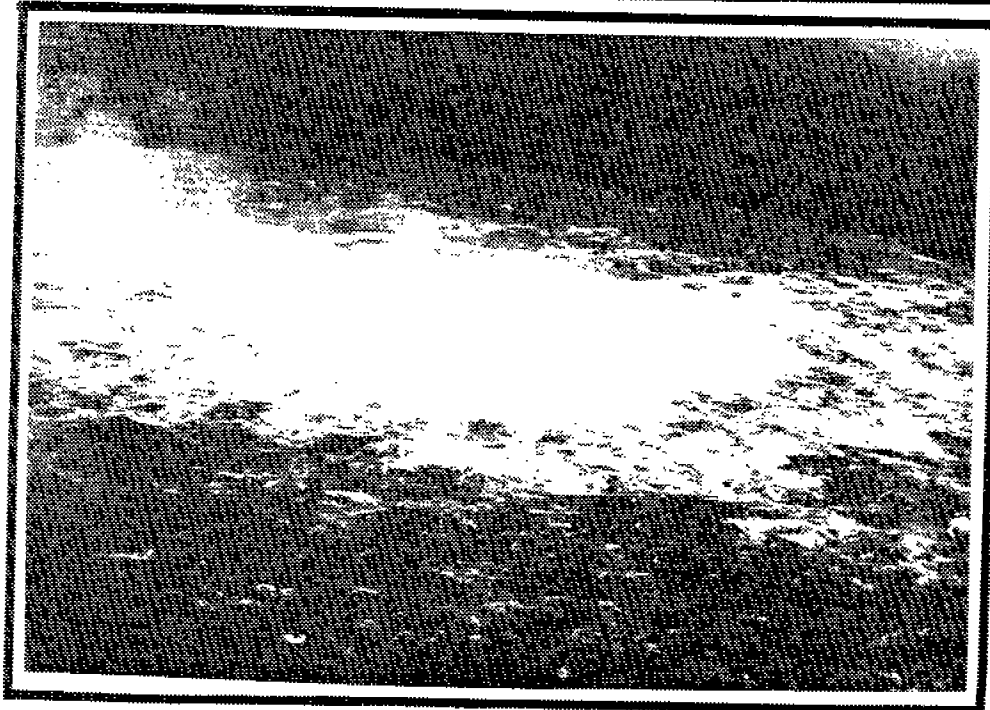
Photographs of Gas Boil and Fire  
After Rig Capsized

In an attempt to prevent the uncontrolled gas flow from igniting, firehoses on the rig were trained on the well bay area. However, the fire water pumps shut down when the rig electrical power was turned off. On January 8, 1989, fireboats were mobilized to the area and began spraying water onto *Teledyne Movable 16* at approximately 1:30 p.m. At 2:30 p.m. the gas flow ignited. At approximately 7:30 p.m. the drilling derrick collapsed. Additional fireboats were dispatched to the location, and by 12:30 p.m., January 9, 1989, approximately 42,000 gallons per minute of seawater were being sprayed onto the rig and fire. Gas bubbling around the rig was noted at 12:01 a.m., January 10, 1989. At 5:00 a.m. the rig was listing to the east at a 10° angle, and at 8:53 a.m. on January 10, 1989, the rig capsized, with the mat section separating from the barge section. The well continued to flow and bubble to the surface of the water, and the gas continued to burn for the next 17 days. (See attachment 5 for pictures of the gas boil after rig capsized.)

In addition to the fire damage, the rig was lost when it toppled and sank. Gas bubbling around the rig had been noted just after midnight on January 10, 1989, and by 5:00 a.m. that day the rig was listing about 10°. At 8:53 a.m. the rig capsized and sank, with the mat section separating from the barge section.

Because this rig was a mat-supported jack-up, the susceptibility to instability from bottom scouring was greater. It is believed that bottom scouring due to the gas flow was a factor in the rig capsizing.
