Failure Report on HPR/CR at KEK/Nomura

SMTF meeting

6 October 2005

Takayuki SAEKI (KEK)

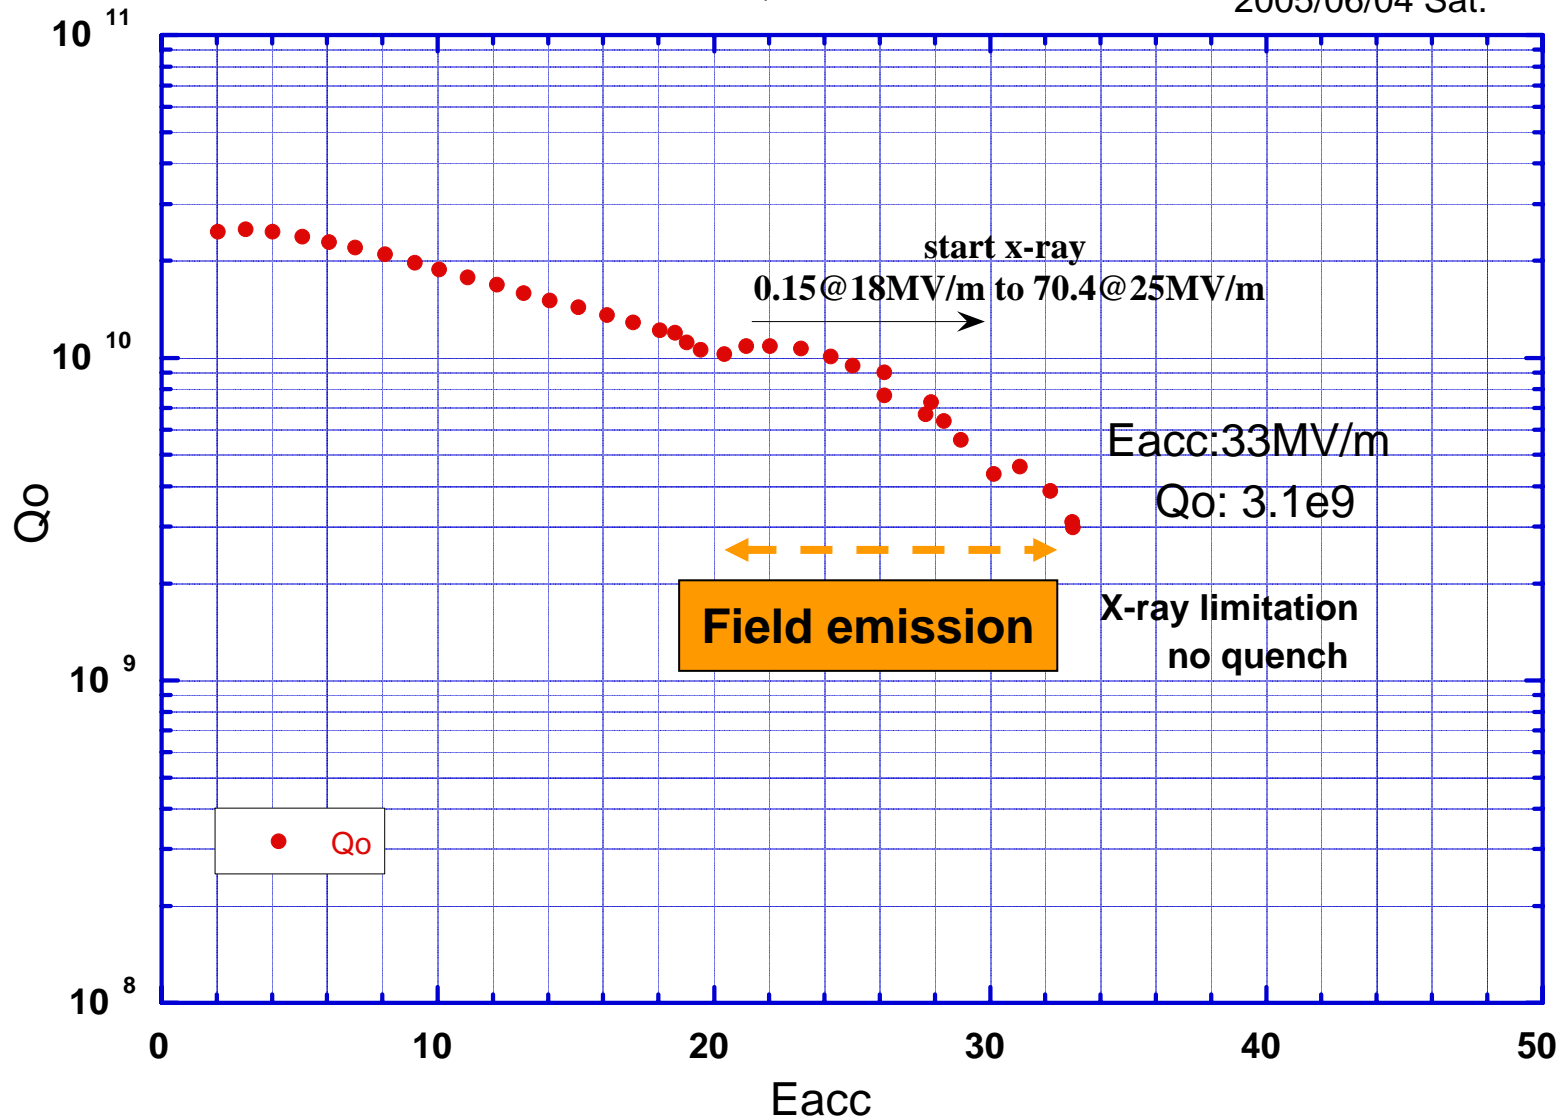
RE-cavity 4th meas.

Oil-contamination problem

Q_0 vs. E_{acc}

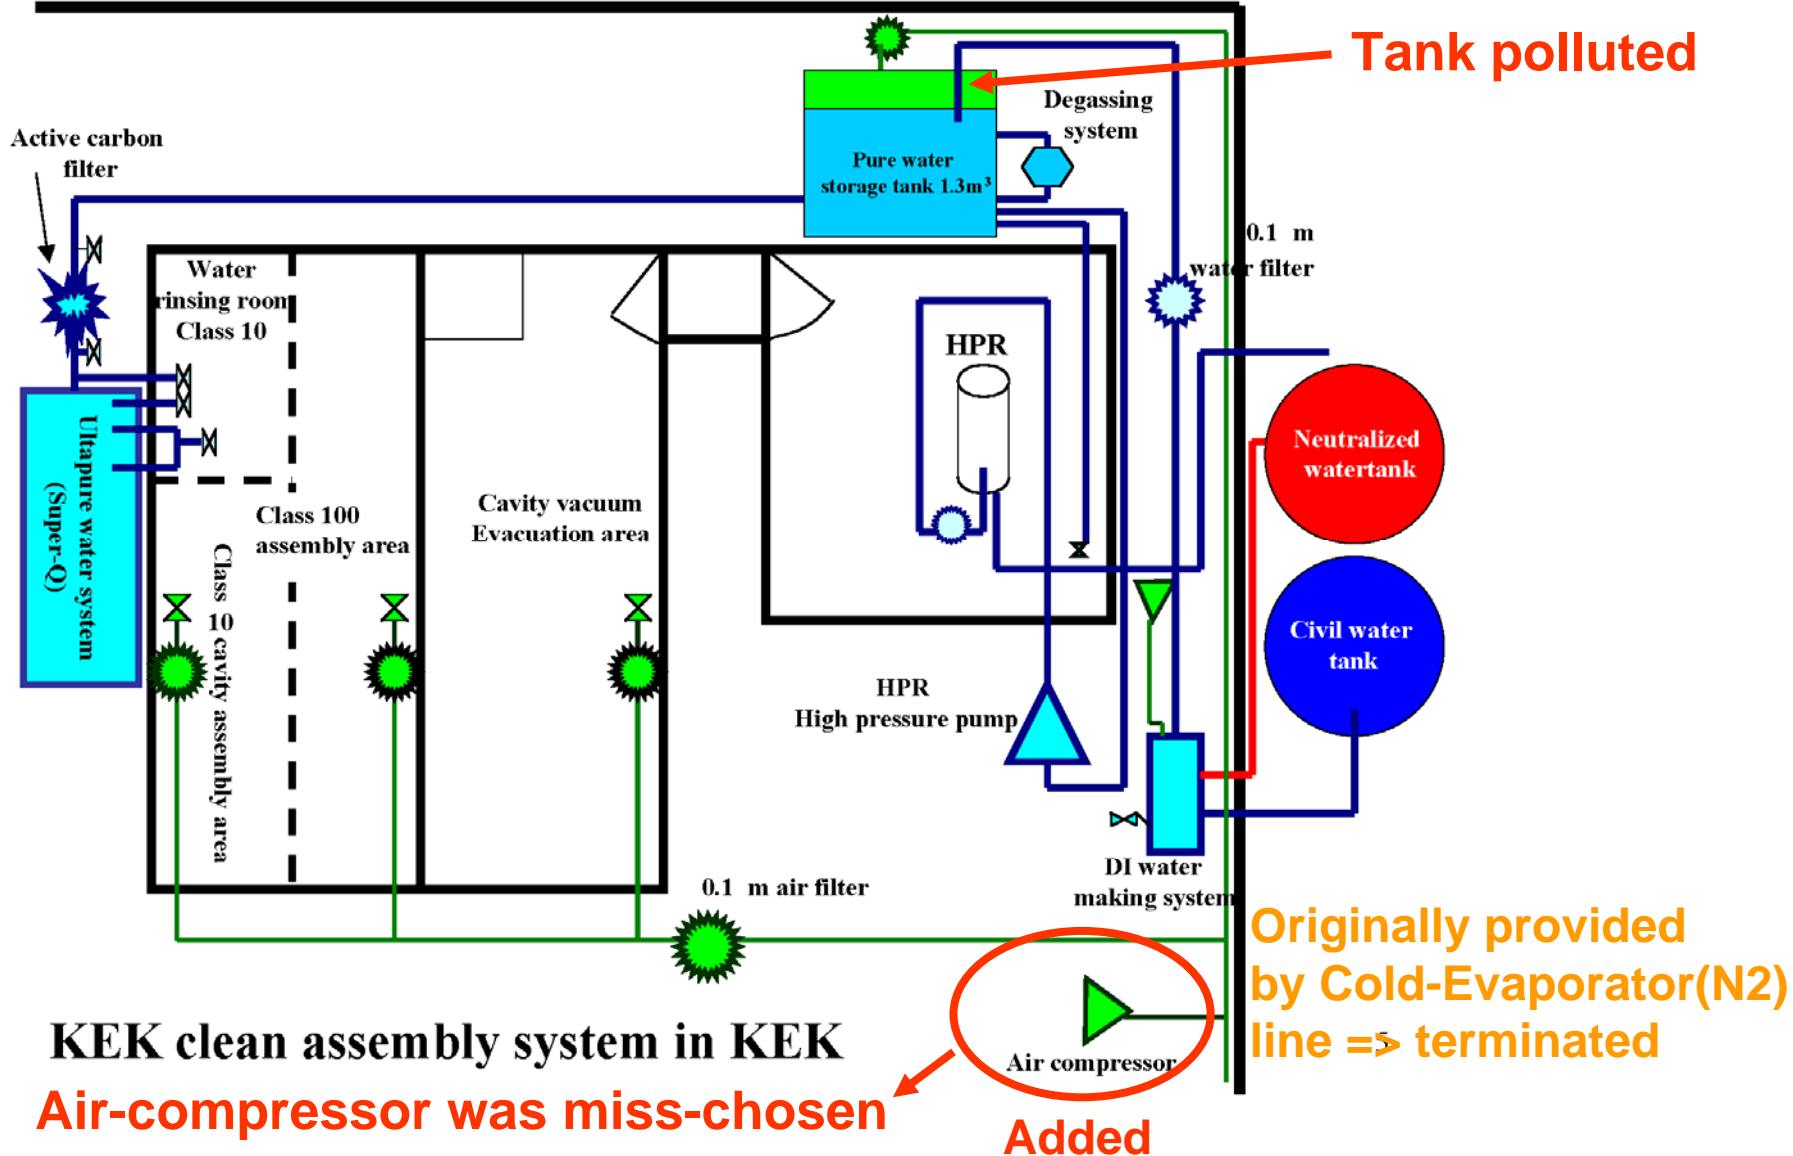
KEK clean assembly system in KEK
Air-compressor was miss-chosen

Added

New oil-free compressor + cleaning tank and pipes.

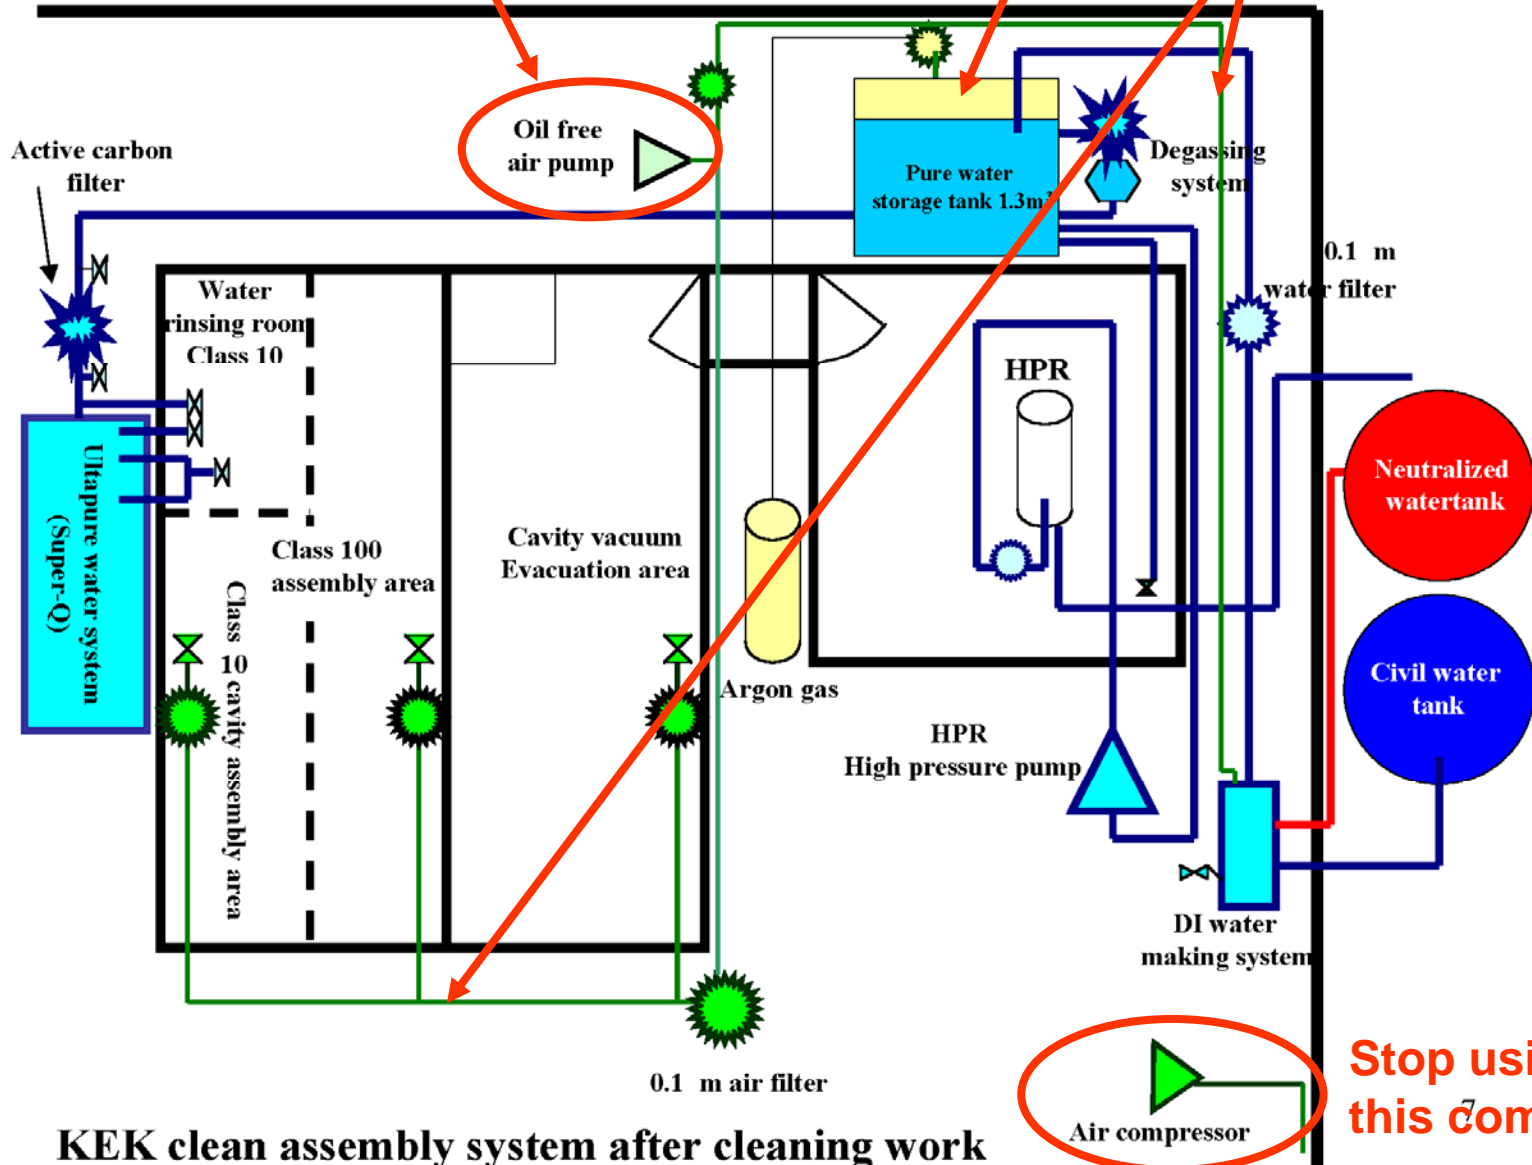
KEK clean assembly system after cleaning work

Stop using this compressor

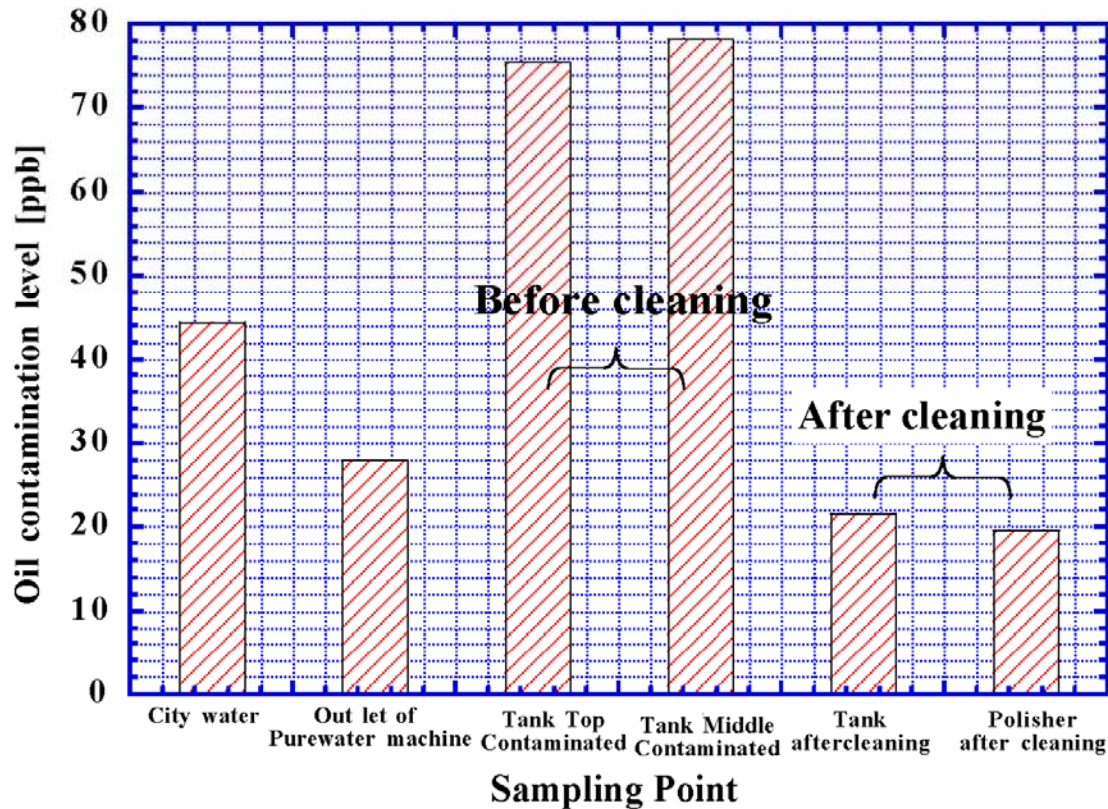
Fig.5 : Oil contamination level decreased to 1/4 by the cleaning work.

No in-line water monitor

=> contamination was found after several VTs.

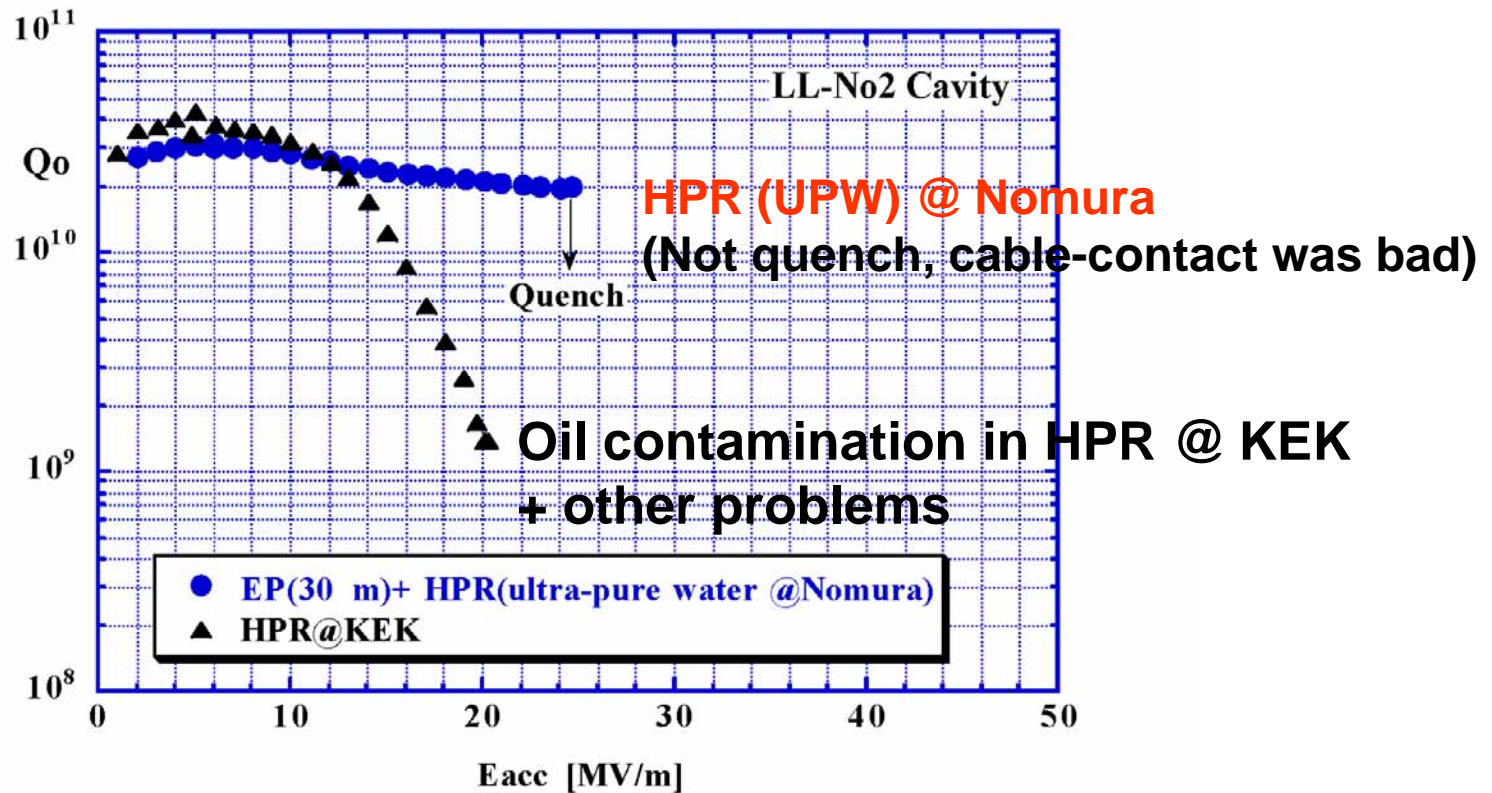
Q0 vs Eacc with HPR (UPW @ Nomura) and
Field-emission at low Eacc with HPR (oil-contamination at KEK)

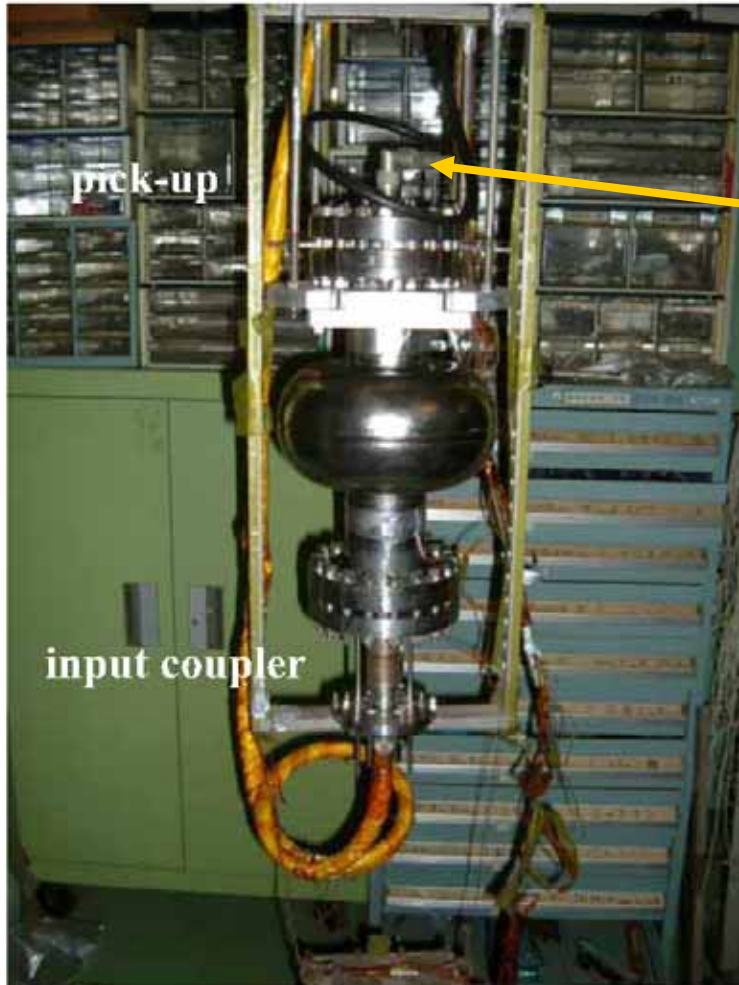
**Pickup cable :
Bad contact at connector.**

**Cycling of cool-down and
warm-up damages the cable.**

**Changing pick-up cable
solved this problem.**

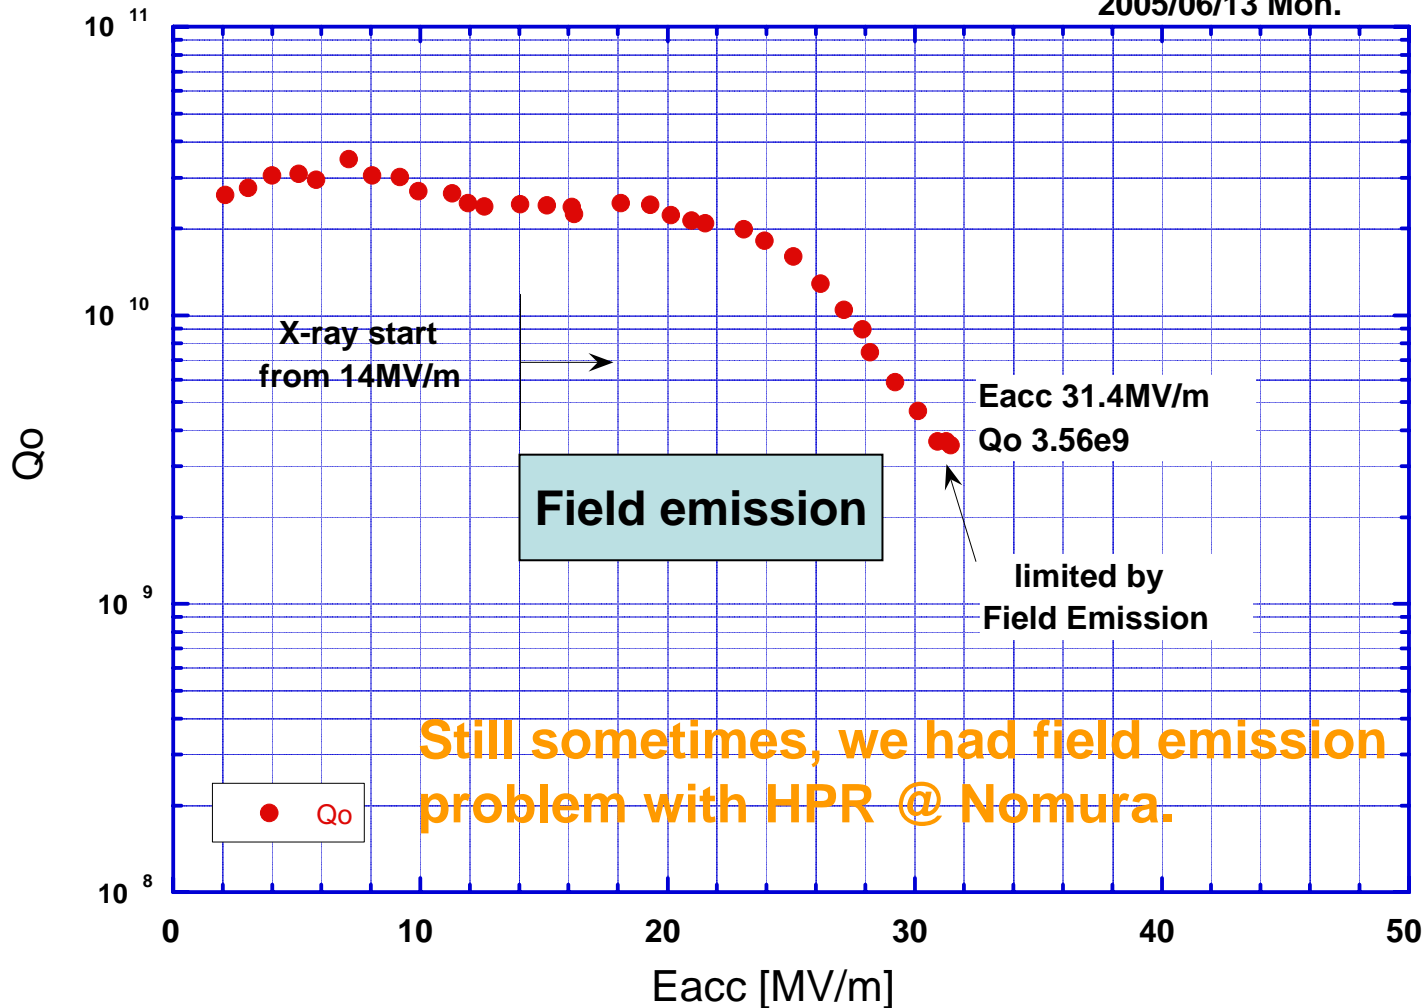
LL-No.1 11th meas.

HPR clean-room problem at Nomura

Aneal(750C*3hr)+EP(30um)+HPR@Nomura
assembling without air blower+Baking(120C*48hr)

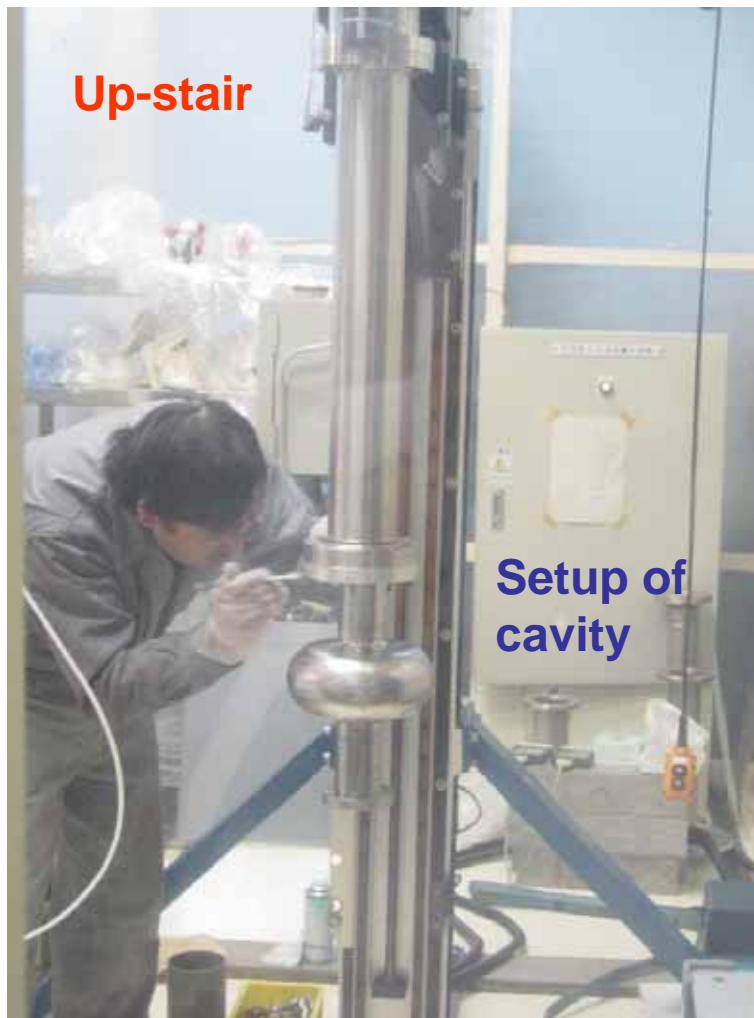
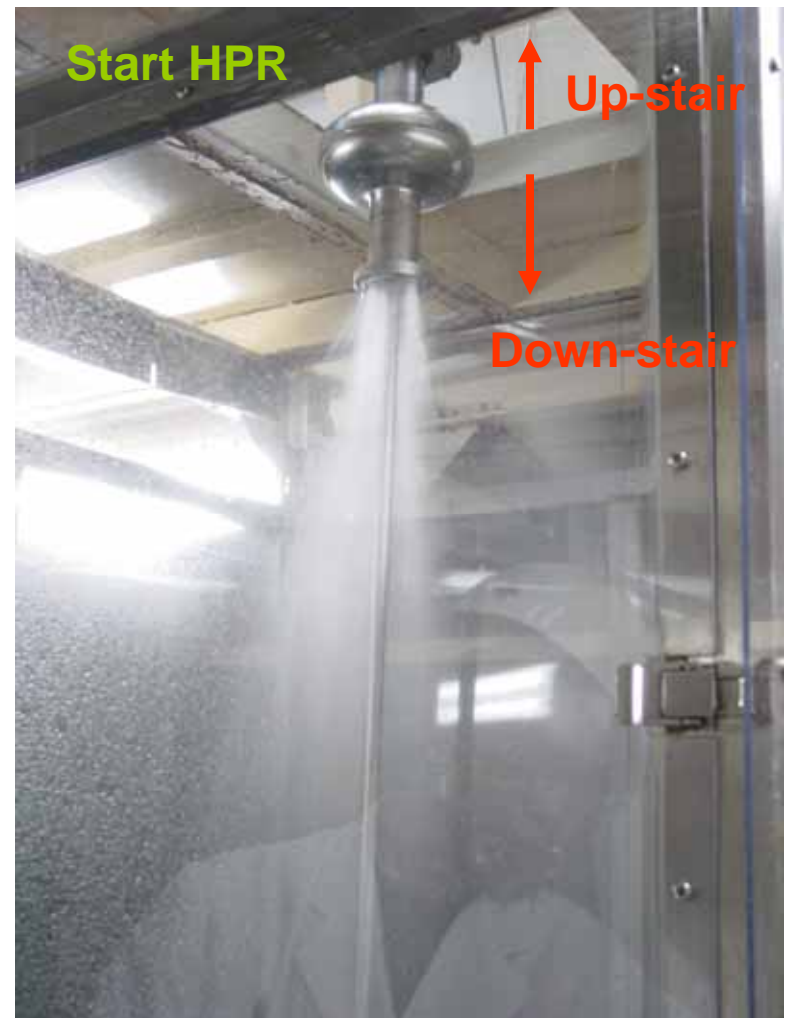
**HPR at Nomura is in clean-room (class 1000).
But the clean-room is not clean enough.**

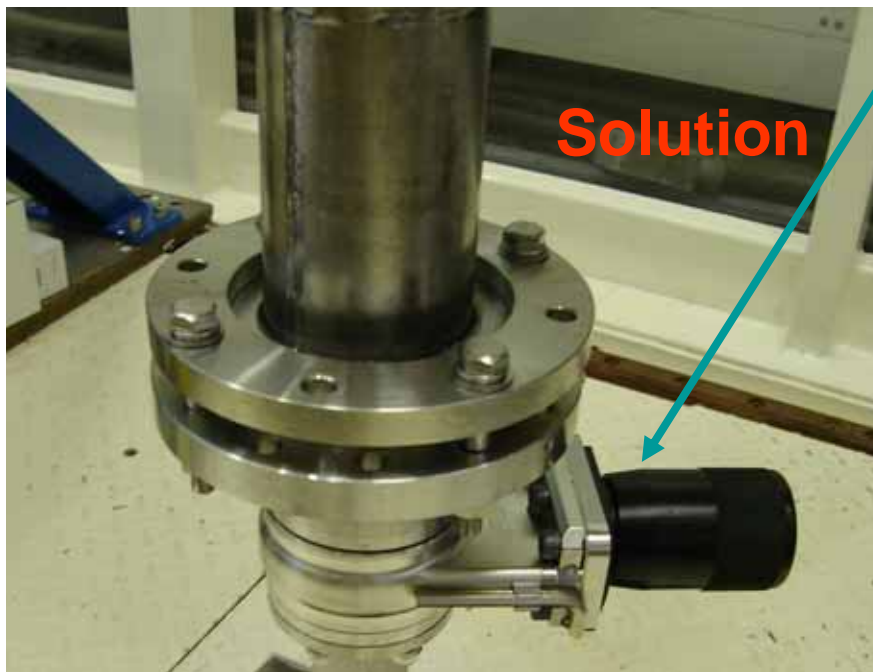
Valve is put on the bottom
flange of cavity before HPR.

After setting the valve and starting
HPR, operator goes out the clean-
room. No operator in the clean-
room during HPR.

15 min. before the end of HPR,
operator comes in the clean-
room again to sit inside the CR.
Then, operator closes calve at the
end of HPR. => carry to KEK.

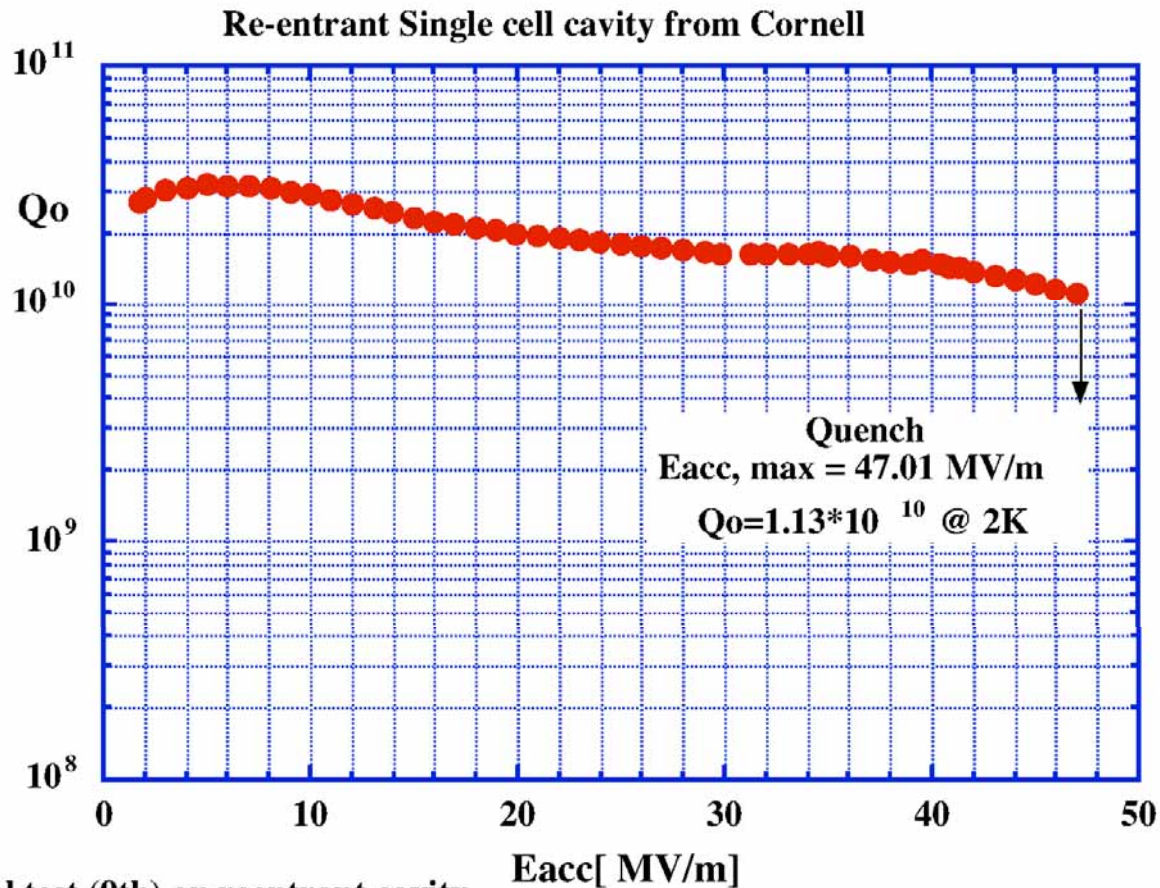
RE single-cell cavity achieved 47 MV/m on 30 July 2005.

: Vertical test (9th) on reentrant cavity

Re-annealed (750°C,3hr) +EP(30μm)+HPR(Nomura, ultra-pure water)+Bake(120°C, 48hr)

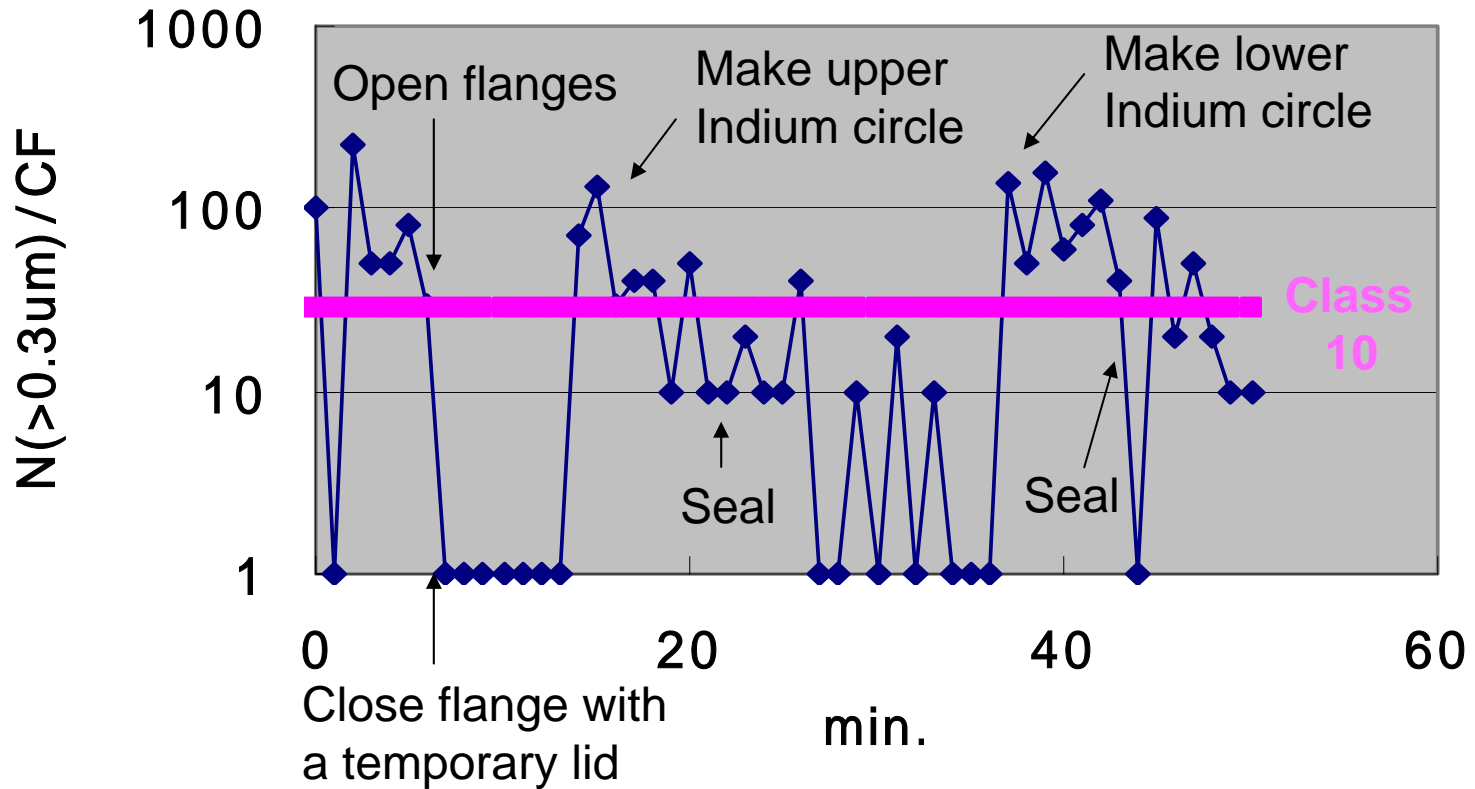
2005Sep14 RE cavity assemble

28 particles ($>0.3\mu\text{m}$) / CF = class 10

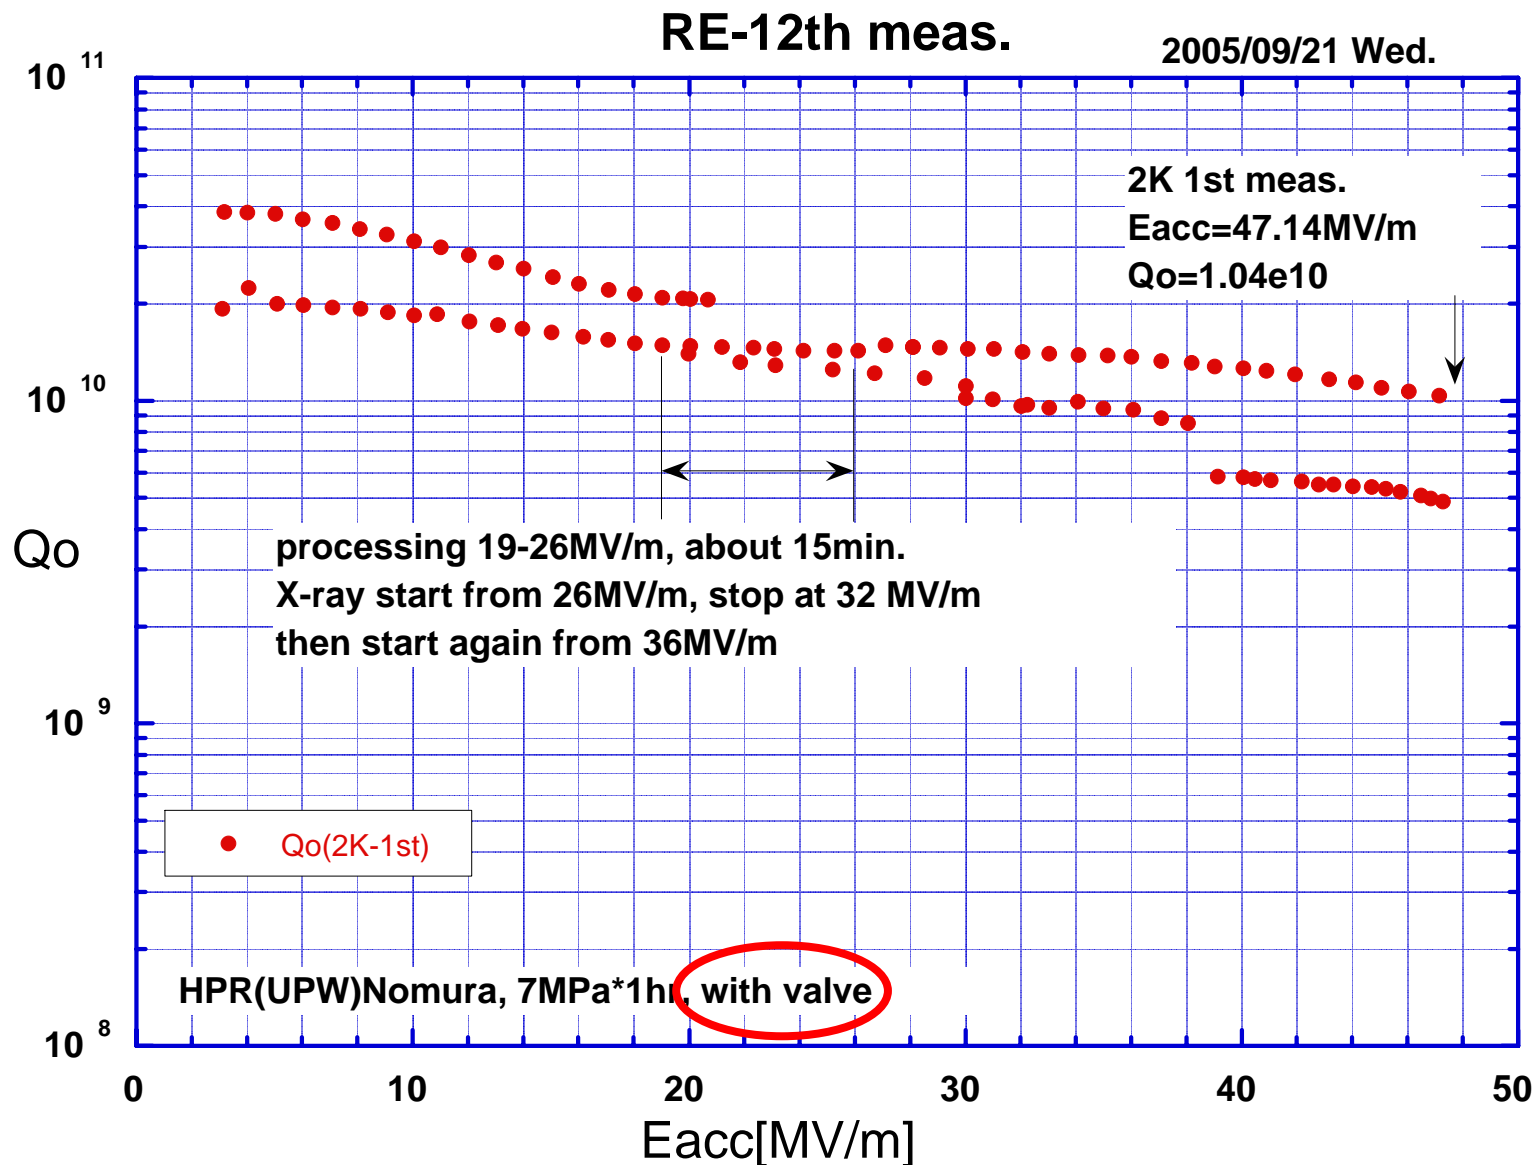
RE cavity performance with HPR @ Nomura (on 14 Sept.) and assembly @ KEK (on 14 Sept.)

- We cleaned up the clean-room at KEK (swept wall, floor, curtain...etc)
- Compared the cleanness of CR before/after the cleaning of CR by particle counter.
- It seems that cleaning CR does not affect so much in cavity performance.
- Operator's moving & acting calmly during assembly is most effective to avoid particle's going inside cavity.
- Also, cleaning CR-wear seems a bit effective.
