REPORT OF INVESTIGATION

**Surface Nonmetal Mine
(Limestone)**

Fatal Powered Haulage Accident

**New Enterprise Stone & Lime Co., Inc.
Somerset Quarry & Mill
Somerset, Somerset County, Pennsylvania
Mine I.D. No. 36-00233**

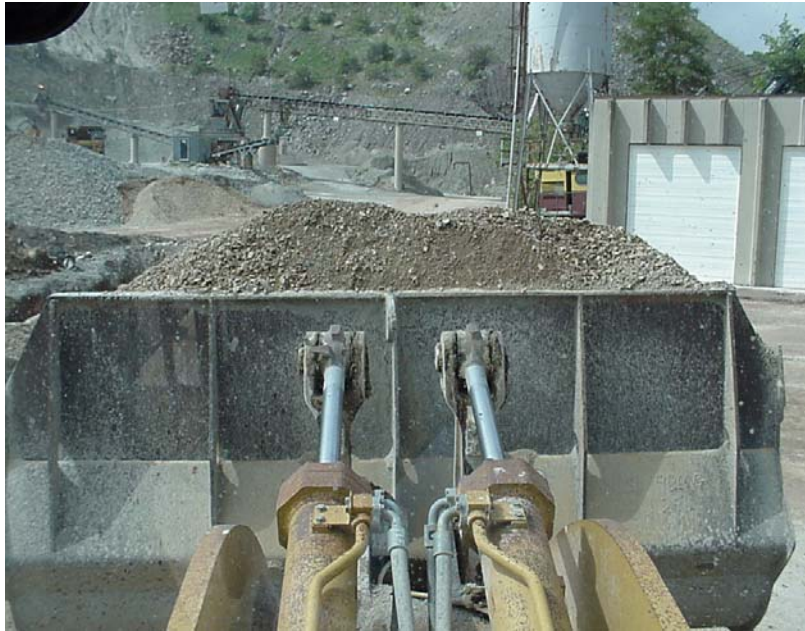
Since the front-end loader was traveling with its bucket approximately two to four feet off the ground at the time of the accident, a simulated test was conducted to determine the "blind areas" for the equipment operator at these raised bucket positions. In this test, the blind area was defined as the area that a six foot tall person, standing on the ground a measured distance from the machine, was not visible to the loader operator. During the test, an observer, who

The attached photo and figure (Appendix B) illustrate the view from the operator's compartment and the resultant blind areas the loader operator experienced. The blind area in front of the loader extended out to 20 feet, 35 feet, and 85 feet, when the bottom of the bucket was two feet, three feet, and four feet above the ground, respectively.

View from Operator's Cab

Corrective Actions: Procedures should be established to use spotters, cameras, lights, signs, barricades, training or other practical means, to ensure the safety of all employees at the work area.

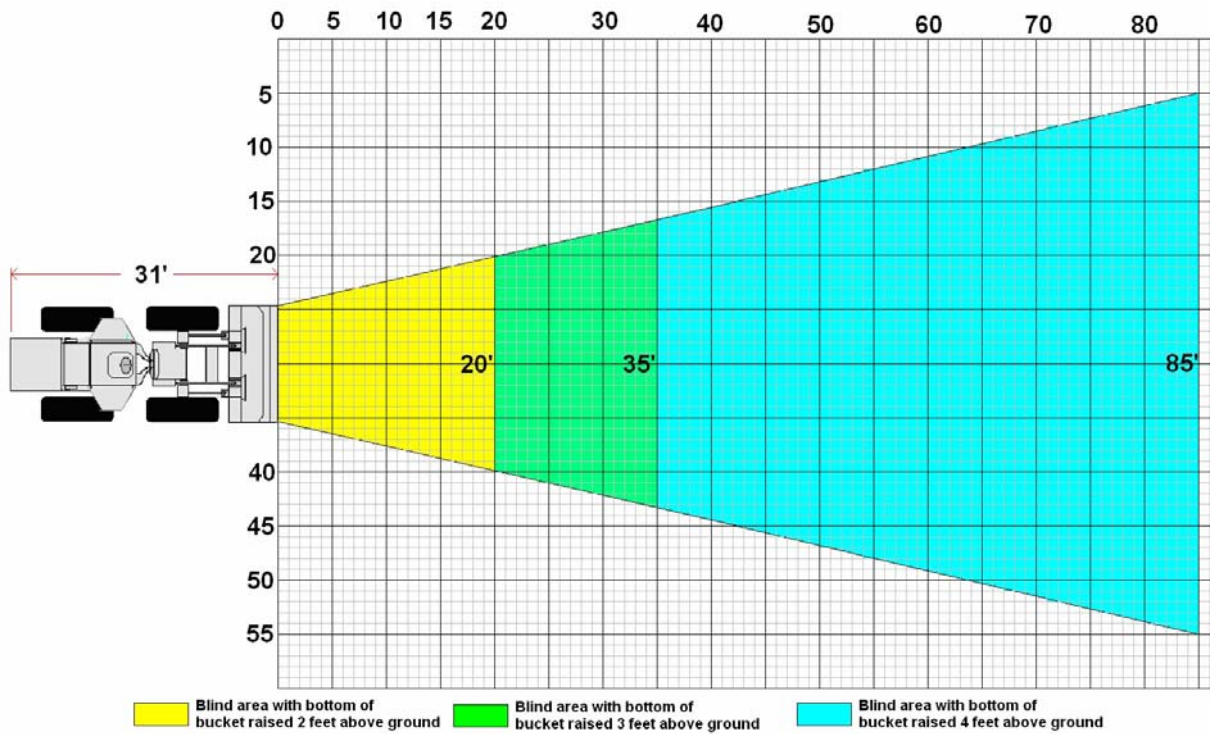
Blind Areas in Operator's Field of Vision
