EPIDEMIOLOGIC

INVESTIGATION

REPORT

1. CASE NUMBER 9 6 0 9 3 0 C C C 7 4 6 5		2. INVESTIGATOR'S ID 8 0 9 0		Firm has not requested further notice	
3. OFFICE CODE 8 6 0	4. DATE OF INCIDENT 9 6 0 9 0 6	5. DATE INITIATED 9 6 1 0 2 3

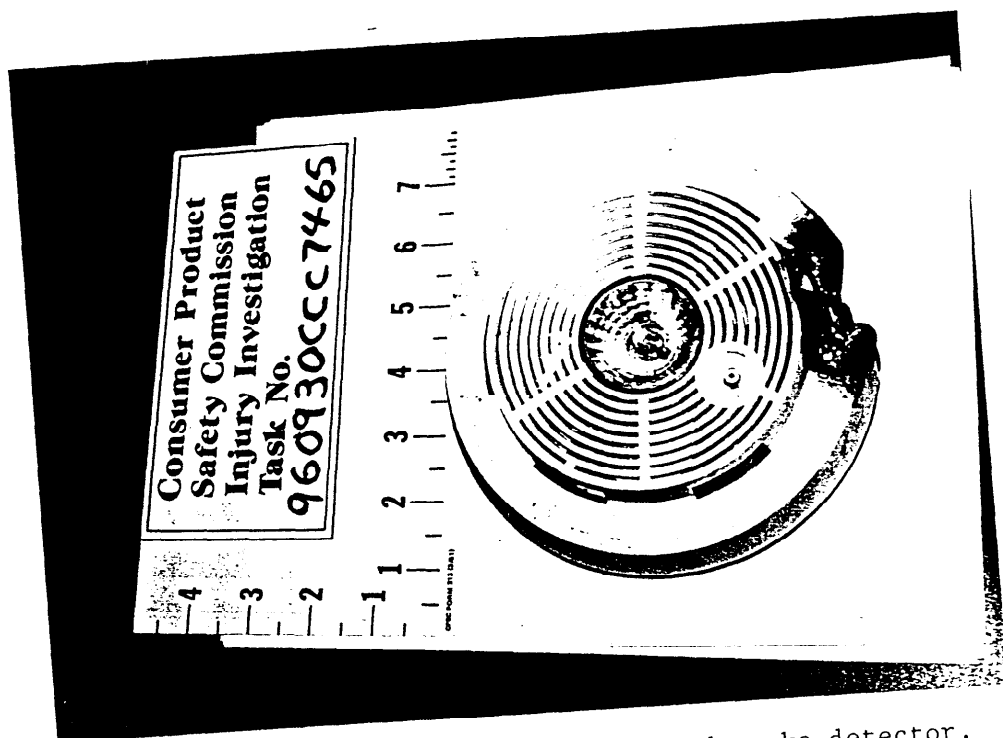
PHOTO #6: Photograph of the fire damaged smoke detector. This is a photograph of the smoke detector's front cover.

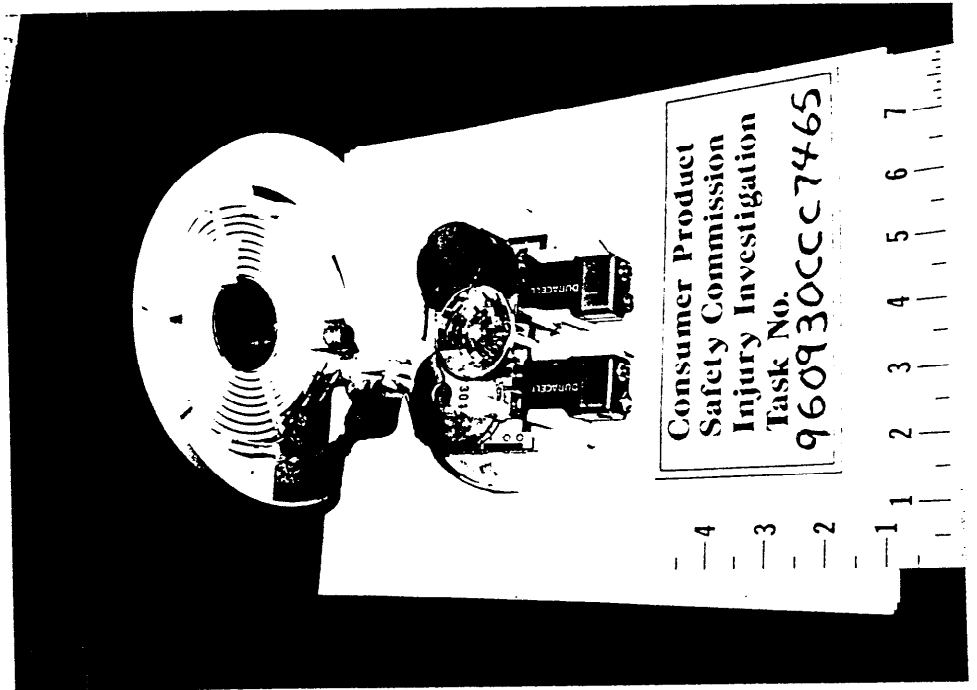
PHOTO #8: Photograph of the smoke detector, with the cover raised. The consumer reports that the batteries were disconnected (after the fire) and set back the battery compartments the opposite direction.

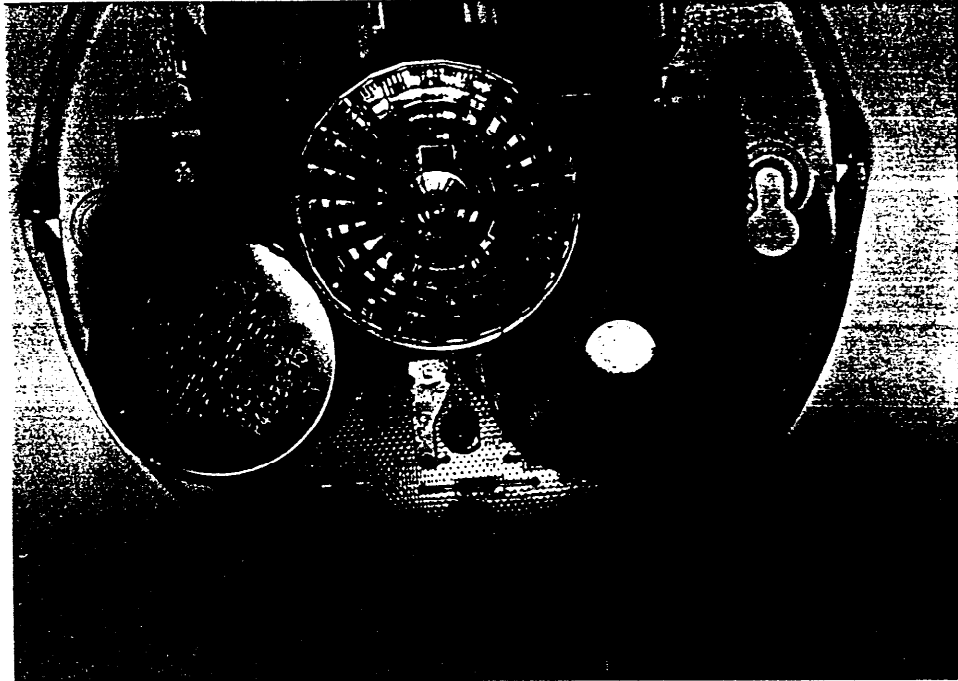
The number "3044" is found marked on a component of the smoke detector (see PHOTOS #10 and #11 of EXHIBIT I). The smoke detector's labeling indicates that the batteries should be replaced, when the smoke alarm's horn sounds at intervals of about once per minute.

PHOTO #10: Close-up photograph of the smoke detector's light and a "CAUTION" mark on a metal surface, just adjacent to the light (on the left side of the photograph above).

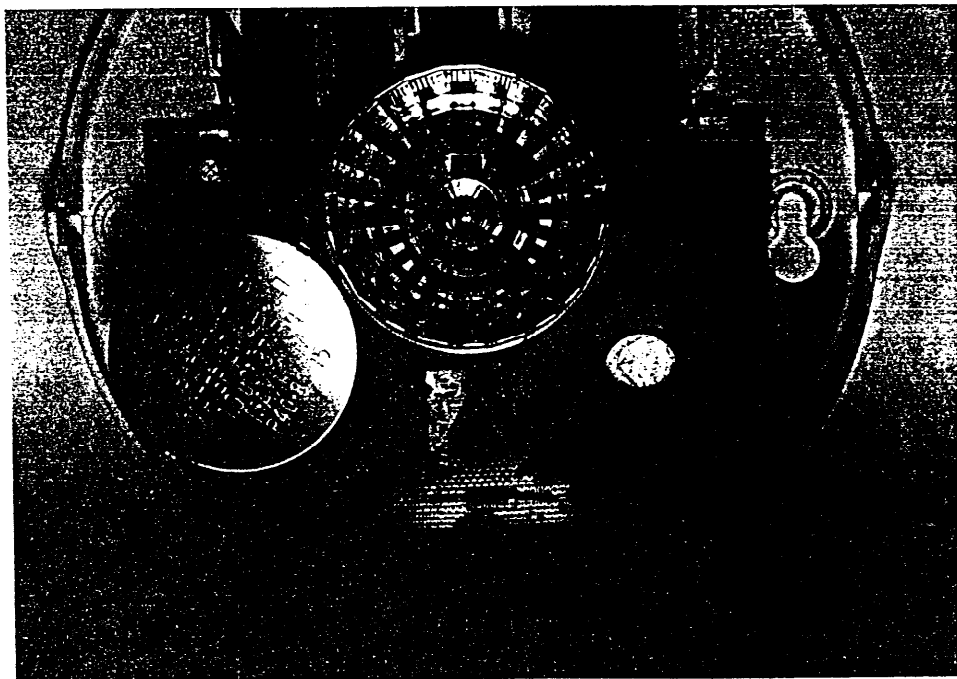
PHOTO #11: Close-up photograph of the smoke detector's light and other components, as also shown in PHOTO #10 above.

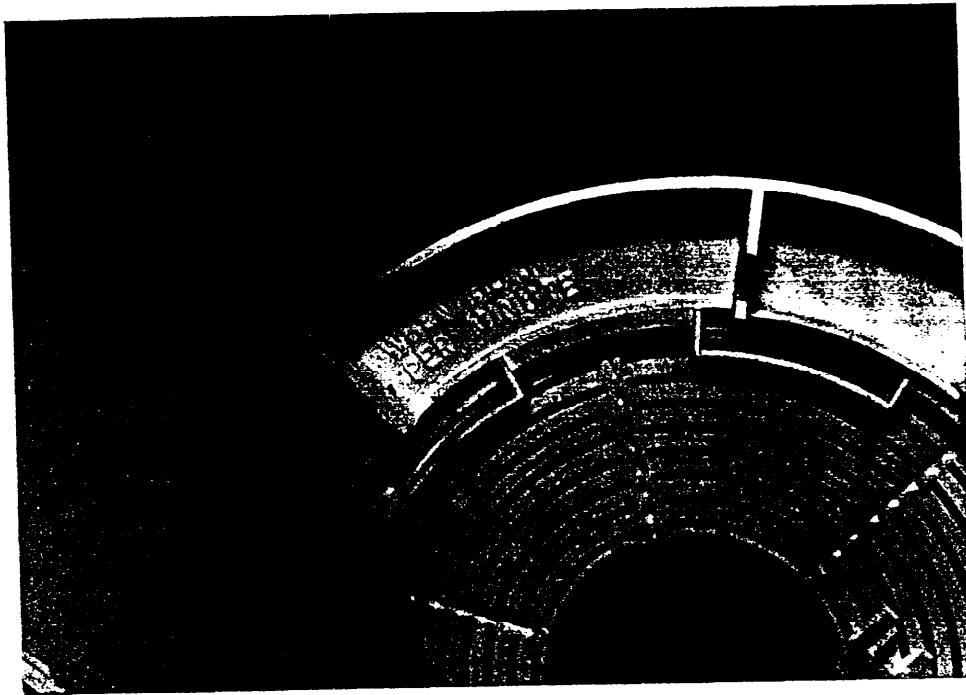
PHOTO #12: Close-up photograph of some of the labeling marks found on the inside of the smoke detector's fire damaged cover.
