# Anodic Oxidation-Induced Delamination of the SUMMiT™ Poly 0 to Silicon Nitride Interface

Richard Plass<sup>\*a</sup>, Jeremy A. Walraven<sup>b</sup>, Danelle M. Tanner<sup>a</sup>, and Frederick W. Sexton<sup>a</sup>  
<sup>a</sup>Radiation and Reliability Physics Department, <sup>b</sup>Failure Analysis Department  
Sandia National Laboratories, Albuquerque, NM 87185

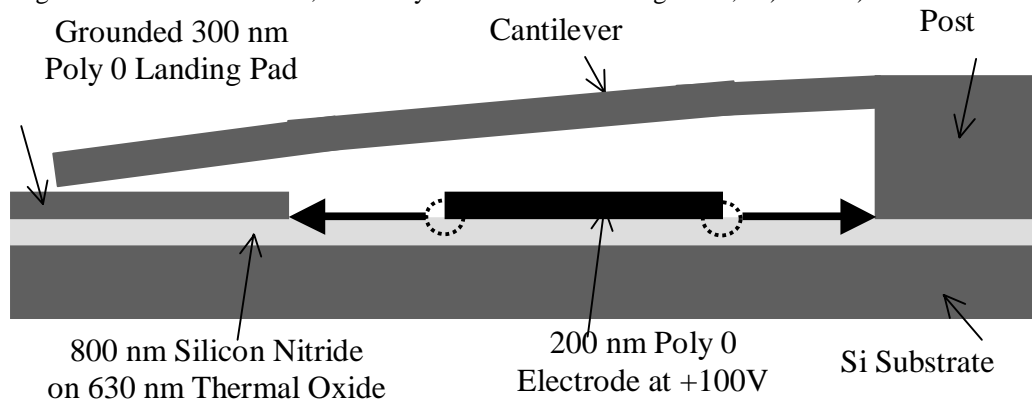
A side-view schematic diagram of the Sandia, Ultra-planar, MEMS, Multi-level Technology (SUMMiT™) Interferometry for Material Properties in MEMS (IMaP™) cantilever test structure is shown in Figure 1. Examples of damage to the Poly 0 pull-down actuation electrodes under both the Poly 12 laminated cantilevers and the Poly 3 cantilevers are shown in the subsequent figures. For the Poly 12 cantilevers, the initial gap between the electrode and the cantilevers is nominally 2 microns, while, for the Poly 3 cantilevers, it is about 6 microns. In Figure 1, the positively charged actuation electrode is shown in black and the surface leakage paths are shown with thick arrows. The OH<sup>-</sup> ions responsible for anodic oxidation travel in the direction opposite the leakage current. In the case of this structure, they react at the point where the polysilicon electrode meets the bare nitride layer, which is also the location of highest field. Hence the primary location for low-density anodic oxide buildup is the edge of the Poly 0 electrode right at the nitride interface, shown by the dashed arcs in Figures 1, 2c) and 3b).

Figure 1. Side view schematic of a short Poly 12 cantilever actuated into an arc shape very early in a humidity test. The critical surface leakage currents are shown by black arrows, and the edges of greatest oxide buildup are at the centers of the dashed arcs.

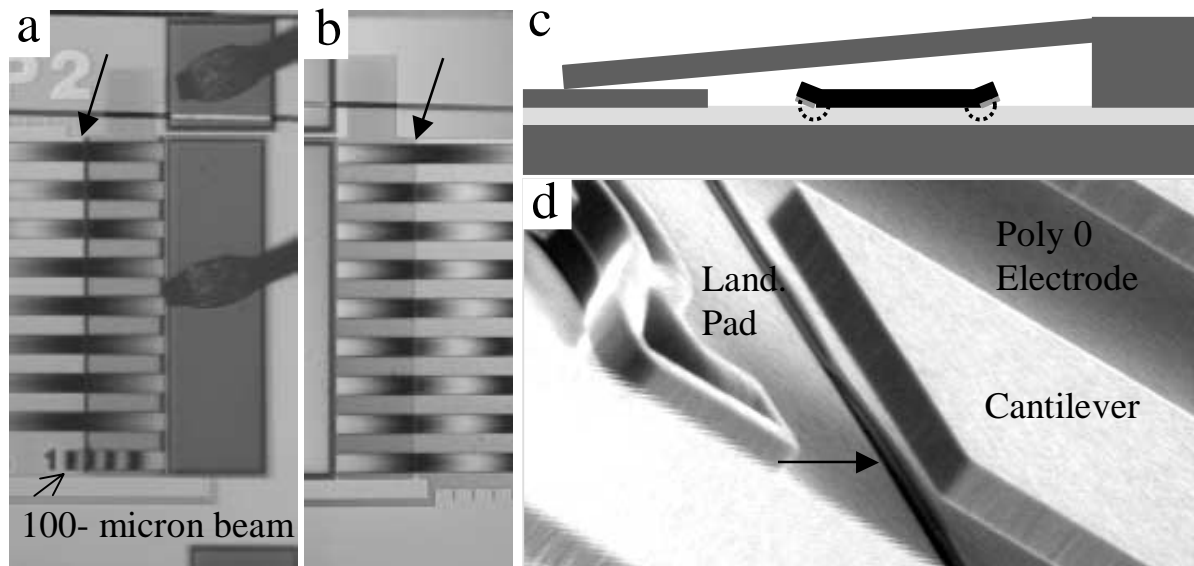
Figure 2. Initial stages of anodic oxidation-induced delamination of the Poly 0 electrode. a) Interferogram of a supercritical CO<sub>2</sub>-dried die exposed to 50% RH at 45°C for 20 days while actuated at +100 volts. Anodic oxidation-induced damage is in its early stage. Just barely visible is a contrast increase of the actuating electrode-to-landing pad gap as compared to b) the unactuated electrode. Also the 100-micron long beam is deflected upward very slightly, as seen by the interference fringes on this beam. c) Side view schematic showing the early stage of the delamination and formation of an oxide layer on the underside of the delaminated region (thin gray line under the black electrode). Note that the point of attack of the interface has moved in from the edge of the electrode. d) Scanning Electron Microscopy (SEM) micrograph of the Poly 3, 200-micron long cantilever region of a supercritical CO<sub>2</sub> dried plus oxygen plasma cleaned die held at 50%RH and 25°C for 50 days and +100 volts actuation. The arrow shows where the electrode is starting to delaminate.

The failure mechanism only initiates at regions under cantilevers, an example of which is seen in Figure 2 d). This fact suggests that the electric field perpendicular to the current flow plays a role in enhancing the current flow. This dependence could be directly field-related or related to the interaction of the field with the surface water layer. Comizzoli and coworkers<sup>4</sup> have suggested that a locally strong perpendicular field could induce a local increase in nitride surface conductivity by electrostriction. That is, they propose that electrostriction locally increases the number of water layers through which the surface current passes, thus increasing the local surface conductivity and the oxidation rate relative to regions where the perpendicular field is not as strong.

The delamination failure mechanism consistently attacks the electrode region under the poly 12 100-micron long beam first. An example of this damage is shown in Figure 2 a), where there are interference fringes only on the Poly 12 100-micron cantilever. The interference fringe patterns of the cantilevers in Figure 3 a), combined with a defocus measurement, indicate that most of the cantilevers have been deflected upward substantially, a situation illustrated in Fig. 3 b). Also worth noting in Figure 3 a) is that the general lack of fringes on the Poly 3 cantilevers indicate the

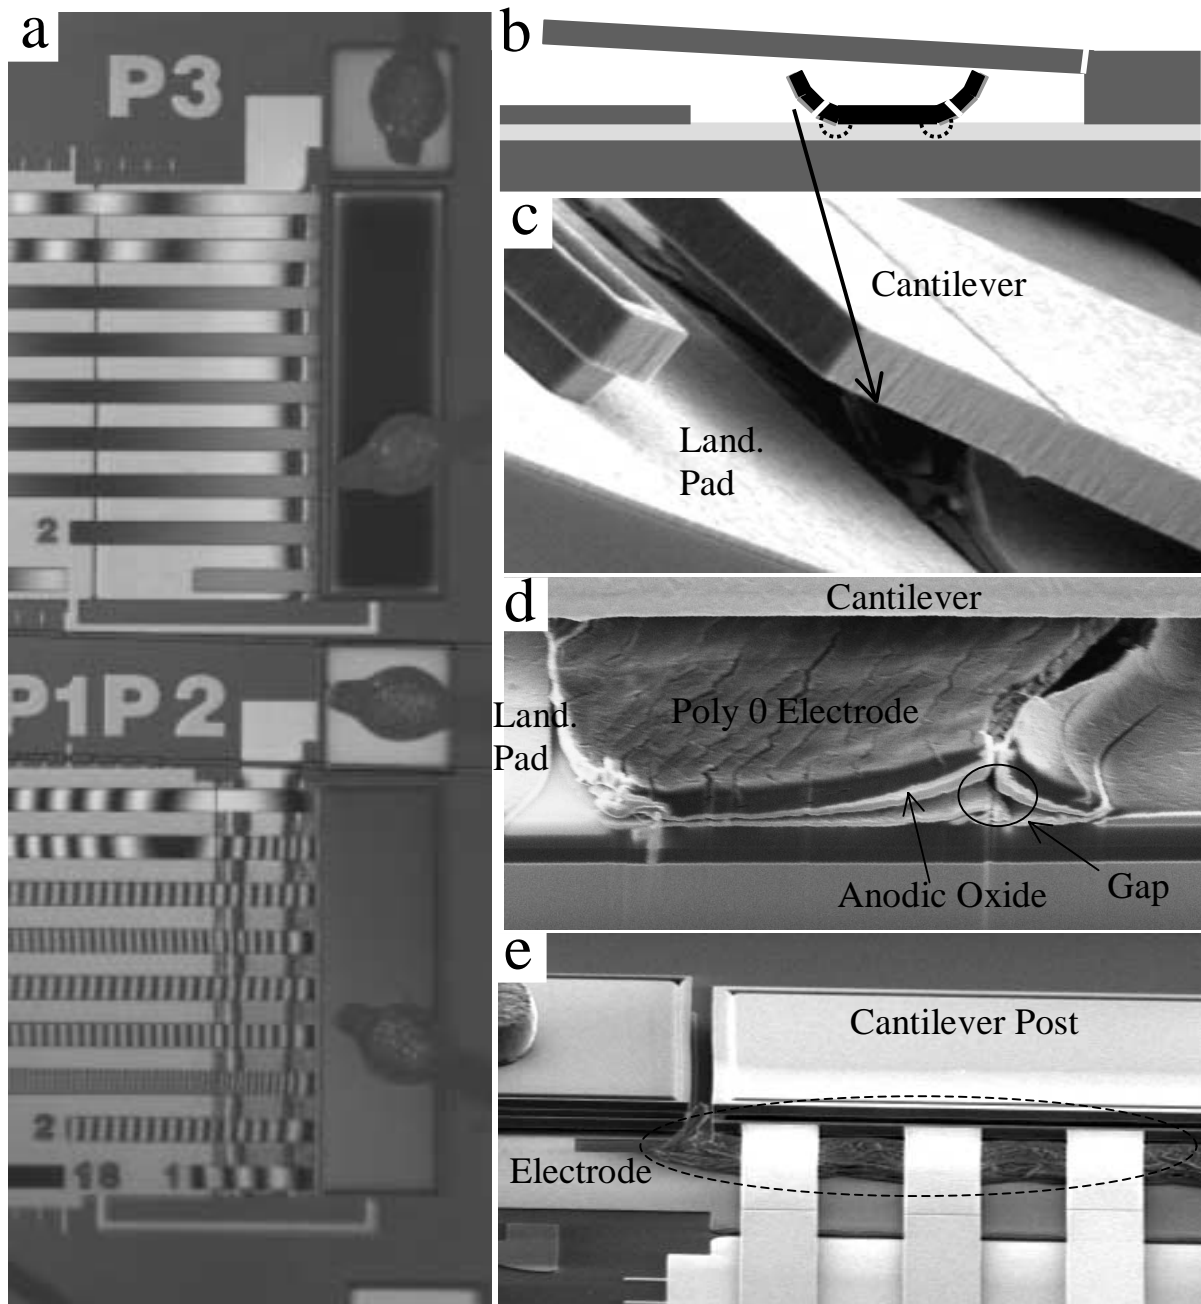
Figure 3. Medium stage anodic oxidation-induced delamination. a) Optical interferogram of a supercritical CO<sub>2</sub>-dried die exposed to 50% RH at 45°C for nine days while actuated at +100 volts. A U-shaped damage pattern is seen around the edges of the Poly 12 actuation electrode. White lines across the poly layers in the side-view schematic of b) show stress points where the polysilicon is likely to crack with increased delamination. c) SEM micrograph of the Poly 12 100-micron long cantilever region of a supercritical CO<sub>2</sub>-dried plus oxygen plasma cleaned die held at 50% RH and 25°C for 50 days showing the mechanical contact of the delaminated poly 0 electrode with the cantilever. d) SEM micrograph of a damaged die taken perpendicular to the long axis of the 100-micron long Poly 12 cantilever showing how the poly 0 electrode has cracked near the delamination point. A focused ion beam cross-section in the foreground of d) shows the delamination gap as well as the (arrowed) light gray anodic oxide under the dark gray poly 0; the medium gray material adjacent to the gap is ion milling debris. e) SEM micrograph of a supercritical CO<sub>2</sub>-dried die held at 50% RH and 25°C for 48 days, where the anodic oxidation delamination was severe on the post side of the electrode (dashed ellipse).

accompanying electrode has not yet delaminated far enough to deflect most of them. The nonuniform contrast of either edge of the Poly 12 actuation electrode in Figure 3 a) illustrates the characteristic damage that we would expect, given the surface leakage paths.

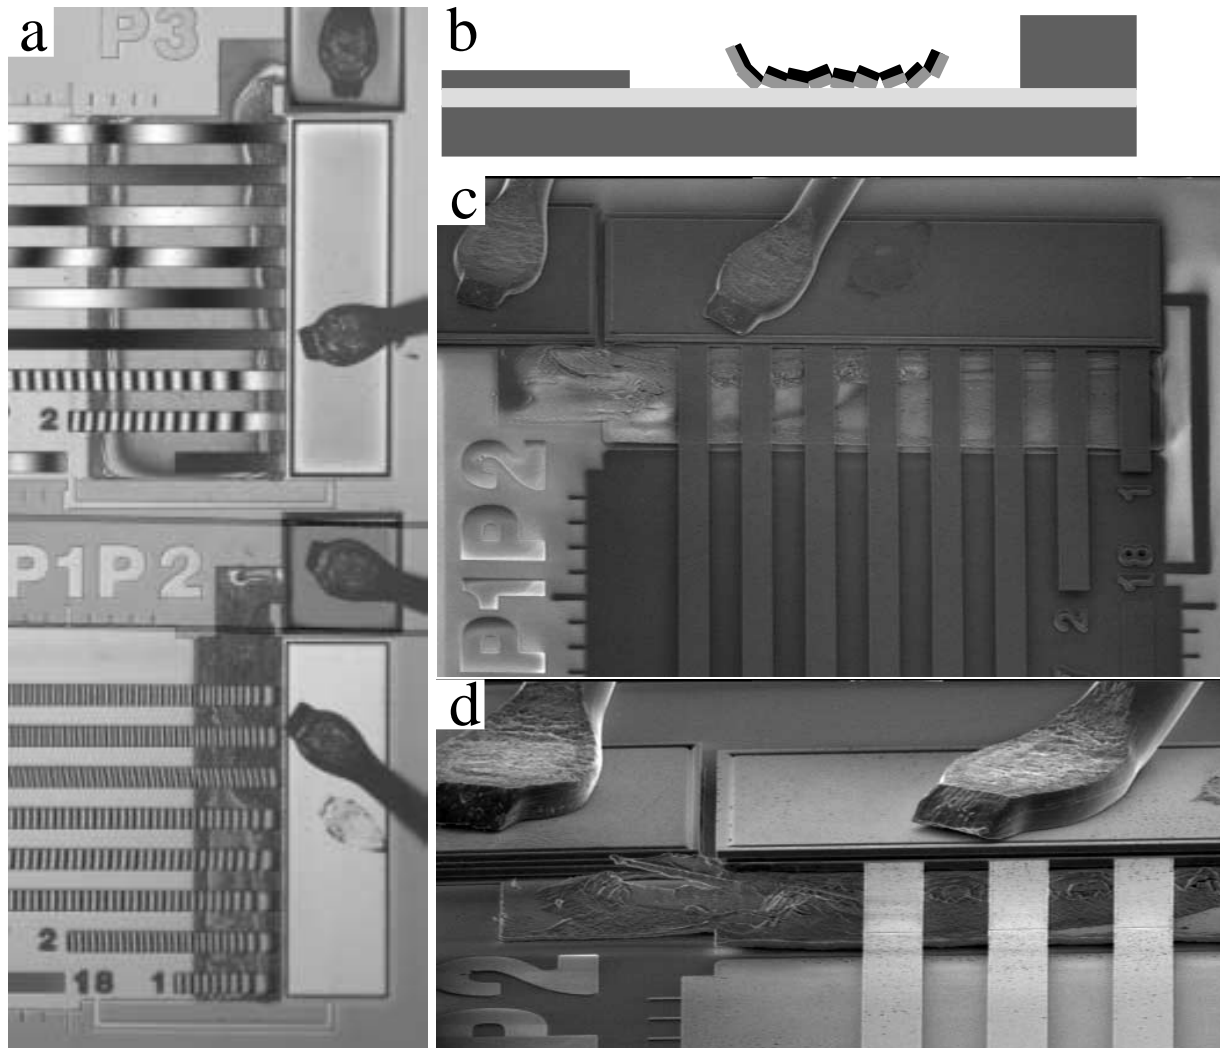
Figure 4. Advanced stage anodic oxidation induced delamination. a) Optical interferogram of a supercritical CO<sub>2</sub>-dried plus oxygen plasma-cleaned die held at 50% RH and 25°C for 101 days showing U-shaped characteristic damage to the edges of the Poly 3 cantilever electrode and essentially complete delamination of the Poly 12 cantilever electrode. The Poly 0 electrode is now mechanically interfering with the 200 and 300-micron long Poly 3 cantilevers, and the Poly 12 900-micron long cantilever has been broken off at its root. A schematic side-view diagram of this situation is shown in b) with details shown in the SEM micrographs of the same die in c) and d) taken at different sample angles.

For prolonged experiments, we find the delamination sometimes produces sufficient force to break a 2.5-micron thick cantilever where it is anchored, as seen in Figure 4. However, the thinner Poly 0 electrode normally breaks near the delamination point. The relative humidity (RH) and temperature conditions under which we see the delamination occur qualitatively agree with those reported by Shea *et al.*<sup>1</sup> and predicted by Comizzoli<sup>3</sup>, namely we see insignificant anodic oxidation at 25% RH and, as discussed below, the oxidation occurs much faster at higher temperatures. Further experiments are in progress.

Figure 4 shows examples of advanced stages of anodic oxidation-induced delamination, where a 900-micron long Poly 12 cantilever has fractured at its root. Though this particular electrode is badly shattered and in contact with the rest of the cantilevers, it can still hold +100 volts without shorting, since the electrode debris is heavily oxidized. Considering the effects of temperature on this failure mechanism, anodic oxidation-induced delamination levels after nine days test duration at 45°C are comparable to parts held for 50 days at 25°C under the same relative humidity conditions, as is shown in Figure 5. The damage at 45°C appears to be more uniform and is perhaps less affected by local electric field variations.

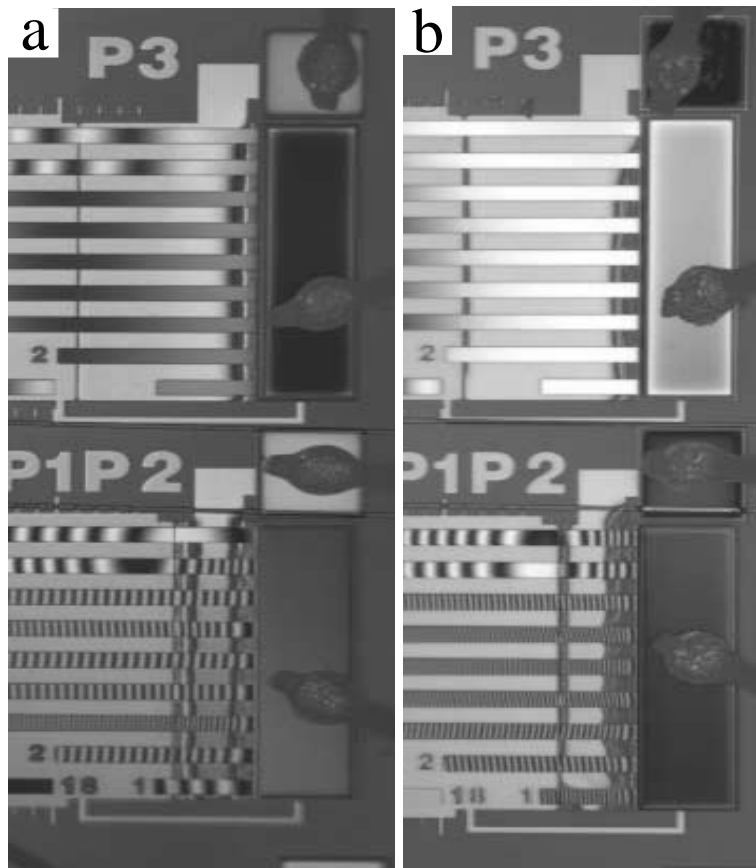
Figure 5. a) Same as Figure 3 a) Optical interferogram of a supercritical CO<sub>2</sub>-dried die held at 50% RH and 45°C for nine days at +100 volts. b) Optical interferogram of a supercritical CO<sub>2</sub>-dried die held at 50% RH and 25°C for 48 days showing comparable delamination levels.
