REPORT OF INVESTIGATION

Surface Nonmetal Mine  
(Dimension Stone)

Fatal Powered Haulage Accident

Grindstone  
Classic Stone LLC  
Port Hope, Huron County, Michigan  
Mine I.D. No. 20-03160

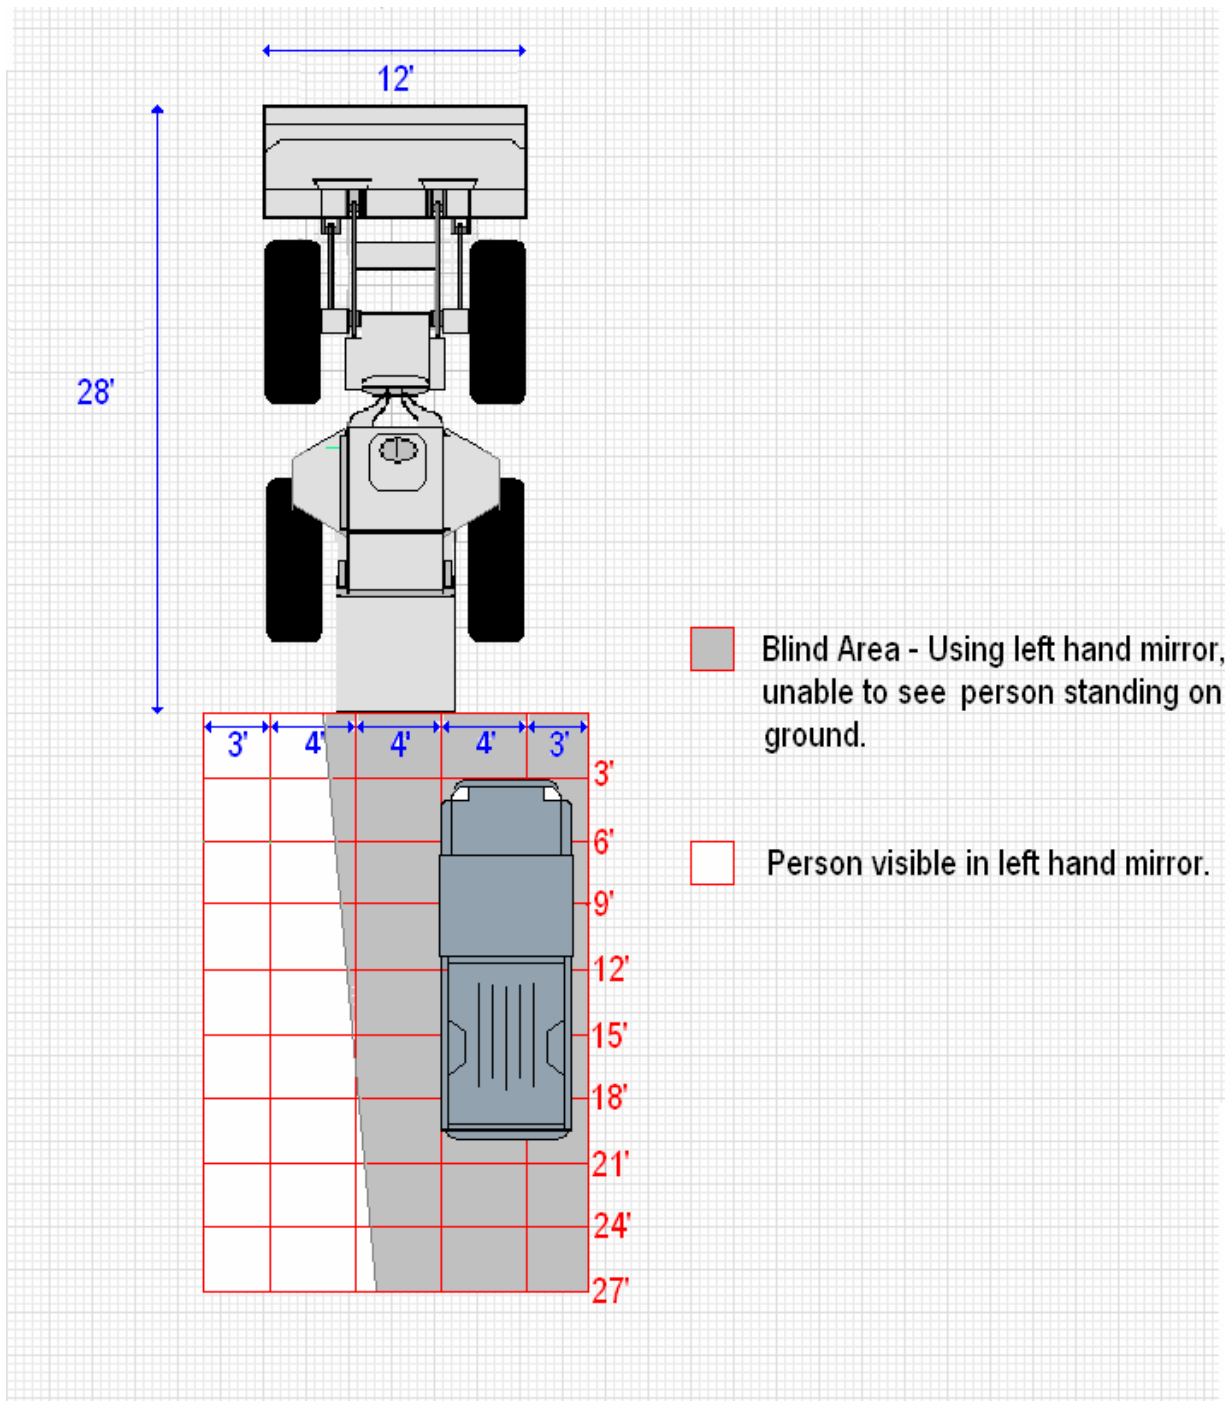
Figure 1

**Visibility Survey** - Four figures showing the results of a visibility survey are included in Appendix C. Figures 1 and 2 show the blind spot area for a loader operator looking at the left outside mirror. Figures 3 and 4 show the area that can not be seen using any of the four mirrors. The right rear tire of the loader ran over the front left side of the pickup truck, indicating that the truck was behind the right side of the loader. This created a blind area for the loader operator who stated he was looking over his left shoulder.

**Corrective Action** – Establish procedures that require smaller vehicles to maintain a safe distance from large mobile equipment until eye contact is made or approval obtained from the equipment operator. The procedures should also require that the equipment operators check all mirrors prior to moving equipment and ensure that all persons are clear. They should sound the horn to warn unseen persons that the equipment is going to move. All employees should be trained and knowledgeable regarding these procedures.
