# NATIONAL TRANSPORTATION SAFETY BOARD

MATERIALS LABORATORY FACTUAL REPORT

Report No. 98-107

Place : East Moriches, New York  
Date : July 17, 1996  
Vehicle : Boeing 747-131, N93119  
NTSB No. : DCA96-M-A070  
Investigator : Al Dickinson

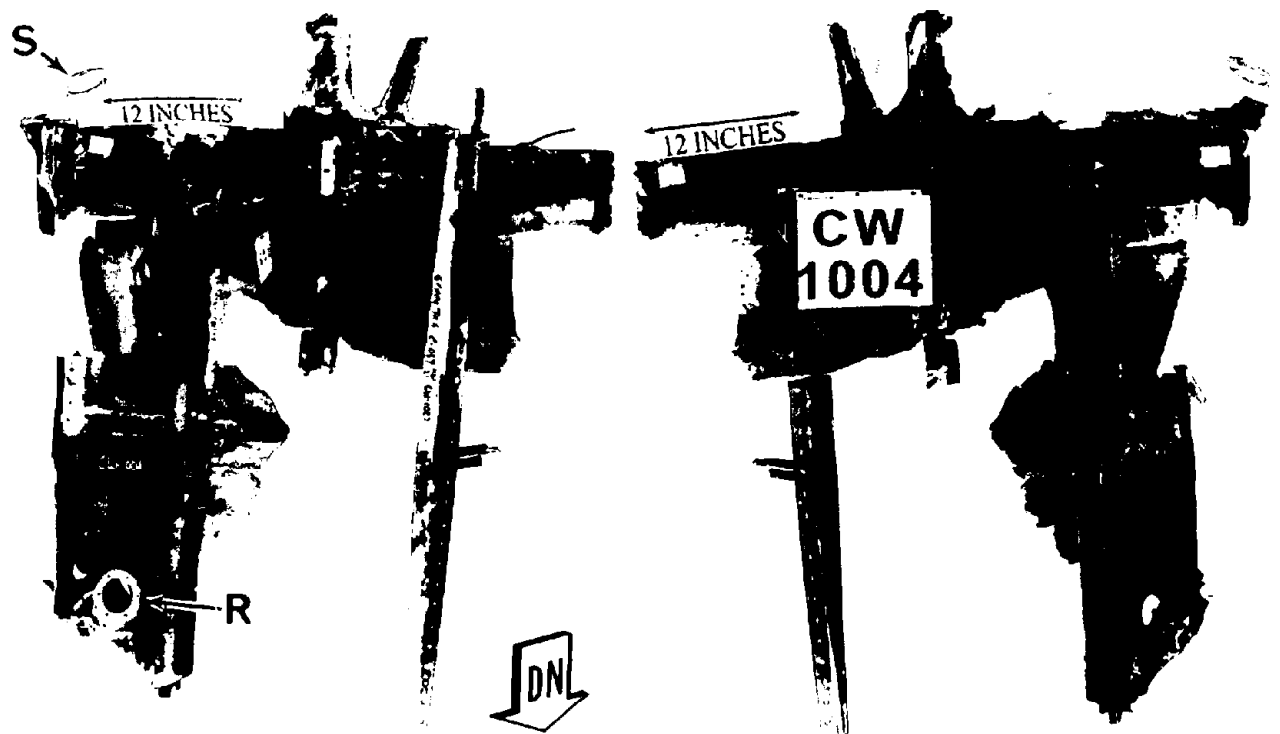
The spacer for the scavenge pump and aft spar fragment were delivered separated from each other to the Safety Board materials laboratory. A photograph of the as-received parts is shown in figure 1. According to the center fuel tank structures notes, titled "Rear Spar-Wing Center Tank, CW-1004, C-2139, -Green", the aft spar fragment was recovered with the spacer still attached to the aft face of the spar, with three screws and safety wires intact. Two of the three screws were not available for examination.

Figure 1. As-received fragment of the aft spar showing the aft face (left) and forward face (right). The spacer, arrowed "S", for the scavenge pump is shown hanging above the spar.

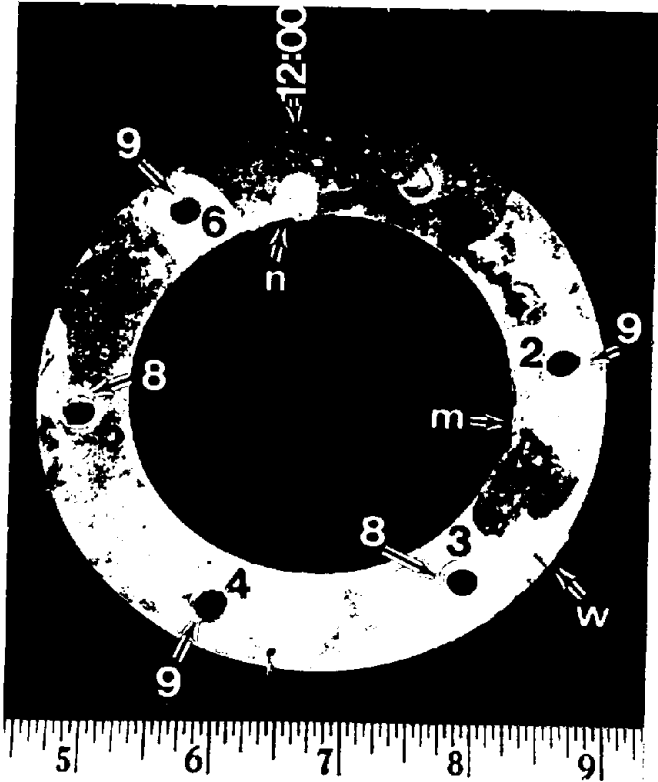
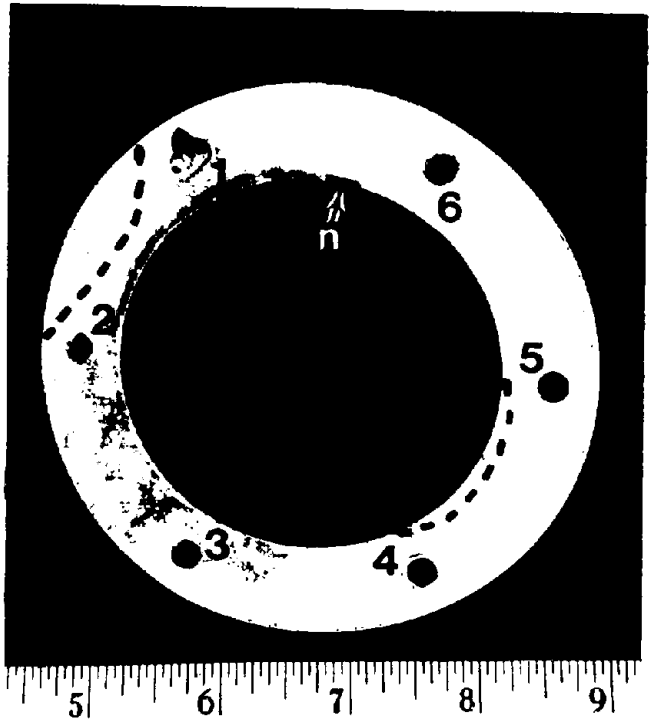
Figure 2 shows close-up photographs of the spacer, arrowed "S" in figure 1, for the scavenge pump. This spacer is manufactured with 6 screw holes, labeled "1" through "6" in figure 2. Screw hole "1" is located approximately in the 1 o'clock position looking forward. Each screw hole has a corresponding attachment hole for a safety wire.

Visual examination of the spacer revealed overall deformation (cupping and twisting) such that the forward and aft faces did not sit flush with the surface of a flat table or the mating aft surface of the aft spar, regardless of the orientation. A screw containing bending deformation in the thread portion was found partially inserted into hole "1" and, in turn, a safety wire was attached between the head of this screw and the spacer. Fragments of safety wire were found attached to the spacer adjacent to holes "4" and "5". The ends of all the safety wires showed evidence that they were cut.

The wall of screw holes "3" and "5" on the aft face of the spacer contained an impression mark from the threads of a screw in the areas indicated by arrows "8" in figure 2. The edge of screw holes "2", "4", and "6" contained deformation marks towards the outer diameter in the areas indicated by arrows "9" in figure 2. These deformation marks are consistent with the screws bending toward the outer diameter. A wall fragment of the spacer had separated in the area indicated by arrow "w" in figure 2. The fracture from this fragment intersected a hole for a safety wire. Also, the inside diameter face of the spacer contained mechanical damage in the two areas indicated by arrows "m" and "n" in figure 2.

The forward face of the spacer contained a crescent shaped discoloration between holes "1" and "2" in the area bound by a dashed line and the outside diameter in figure 2. Another crescent shaped discoloration was found between holes "4" and "5" that was bound by a dashed line and the inside diameter in figure 2.

Figure 2. Overall view of the aft face (top) and forward face (bottom) of the spacer for the scavenge pump.

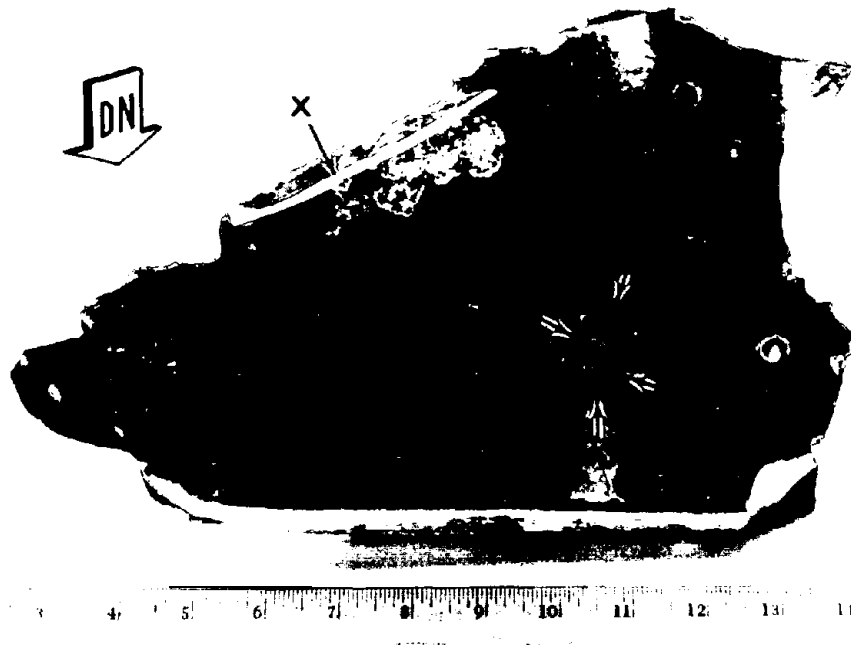
Figure 4 shows a photograph of the forward face of the bent portion of the spar after it was excised. The bottom end of this piece contained a portion of the lower spar cap that was coated with a layer of black sealant. A layer of sealant was found torn off the forward face of the cap in the area bound by unmarked arrows in figure 4, exposing bare metal surface. The bare metal surface contained random oriented gouge marks. The position of these gouge marks on the bent portion coincide with the installed location of the receiver housing. No fragment of the housing for the receiver was found attached to the aft spar and cap.

Figure 4. Close-up view of the excised bent portion of the aft spar showing the forward face which was not visible prior to excising. Cut end is indicated by arrow "X".

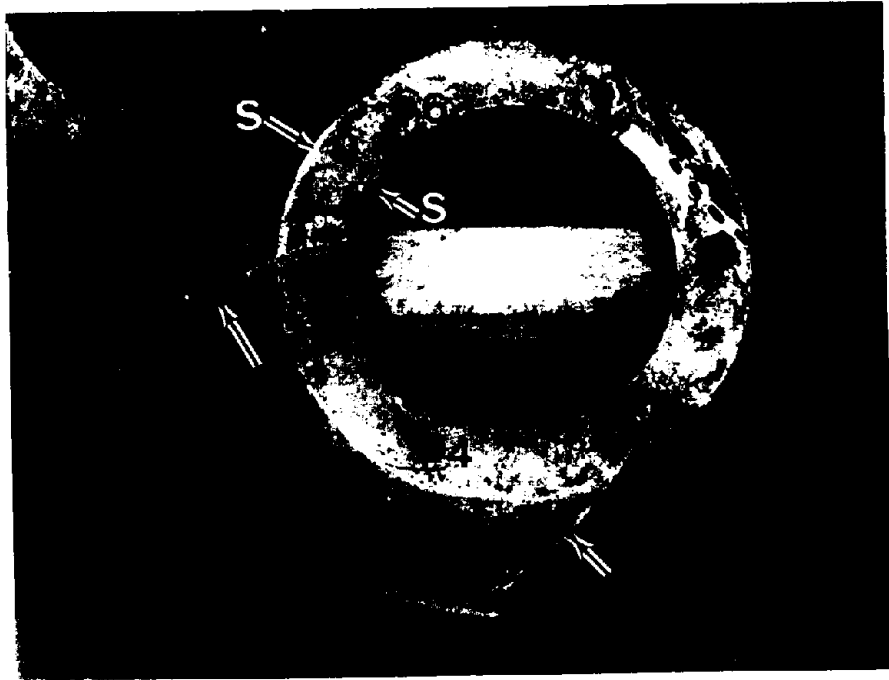
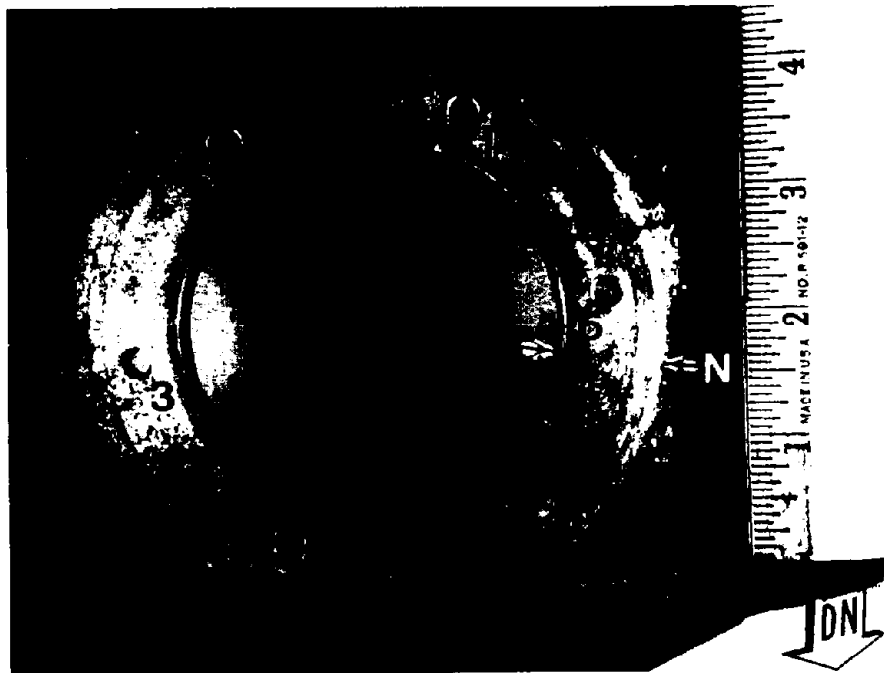
The aft face of the spar in the area of the attachment hole for the scavenge pump contained an outline pattern of the spacer between arrows "S" in figure 5. The area located outside this pattern contained a heavy deposit of dirt and soot. The region inside the outline pattern contained a crescent shaped discoloration between holes "1" and "2", in the areas bound by a dashed line and the outside diameter in the upper photograph of figure 5. Similar discoloration was found between holes "4" and "5", in the areas bound by

a dashed line and the inside diameter in the upper photograph of figure 5. These crescent shaped discoloration marks correspond to those found on the forward face of the spacer in figure 2. Further, the screw holes on this spar contained deformation and thread marks consistent with those found on the spacer. Two gouge marks in the shape of an arc were noted on the aft face of the spar in the areas indicated by unmarked arrows in the upper photograph of figure 5. One of these marks intersected screw hole "3" and the other nearly intersected screw hole "5".

The forward face of the spar in the area of the attachment hole for the scavenge pump contained an outline pattern of the receiver mounting flange between arrows "N" in the lower photograph of figure 5. The forward face of the aft spar in the area of the attachment hole contained a crescent soot mark between holes "1" and "2" (see area bound by a dashed line and the outer diameter of the receiver mounting flange in the lower photograph of figure 5). The surface of the aft spar underneath the receiver mounting flange showed no evidence of sooting, except for the crescent soot mark noted earlier. The attachment hole for the scavenger pump contained no mechanical damage that corresponded to the two mechanical damaged areas found in the inside diameter of the spacer (indicated by arrows "m" and "n" in figure 2).

Figure 5. Overall view of the aft face (top) and forward face (bottom) of the aft spar in the area of the scavenge pump attachment hole. The number next to each screw hole corresponds to those on the spacer in figure 2.

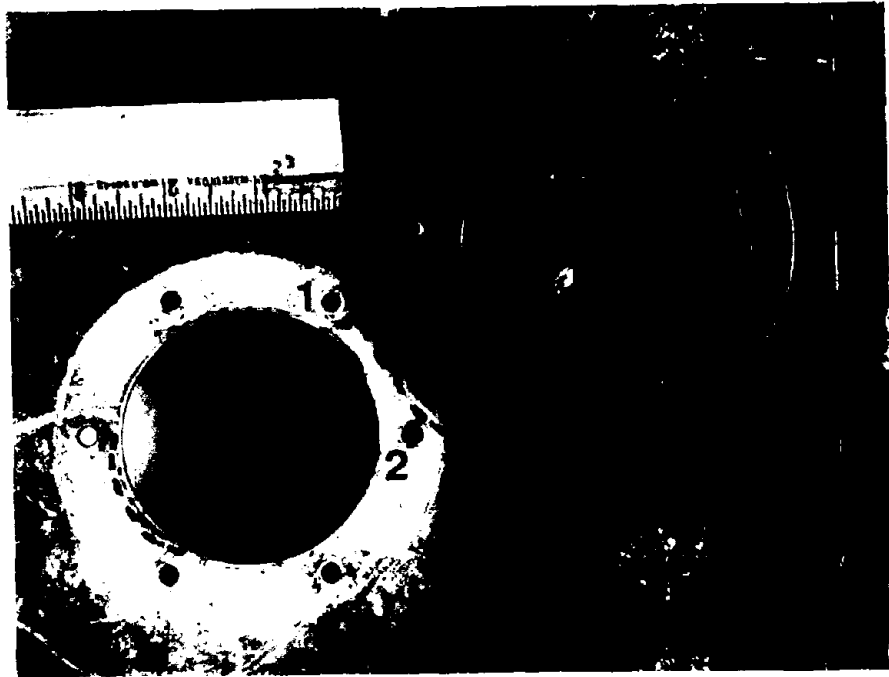
Figure 6 shows a photograph of the mating faces of the spacer and aft spar. Figure 7 shows a photograph of the spacer as if installed on the aft surface of the spar. As indicated earlier, the aft face of the spacer between the 9 and 1:30 o'clock position was covered with a dark deposit. The spar in the area above the spacer was also covered with the same dark deposit.

The orientation of the spacer and spar in figure 7 is consistent with the recovered position of the spacer, according to a photograph found in the center fuel tank structures notes. Examination of the photograph in the structures notes revealed screws were installed in holes "1", "3", and "5" in figure 6.

Figure 6. Mating surfaces of the spacer and aft spar.

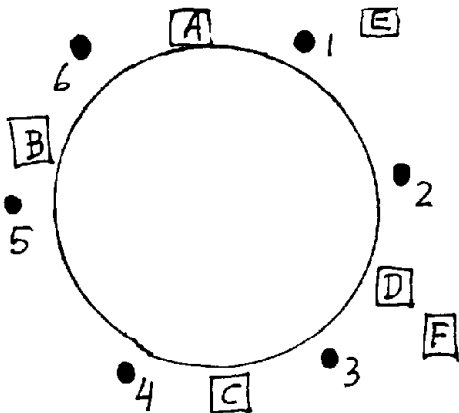
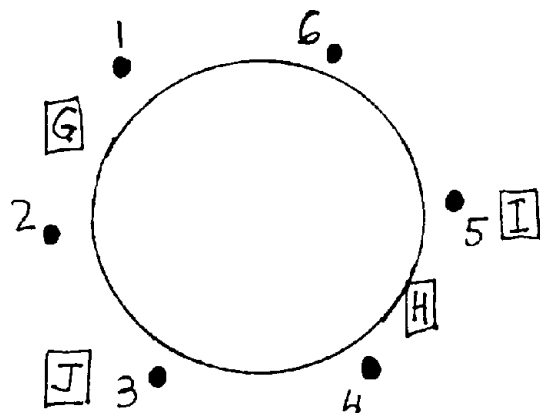
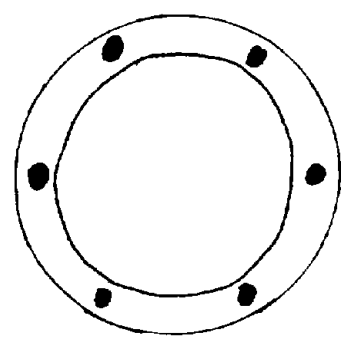
TABLE 1. EDDY CURRENT MEASUREMENTS

Conductivity measurements were made on the spacer and aft spar in the areas indicated in the sketch in Table 1. The conductivity measurements of the spacer and the aft spar were within BAC 5946 specified values (see Table 1). Rockwell hardness testing on the forward face of the spacer between holes "4" and "5" measured from 72 to 78 HRB, which was within the specified range (63 to 83.5 HRB).

<p>AFT SURFACE OF AFT SPAR</p>	<p>7075-T6 Aluminum alloy (1.6Cu, 2.5Mg, 0.23Cr, 5.6Zn, % by weight, nominal)</p>	<p>30 - 35</p>	<p>A = 30.5                      B = 30.5                      C = 30.6                      D = 30.5                      E = 30.5                      F = 30.6</p>

<p>FWD SURFACE OF AFT SPAR</p>	<p>7075-T6 Aluminum alloy</p>	<p>30 - 35</p>	<p>G = 31.0                      H = 31.0                      I = 31.0                      J = 31.0</p>

<p>SPACER (FWD &amp; AFT SURFACE)</p>	<p>2024-T3 Aluminum Alloy (4.4Cu, 0.6Mn, 1.5Mg, % by weight, nominal)</p>	<p>28.5 - 32</p>	<p>All measurements were 29.0</p>
