REPORT OF INVESTIGATION

Fatal Machinery Accident
April 3, 2004

Mercer Deep Mine
Brooks Run Mining Company, LLC
Erbacon, Webster County, West Virginia
I.D. No. 46-08875

Investigative Report and Equipment Related Physical Factors for
a Fatal Accident at
Brooks Run Mining Co., LLC
Mercer Deep Mine
April 3, 2004

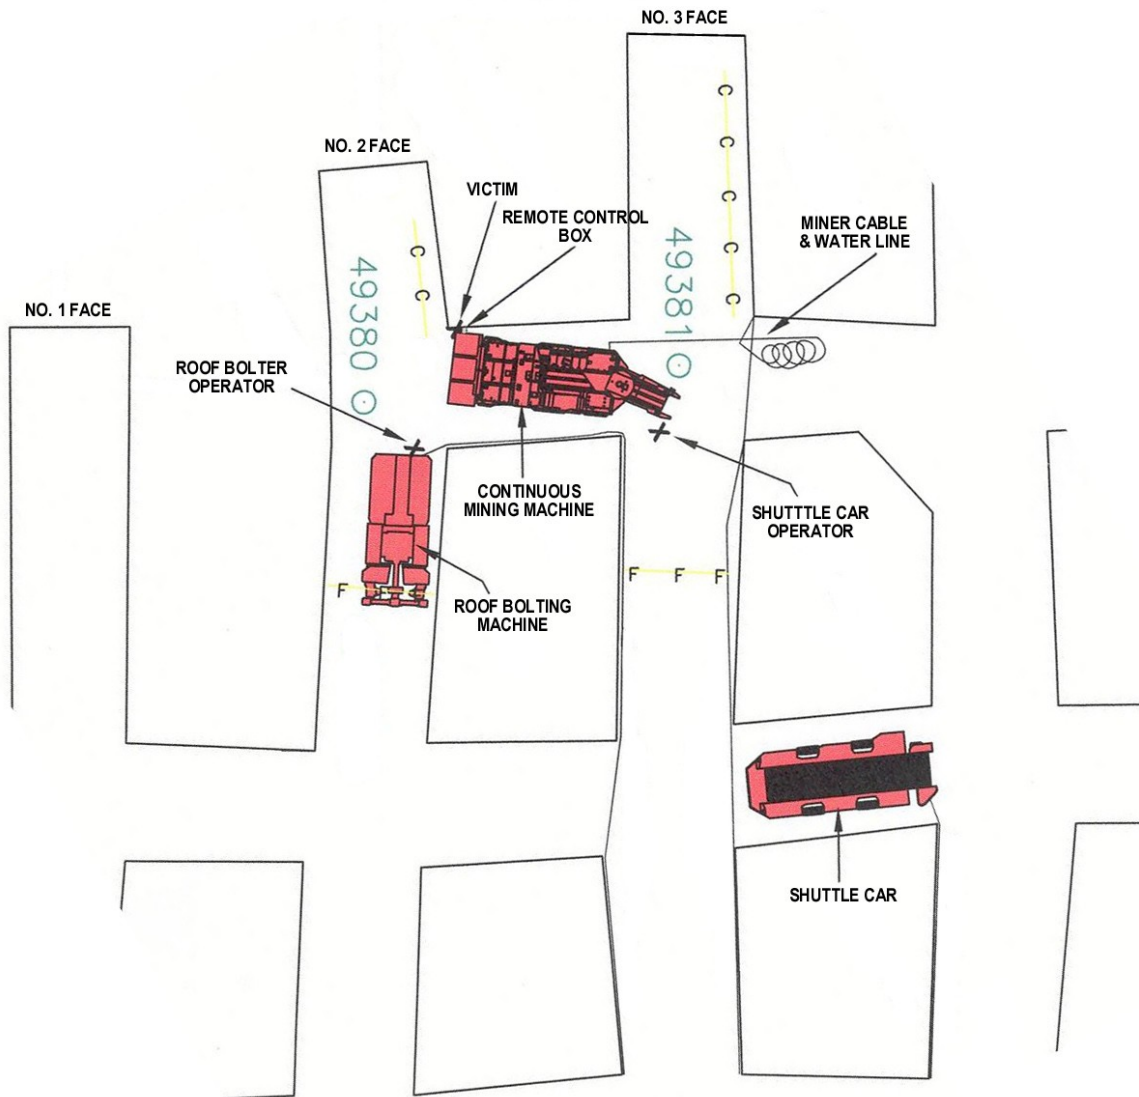
Fatal No. 7
 April 3, 2004
 Brooks Run Mining Company LLC
 Mercer Deep Mine
 46-08875

At 11:40 p.m., on Saturday, April 3, 2004, a 47-year old continuous mining machine operator with 29 years of mining experience was fatally injured at the Brooks Run Mining Company, LLC's Mercer Deep Mine. The accident occurred while William Brady, Continuous Mining Machine Operator, was tramming the continuous mining machine in high speed through the No. 3 left crosscut. Brady was positioned in a hazardous location and was pinned between the ripperhead of the continuous mining machine and the right (inby) coal rib of the No. 3 left crosscut.
