**NATIONAL TRANSPORTATION SAFETY BOARD**

**OPERATIONS GROUP FACTUAL REPORT**

**DCA 08 FM 002**

On Saturday, November 3, 2007 at approximately 0143 (EDT) the 819-foot, 62929 gross ton Bahamas-registered tank ship *Axel Spirit*, carrying a cargo of 441,000 barrels of Maya crude oil from the Petroleos Mexicanos (PeMex) marine oil complex in Cayo Arcas, Mexico to the Chevron facility in Perth Amboy, New Jersey, allided with Ambrose Light at the entrance to New York Harbor.

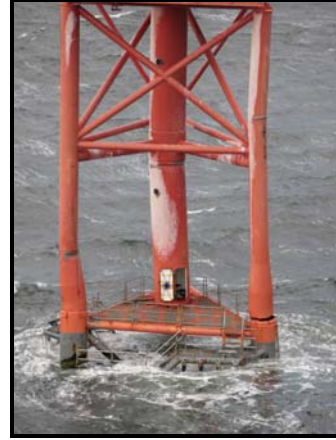
Fig 2. Ambrose Light (Post Allision)<sup>3</sup>

At 0143 the *Axel Spirit* struck Ambrose Light, causing extensive damage to the tower structure and the rotating beacon. The vessel incurred damage to its sideshell and internals above the waterline and at the turn of the bilge on the starboard side. Various accounts of the incident from each of the bridge team members described the close encounter with Ambrose Light. Some felt a vibration and others stated they saw a very bright light. Just prior to contact, the master gave a left rudder order to maneuver the vessel away and then, when Ambrose Light was close alongside amidships to starboard, he gave a right rudder order to swing the stern away.

The significant damage to the support structure of Ambrose Light and the rotating beacon had gone undetected by other vessels in the area and the pilot boat *New York* for 1 hour and 32 minutes after the allision. At 0315, the mate serving in the 0001 to 0600 watch rotation on board the *New York*, which was still positioned in the precautionary area near Ambrose Light, noticed that the aid to navigation (ATON) was not functioning properly and reported the discrepancy to VTS New York personnel.<sup>57</sup> The VTS New York watch supervisor immediately acted upon the report and began broadcasting a safety broadcast notice to mariners (BNTM) via channel 16, VHF radio, which informed local mariners monitoring the radio of the reported discrepancy, and urged caution while transiting the area.<sup>58</sup> Due to the darkness, increasing winds and unfavorable sea conditions brought about by the remnants of Hurricane Noel passing the area offshore, immediate verification of the status of Ambrose Light could not be safely performed by U.S. Coast Guard assets.

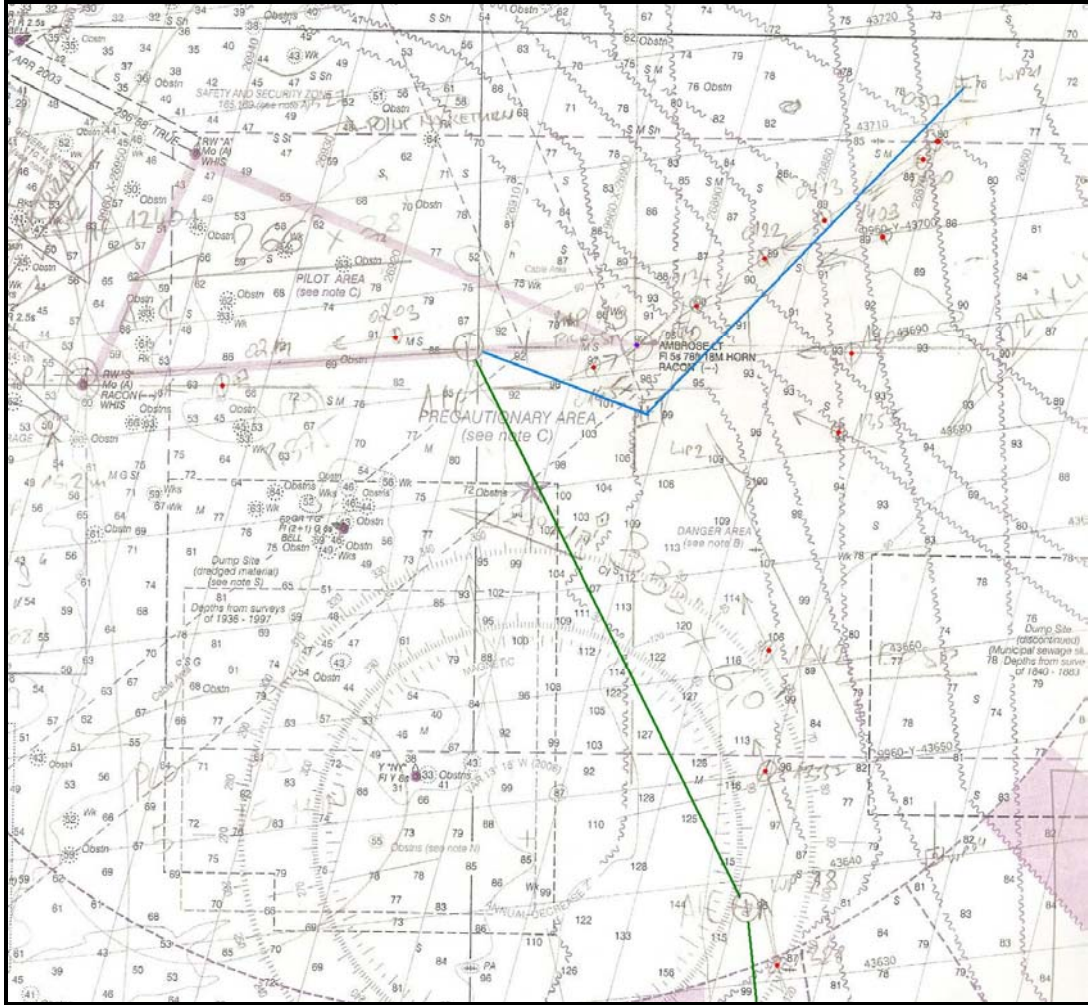
According to the passage planning procedure found in the SMS, this diversion from the original and agreed upon waypoints identified in the passage plan required the Master to initiate a revision or amendment to the passage plan.<sup>15</sup> The SMS requirement to amend the passage plan when such deviations occur is also restated on the waypoint check list form within the actual passage plan created for the voyage from Cayo Arcas, Mexico to the Chevron facility at Perth Amboy, New Jersey. A special note on that form addresses the exact scenario, which occurred with the diversion of the *Axel Spirit*. The note states, "*closely monitor execution of the passage plan and amend it if any way points are changed (e.g. vessel proceeding to anchorage instead of picking up pilot)*".<sup>16</sup> No such amendment or revision to the passage plan was initiated by the master or completed by the second officer for either the transit from waypoint #18 to the anchorage area, or for the shift from the vessel's position at anchor to the Pilot Area. At some time after the allision, the Second Officer laid down on the vessel's chart the revised intended track line of the vessel for the segment of the voyage from the vessel's position at anchor to the Pilot Area (Shown by the blue line in Figure 4). He also generated an amended waypoint check list form, signed it and inserted the form into the original written passage plan. During an interview with the Second Officer, he stated the last discussion regarding the approved written passage plan and navigational chart occurred prior to the vessel's arrival from Mexico and that on the night of the incident, "*No, it was not discussed. There was no time to discuss.*"<sup>17</sup>

**Fig 4. Extract of Navigational Chart 12326 from the *Axel Spirit* with color enhancement added. Intended track line per the vessel’s passage plan is overlaid in green, with waypoints #18 and #19 marked using small circle to intersect track line. The amended track line placed on the chart by the second officer after the vessel’s allision with the Ambrose Light is overlaid in blue. Actual position fixes taken by the second officer on the 1200 to 1600 watch on November 2, and on the 0000 to 0400 watch on November 3, have been identified on the chart extract using a red dot.**
