Investigation Report 474/06

Serious Marine Casualty

**Collision of CMV KLENODEN
with CMV HANJIN CAIRO
on 9 September 2006
in Hamburg**

15 July 2007

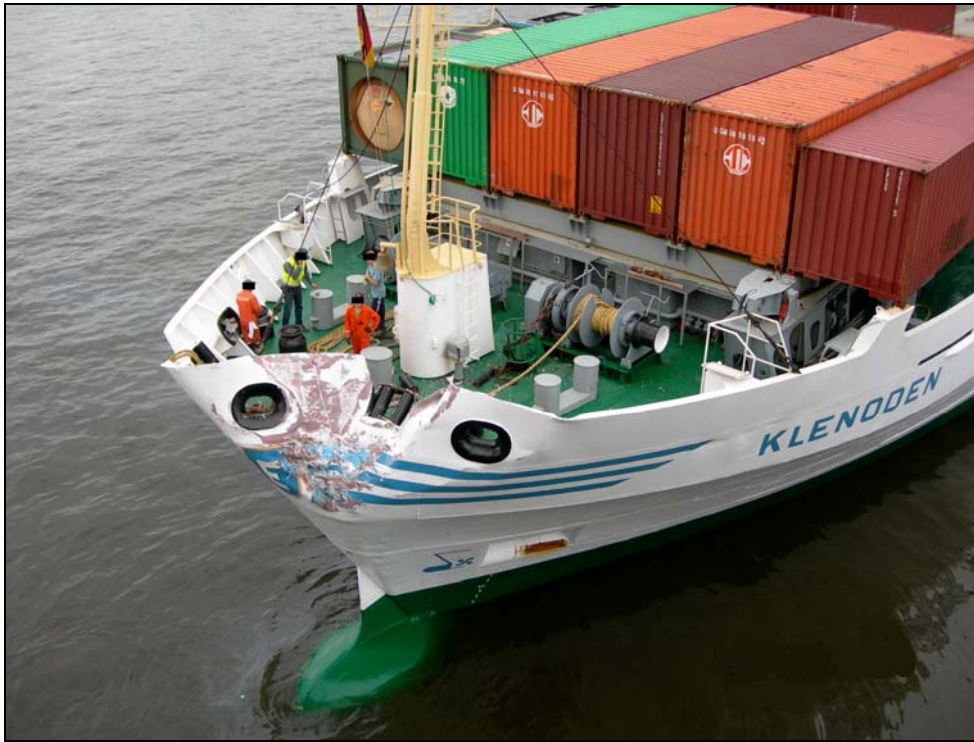
Figure 6: Damages on the stem and foremast of KLENODEN

KLENODEN was heavily incised by the collision in the area of the stem at a length of about 8.5 m and a height of about 3.6 m, and the foremast was bent (see fig. 6).
