Pipefitter Burned When Soldering Torch Fails

Issue Number 2006-13, Article 2: Pipefitter Burned When Soldering Torch Fails

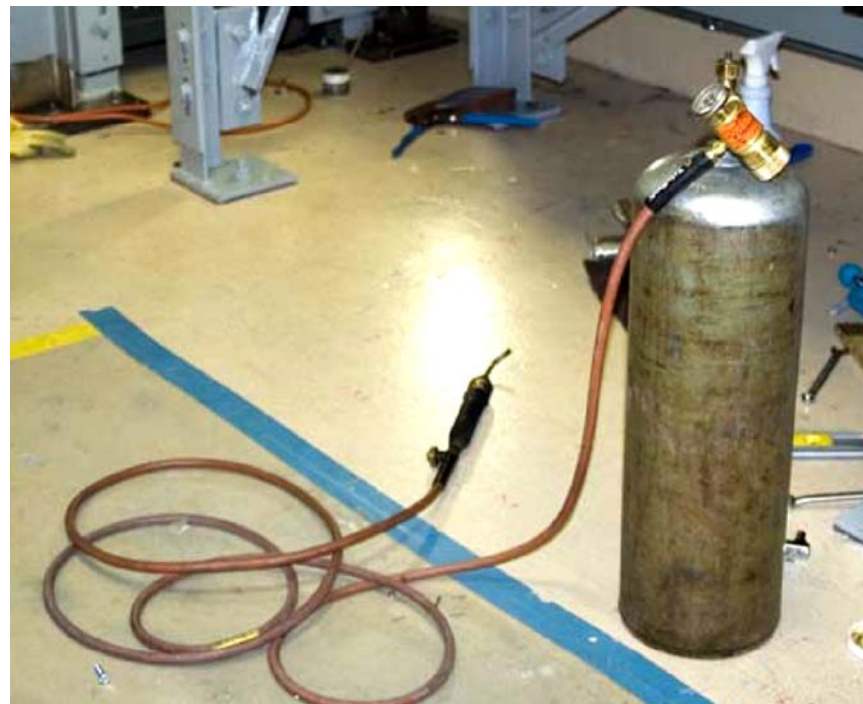
Figure 2-1. Acetylene bottle, regulator, hose, and torch head

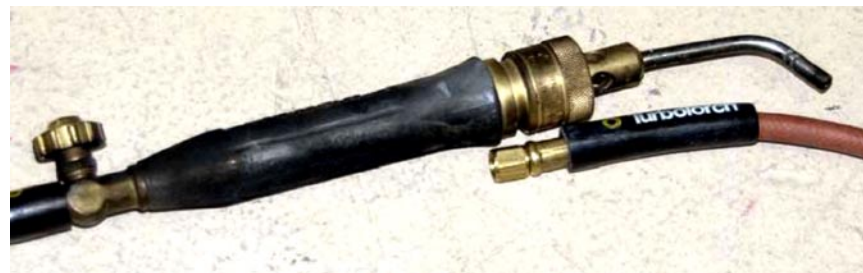
Figure 2-2. Torch head and hose connection to the acetylene bottle

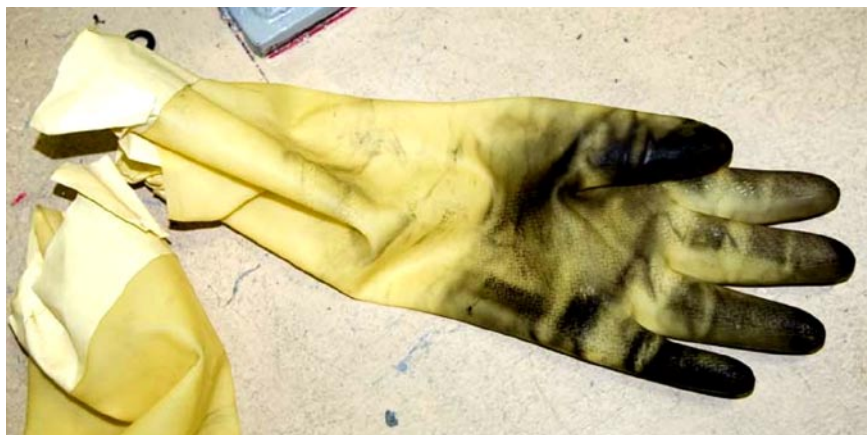
When the pipefitter pulled off his surgeon's gloves, he saw that the left glove was blackened, but had not failed (Figure 2-3), and the right glove was not significantly marked. Investigators believe the burns on the thumb, middle, and little finger of the pipefitter's left hand were caused by sweat in the glove that was turned to steam by the heat of the flames.

Figure 2-3. Pipefitter's blackened left glove

The KSL team also determined that the PPE used for the job was inadequate in that only surgeon's gloves were being worn for radiological protection, rather than leather or flame-retardant gloves, which would provide thermal protection. Although LANL's implementing requirement for PPE required the use of gloves to protect against potential tissue burns, KSL's procedure for gas welding and cutting did not include a requirement for leather or flame-retardant gloves during soldering. KSL will modify their procedure to include this requirement.

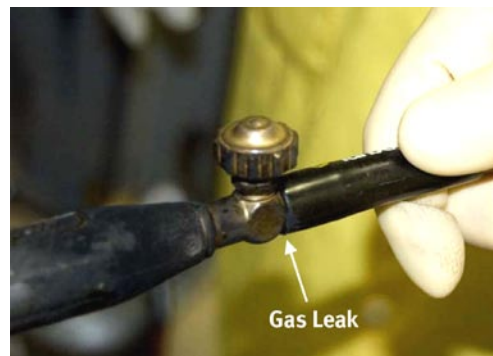
KSL management appointed a team to investigate the incident. They determined that the incident was caused by a loose hose connection on the torch head that allowed acetylene gas to escape and ignite (Figure 2-4). The hose connection did not have an engineered locking device to ensure the integrity of the connection.

The TurboTorch manufacturer's instructions required performing a leak test and tightening any loose connections, but those instructions were not included in the KSL work instructions.

Because the torch lacked an engineered locking device at the hose connection, the manufacturer-recommended controls were inadequate to prevent recurrence of this type of failure.

Figure 2-4. Closeup of hose connection at torch valve torch

The KSL general manager directed that all torches of this design (i.e., single-hose, air-acetylene) be removed from service. Two-hose oxyacetylene or disposable propane bottle torches will be used instead.

KSL will also modify their procedure for preparation and control of KSL work instructions to ensure that appropriate manufacturer's requirements, LANL and regulatory requirements, and specific equipment and tools are included in the development of work instruction procedures. In addition, KSL has decided to switch from copper piping to stainless steel piping, which is joined by orbital welding, thus eliminating the need for high-temperature brazing.

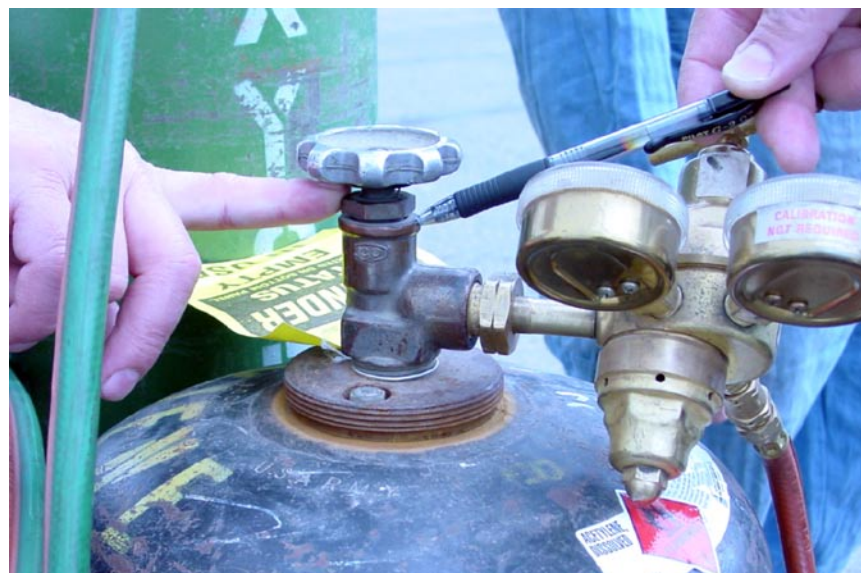
- On April 6, 2004, at the Idaho National Laboratory, a worker felt heat through his glove and noticed a small flame as he attempted to close the isolation valve on an acetylene bottle following oxy-acetylene cutting. The flame originated between the valve stem and the packing nut (Figure 2-5). Investigators identified several other oxy-acetylene torch systems that leaked either at the valve-stem packing nut or at the regulator threads. The gas-bottle vendor stated that occasional packing-nut leaks on acetylene bottles can be expected. Investigators recommended testing the systems for leaks. (ORPS Report NE-ID--BBWI-SMC-2004-0003)

Figure 2-5. Fire originated between the isolation valve and packing nut
