**FEDERAL AVIATION ADMINISTRATION  
AIRWORTHINESS DIRECTIVES  
SMALL AIRCRAFT, ROTORCRAFT, GLIDERS,  
BALLOONS, & AIRSHIPS**

**BIWEEKLY 2004-01**

**Biweekly 2004-01**

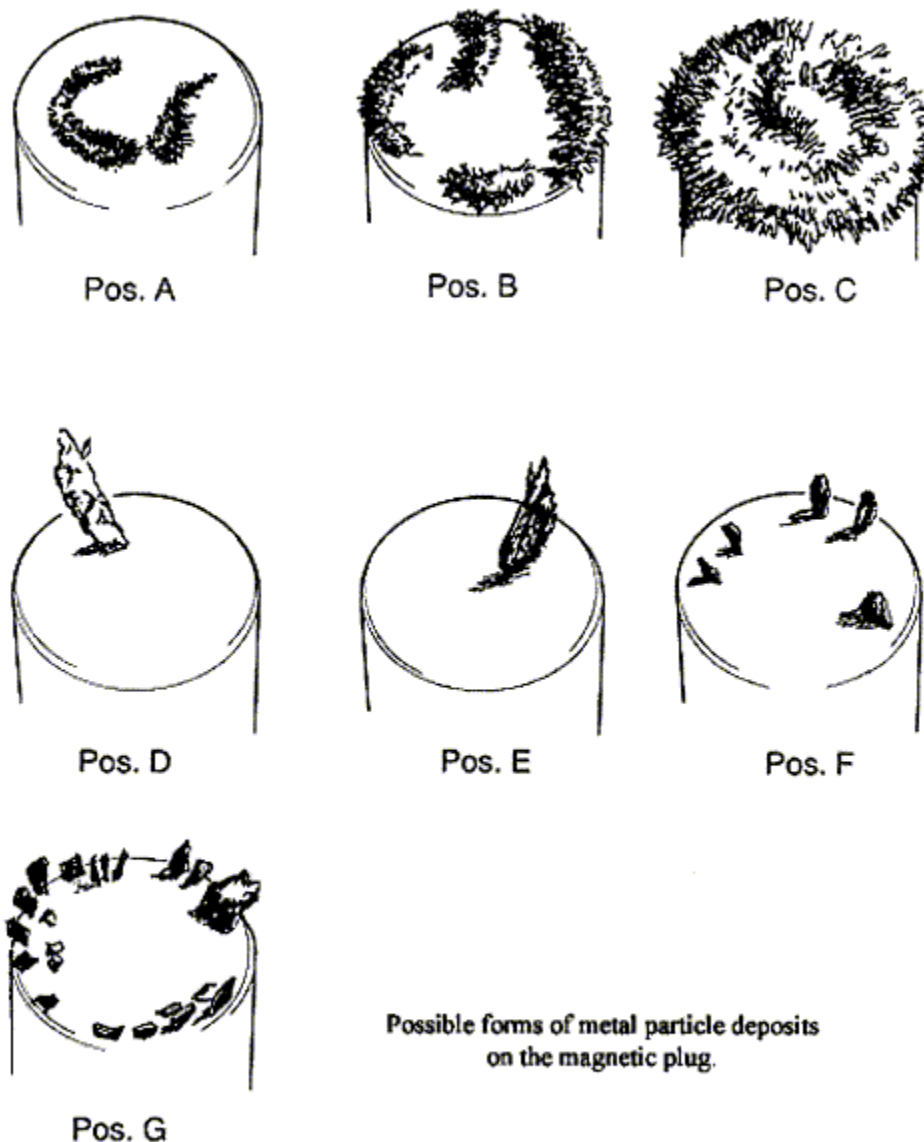
(a) Until you do paragraph (b) of this AD, before the first flight of each day, inspect the magnetic plugs of the TR transmission and INT gearbox for metal particles deposits by reference to Figure 1 of this AD.

(1) If you find a small amount of fine fuzz as shown in "Pos. A" of Figure 1 of this AD, clean the magnetic plug and reinstall it after ensuring that the O-ring is correctly positioned and there is no other damage.

(b) No later than February 23, 2004, replace bearing, P/N 4639310006 with S/N 3246 through 3598, with an airworthy bearing or replace the affected TR transmission or INT gearbox with an airworthy TR transmission and INT gearbox that does not contain the affected bearing.
