## Coal Mine Fatal Accident 2003-15

Operator: Cody Mining Company, Inc.  
Mine: # 1 Mine  
Mine I.D. No. 15-17373  
Accident Date: June 13, 2003  
Classification: Explosives  
Location: District 6, Floyd Co., Kentucky  
Mine Type: Underground  
Employment: 12  
Production: 150 tons/day  
Seam Height: 32 inches  
Mining Method: Conventional (Solid Blasting)

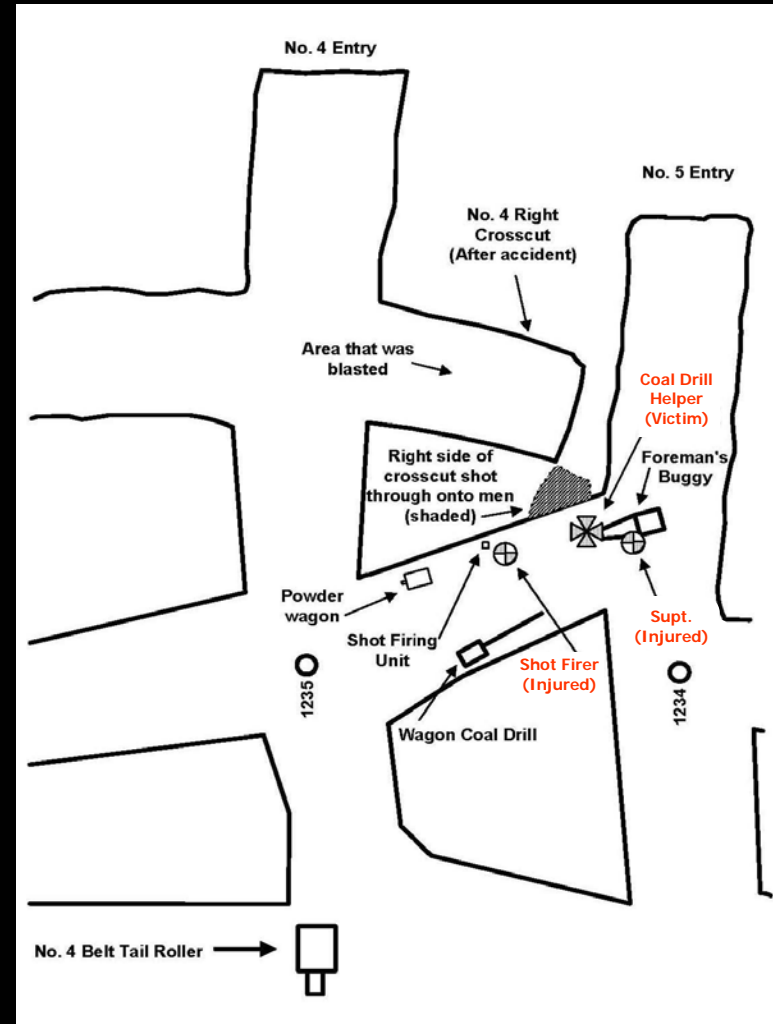
- A 21-year-old Coal Drill Helper with 2-yrs total mining experience was fatally injured when the working face of a crosscut was blasted into the next outby crosscut.
- Two other miners were also injured in this accident, one of them seriously.
- The victim and his co-workers had retreated to the last open crosscut to set off the shot when the accident occurred.

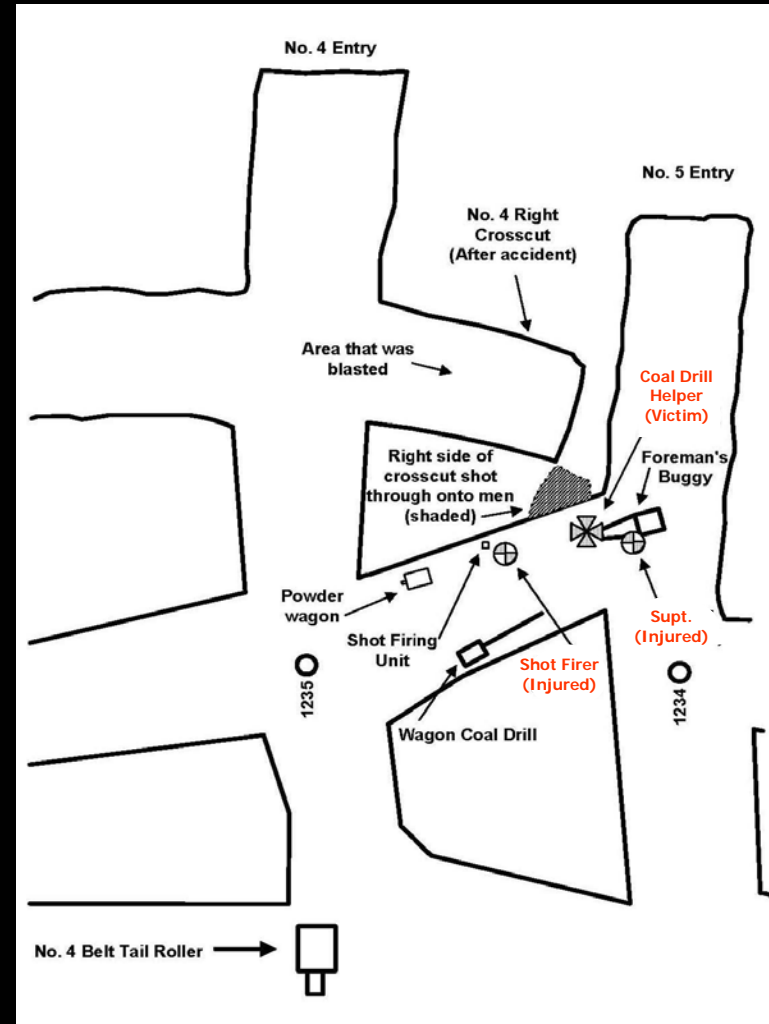
- The entries & crosscuts of the working section were driven off-centers, resulting in the 4 Right crosscut blasting into the outby crosscut.
- The cause of the accident was the failure to maintain proper sight lines and centers, the failure to conduct adequate preshift examinations, and excessive entry and crosscut widths.

- Causal Factor: A sightline or other method of directional control to maintain the projected direction of mining was not being used.
- Corrective Action: Mine management should ensure that a sightline or other methods of directional control is utilized in all entries, rooms, and crosscuts to maintain proper centers and direction of mining.

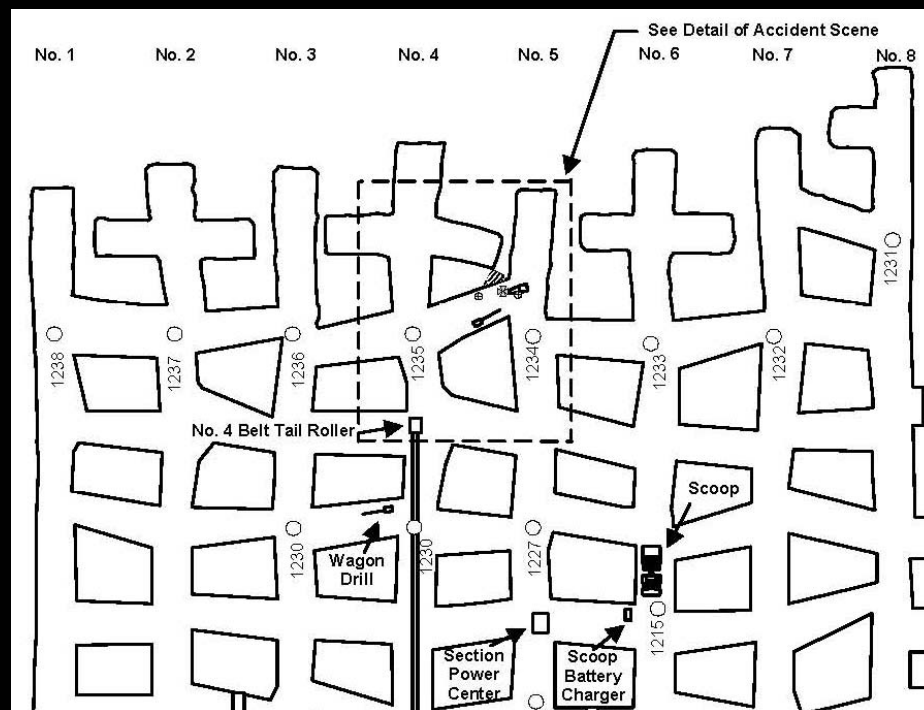
- Upon arriving on the section, the Superintendent and Coal Drill Helper started drilling in the 1 Entry working face while others used scoops to load coal from the 6 Left face.
- Prior to the accident, the following additional working faces were also drilled for blasting: 2 Left Crosscut, 2 Entry, 2 Right Crosscut, 3 Entry, 4 Left Crosscut, 4 Entry, and 4 Right Crosscut.

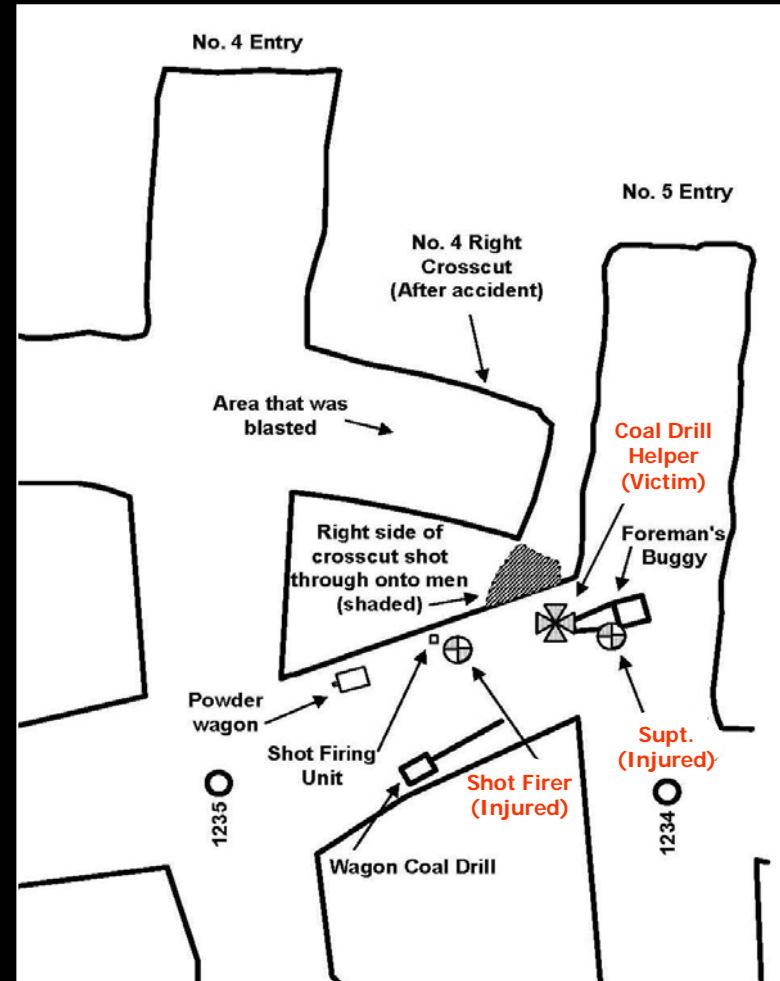
- At approximately 12:30 p.m., 3 working faces in the 4 Entry were ready to be blasted.
- The Shot Firer detonated the 4 Right Crosscut after receiving the "all clear" signal from the Supt., who had also been performing duties as drill operator.
- The shot broke through into the outby crosscut where the Shot Firer, Supt., & Coal Drill Helper were located.

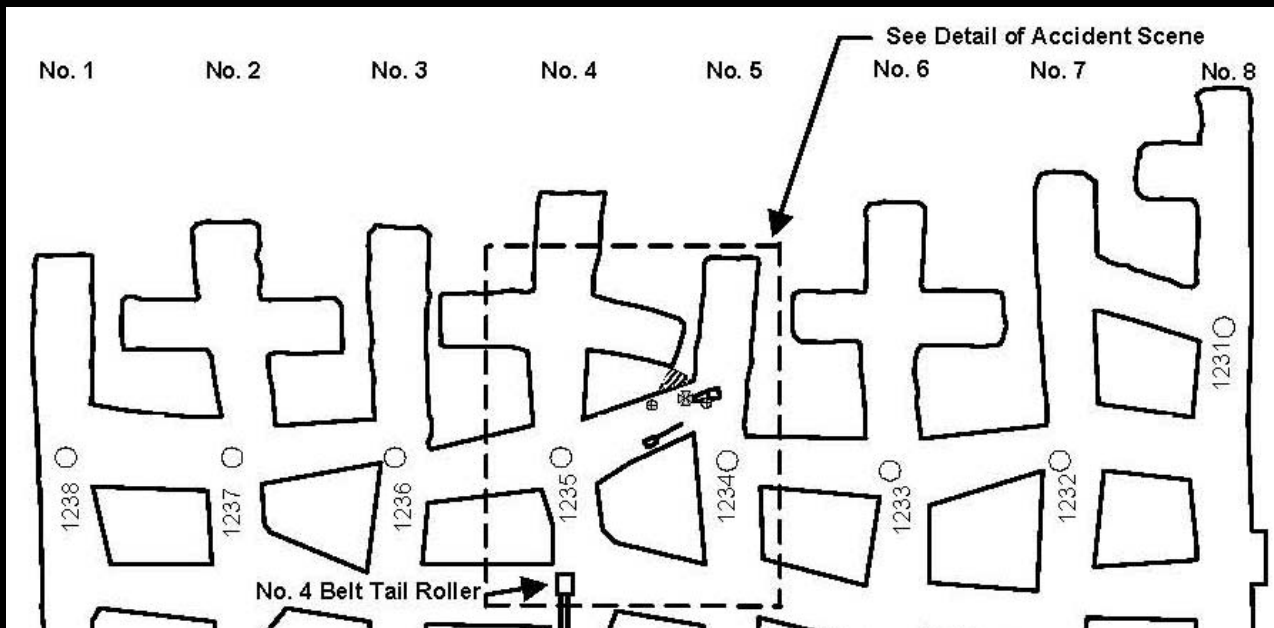
- The Shot Firer crawled over to the 6 Entry to obtain help from the roof bolting crew.
- A Roof Bolting Machine Operator responded to the accident site, where he found that the Coal Drill Helper had been fatally injured and that the Superintendent was seriously injured.
- Other miners also responded and the surviving injured miners were transported to the surface.

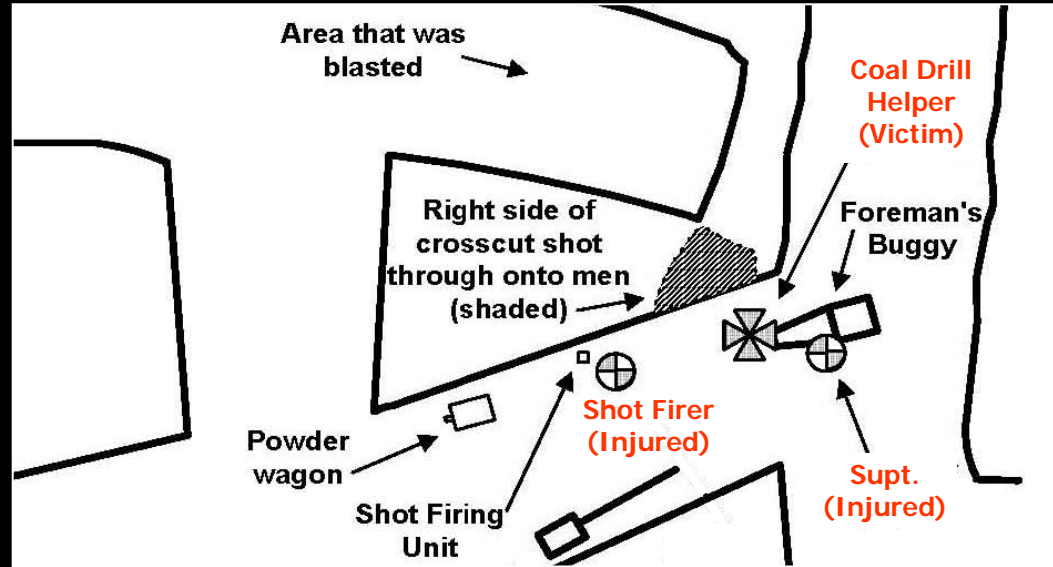
- An excessive amount of explosive was used in the holes drilled for blasting, which further increased the danger of shooting into an adjacent area.
- A non-permissible coal drill, equipped with a 12' auger, was being used to drill blast holes into the working faces.
- The 12' hole depth placed the explosive charge close to an adjacent mine opening, permitting the unplanned release of energy from the detonated explosives into the area occupied by the injured miners.

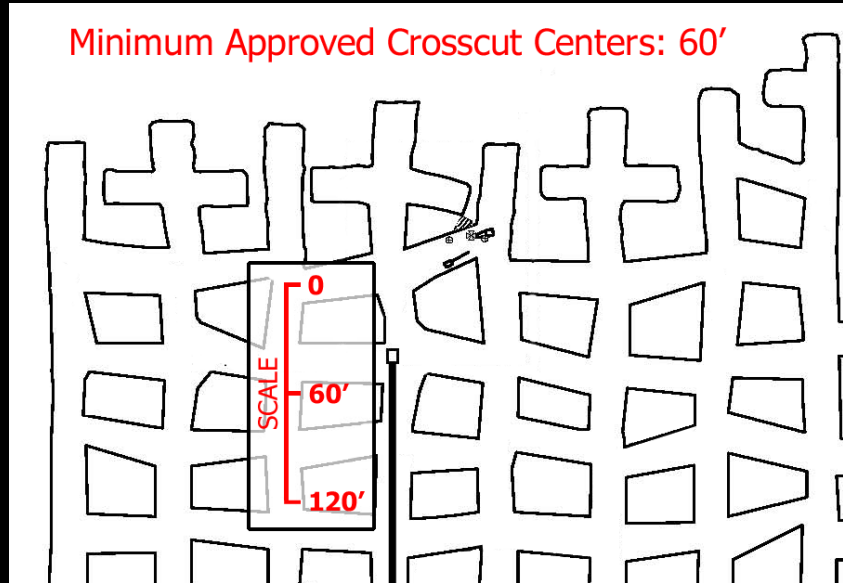
- The operator was not complying with the approved roof control plan.
- Crosscuts in all 8 entries of the working section were driven on centers of 30-40'.
- The approved roof control plan specifies minimum crosscut centers of 60-80'.
- The reduced crosscut centers reduced the size of the pillars, contributing to the accident.
