LIGHTNING SUPPRESSION AT TELEMETERED TRAFFIC MONITORING SITES (TTMS)

Bruce A. Harvey, Ph.D.

Dept. of Electrical and Computer Eng.

FAMU-FSU College of Engineering

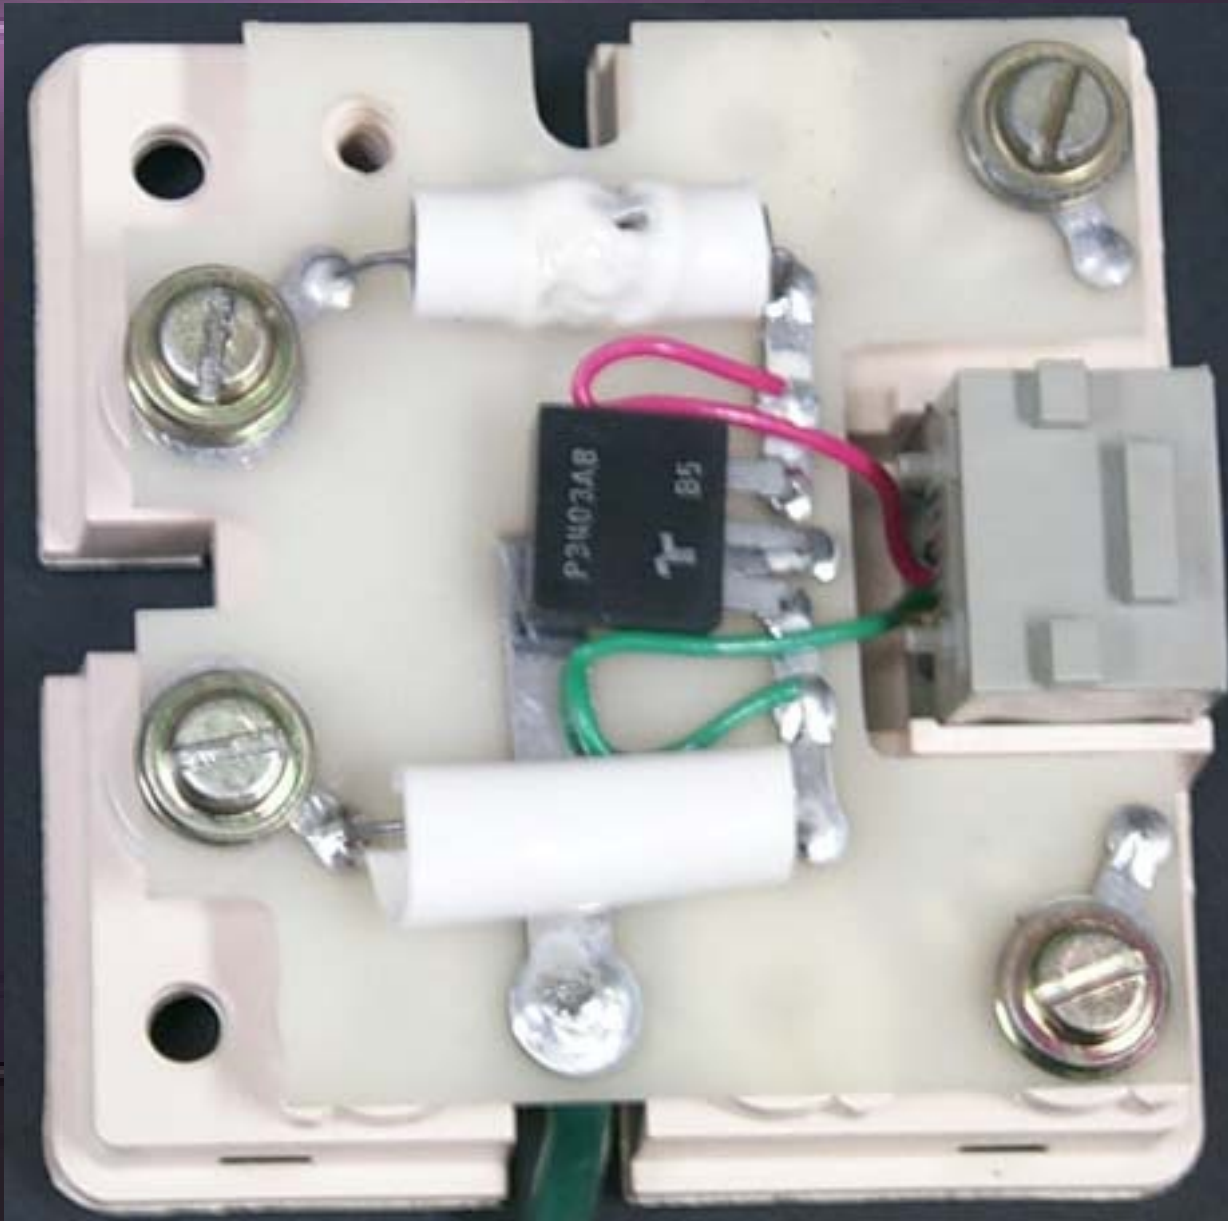
Typical Failed Surge Suppressor

- Early Surge Suppressors had Fuses Blown
- Most Times the Blown Fuse was the Only Damage Noted (>75% Failures Due to Fuse)
- Occasionally Catastrophic Damage
- Newer Devices:
 - Gas Tubes – More Reliable than Fuses, Fast
 - Resettable Fuses – Slow, for Safety
 - Sidactor – Solid-State Voltage Limiter, Very Fast
Now the Likely “Weakest Link”
- None of the Newer “Failed” Suppressors Not Working

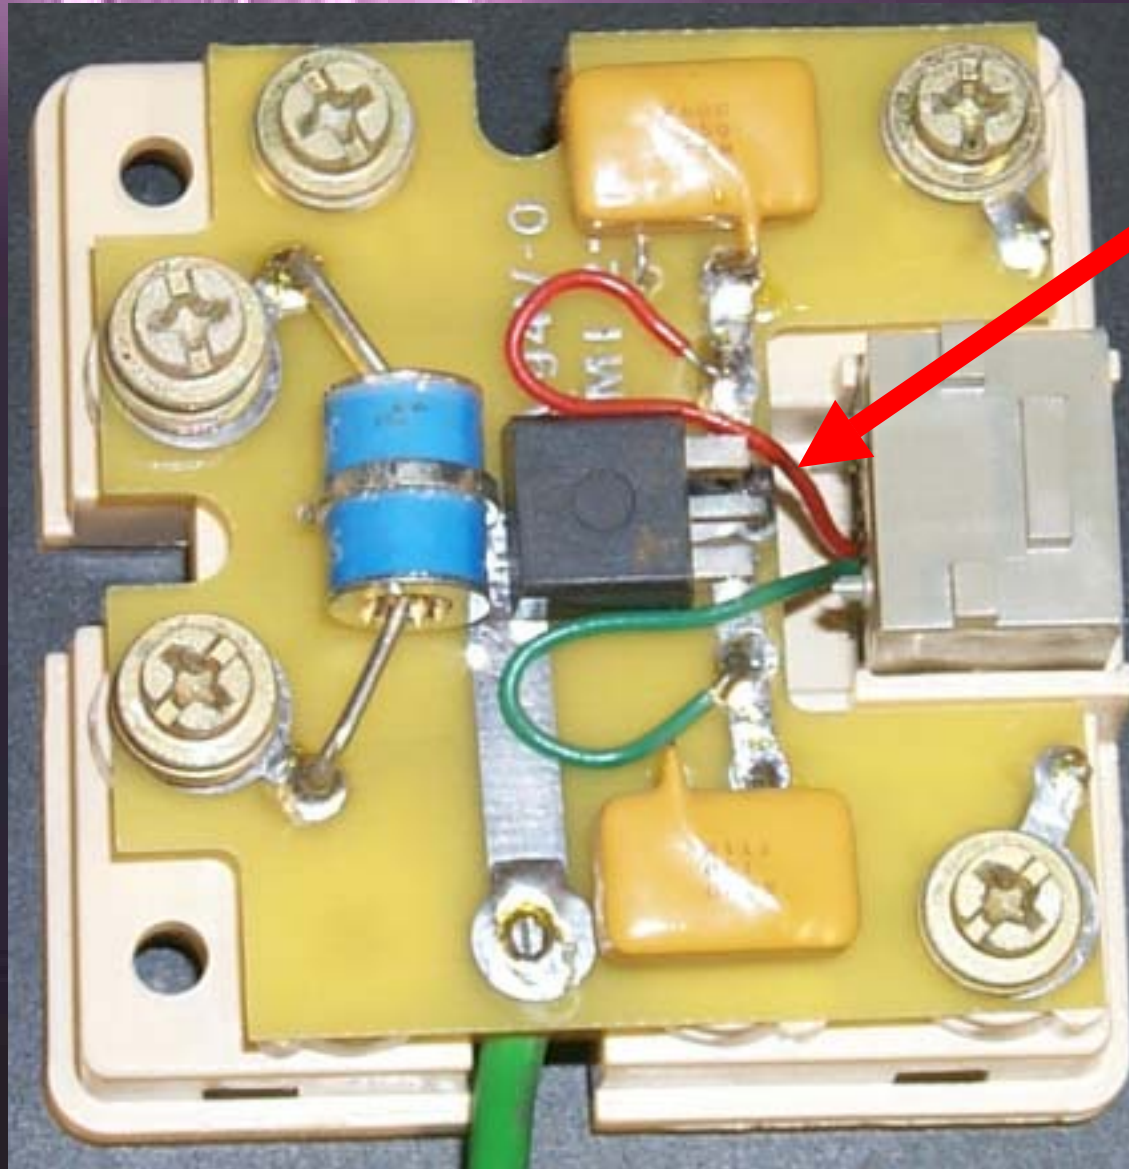
Typical Failed (?) Surge Suppressor

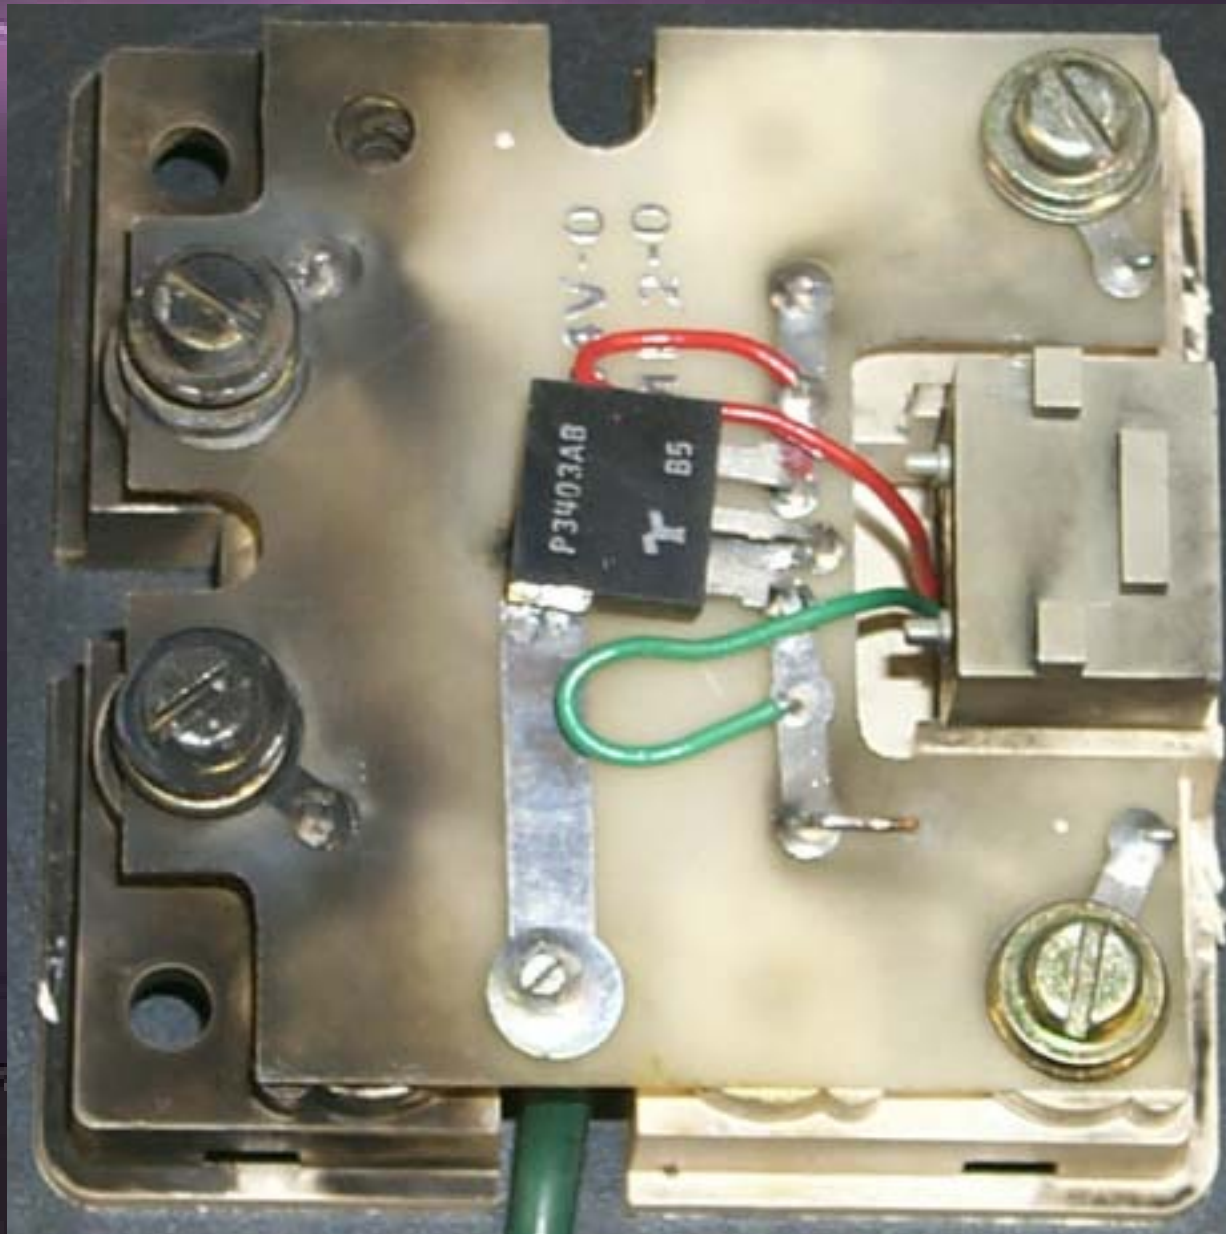
Atypical Failed Surge Suppressor

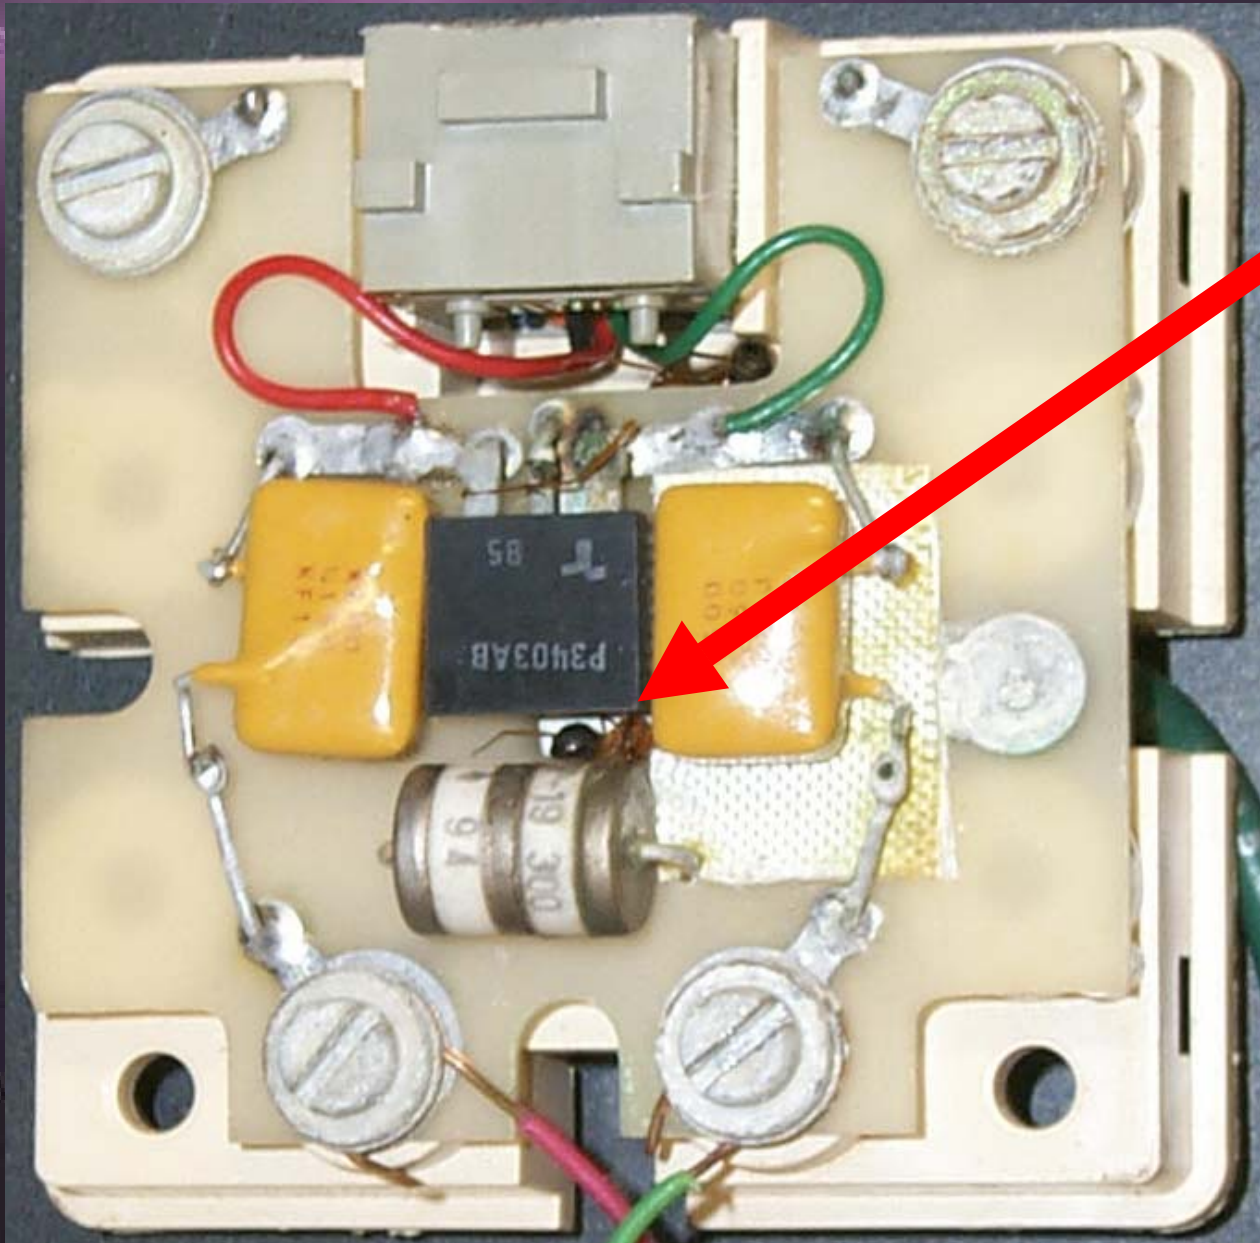
Other Surge Suppressor Hazards

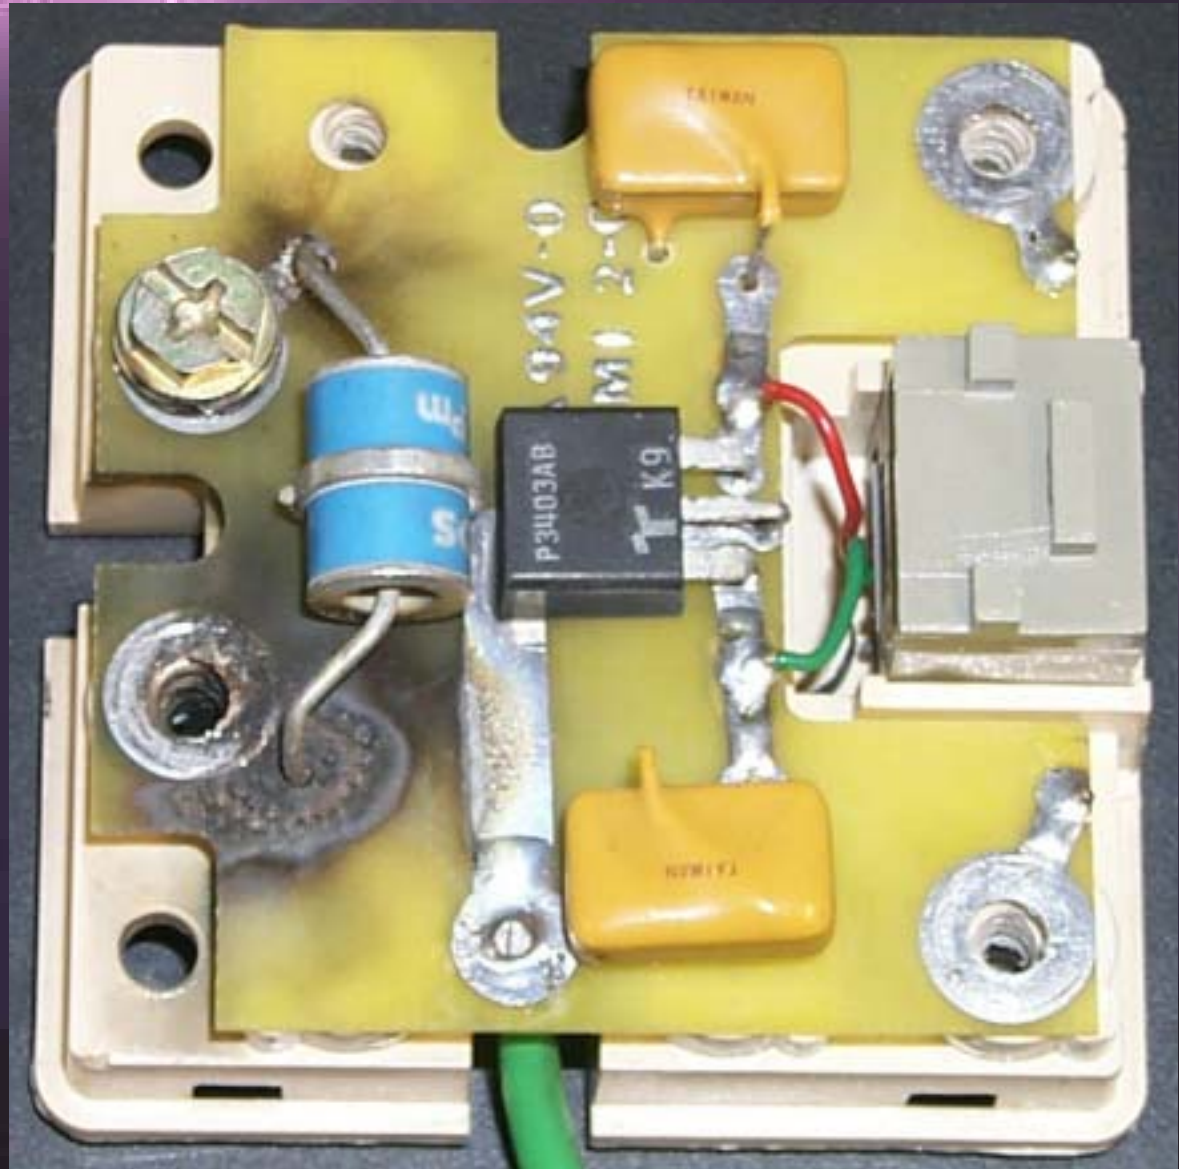
Coupling of Surges Critical

- Wire Not Secured Tightly Between Washers
- Surges Destroyed Circuit Traces
- NOT Typical of Devices Failed in Field

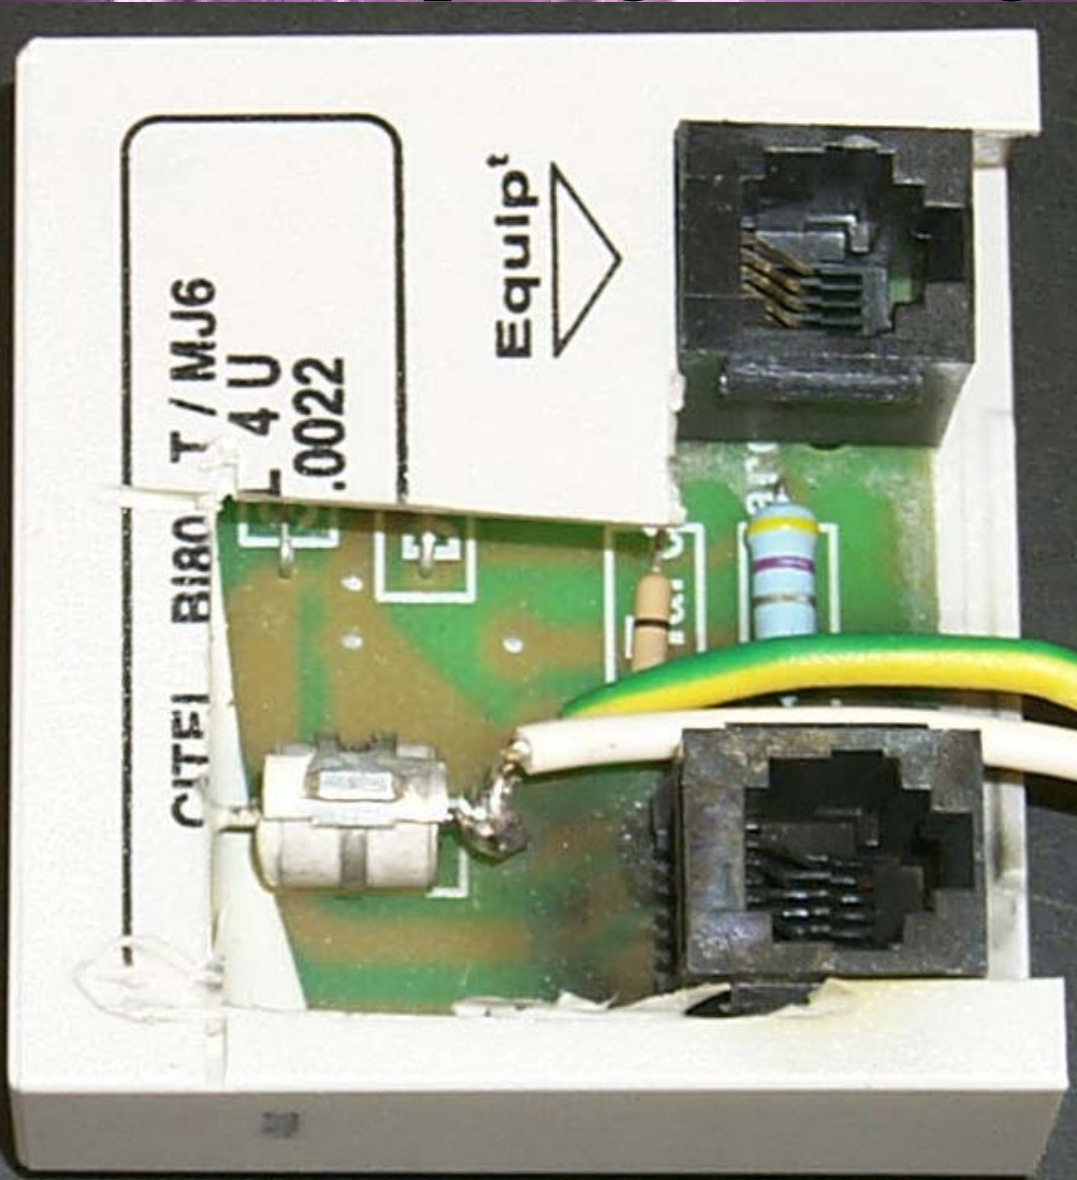
Coupling of Surges Critical

- Surge Mode
 - Line-to-Line
 - Destroyed Connector
- NOT Typical of Field Experience
