# OPERATING EXPERIENCE SUMMARY

**U.S. Department of Energy**  
**Office of Environment, Safety and Health**  
OE Summary 2004-23  
November 29, 2004

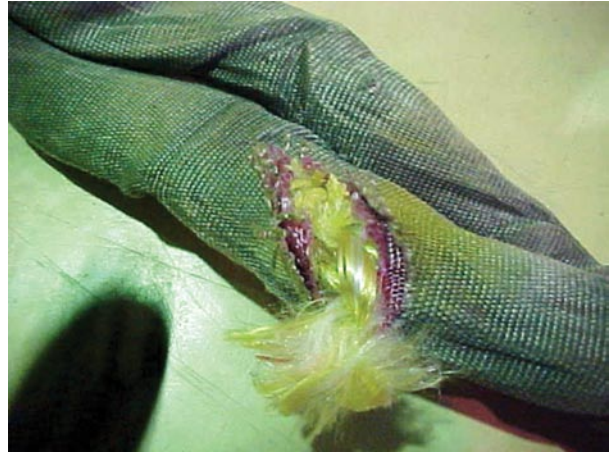
A review of the lifting plan revealed that the nylon slings were improperly attached to a steel lifting attachment, which cut into the slings. The plan directed attaching the slings using a basket arrangement (from the shackles on a spreader bar, through the lifting attachment, and directly back to the shackle). Instead, the rigger attached the slings in a choker arrangement, which was specified in the lift plan for an alternate lifting attachment.

Preliminary information from the investigation shows that a lift of this type had not been performed in approximately 9 months and that the instructions in the lifting plan may not have been well defined. Also, the rigger used blotter paper for sling protection, which proved inadequate to prevent damage to the slings (Figure 1-1). The rigger and the Person-In-Charge signed the lift plan indicating that the rigging had been properly installed; however,

*Figure 1-1. Synthetic web sling damaged by sharp edges of steel lifting attachment*

*These events underscore the importance of following the approved lift plan and ensuring that the rigging selection and configuration are correct. The Person-In-Charge should conduct a physical check of the load to verify its configuration during the walkdown of the load movement path. Calculations for weight and center of gravity should be checked for accuracy as part of the lift plan review process.*

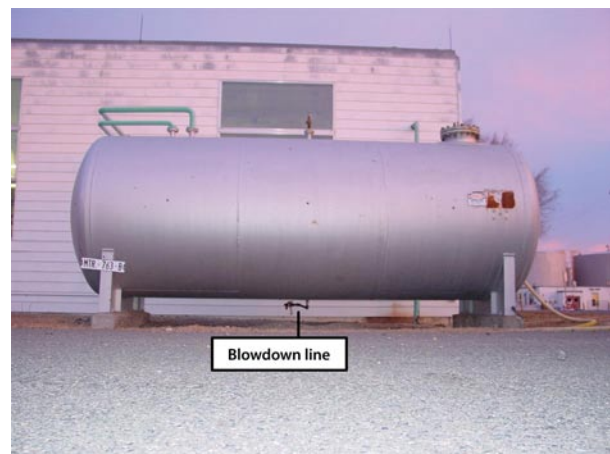
On November 19, 2004, at the Idaho Test Reactor Area, a section of blowdown line for a compressed air receiver tank unthreaded from a pipe nipple and flew approximately 70 feet, striking a dumpster. An operator was bleeding air from the air receiver through the blowdown line at the time of the event. There were no injuries. (ORPS Report ID--BBWI-ATR-2004-0014)

The operator was performing a functional test on the automatic start feature of the air compressor controllers. The test required the operator to bleed air from the air receiver tank through the blowdown line connected to the bottom of the receiver (Figure 2-1) until the pressure lowered to the start setpoint for the compressors. The receiver was pressurized to 130 psig at the start of the test. After the operator partially opened the ball valve on the blowdown line, he saw the piping start to rotate and unthread from the nipple. He immediately vacated the area, exiting just as the line blew off and became a missile.

**Figure 2-1.** *Compressed air receiver tank viewed from the direction of the garbage dumpster*

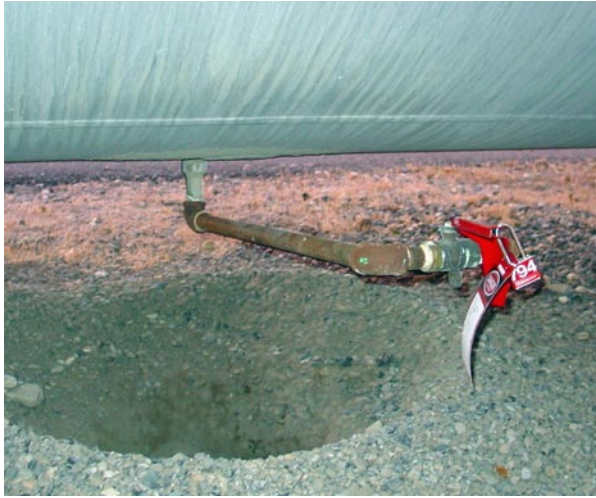
of the tank, a 4-inch length of pipe, a 90-degree elbow, a 30-inch length of pipe, another 90-degree elbow, a 2-inch length of pipe, a ball valve, and a 4-inch length of pipe. Figure 2-2 shows the blowdown line after it was reattached to the tank.

**Figure 2-2. Configuration of blowdown line with locked and tagged ball valve**

The existing piping configuration allowed the reaction of the escaping air to rotate the pipe in the unthreaded (counter-clockwise) direction. The hole in the ground was produced by air escaping from the nipple after the line blew off.

The blowdown valve is operated each week to check for moisture accumulation in the tank. At some point, the blowdown line had been modified from a short pipe and valve pointing downward from the tank to the current configuration. Apparently the configuration was changed so the operators would not have to go underneath the tank to access the valve, as well as to alter the discharge path away from the dirt to eliminate the hazard of flying debris. However, the modification did not include a support or pipe restraint to prevent movement. A work order was prepared to reconfigure and anchor the piping to prevent recurrence.

*This event underscores the importance of using proper piping supports and restraints. Piping that is subject to jet forces, flow-induced vibration, or equipment-induced vibration should be adequately restrained and supported to prevent movement to ensure the integrity of the system and prevent a missile hazard. Piping system modifications*

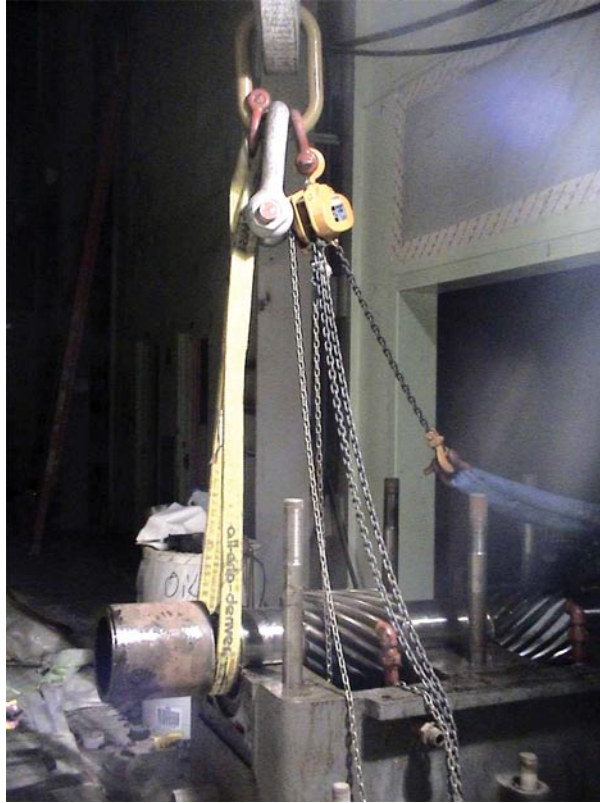
**Figure 3-1. Gearbox shaft and rigging**

As part of ongoing equipment dismantlement, workers were removing a splitter gearbox from a rolling mill. The workers had already rigged and removed the gearbox cover and an intermediate shaft and were in the process of lifting another shaft. A yellow nylon sling attached one end of the shaft to the hook, and a chainfall and blue nylon sling attached the other end to the hook. The chainfall was to be used to level the load as it was lifted because the gearbox was located adjacent to a wall. Figure 3-1 shows the rigged shaft.

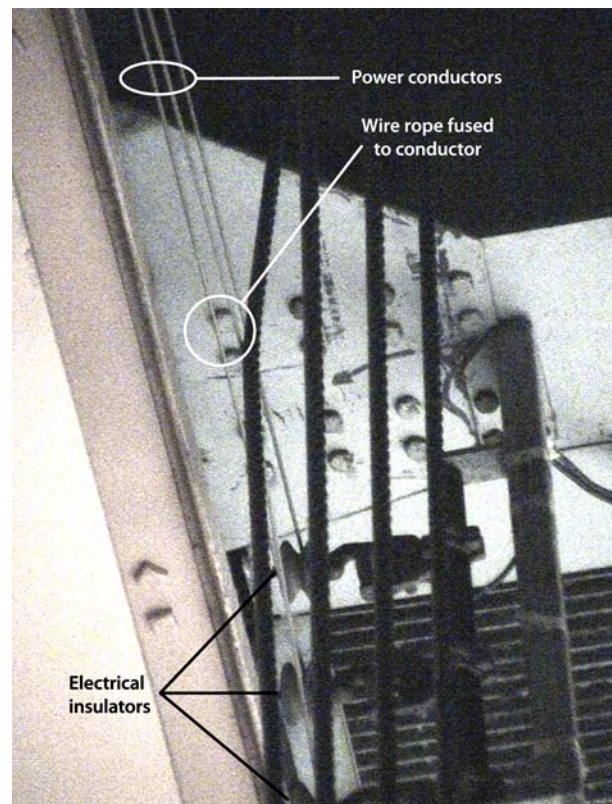
the crane operator to “bump up” to put tension on the crane, one of the running lines arced to the B phase power conductor and they fused together (Figure 3-2).

The crane is a 35-ton, overslung, bridge crane, manufactured by Moffett and installed in 1955. The conductors are bare copper and are attached to the crane rail by insulators that stand off approximately 4 inches, with 8 inches of separation between phases. The B phase is the lowest of the three conductors and the closest to the running lines.

- Having the load block at 5 degrees off vertical (towards the conductors) resulted in one of the running lines being within 4 inches of the bottom conductor.
- This model crane hoist has only one speed, making fine movement control difficult. When the operator bumped up on the control to take the slack out of the running lines, contact was made with the energized conductor, tripping power to the crane and to lights in the building.

**Figure 3-2. Looking at the hoist cables from below the crane**

Corrective actions will include reviewing the JHA for working with cranes to ensure that it addresses safe working distances around electrical conductors and any controls that would be required. Work crews will be briefed on this event and on any JHA changes. Inspectors will check other onsite cranes for similar construction.

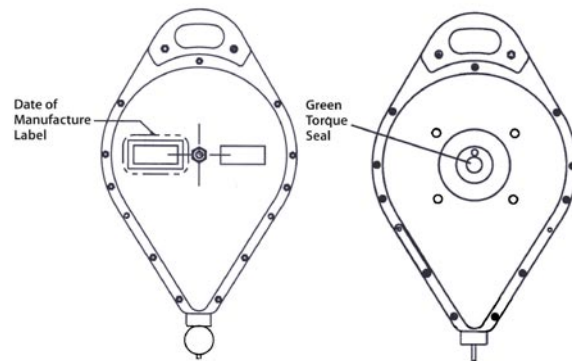
The Stop Use and Return Notice stemmed from an MSA investigation that revealed that housing subassemblies in some 70-foot SRLs and 95-foot Rescuers were improperly manufactured by a supplier. Although the units will lock in the event of a fall, MSA discovered that the line extension (deceleration distance) exceeds the MSA-specified distance of 40 inches. This condition occurs in only a small percentage of the units, and there have been no incidents or injuries related to the problem. However, MSA must open and examine the units to identify any problems and fix them.

**Figure 4-1. Location of date label and torque seal**

Users of the affected SRLs and Rescuers should immediately remove them from service and inspect them to identify the date of manufacture and to determine whether a green torque seal is present. Figure 4-1 shows the location of the date label and the green torque seal.
