Collision of Two Burlington Northern Santa Fe Freight Trains Near Clarendon, Texas May 28, 2002

Railroad Accident Report NTSB/RAR-03/01

**Collision of Two Burlington Northern Santa Fe
Freight Trains Near Clarendon, Texas
May 28, 2002**

**NTSB/RAR-03/01
PB2003-916301
Notation 7558
Adopted June 3, 2003**

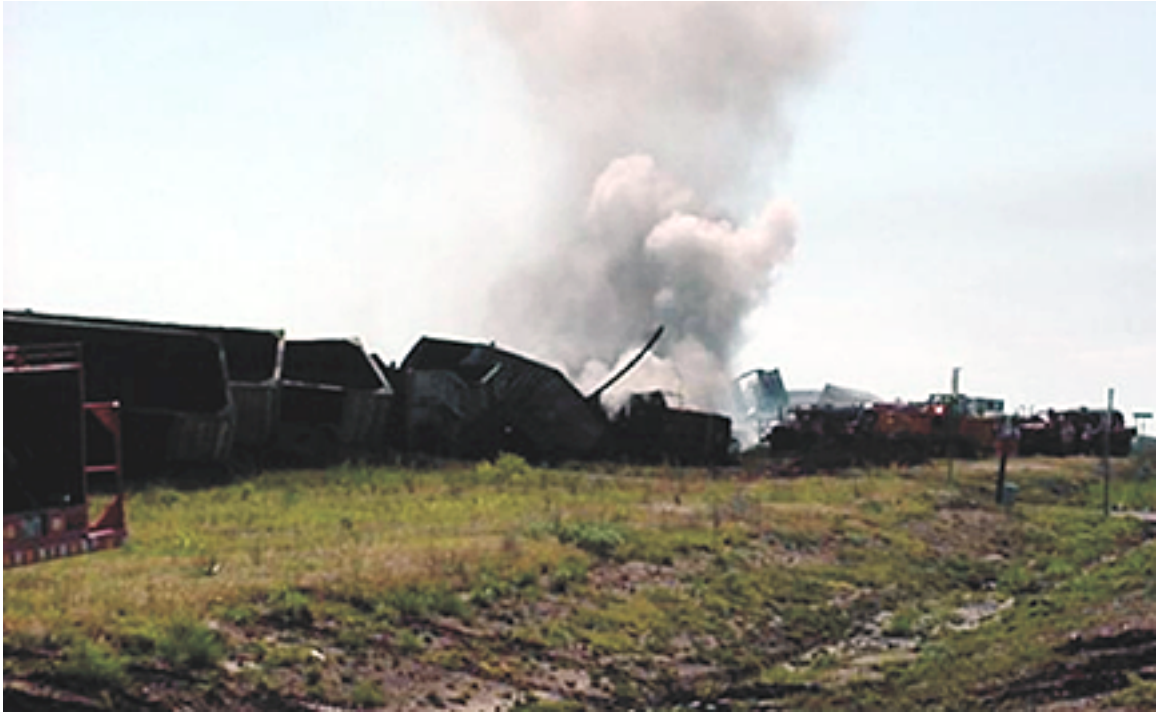
Figure 3. Wreckage of coal train.

Event recorder information indicates that both trains' brakes were placed in emergency before the collision. At the time the coal train was placed in emergency, it was moving at 49 mph. The intermodal train was placed in emergency as it was moving at 42 mph with the throttle in the 8th notch (maximum power). An engineering survey commissioned by the BNSF indicates that the coal train went into emergency 1,093 feet before the collision point and that the intermodal train went into emergency 1,064 feet before the collision point. At the point of the collision, the coal train had traveled for almost 10 minutes and about 7.8 miles from the point where it should have waited for the arrival of the intermodal train. (See figures 3 and 4.)

The postcollision fire consumed most of the combustible material in both locomotive cabs. The first six platforms of the intermodal train were also damaged by fire.⁸ Both locomotives at the head end of the coal train were derailed. The coal train's lead locomotive was destroyed. In addition to being damaged by fire, the cab section was separated from the frame and crushed into an unrecognizable shape. The second locomotive was also severely damaged. The first 23 cars of the coal train were derailed and destroyed. The distributed power locomotive at the rear of the coal train was not damaged. The two locomotives of the intermodal train were derailed; the lead locomotive was destroyed. The first four intermodal cars, a total of 12 double-stack platforms, were also derailed. The first 3 intermodal cars, each with 3 double-stack platforms, were destroyed, along with the 18 loaded containers that were carried on these cars.
