### III. Existing Conditions -- Truman Carriage House (HS-02)

#### Introduction and Description

HS - 2 TRUMAN GARAGE  
 HARVEY S. TRUMAN N. H. S.

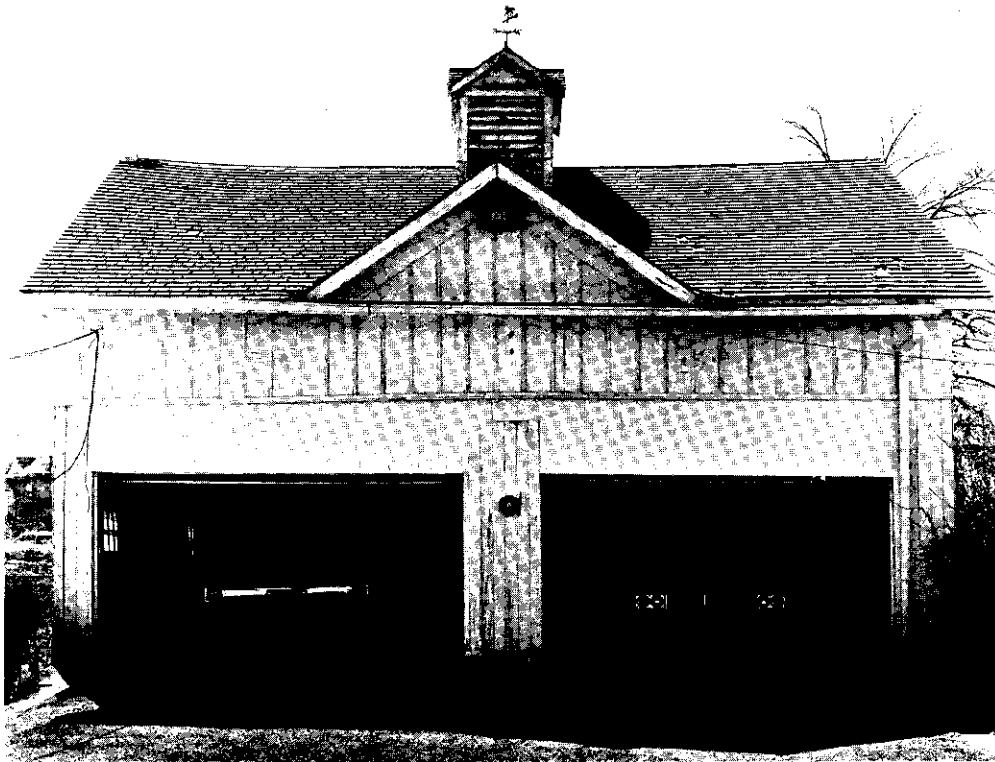
The two 7 foot x 13 foot 8 inch rolling overhead doors on the north elevation are in good condition except for the lower roller guides and pulleys which exhibit surface rust. The garage doors are paneled with the top panel glazed and are painted white. The doors are binding due to the shifting of the structure.

Fig. 3.1 Truman Carriage House, Fall 1985. North elevation (looking south). Credit: Zoom Studios

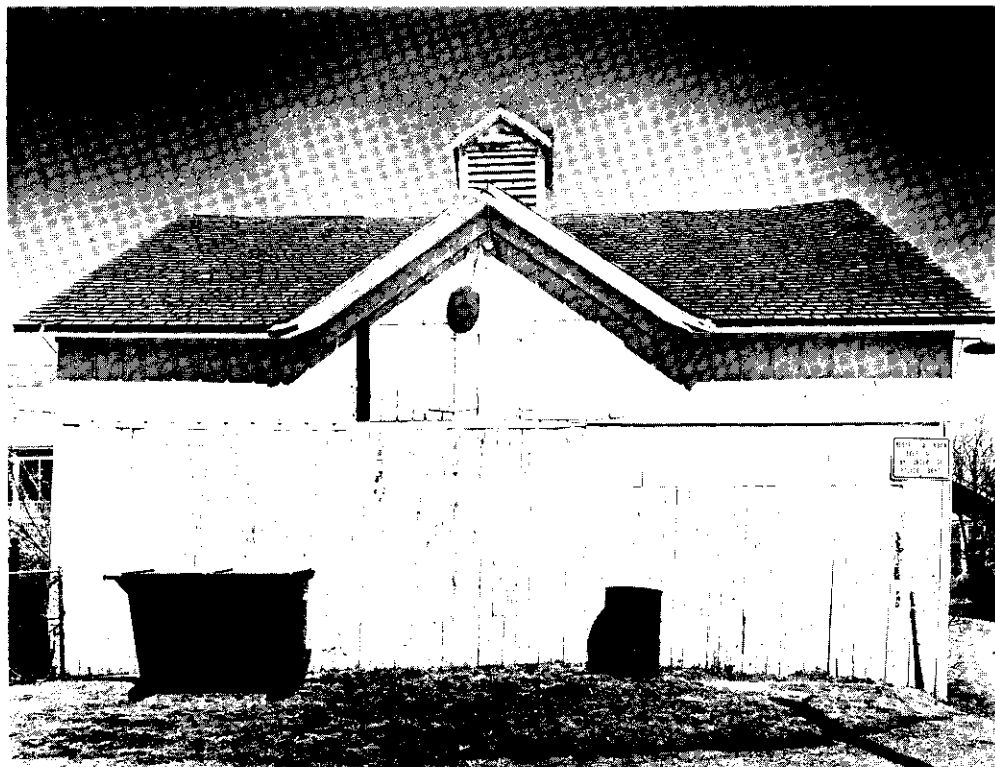
Drainage around the structure is generally very poor. At the south elevation adjacent to the alley, soil and gravel has been built up to obtain positive drainage away from the Carriage house. Unfortunately, the exterior grade now rises above the interior grade of the concrete floor slab. This has led to severe deterioration of the siding, foundation sill and structural post bases. It appears that the exterior grade has been raised at least 20 inches along the south elevation with

The siding on the south elevation is  $3/4$  x  $5-1/4$  inch vertical tongue and groove extending to the same height as the north elevation capped by a metal drip or simple square molding. It is sound except for the lower 6 to 10 inches which is in contact with the ground. Above the tongue and groove is board and batten siding.

Fig. 3.2 Truman Carriage House, Fall 1985. South elevation (looking north). Credit: Zoom Studios

No gutter exists on the south elevation. Lack of proper roof drainage and site grading which is sloped towards the south wall instead of away from it has caused the lower ends of the siding to decay. A gutter and downspout should be installed on this elevation and the site regraded to facilitate drainage away from the building.

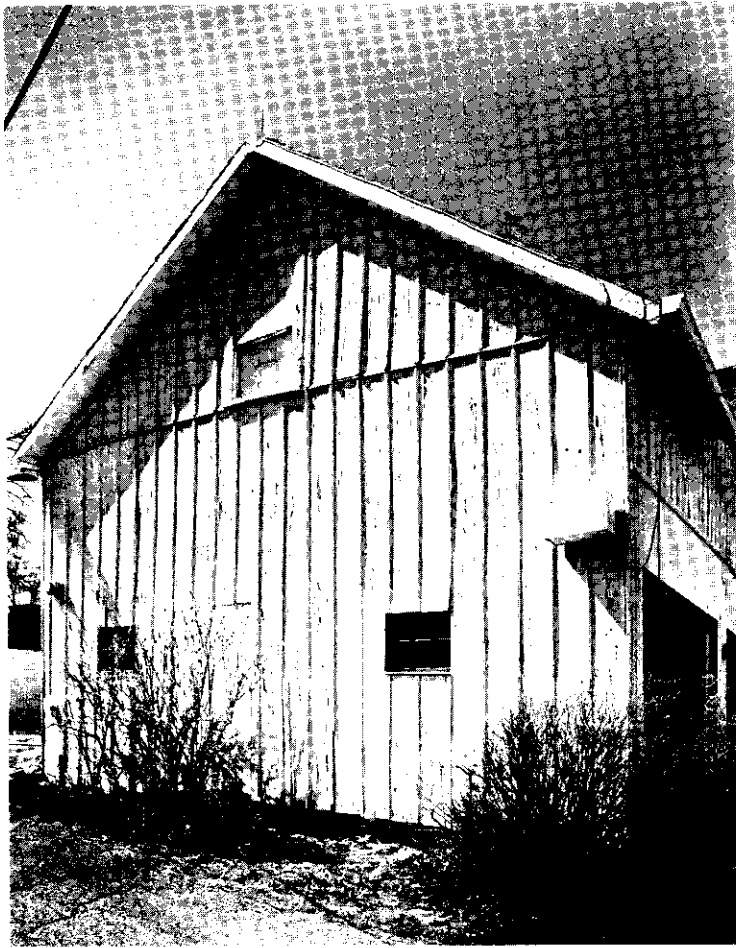
The grade along the east elevation is approximately 1 foot below the top of the foundation wall. Moisture problems are not apparent; there is a slight slope away from the building towards the driveway.<sup>2</sup>

The siding on the east elevation exhibits numerous open joints and missing or non-original battens. Relative to the west elevation, it is in poor condition. The edge is not in direct contact with the soil and is in sound condition.

Fig. 3.3 Truman Carriage House, Fall 1985. East elevation (looking west).  
Credit: Zoom Studios

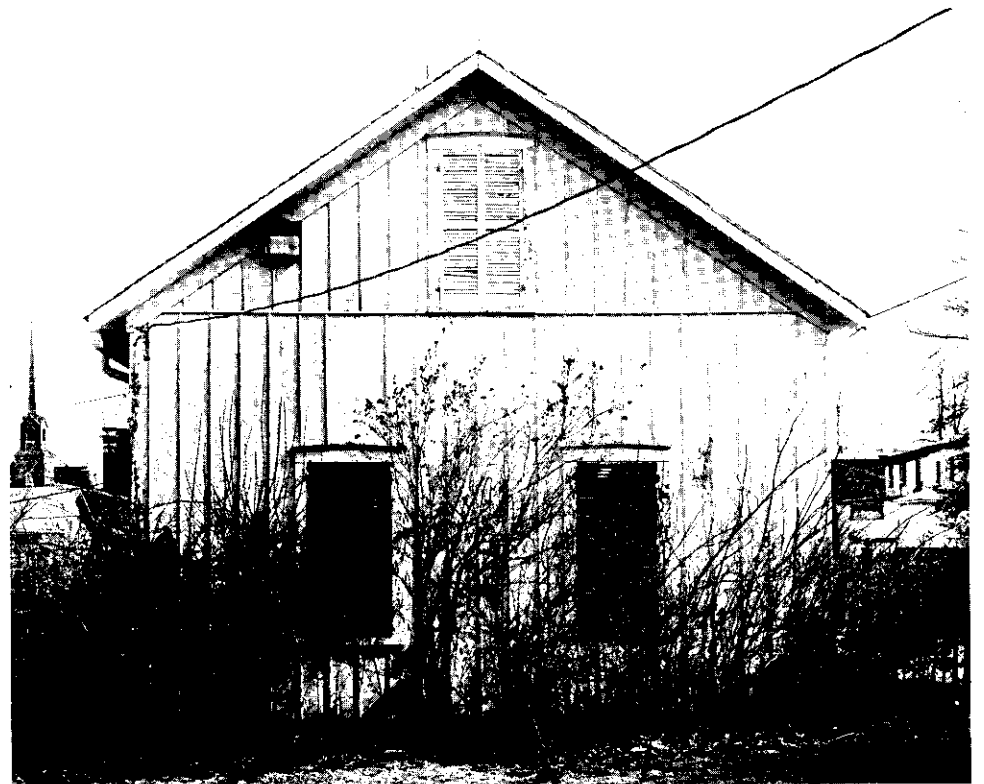
The west elevation shares some of the same problems as the south elevation. The soil has been built-up 2 inches above the top of the foundation wall. Tall, thick bushes along the west elevation have compounded moisture problems by reducing ventilation and sun exposure. The only downspout on the building drains rain water at the northwest corner. Negative slope causes water to pond in this area.

The Carriage house is sheathed in  $3/4$  x  $11-3/4$  to  $12-3/4$  inch board and batten siding or  $3/4$  x  $3-1/4$  or  $5-1/4$  inch tongue and groove<sup>14</sup> wood siding painted white. The east and west elevations are sheathed entirely with board and batten. The siding on the west elevation is in fair condition. The lower edge of the boards has decayed because it is in contact with the soil, a few battens are split, and a portion of the first board is missing at the southwest corner. Otherwise all boards and battens are intact.

Fig. 3.4 Truman Carriage House, Fall 1985. West elevation (looking east).  
Credit: Zoom Studios
