Near Miss — Worker Pinned Between Manlift and Overhead Pipe

Issue Number 2008-05, Article 1: Near Miss — Worker Pinned Between Manlift and Overhead Pipe

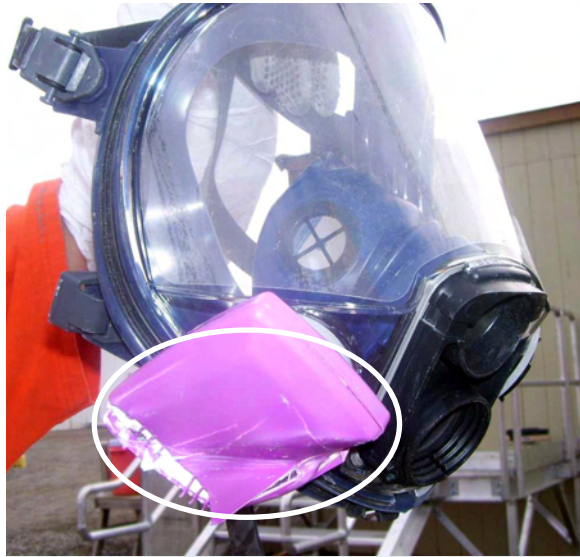
Figure 1-2. Damage to pink filter on painter's respirator

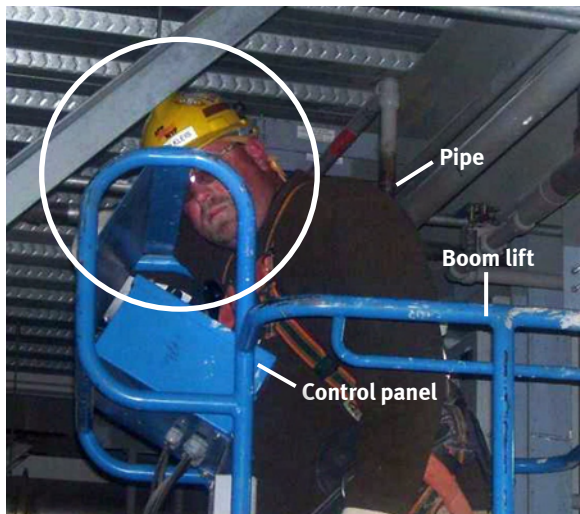
The painter was working in tight quarters (i.e., pipe supports, piping, I-beam, and ceiling) and was wearing a respirator. When the foreman asked him to stop work, he put the grinder down, but was unaware that the cord had looped around the toggle switch. He began to lower himself to the ground, and when he engaged the foot pedal and pulled the stop switch to the “on” position, the lift moved unexpectedly. The worker’s left hand was pinned between the control panel guard and an I-beam; his head, neck, and back were pinned between the control panel guard and a 2-inch-diameter pipe. The worker had not removed his respirator, and investigators believe that may have impaired his ability to see the control panel as he began his descent. Figure 1-2 shows the filter on the painter’s respirator, which was crushed in the accident. Figure 1-3 shows a re-enactment of the event, with the worker’s back against the pipe and his chest and head pressed into the control panel.

Figure 1-3. Re-enactment of the accident
